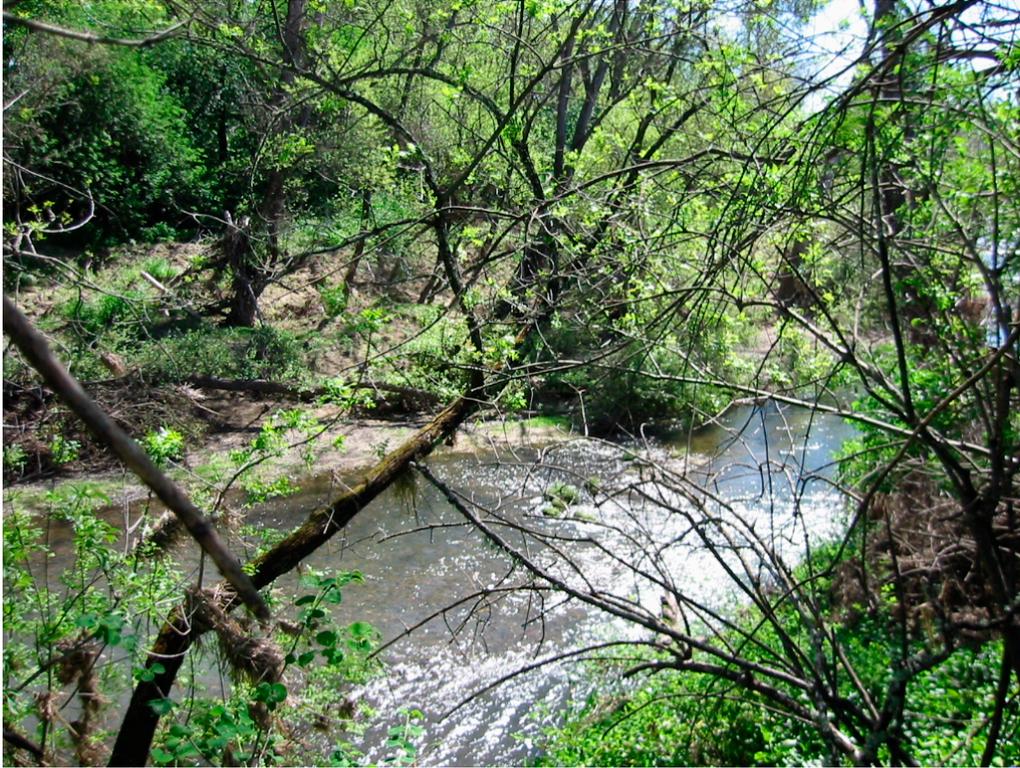
Photograph B-11. Possible knickzone in Peju Provinces and Round Pond Reach

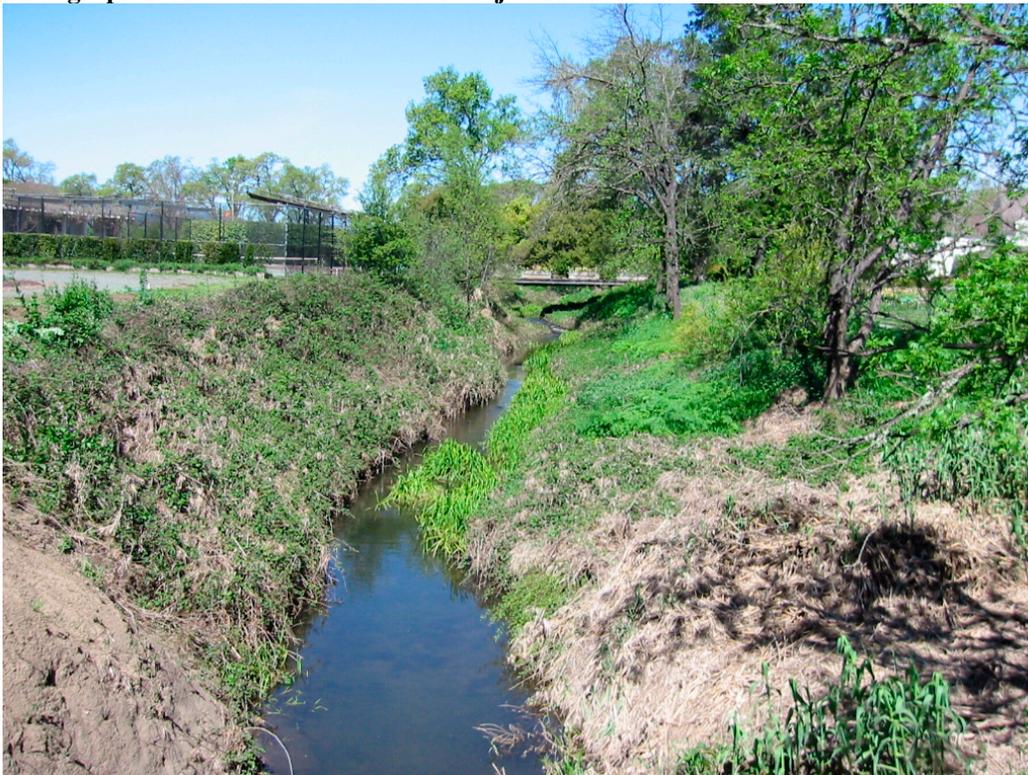
Photograph B-12. West side incised tributary at Wilsey property

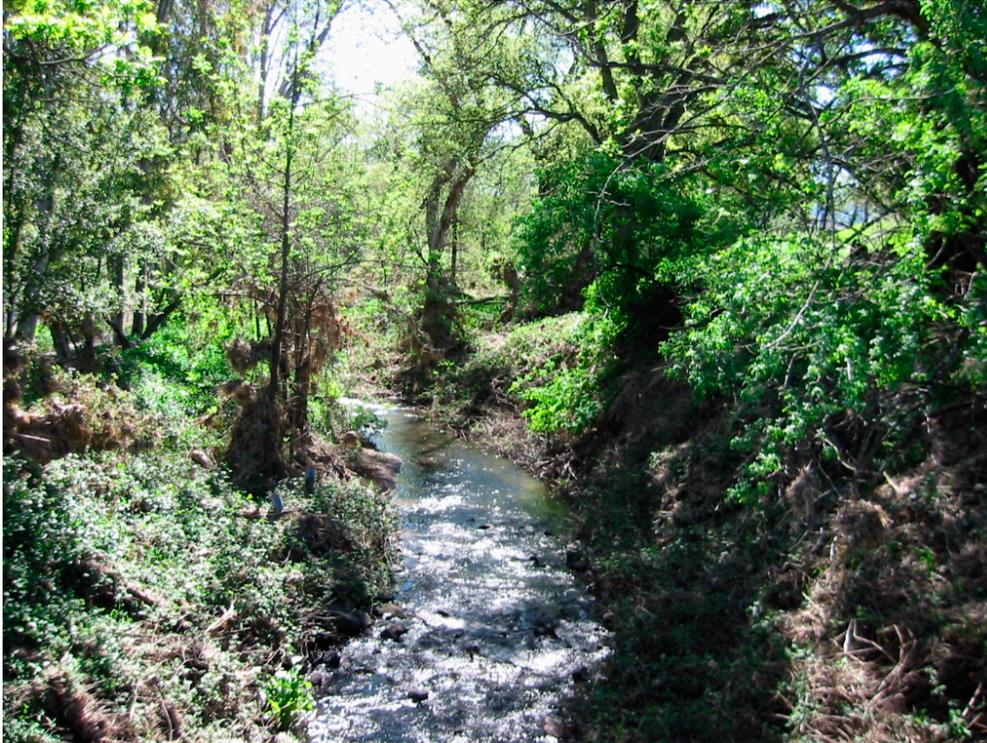
Photograph B-13. Looking downstream on west side tributary, Wilsey property

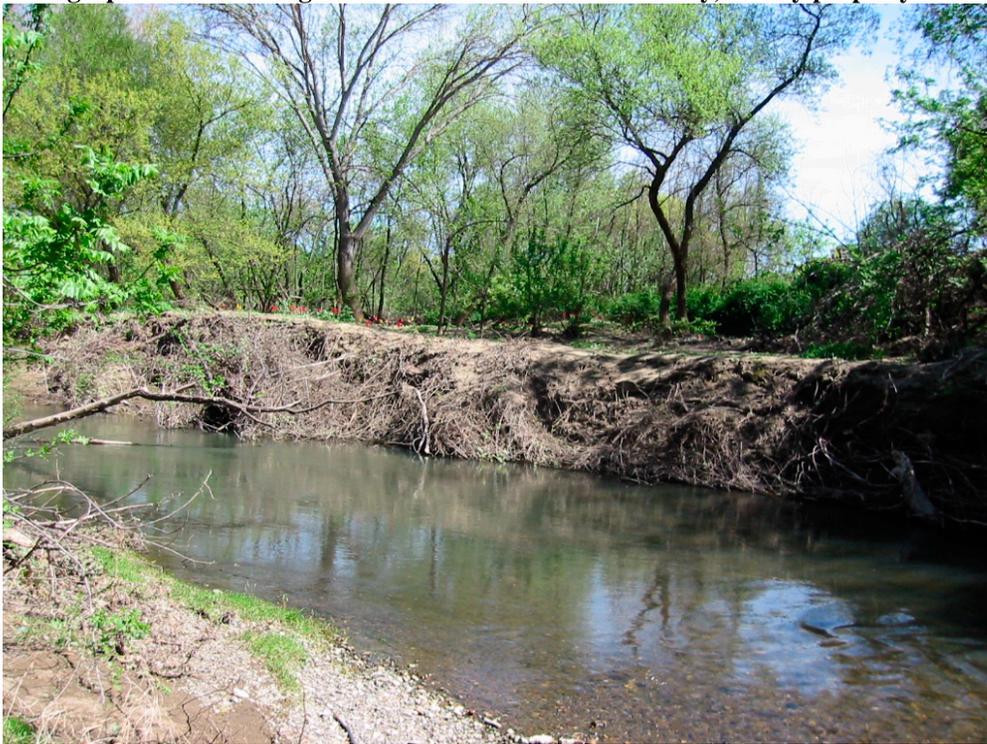
Photograph B-14. Round Pond south of Rutherford Rd from the Wilsey property, stage 5

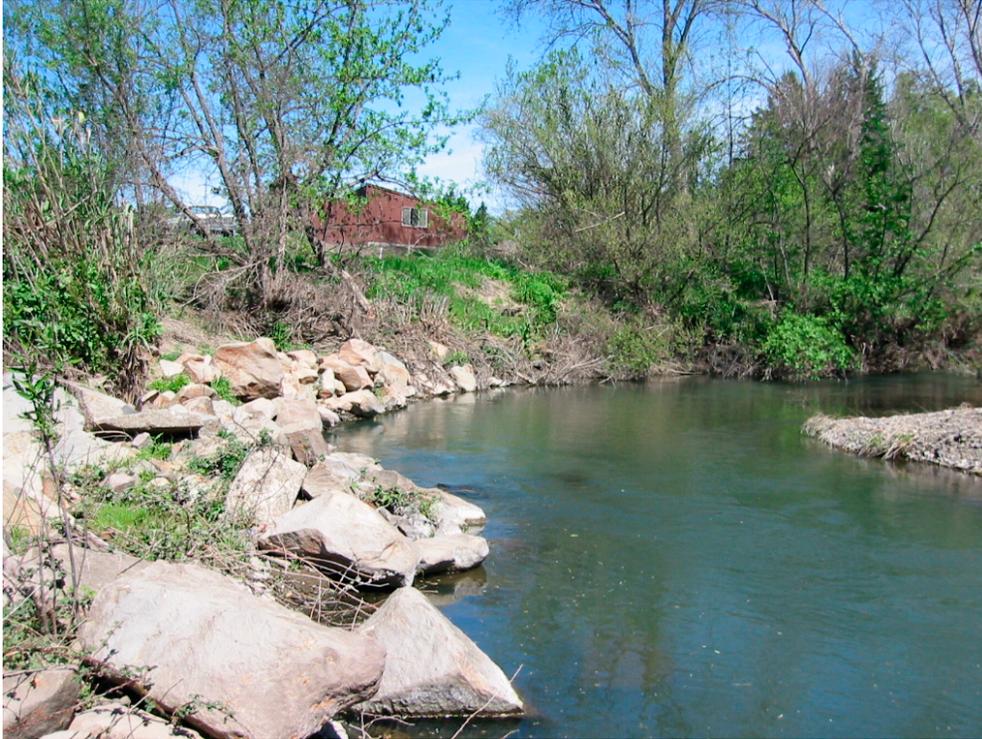
Photograph B-15. Undercut rip rap protection on the Wilsey property (west bank), stage 5 outside bend

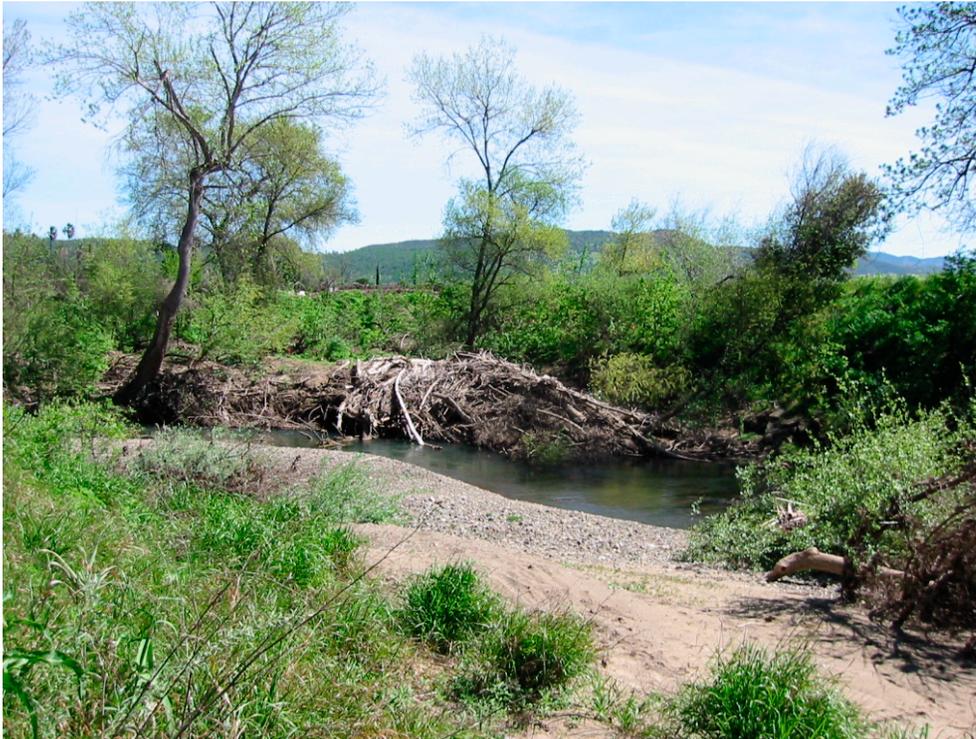
Photograph B-16. Within the Wilsey property - east bank from west bank, stage 6
