NAPA RIVER RUTHERFORD REACH RESTORATION PROJECT ANNUAL MONITORING REPORT - 2019

Reach 8, May 2019

Napa County Flood Control and Water Conservation District
804 First Street
Napa, California, 94559
Contact: Jeremy Sarrow
(707) 259-8204

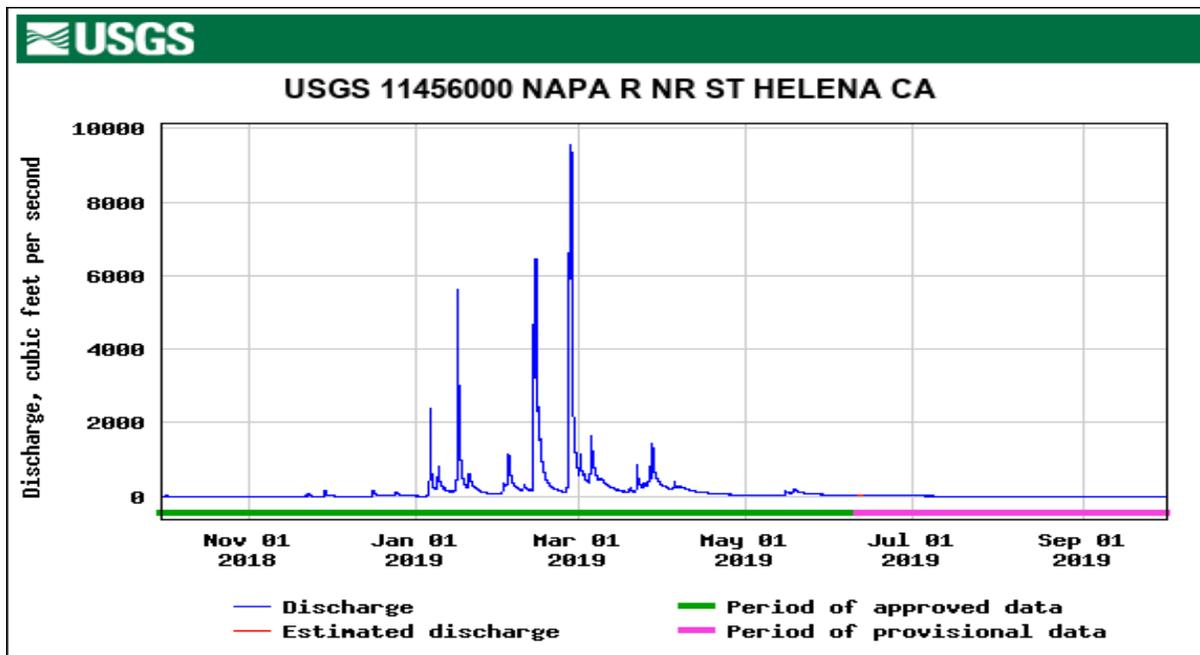
Figure 6. 2018-2019 streamflow, Napa River Rutherford Restoration Reach, USGS Station 11456000.

river receded until measurable streamflow ended on August 15, 2019. A plot of streamflow measured at Station 11456000 during the 2018-19 water year is included as **Figure 6**.

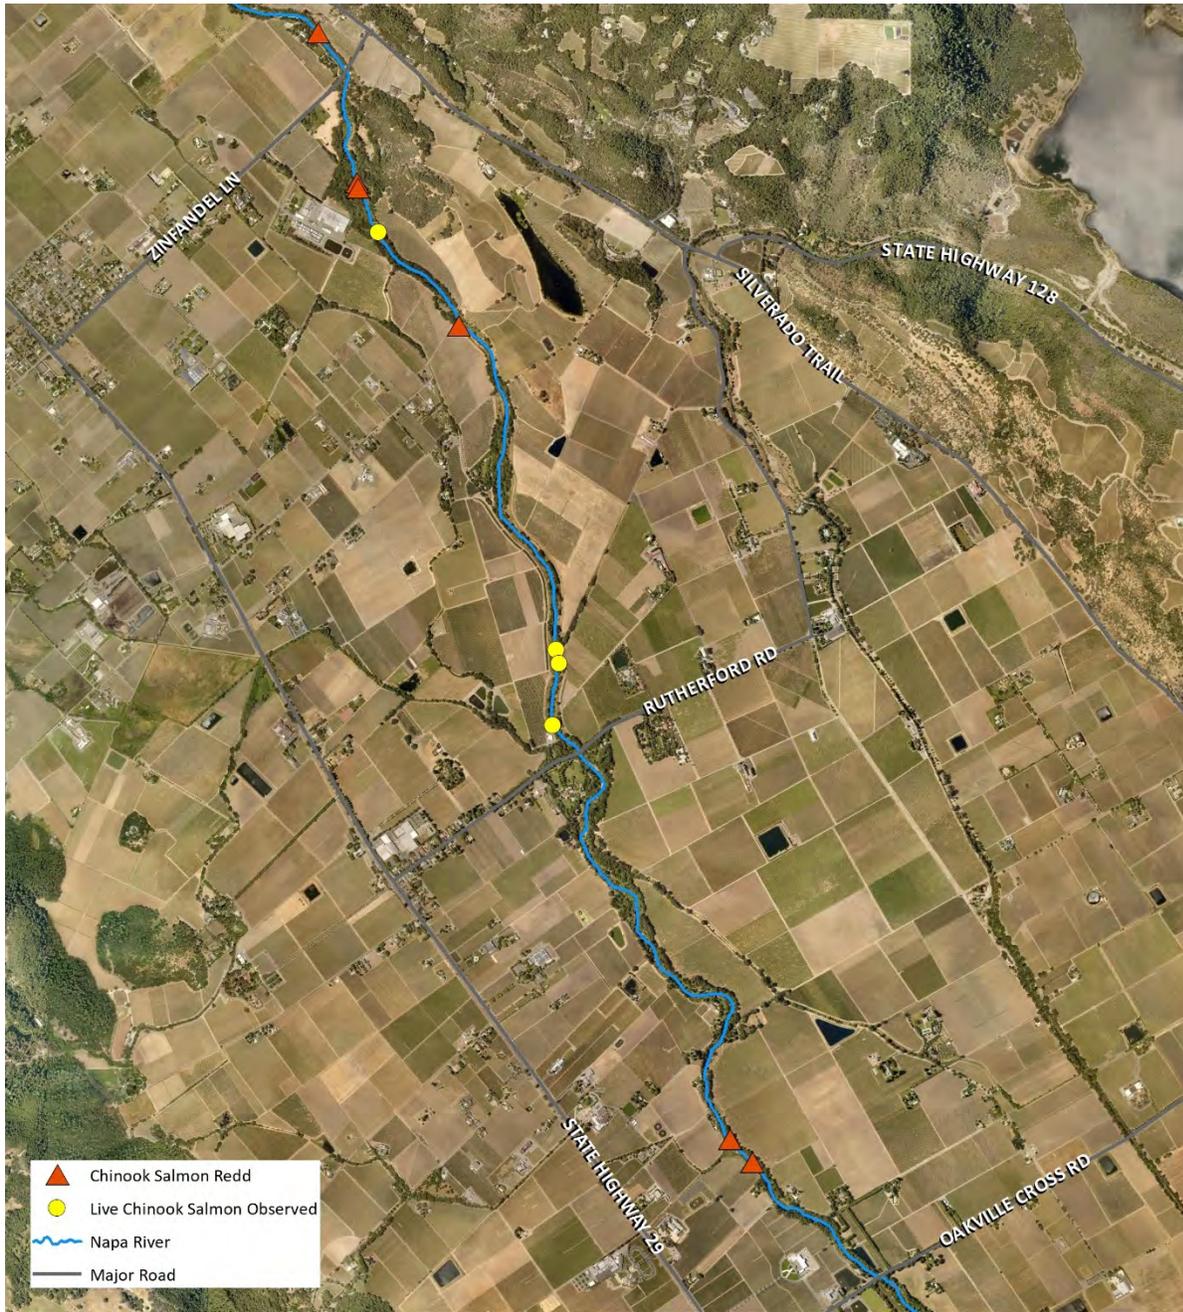
Figure 8: Redd and live adult survey observation locations

The results of the two surveys covering the Rutherford project reach are shown in **Table 9**. A total of four live adult Chinook salmon and five redds were observed throughout the reach, see **Figure 8** below. Of the five redds, four were constructed at riffle crests and one was constructed in the middle of a deep riffle. All of the live fish were observed holding in pools and glides, and no active redd digging or redd guarding behaviors were observed. Based on observations throughout the watershed, it appears that most Chinook spawning activity took place as soon as flow in the Napa River was sufficient to allow for upstream migration. In the 2019-20 spawning season, this likely occurred immediately following storms on December 2nd and 7th.
