Napa River Rutherford Reach Restoration Project Annual Maintenance Survey

August 2009

*Napa County Flood Control and
Water Conservation District
Napa County, California*

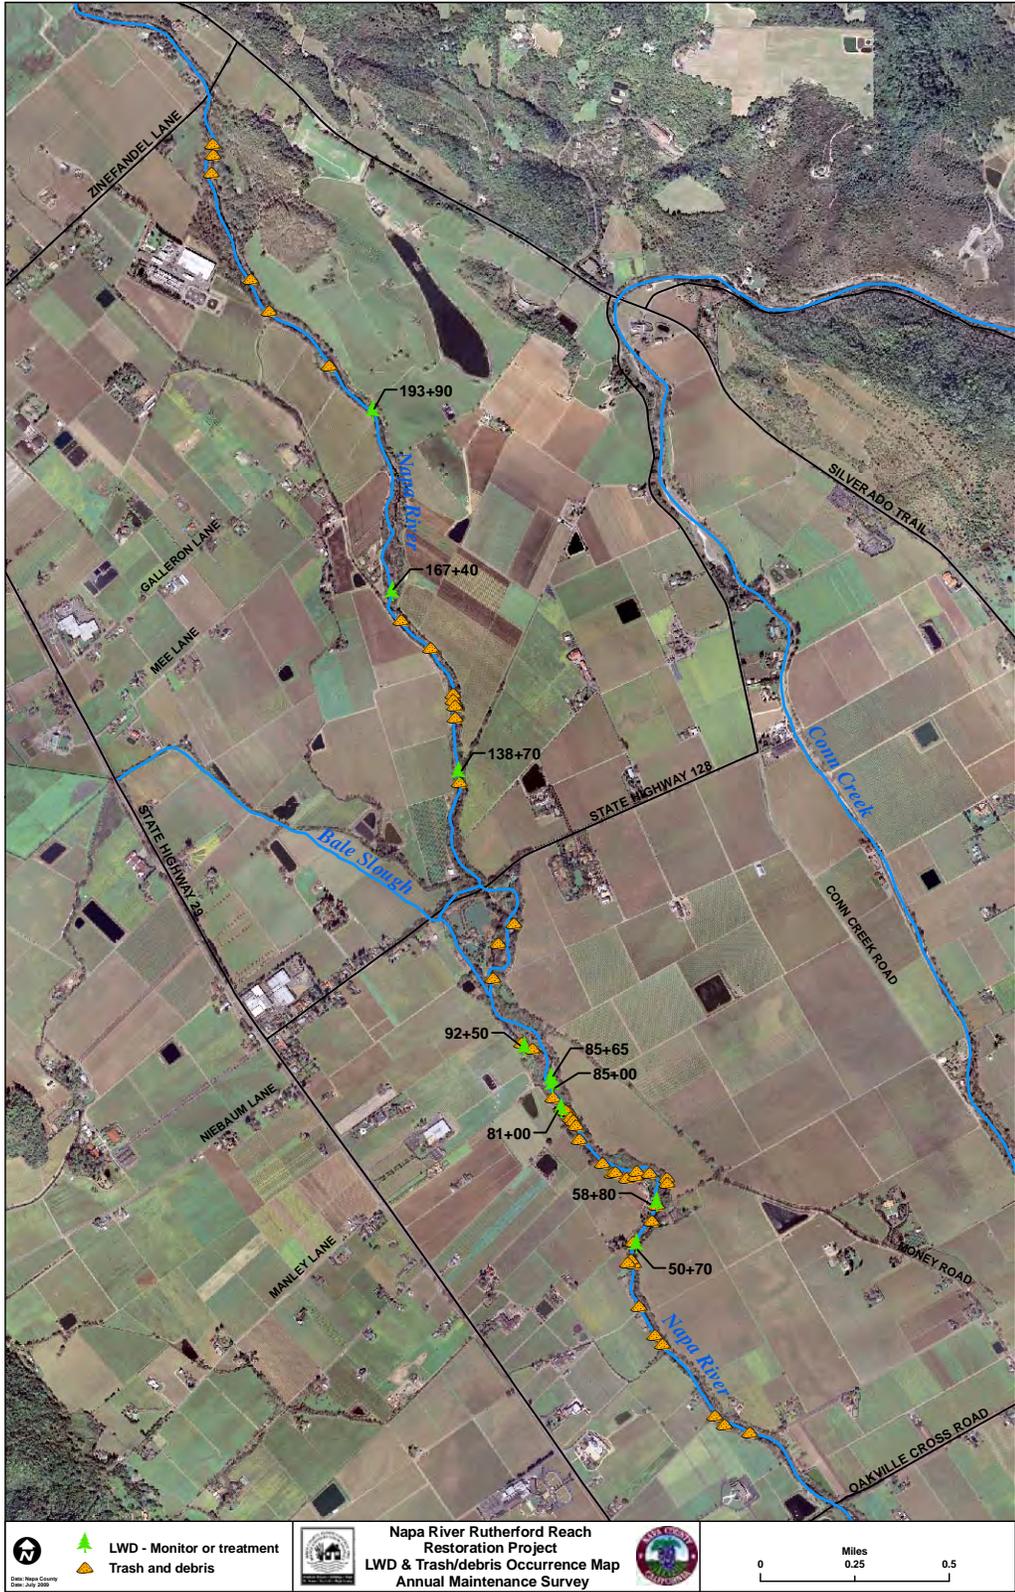
Figure 2: LWD, Trash and Debris Occurrence Map

A total of 47 occurrences of trash and debris were documented in the Project area with the dominant trash and debris type being tires (19) and the remaining 28 occurrences of trash and debris were objects such as irrigation drip lines, tarps, metal objects (storage drums, appliances, lawn mowers, etc.), a TV set, kiddy pool, car batteries, concrete rubble and a 1947 Buick automobile. Figure 2 shows the location of the trash and debris documented while Chart 1 below represents the amount of trash types documented during the stream survey.

A total of nine occurrences of large woody debris (LWD) were documented and ranked that represent potential maintenance issues (Table 2, Figure 2). LWD that ranked low did not receive any specific recommendations, while the LWD that ranked medium was recommended to be monitored to track any additional accumulation, mobilization, or incipient scour. For LWD that ranked high it is recommended that the LWD be treated by either realignment, relocation, or thinning out of smaller wood (<12-inches-in-diameter and/or <6-feet-long) to provide aqueduct hydraulic conveyance of high stream flows and prevent flooding and/or bank erosion. In locations where LWD was located in proximity of a designed Project feature, the LWD will be integrated into the design feature for use during Project construction.

River Station ID	LWD feature	Priority	Recommendation	Notes
50+70	Large single LWD, side channel, large pool	Medium	Monitor	Monitor for accumulation
58+80	Small wood accumulation (>10), side channel, small pool	Medium	Monitor	Monitor for potential bank erosion
81+00	Large wood accumulation/jam (>10), full channel, large pool	High	Monitor /Partial treatment	Thin out smaller wood to reduce backwater potential
85+00	Large single LWD, full channel, large pool, root wad attached	Medium	Monitor	Adjacent to designed feature: incorporate into project construction
85+65	Large wood accumulation (2 < 9), riffle bar stability	Low	Monitor	Monitor for potential erosion
92+50	Medium wood accumulation (2 < 9), side channel, medium pool	Medium	Monitor	Adjacent to proposed bench cut: incorporate into project construction

138+70	Medium wood accumulation (2 < 9), full channel, medium pool	Medium	Monitor/ Partial treatment	Thin out smaller wood to reduce flood potential – landowner request
167+40	Center/full channel willow mass providing instream shelter	Low	Monitor	Monitor for potential erosion, may consider thinning out of smaller wood
193+90	Large wood accumulation/jam (>10), full channel, large pool, root wad	Medium	Monitor	Monitor for potential erosion, possible candidate for thinning and/or realignment of wood

- Removal of all trash and debris from the stream channel that can be fairly easily accessed with a combination of hand labor and/or pulley/winch assisted mechanisms.
- Realignment and thinning out of two LWD structures (<12-inches-in-diameter and/or <6-feet-long) adjacent to Landowner property as recommended by survey team and requested by Landowner (Table 2).
- Control and treat large accessible patches of invasive plants that are ranked as “high” impact invasive species and are known Pierce Disease hosts, including poison hemlock, periwinkle, and Himalayan blackberry, control and treat giant reed and Red sesbania patches with appropriate control measures including mechanical removal and herbicide application (this task also includes re-vegetation planting and irrigation of treatment sites where treatment has left significant gaps in the riparian under story canopy).

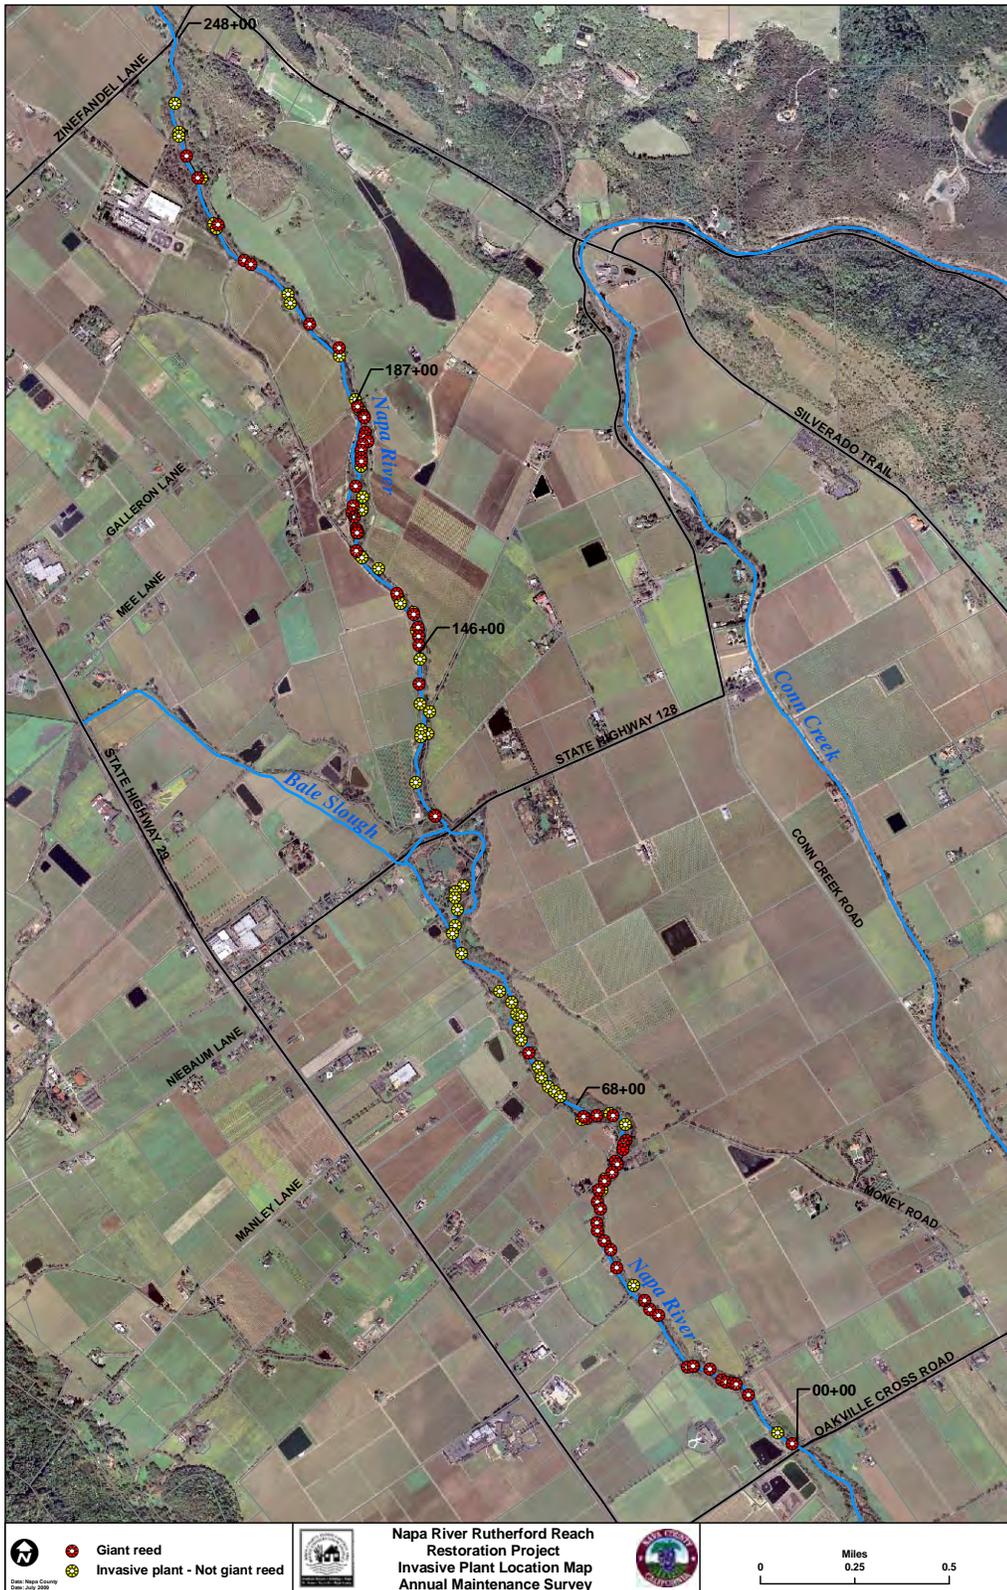
Figure 3: Invasive Plant Species Occurrence Map

A total of 121 occurrences of invasive plants were identified and documented within the Project area (Figure 3). Giant reed was the dominate invasive plant while tree-of-heaven, poison hemlock, Himalayan blackberry, and periwinkle also occurred in relatively high populations with sesbania, black locust, and fennel occurrences being relatively low. The distribution of giant reed was generally limited to those areas not treated previously through invasive plant removal programs. The largest patches of giant reed within the Project area occurred on the west bank from river station (RS) 187+00 to RS 146+00 and on both the east and west banks downstream of RS 68+00 to RS 00+00 (Oakville Cross Road); Figure 3. The distribution of tree-of-heaven, poison hemlock, Himalayan blackberry, periwinkle and fennel occurrences were roughly continuous throughout the project area while sesbania and black locust was generally limited to nine small patches. Table 1 summarizes the invasive plant species observed during the stream survey. Further, Table 1 lists if the species is a Pierce Disease host and ranks each species as a “high” or “moderate” impact invasive species as defined by the California Invasive Plant council (Cal-IPC); the Cal-IPC list primarily includes plants exhibiting some level of invasiveness in native habitats.

While it is anticipated that many of the invasive plants can be eradicated due to their natural history, such as giant reed (a perennial), 100% eradication is likely neither possible nor realistic with species such as poison hemlock (a biennial) within the first, second or third treatment years. Control and adaptive management of target invasive plant species over the life of the Project is the goal. All maintenance work will be conducted in accordance with the regulatory permits issued for the Napa River Rutherford Reach Restoration Project.
