Napa River Rutherford Reach Restoration Project Annual Maintenance and Monitoring Survey

Napa River June 2013

July 2013

*Napa County Flood Control and
Water Conservation District
Napa County, California*

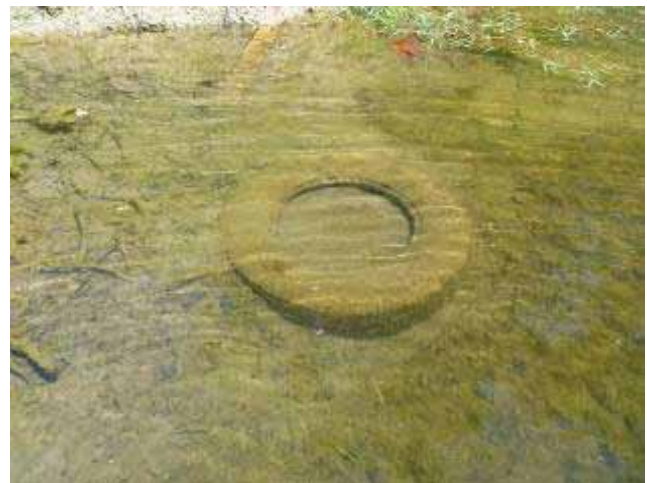
Picture 1: Trash and Debris

A total of 25 occurrences of trash and debris (Picture 1) were documented in the Project area with the dominant trash and debris type being tires (10 occurrences), see Picture 1, and the remaining 15 occurrences of trash and debris being various objects including irrigation drip lines, plastic containers, tarps and metal objects. This represents a significant decrease in the amount of trash and debris documented and removed from the four prior maintenance surveys. By contrast, the lowest number of trash occurrences documented in 2011 was 48 significant items. Figure 2 shows the location of the trash and debris documented. Graph 1 below represents the amount and types of trash documented during the stream survey and depicts the general long-term trend of a decrease in trash and debris found in the river.

- Removal of all trash and debris from the stream channel that can be readily accessed and accomplished with hand labor, pulley or winch assisted mechanisms.

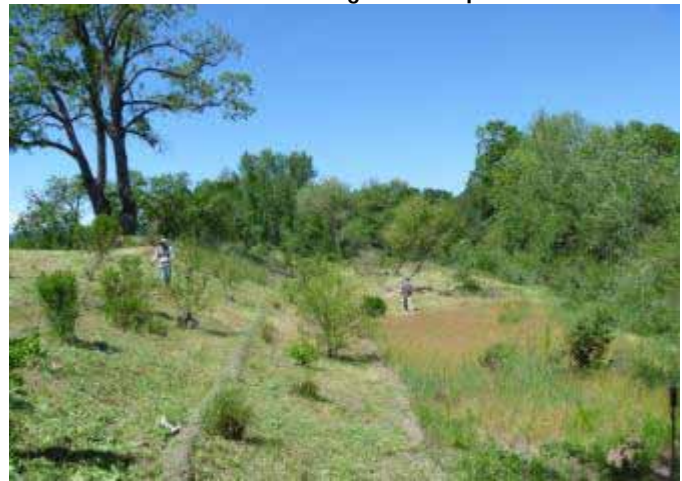
Picture 2: Annual weed mowing/invasive plant abatement

Additional non-native invasive plants and Pierce host plant treatment is currently taking place in Reaches 1 though 4 and 8 under the post construction re-vegetation maintenance contracts (Picture 2). Species currently being removed include Himalaya blackberry, periwinkle (*Vinca sp.*), giant reed, poison hemlock, tree off heaven and native and/or hybridized grape species. In limited instances Mugwort (*Artemisia douglasiana*), a native species that hosts Pierce Disease bacteria, has been managed pursuant to specific landowner requests.

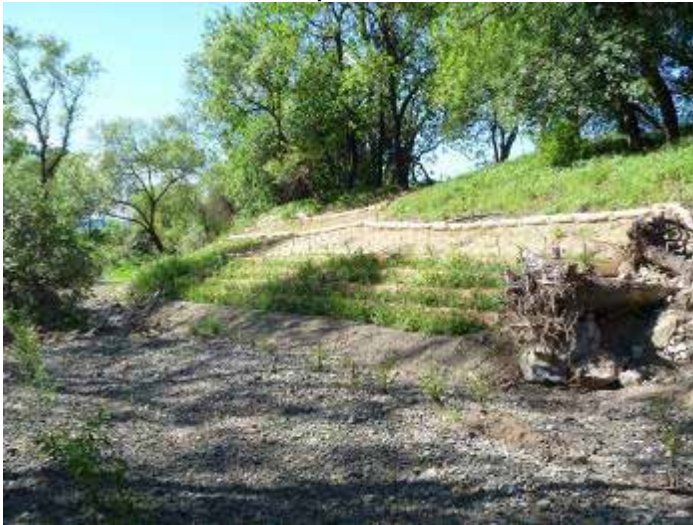
Picture 3: Reach 8 erosion repair site (March 2013)

In the newly constructed Reach 4, west bank, and Reach 8 sites, the downstream and upstream ends of several of the floodplain benches, where graded areas transition to unaltered slopes, experienced scour and erosion related to the December 2012 high stream flows. Those transition areas were replanted willow and cottonwood stakes and rebuilt with vegetated soil lifts (VSL) in March of 2013 and appear to be growing and holding well (Picture 3).

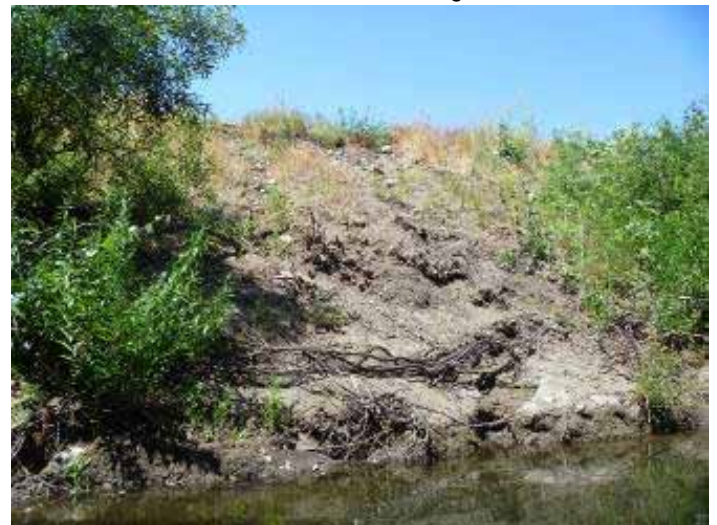
Picture 4: Arundo treatment site showing bank erosion

Previous and ongoing efforts to manage and remove giant reed (Arundo) have been successful in significantly reducing the amount of giant reed in the entire Project area. Graph 2 below depicts the general decline of Arundo throughout the Project area. Many of the eroding banks where Arundo has been cleared has been, or is planned to be, treated as part of the river restoration project. Currently, only small or re-sprouting patches require treatment under the Maintenance Assessment District.

As previously mentioned, there are additional areas of localized bank erosion related to the previously treated Arundo sites (Picture 4) that the District intends to address/stabilize using a combination of bio-technical methods such as those utilized above in the fall of 2013. See Table 3 for the location and details of the proposed bank stabilization work to be conducted at these sites.

River Station/Reach	Property	Proposed Work
191+75 (Reach 2)	Frogs Leap	Remove dead Arundo stalks and excavate root mass where feasible. Cover exposed areas of soil with erosion control fabric, straw wattles and erosion control jute net, seed mix in Fall and plant with live willow stakes.
156+50 (Reach 4)	Emmolo Vineyards	Remove dead Arundo stalks and excavate root mass where feasible. Cover exposed areas of soil with erosion control fabric, straw wattles and erosion control jute net, seed mix in Fall and plant with live willow stakes; possible brush mat.
142+80 (Reach 4)	Caymus Vineyards	Remove significant stand of dead Arundo stalks and excavate root mass where feasible. Cover exposed areas of soil with erosion control fabric, straw wattles and erosion control jute net, seed mix in Fall and plant with live willow stakes; possible brush mat.
29+50 (Reach 9)	Laird	Will be treated as part of Reach 9, east bank, 2014 construction and re-vegetation work.

- Repair and stabilize exposed stream banks at *Arundo* treatment sites as outlined in Table 3. Additionally, more comprehensive bank stabilization measure will be implemented at one of these sites once Project construction related commence during the summer of 2014.

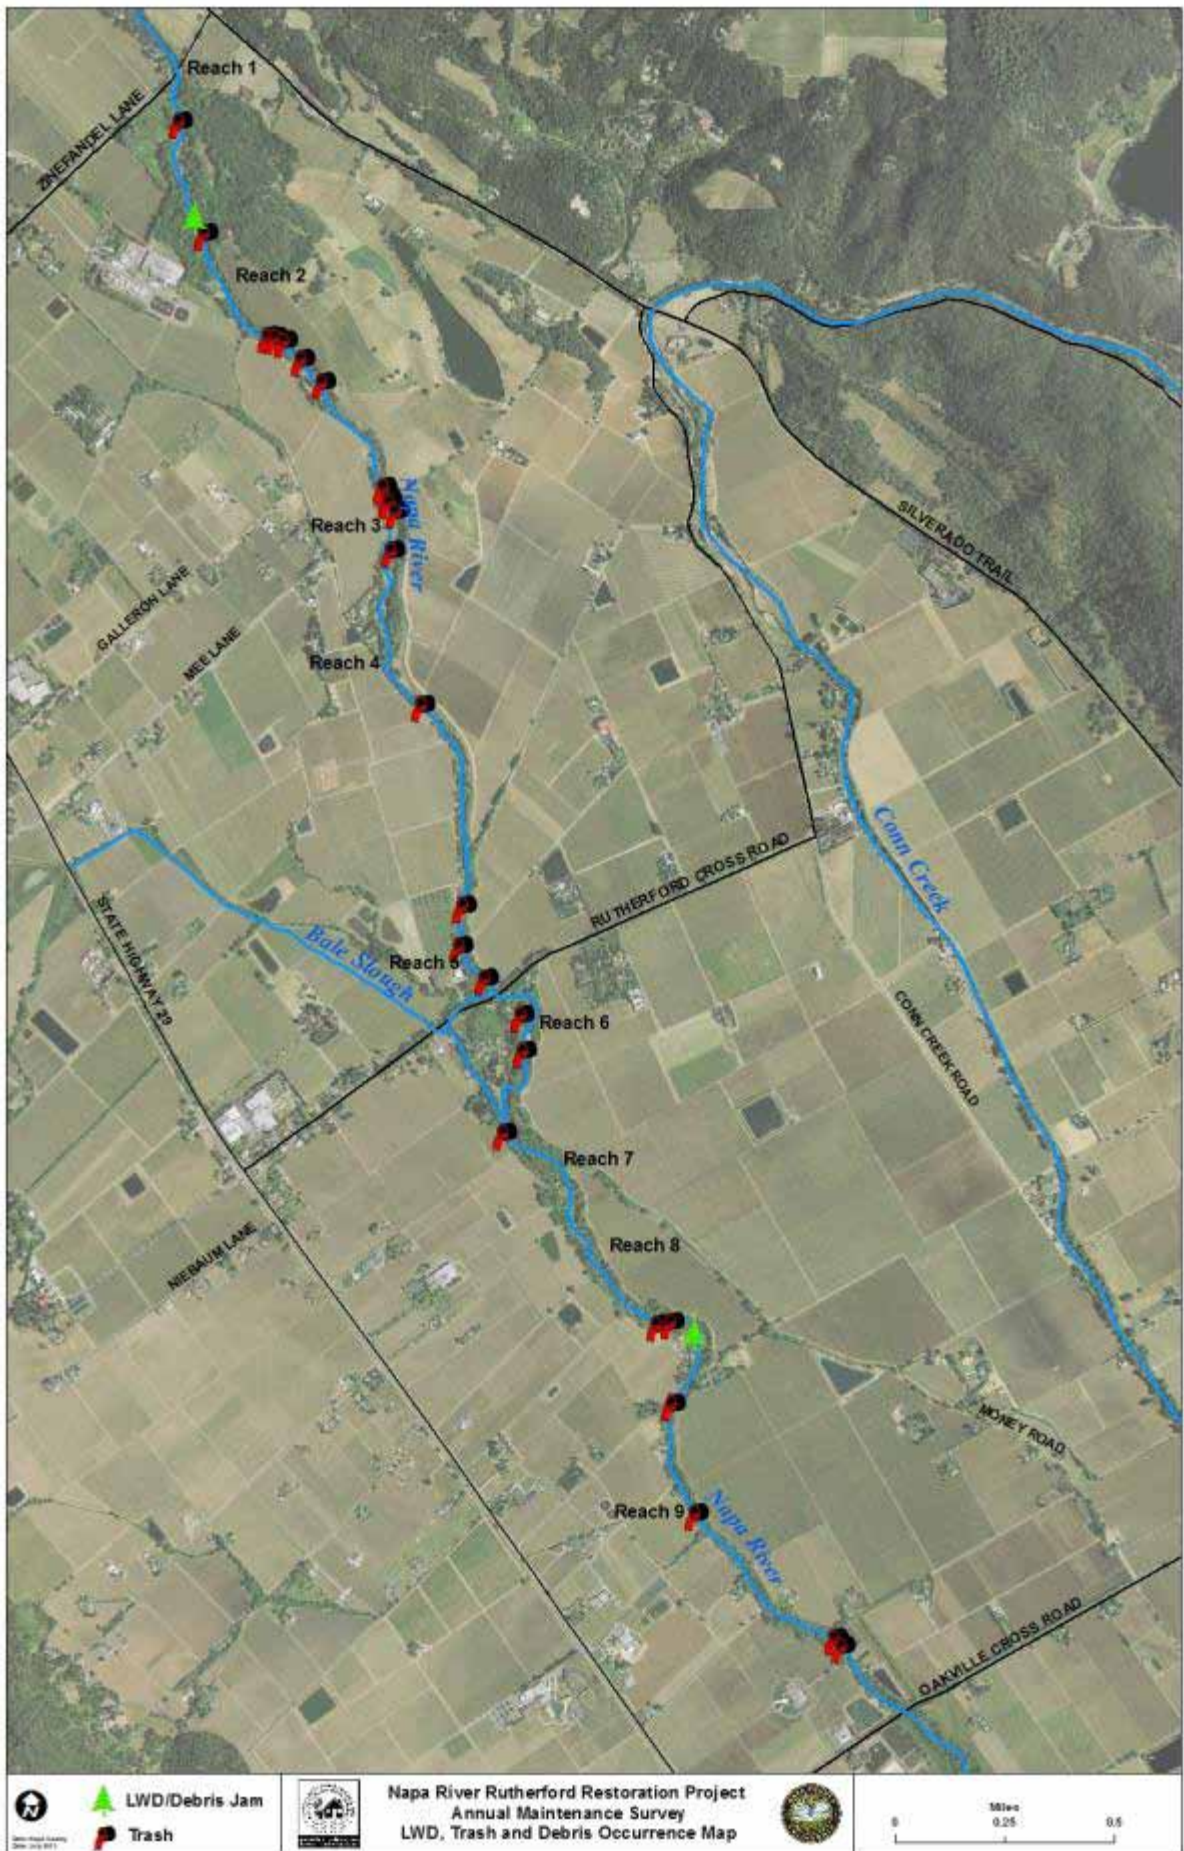
Figure 2: LWD, Trash and Debris Map

A total of 200 large woody debris (LWD) structures and boulder clusters were documented and evaluated during the 2013 stream survey, 115 of which were naturally recruited LWD (minimum size: one foot diameter and six feet long); with the remaining 85 either LWD or boulder clusters structures installed as part of the restoration Project. Of the 115 naturally recruited LWD occurrences documented, 2 have been prioritized for maintenance in the 2013 work plan (thin out smaller wood, trim trunk and/or realign larger wood to reduce flood potential or erosion) (Table 2, Figure 2). As previously reported at the Spring 2013 LAC meeting, following high flow events on November 30th and December 23rd, two debris jams in Reach 8 (Sequoia Grove) were thinned out (twice) that required considerable resources to remove. As part of the Reach 8BC construction activities this year, the contractor will salvage suitable pieces of wood from the LWD debris jam at Sequoia Grove to utilize in the creation of in-stream habitat structures. The remaining 113 naturally recruited LWD occurrences that were surveyed function as important in-stream fish habitat and do not require maintenance. The distribution, habitat function and accumulation trends of all occurrences of LWD will be presented in a separate annual habitat monitoring report.

River Station/Reach	LWD feature	Recommendation	Notes
228+20 (Reach 1)	Large single trunk alder, center channel, root wad diverting flow into right bank	Maintenance Recommended	Treatment – remove large limbs, leave trunk, to increase channel flow capacity, minimize root wad surface area
65+00 – 63+50 (Reach 8)	Large wood accumulation/jam (>10), west channel	Maintenance Recommended	Treatment – large wood to be incorporated into Reach 8B/C project construction as in stream habitat structure. This debris jam was also thinned out in February and March of 2013

- Limb/ thin large branches and/or root wads at LWD jams (<12-inches-in-diameter and/or <6-feet-long) adjacent to landowners property as recommended by survey report (Table 2).

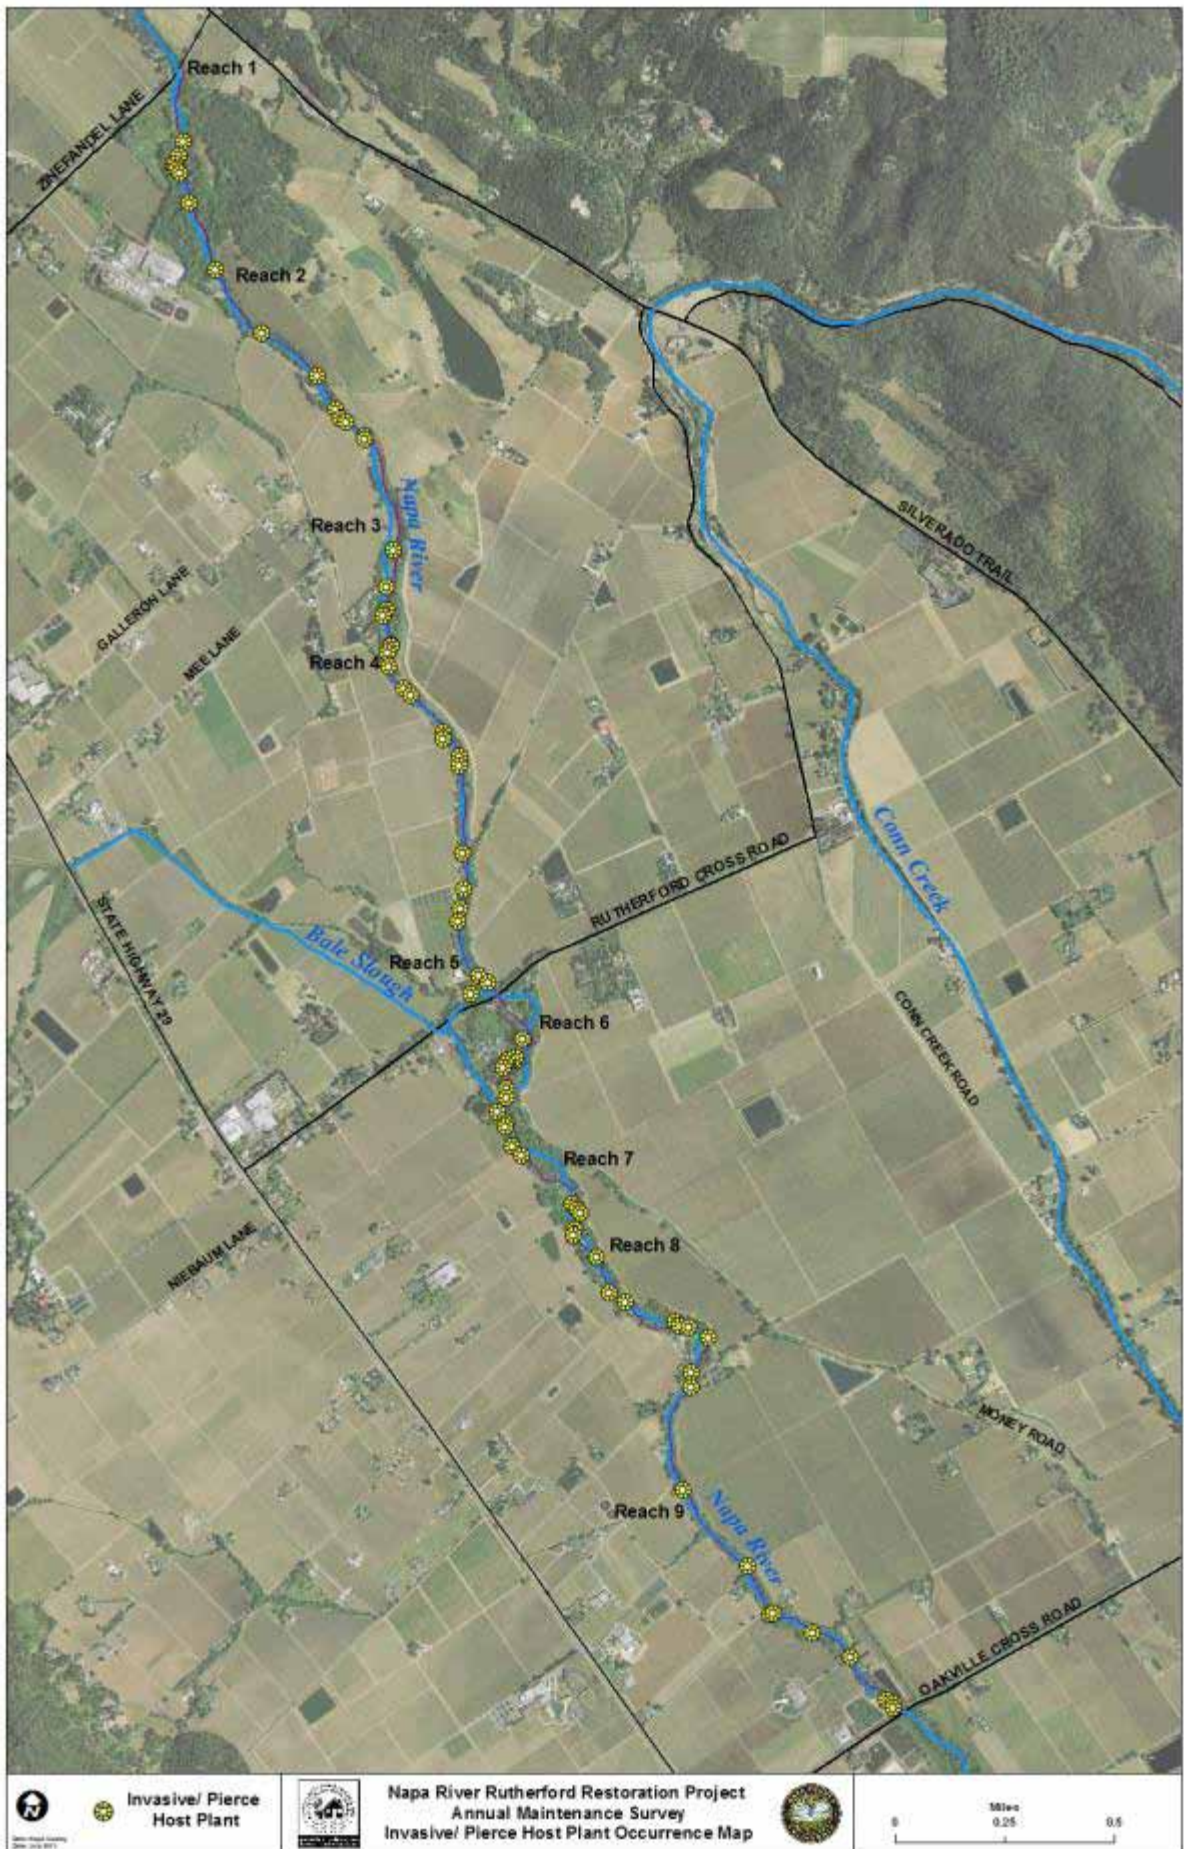
Figure 3: Invasive/ Pierce Host Plant Occurrence Map

A total of 72 occurrences of invasive non-native plants were identified, 33 of which were Pierce host plants, and will be targeted for treatment within the Project area (Figure 3). As in previous surveys, Giant reed, Himalaya blackberry, periwinkle (*Vinca sp.*), poison

A total of 55,321 square feet (sqft) of non-native invasive and Pierce host plants was documented including 42,688 sqft of Himalaya blackberry, 5,662 sqft of giant reed and the remaining 6,971 sqft being a combination of native/non-native grape, periwinkle and sesbania. It is important to note that there are additional occurrences of grape, periwinkle and other Pierce host plants present beyond the river’s top of bank, out of view of the in-channel river survey; therefore it is recommended that landowners contact the maintenance lead with any requests for management of invasive and/or Pierce host plants in the riparian zone beyond the top of bank that may be missed during the channel survey.

Common Name	Scientific Name	Infested Area (SqFt)	Pierce Disease host	Cal-IPC Ranking
Giant reed	<i>Arundo donax</i>	5,662	No	High
CA & Hybrid Grape & Periwinkle	<i>Vitus sp., Vinca major</i>	6,971	Yes	None/Moderate
Himalaya Blackberry	<i>Rubus armeniacus</i>	42,688	Yes	High
Total		55,321

- Treat large accessible patches of invasive and Pierce host plants that are ranked as either “high” or “moderate” impact species including periwinkle, Himalaya Blackberry, native and hybridized grape species and giant reed; this task also includes appropriate re-vegetation planting/seeding and irrigation of treatment of sites where treatment has left significant gaps in the riparian under story canopy.

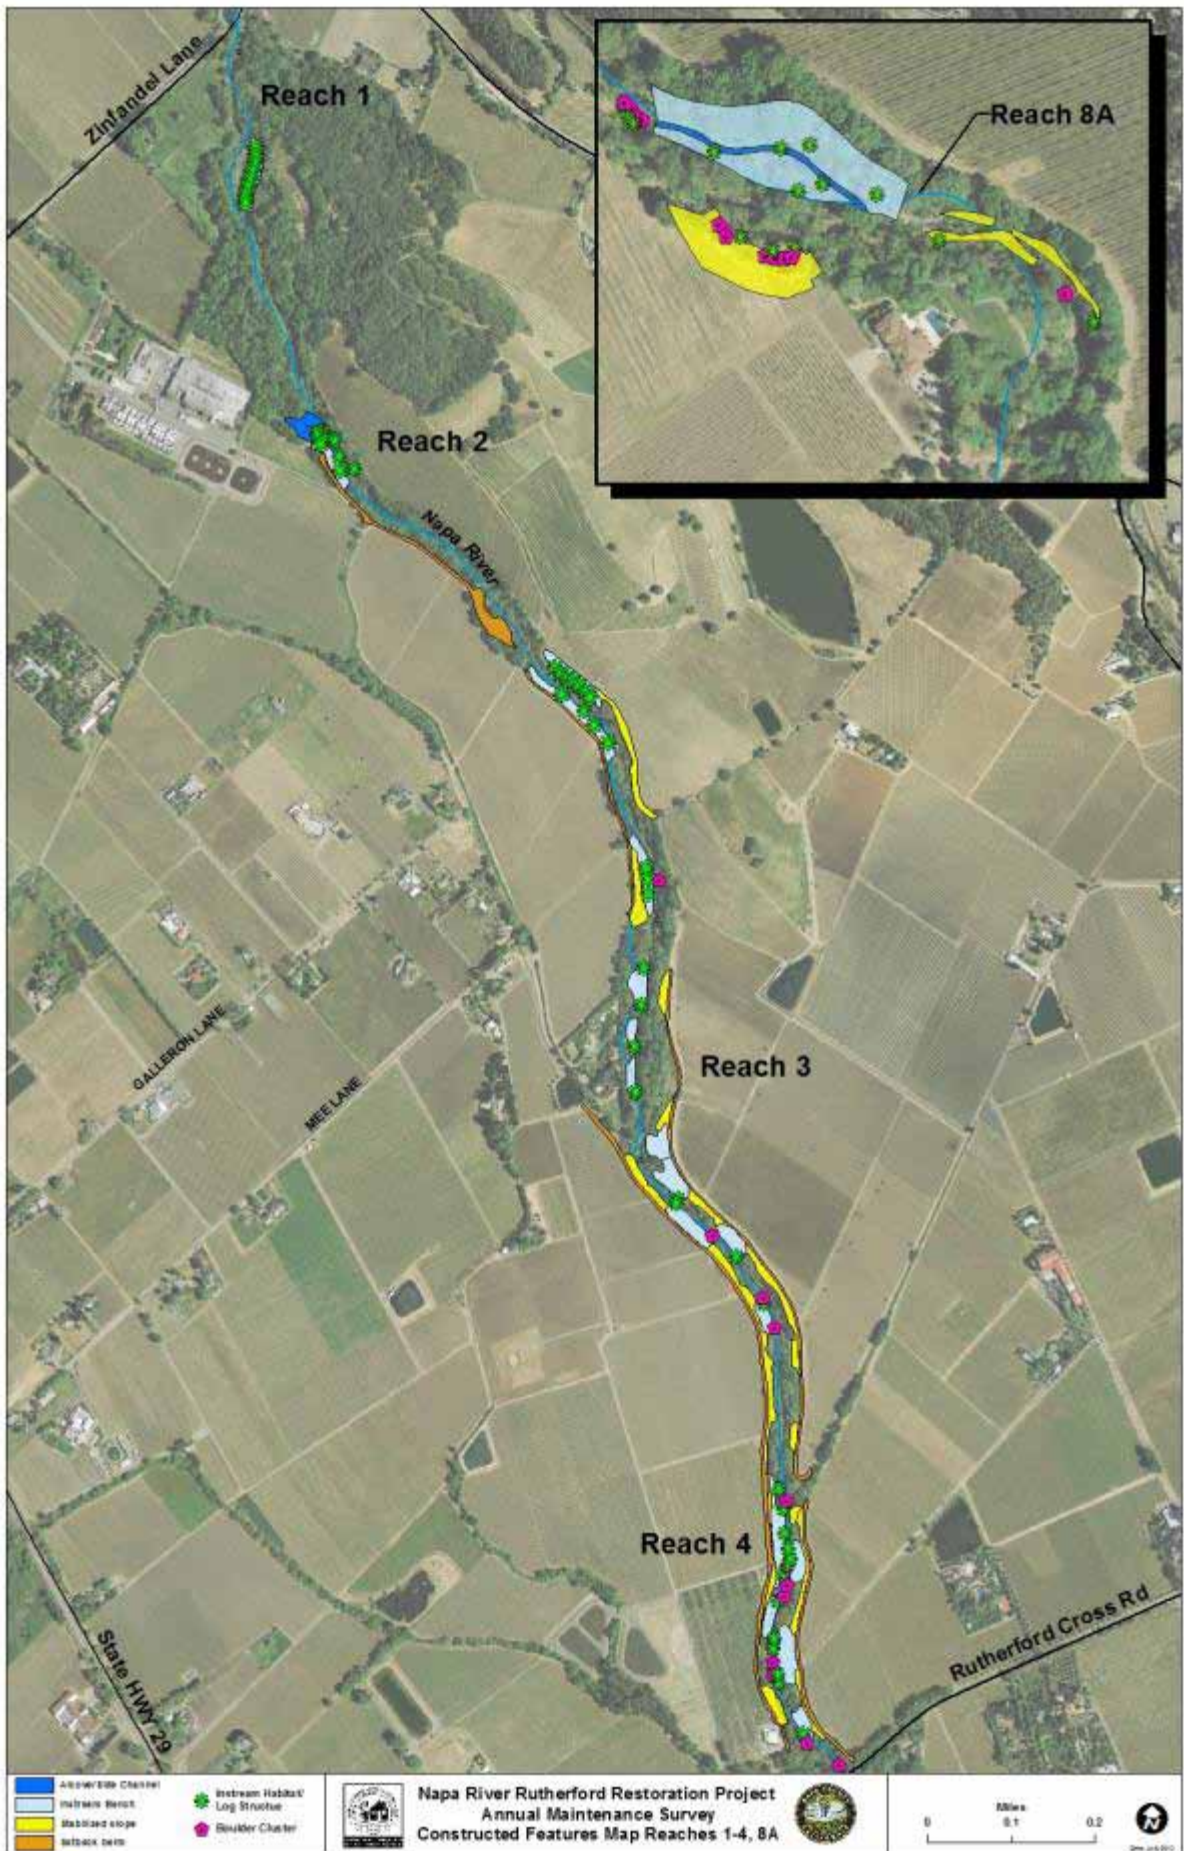
Figure 4: Constructed Features Map

As mentioned previously, at the time of this survey, construction has been completed through Reach 4 and the upstream end of Reach 8, resulting in the installation of 20 flood plain benches and 1 backwater alcove, 47 root wad and bench log structures and 5 boulder clusters. At the time of the survey, all LWD and boulder cluster structures that were able to be located appeared to be functioning as designed and will not require maintenance in 2013. However, 2 LWD structures and 1 boulder cluster were not able to be located and are presumed to be buried, but will likely be revealed in future years by high stream flow scour when they will regain habitat value.
