Napa River Rutherford Reach Restoration Project

Annual Maintenance and Monitoring Survey

July 2015

***Napa County Flood Control and Water Conservation District
Napa County, California***

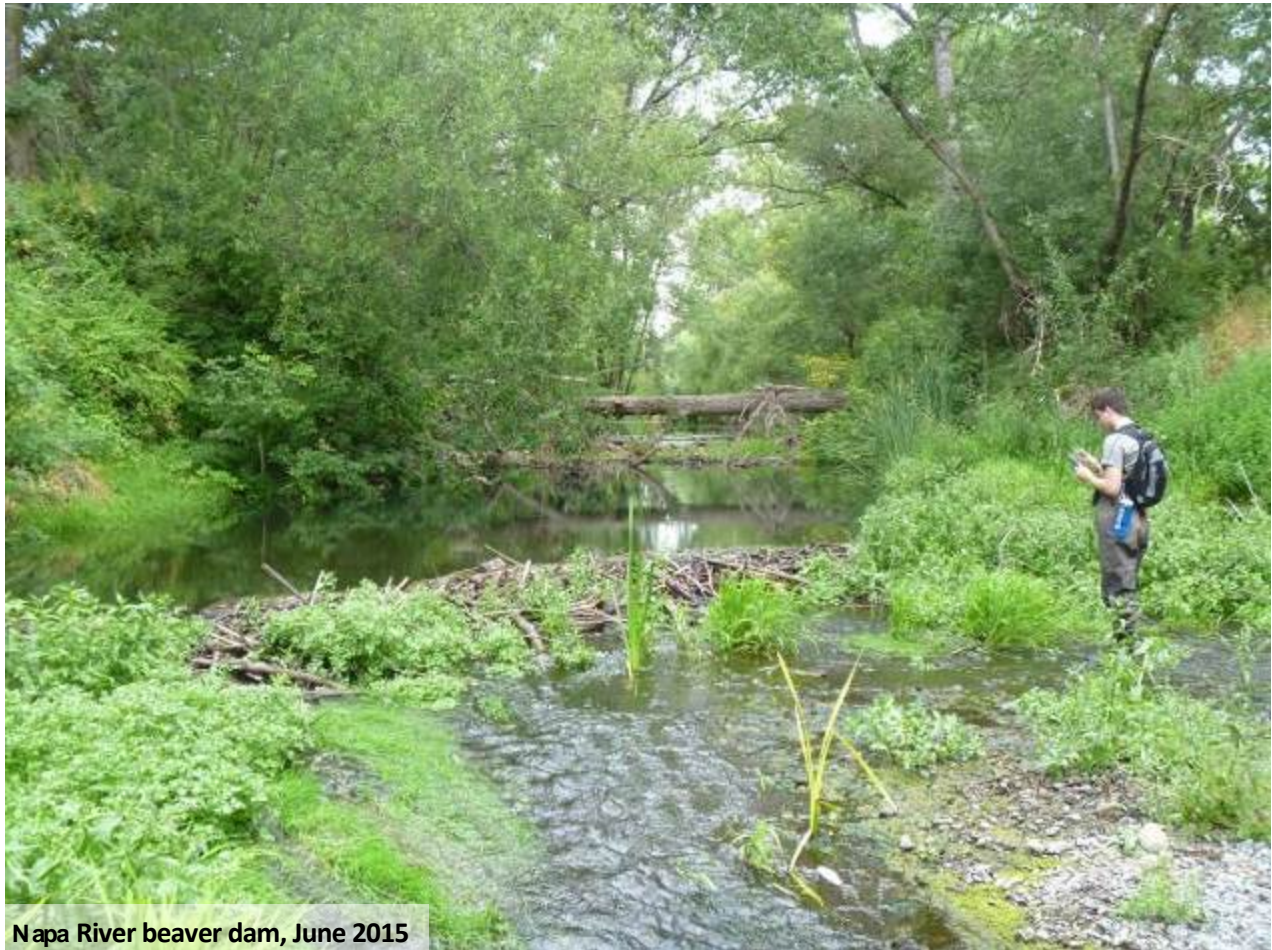
Napa River beaver dam, June 2015

As documented in previous surveys, a significant level of beaver activity (dam building, downing of trees) has been noted in the Project reach. District staff documented twelve (12) beaver dams (See report cover photo) in the Project reach. In general, the District does not consider beaver dams to be an issue that would cause bank erosion or localized flooding; the dams are relatively small in relative to the river channel and typically wash away during high winter flows. During the low flow season, the dams impound slow water, providing cool pool habitat for aquatic wildlife.

- Manage 2 LWD jams (<12-inches-in-diameter and/or <6-feet-long) adjacent to landowners property in Reach 9.
- Continue to protect large riparian trees with hardware clothe in areas that are in close proximity of active beaver dams

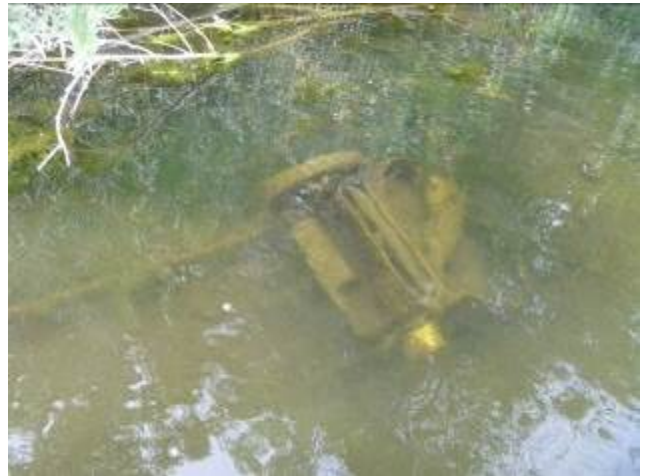
Picture 1: Lawn mower in stream channel

- Removal of all trash and debris from the stream channel that can be readily accessed and accomplished with hand labor, pulley or winch assisted mechanisms.

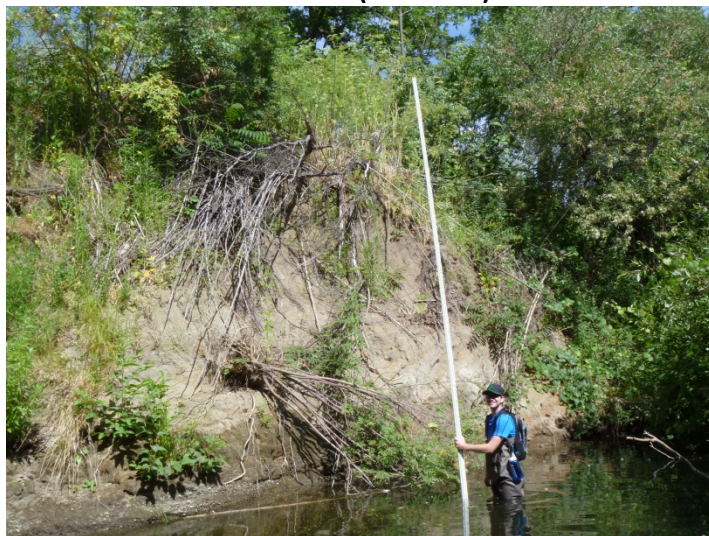
Three areas of localized bank erosion (**Picture 2**) were documented during the survey that the District intends to address/stabilize using a combination of bio-technical methods during the fall of 2015. See **Table 3** for the location and details of the proposed bank stabilization work to be conducted at these sites.

Picture 2: Reach 4 erosion site (June 2015)

River Station/Reach	Description	Proposed Work
150+35 (Reach 4)	Localized erosion at outlet of floodplain bench	Plant slope with willow pole stakes and/or willow brush mat.
140+25 (Reach 8)	Localized erosion at outlet of floodplain bench	Plant slope with willow pole stakes and/or willow brush mat.
56+75 (Reach 8)	Arundo treatment site, un-vegetated	Cover bare slope areas adjacent to LWD structure with erosion control fabric and jute net, broadcast erosion control seed mix and plant with live willow stakes in fall.

- Repair and stabilize exposed stream bank erosion areas as proposed in **Table 3**.
- Conducted annual spring/ summer mowing of non-native grasses/shrubs on constructed flood plain benches as needed.

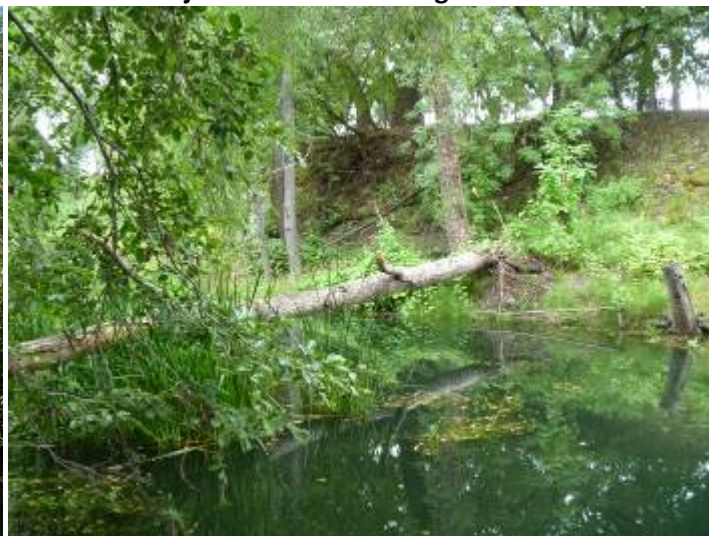
Picture 3: LWD jam marked for management

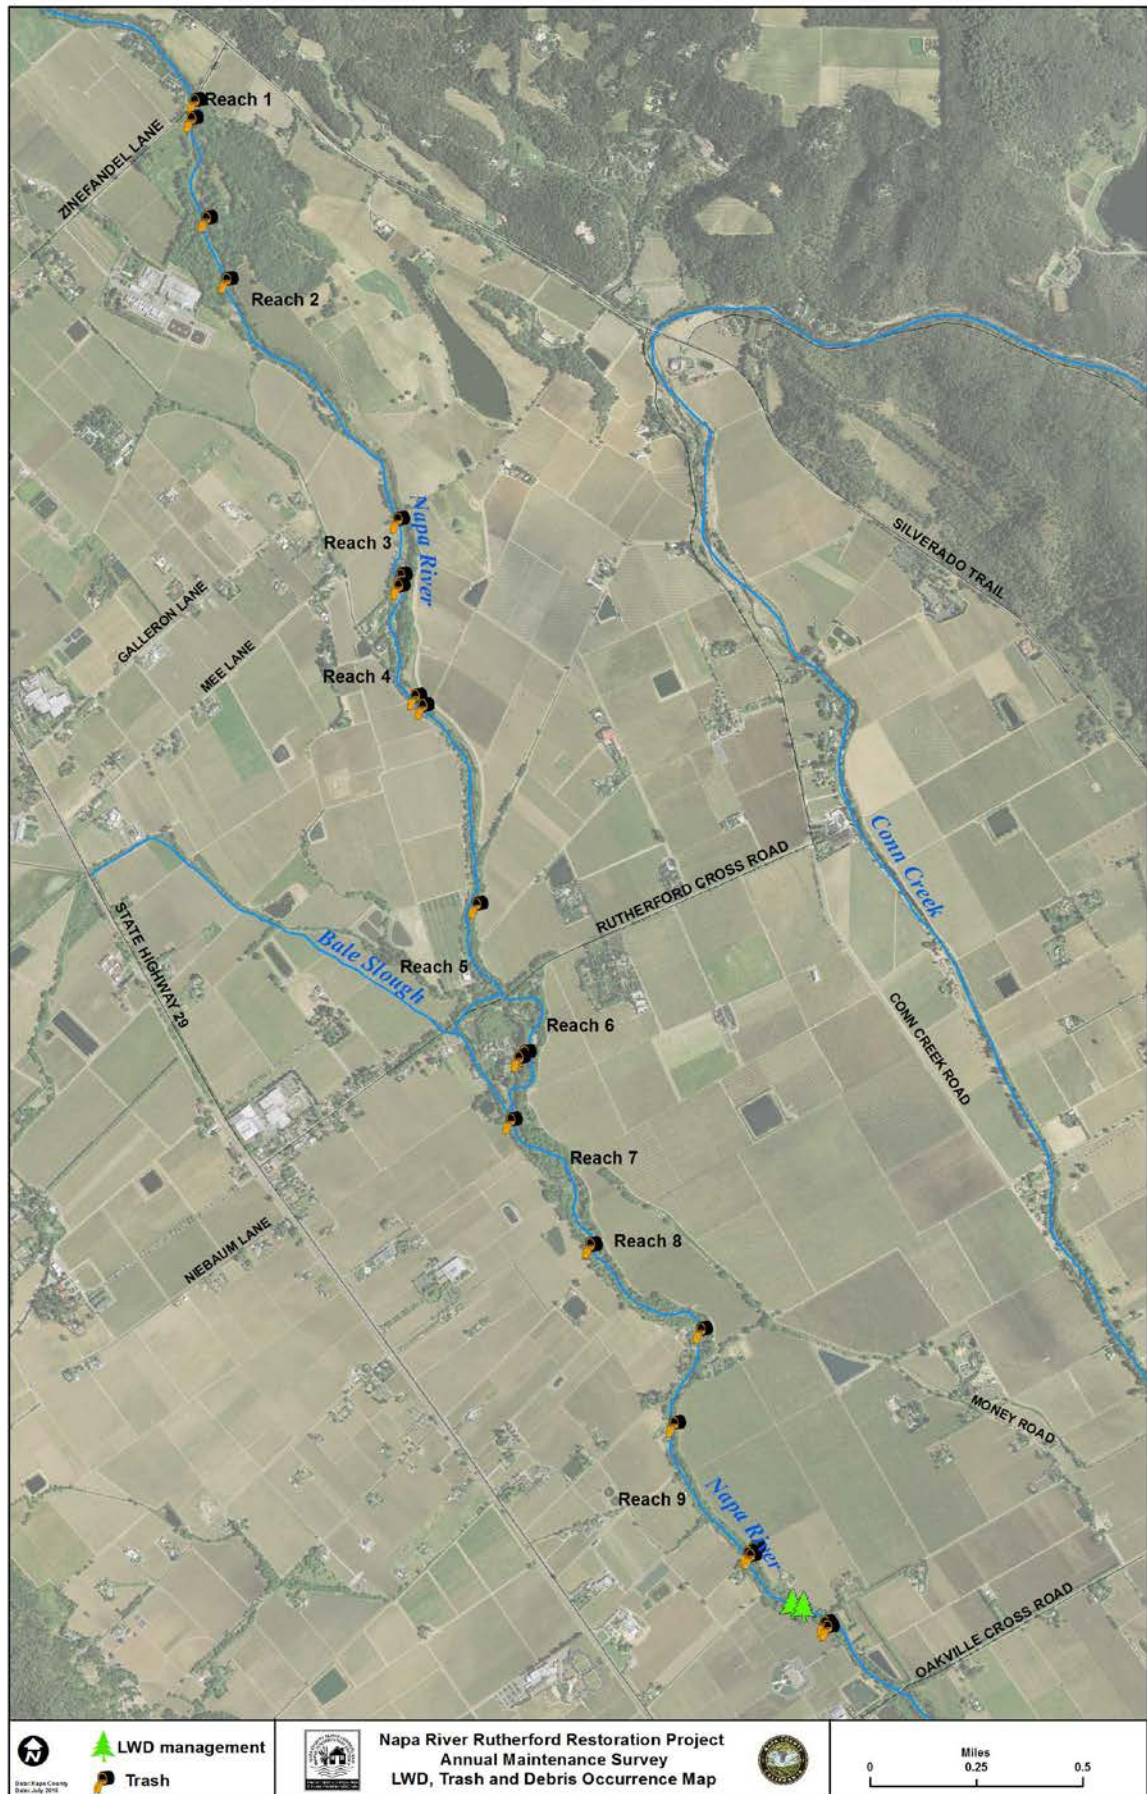
Figure 2: LWD, Trash and Debris Map

A total of 22 occurrences of trash and debris were documented in the Project area. **Graph 1** illustrates the number and types of trash documented during the stream survey, including tires, drip lines, appliances and metal debris, and plastic. Since surveys began in 2009, tires have consistently been the dominant debris documented in the channel. This year 9 of the 22 occurrences were tires. The remaining four (13) occurrences of trash and debris were drip lines, a plastic tarp, a lawn mower, and an oven (**Picture 1**). **Figure 2** shows the locations of the surveyed trash and debris. While overall occurrences of trash and debris are less when compared to the peak number (48) documented in 2011, more were documented this year (22) than last year (13).

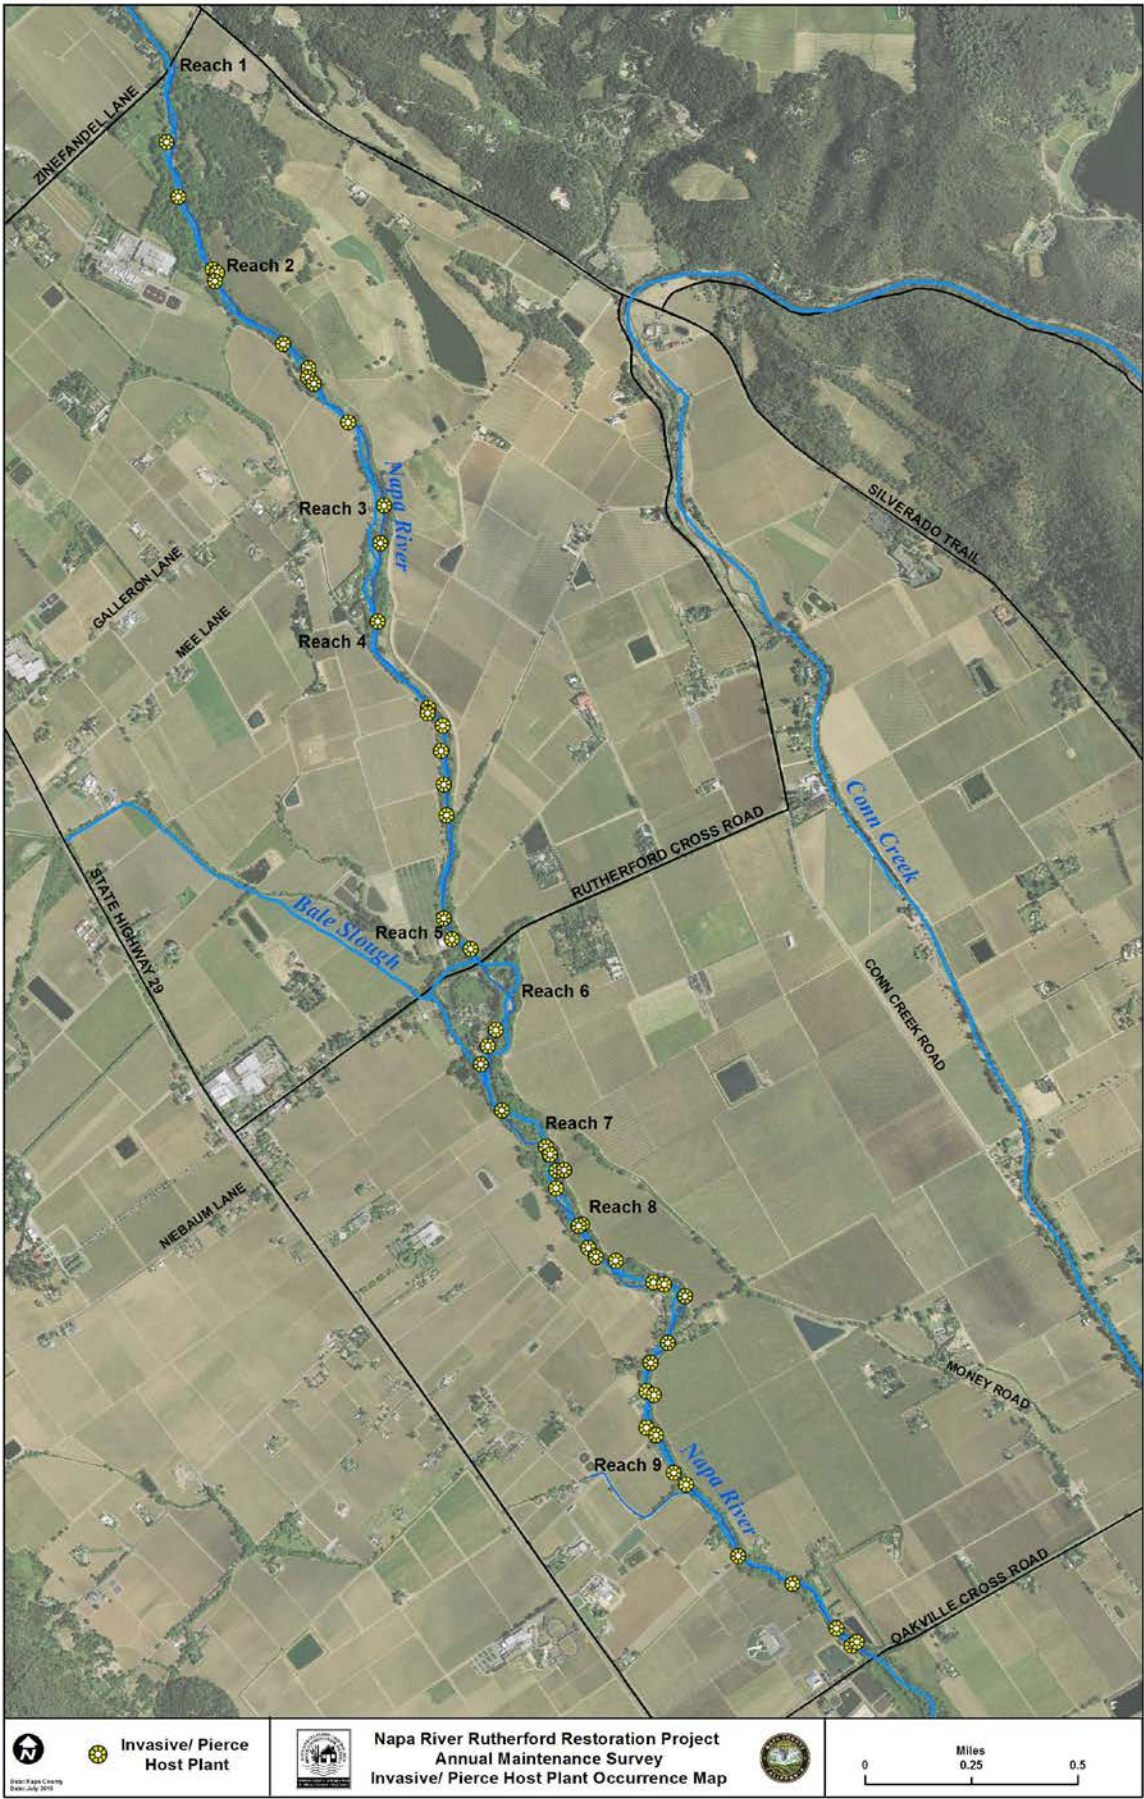
Figure 3: Invasive/ Pierce Host Plant Occurrence Map

Figure 3 depicts the location of significant occurrences of invasive/Pierce host plants that were documented during the 2015 stream survey. Himalayan blackberry, native and hybridized grape, periwinkle (*Vinca major*) and Mugwort (*Artemisia vulgaris*) were the dominant target plants identified; other target species documented include tree-of heaven, red sesbania and black locust but were limited in distribution. Invasive species such as poison hemlock, fennel, etc. were observed but not quantified during the survey as a result of land owner's requests in previous meetings to focus on and use funds for treatment of only invasive plant species that are considered Pierce host's species or priority invasive non-native species.

A total of 114,640 square feet (sqft) of non-native invasive and Pierce host plants were documented including 37,582 sqft of Himalayan blackberry, 41,153 sqft of native/hybrid CA grape, 9,612 of periwinkle, 23,252 sqft of Mugwort, and 3,041 sqft of giant reed (*Arundo*). It is important to note that there are additional occurrences of grape, periwinkle and other Pierce host plants present beyond the river's top of bank, out of view of the in-channel river survey; *therefore we request that landowners contact the maintenance lead with any additional requests for management of invasive and/or Pierce host plants in the riparian zone beyond the top of bank that may not be documented during the channel survey.*

- Treat large accessible patches of invasive and Pierce host plants with glyphosate including Himalayan Blackberry, Mugwort, Vinca, native and hybridized grape species and giant reed; this task also includes appropriate re-vegetation planting/seeding and irrigation of treatment of sites where treatment has left significant gaps in the riparian under story canopy.
