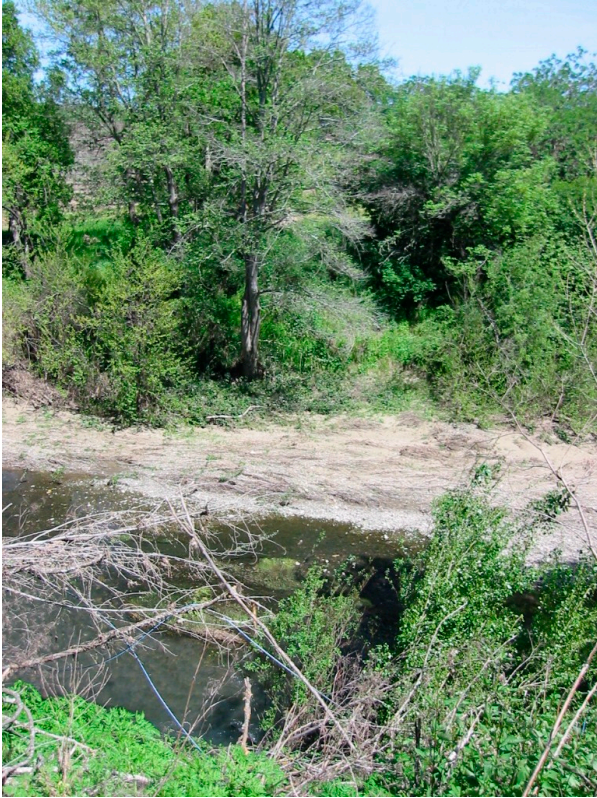
Photograph B-41. East bank, Carpy Connoly from north end of C Mee property

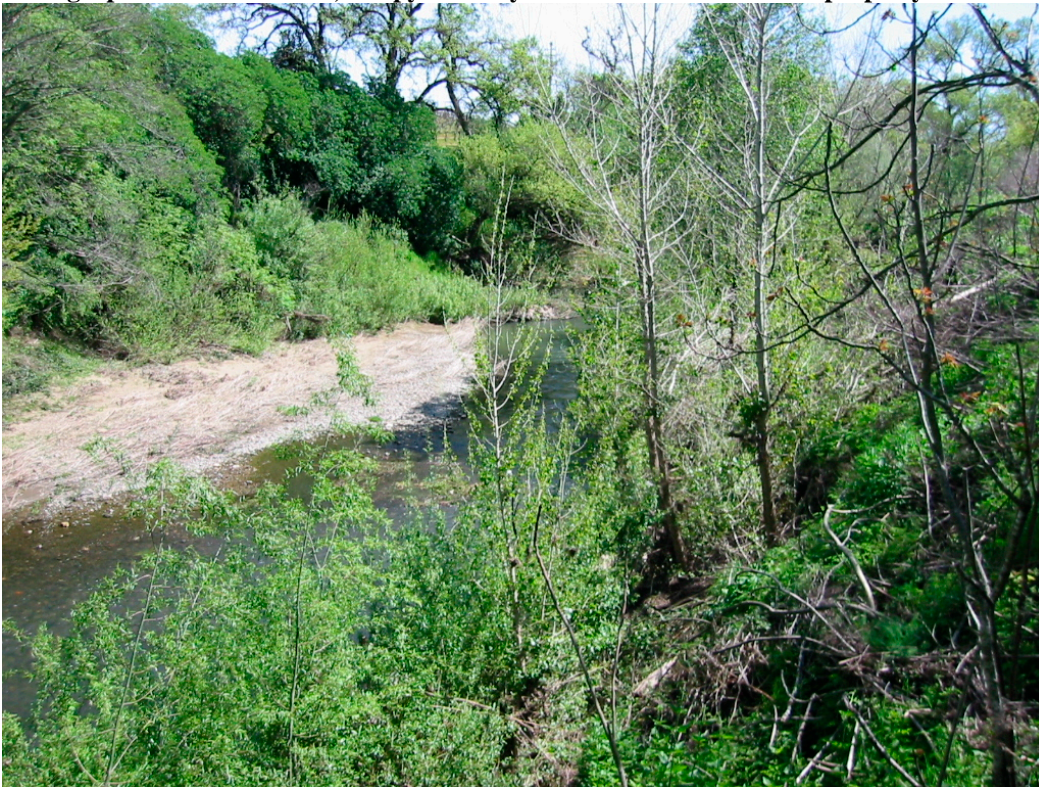
Photograph B-42. East bank, Carpy Connoly from north end of C Mee property, stage 5

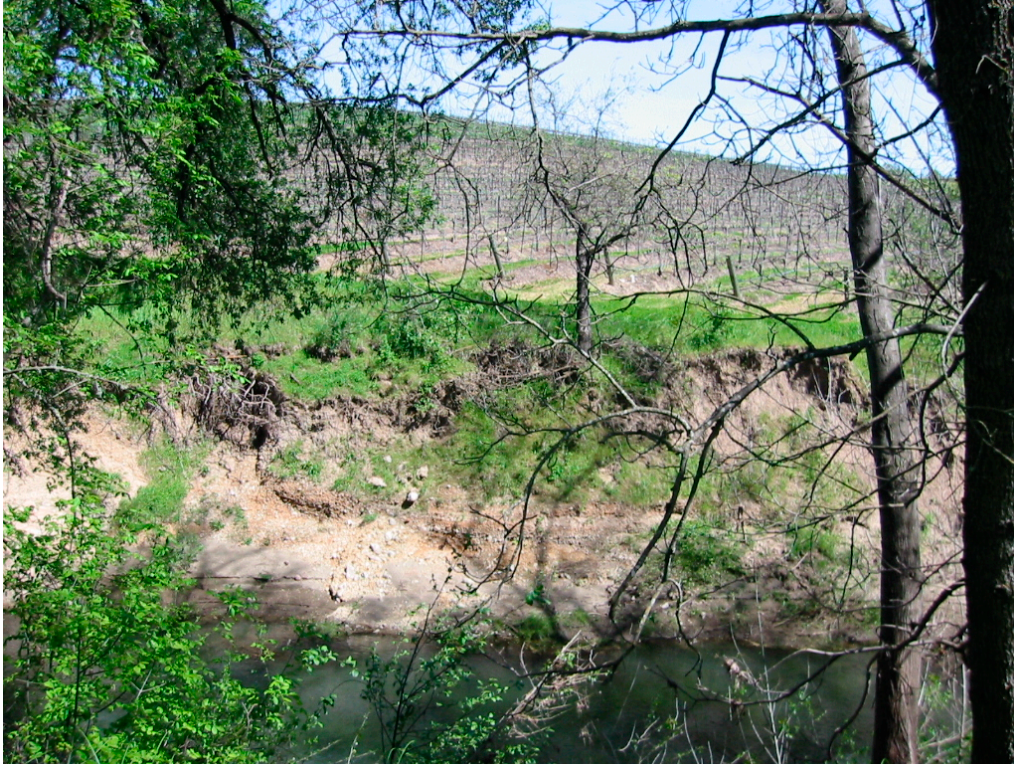
**Photograph B-43. Bank erosion on the southern boundary of Quintessa, from southern boundary of Frogs Leap
One of the three top priority restoration sites. stage 4 outside bend.**

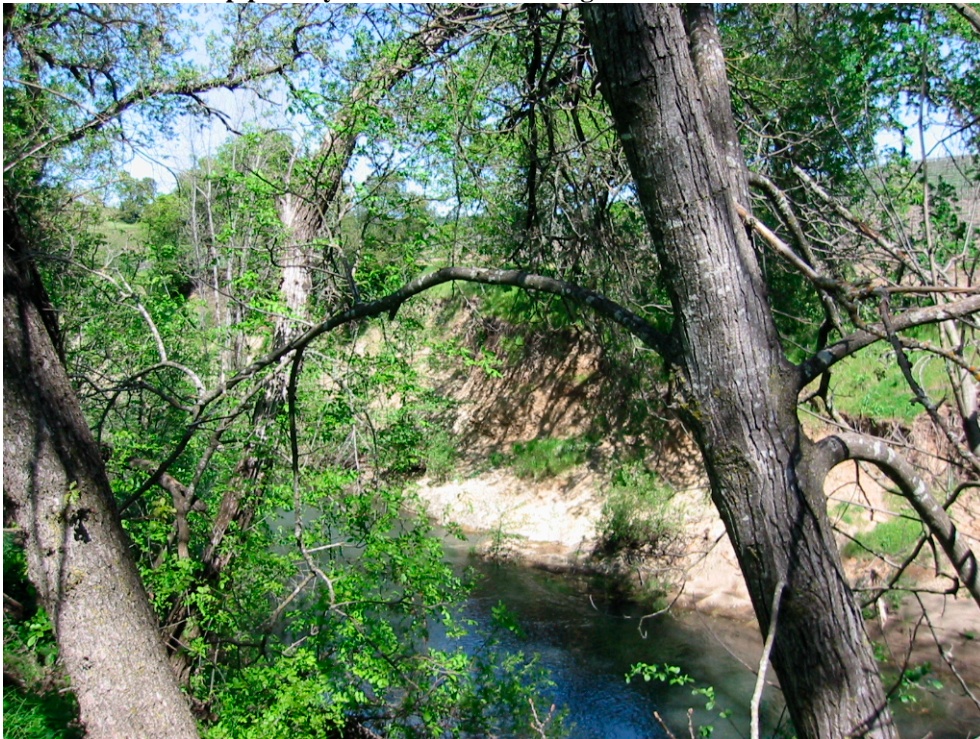
Photograph B-44. Bank erosion on the southern boundary of Quintessa, from southern boundary of Frogs Leap, stage 4

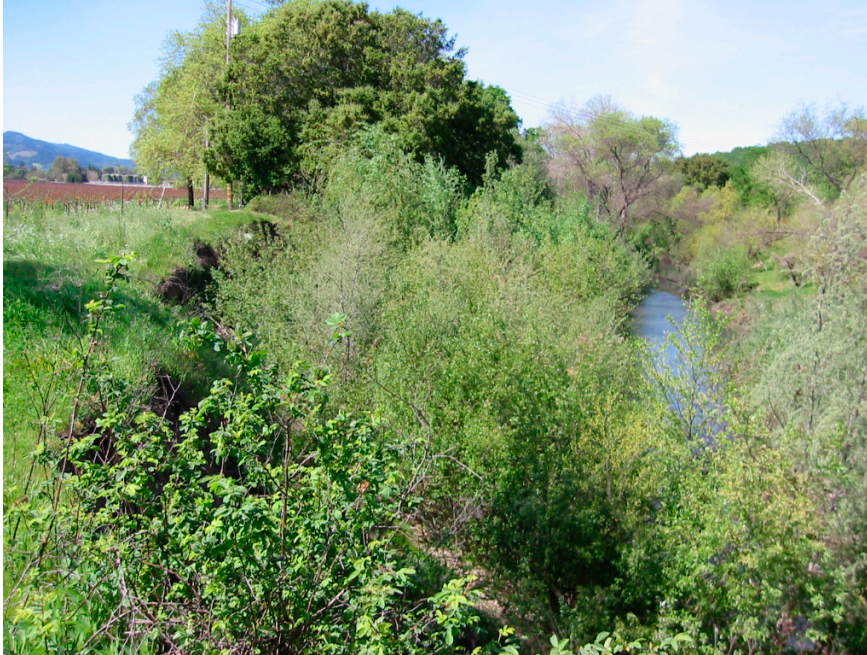
Photograph B-45. Local bank erosion mid way up the Frogs Leap property, Quintessa on far bank, stage 4

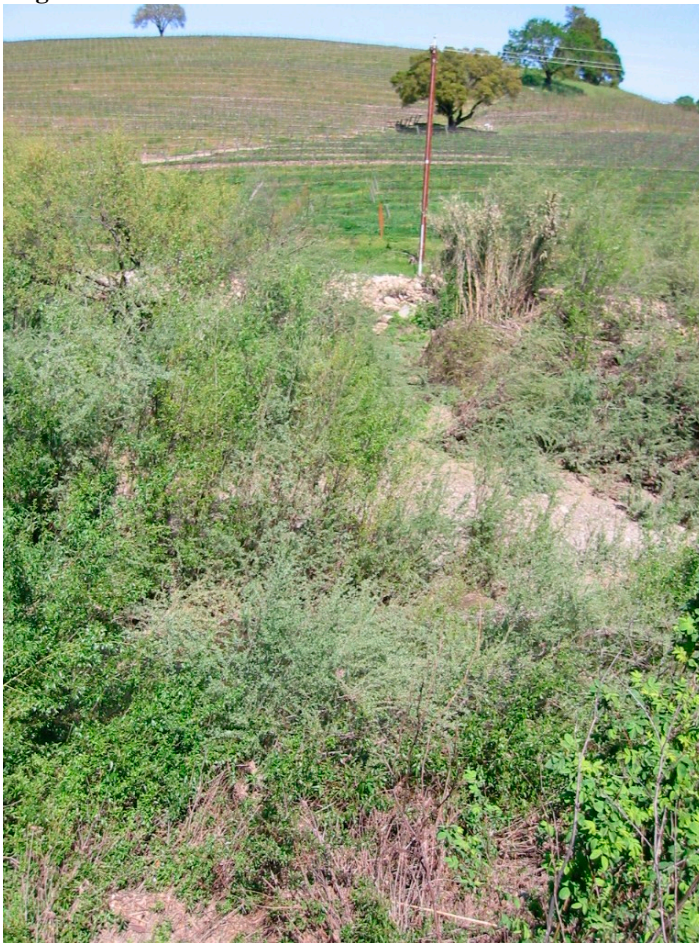
Photograph B-46. Bank erosion on the Quintessa property, from mid way up Frogs Leap

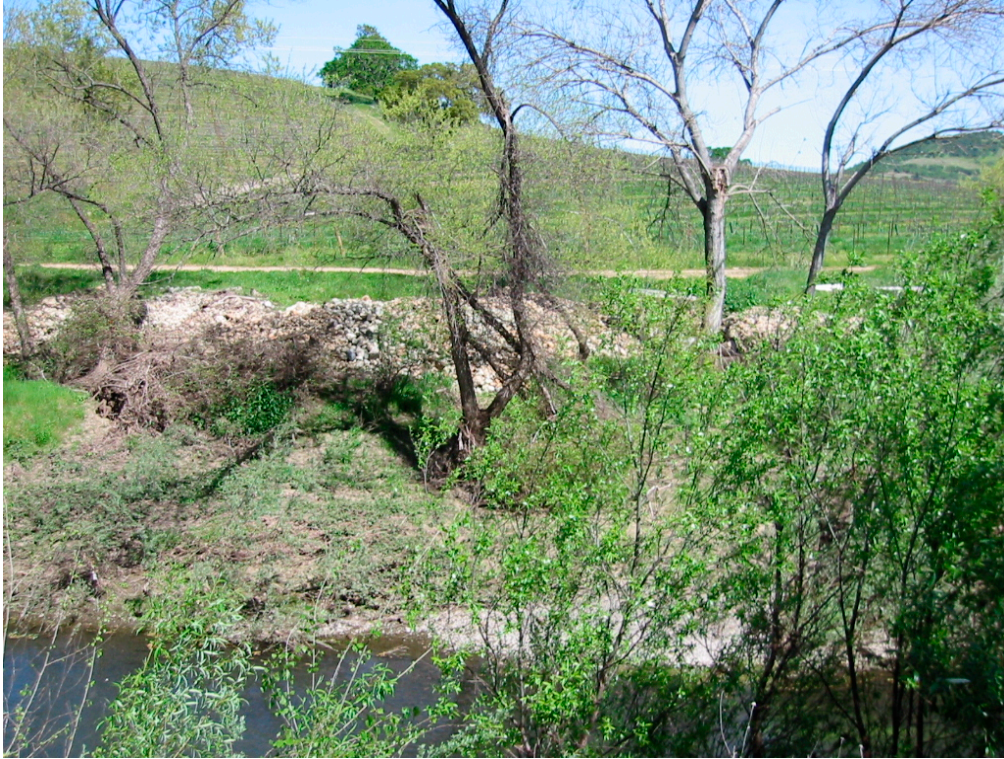
Photograph B-47. Rip rap protection on the Quintessa property, opposite mid point on Frogs Leap

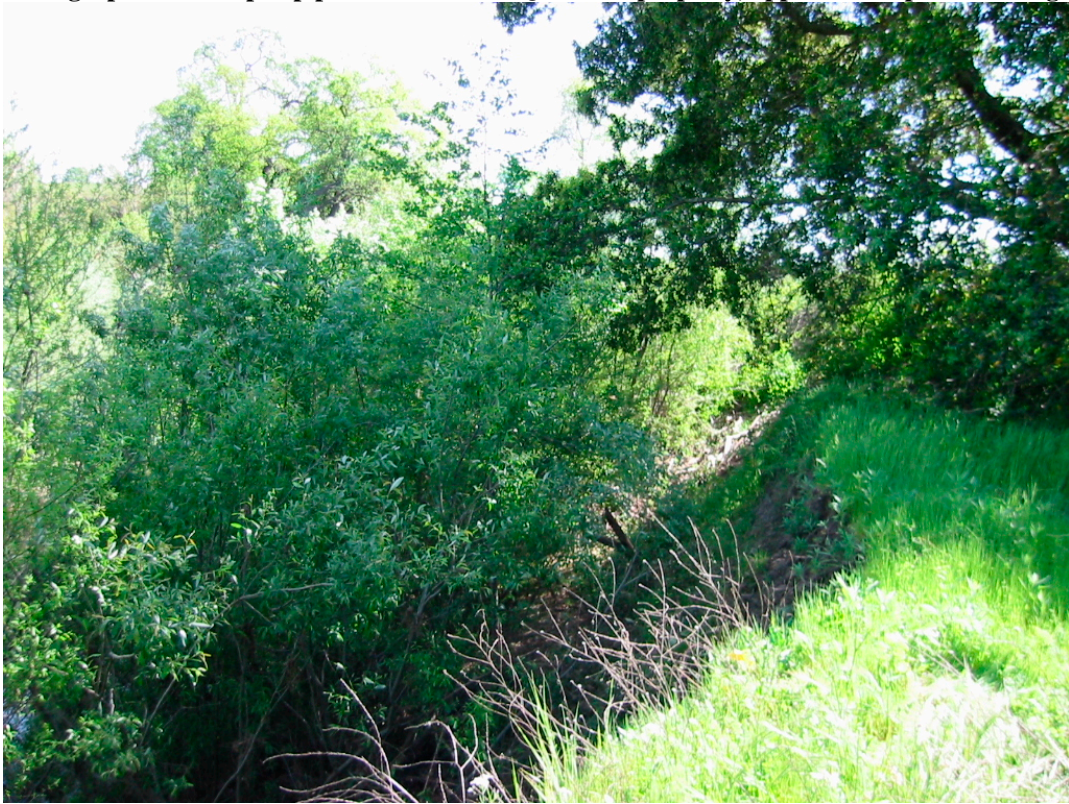
Photograph B-48. Steep west bank on mid section Frogs Leap
