Appendix B

Images of the Napa River, Rutherford Reach

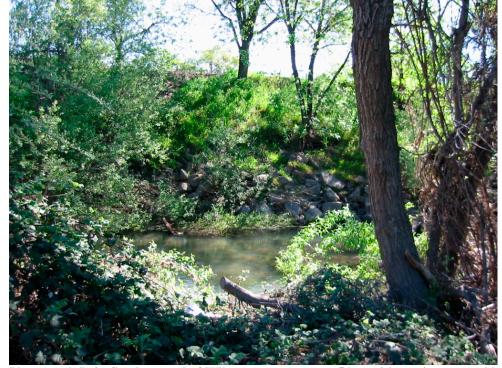
Photograph B-2. Southern end of Wilsey property, stage 5 but with erosion on outside (east) bend

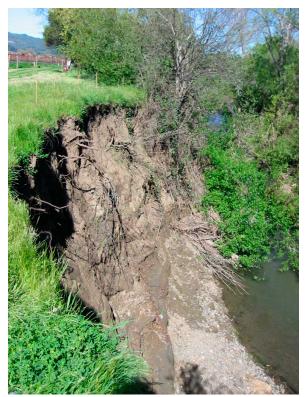
Photograph B-3. Bank collapse on Sequoia Grove property

One of the priority restoration sites, this reach is stage 5, but receives impinging flows.

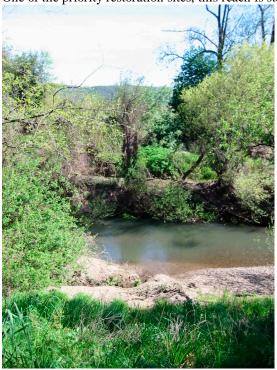
Photograph B-4. Looking from Sawyer to Wilsey properties
