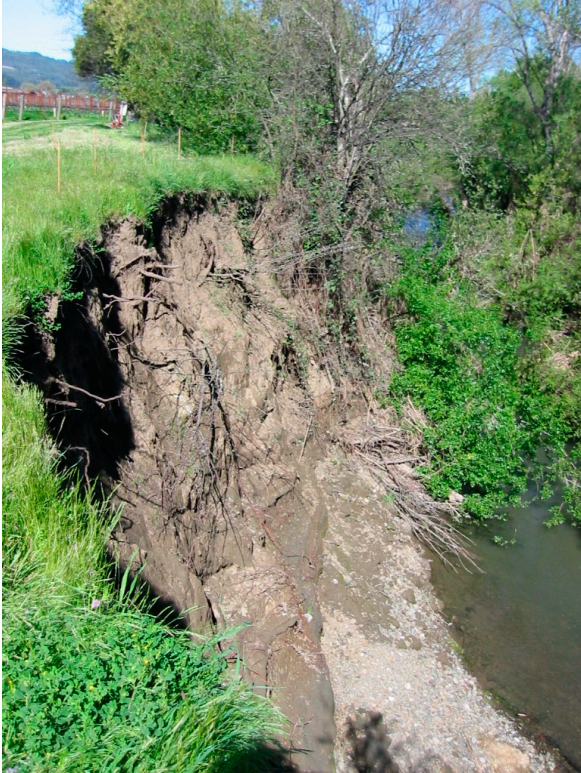
Photograph B-3. Bank collapse on Sequoia Grove property
One of the priority restoration sites, this reach is stage 5, but receives impinging flows.

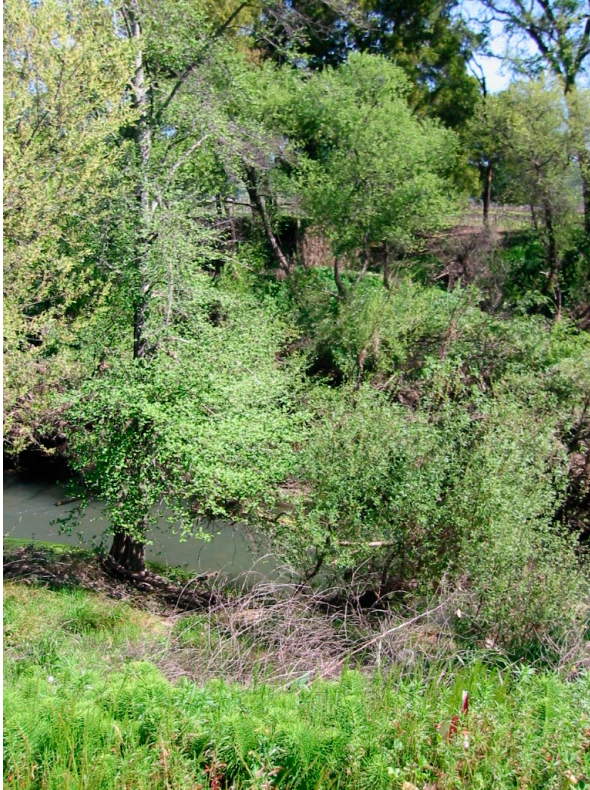
Photograph B-5. Looking from the Sawyer to Wilsey properties, stage 5 with terrace development

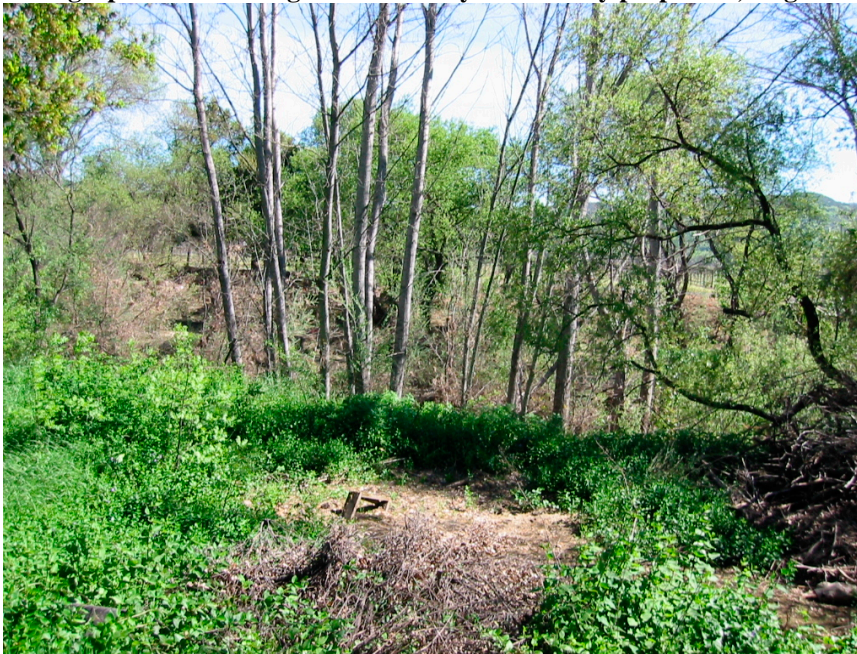
Photograph B-6. From southern end of St Supery to Wilsey property, stage 6 with vegetated terraces

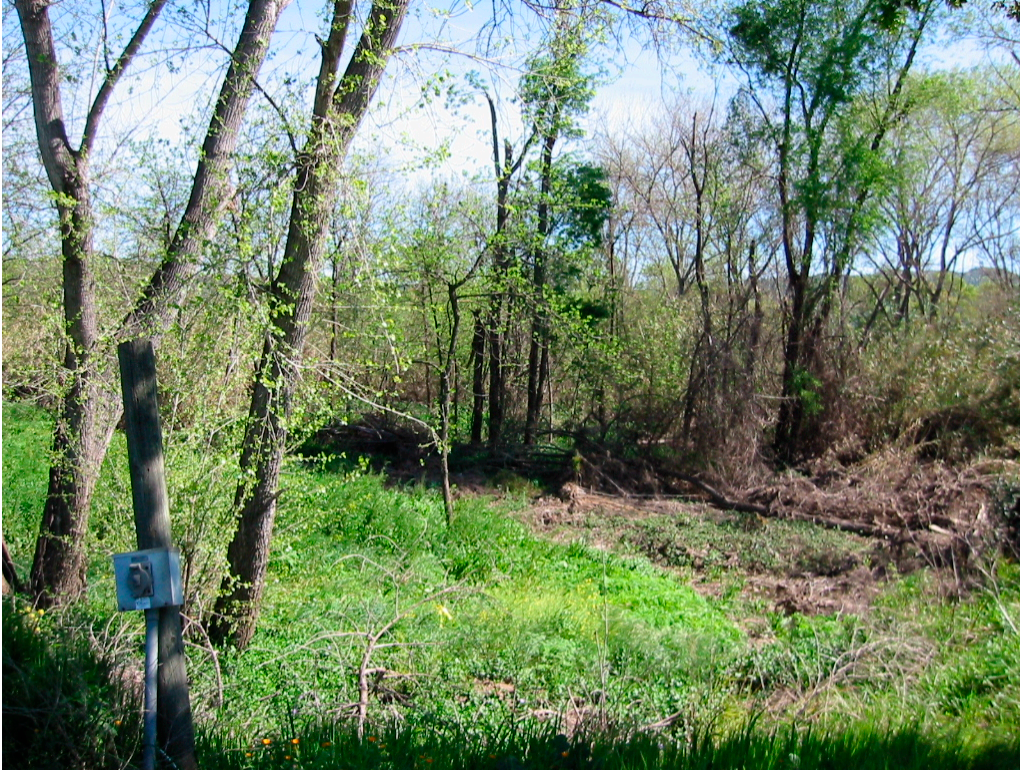
Photograph B-7. Looking from the central St Supery to Wilsey properties, stage 6

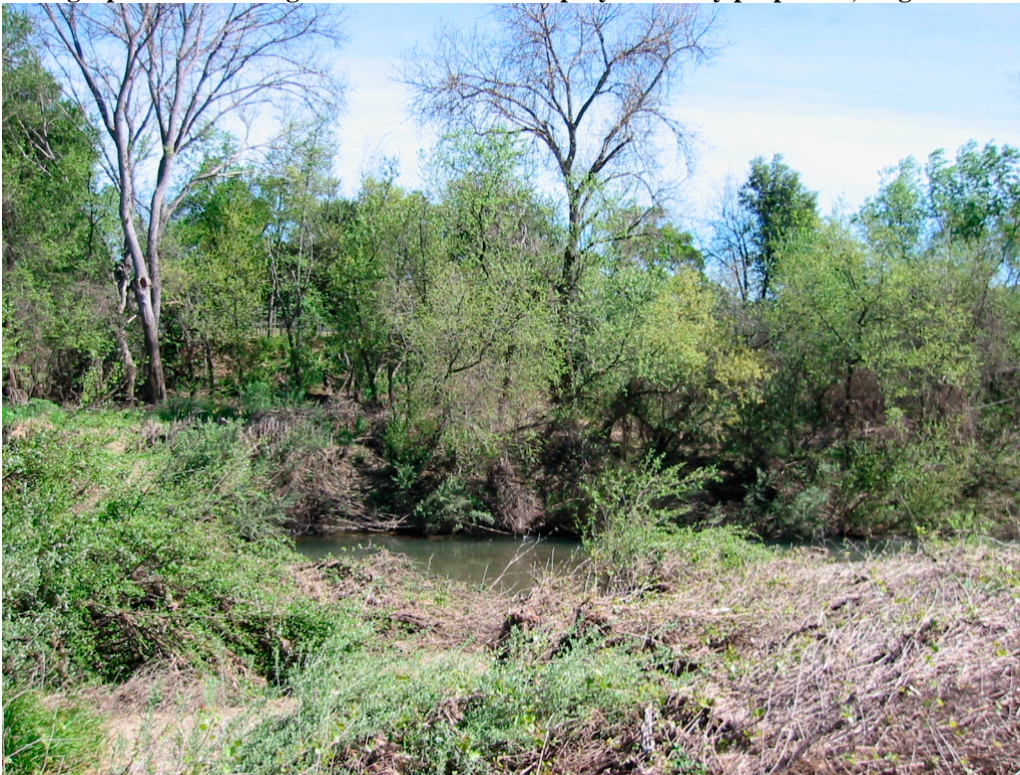
Photograph B-8. Looking from the northern St Supery to Wilsey properties, stage 6 but in need of revegetation

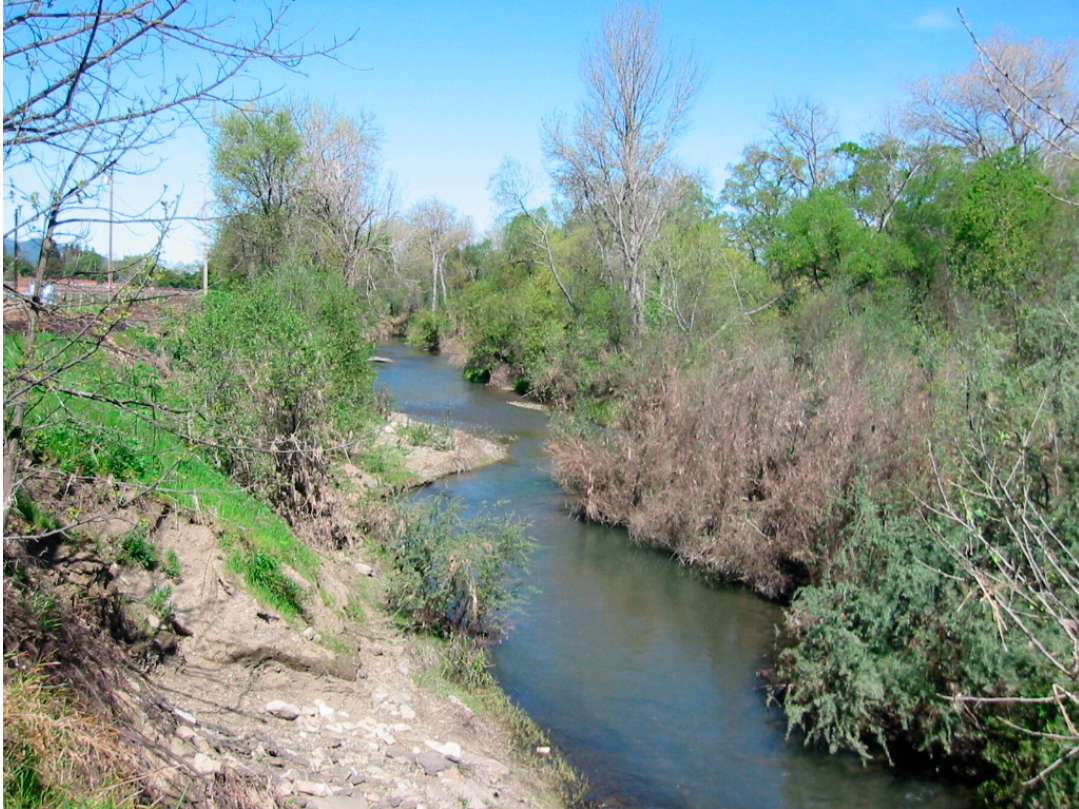
Photograph B-9. Northern boundary of St Supery and Wilsey properties, moving into stage 5

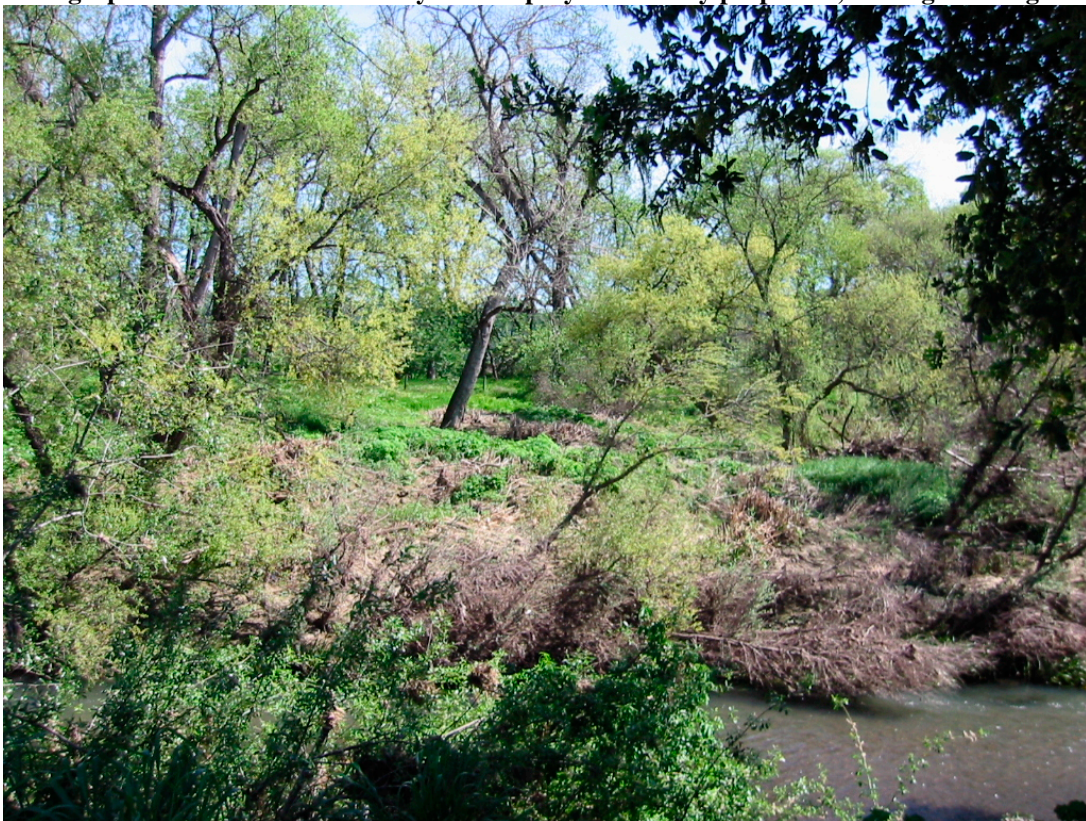
Photograph B-10. Southern boundary of the Round Pond property from the west bank, stage 5
