# Napa River Rutherford Reach Restoration Project Annual Maintenance and Monitoring Survey

Napa River July 11, 2011

**July 2011**

**Prepared by:**  
*Napa County Flood Control and  
Water Conservation District  
Napa County, California*

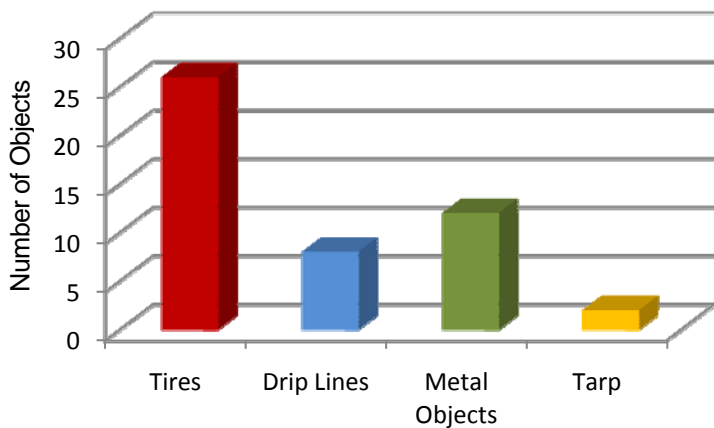
**Graph 1: Trash and Debris**

A total of 48 occurrences of trash and debris were documented in the Project area with the dominant trash and debris type being tires (26) and the remaining (22) occurrences of trash and debris being various objects including irrigation drip lines, tarps, agricultural smudge pots, large residential kitchen and electronic appliances, an automobile rim and a lawn mower. Figure 2 shows the location of the trash and debris documented, the greatest accumulation of trash was found in Reach 8. Graph 1

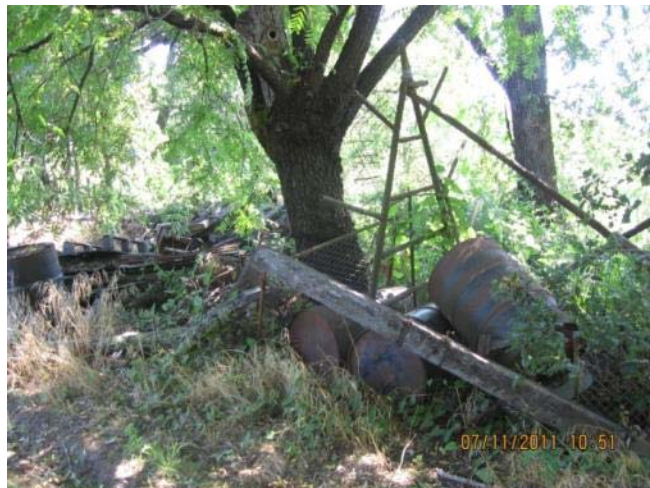
**Picture 1: Trash and Debris**

below represents the amount and types of trash documented during the stream survey. Several incidences of metal debris storage near or on the top of the river bank were noted (Picture 1). It is possible that such debris could be washed into the river channel during high flow events. This situation could be remedied if the landowners were mindful of this situation and either disposed of any such debris or moved it at least 100 feet back from the top of the river bank. This issue will be brought to landowner’s attention as part of regular outreach regarding the river maintenance program.

- Removal of all trash and debris from the stream channel that can be readily accessed and accomplished with hand labor, pulley or winch assisted mechanisms.

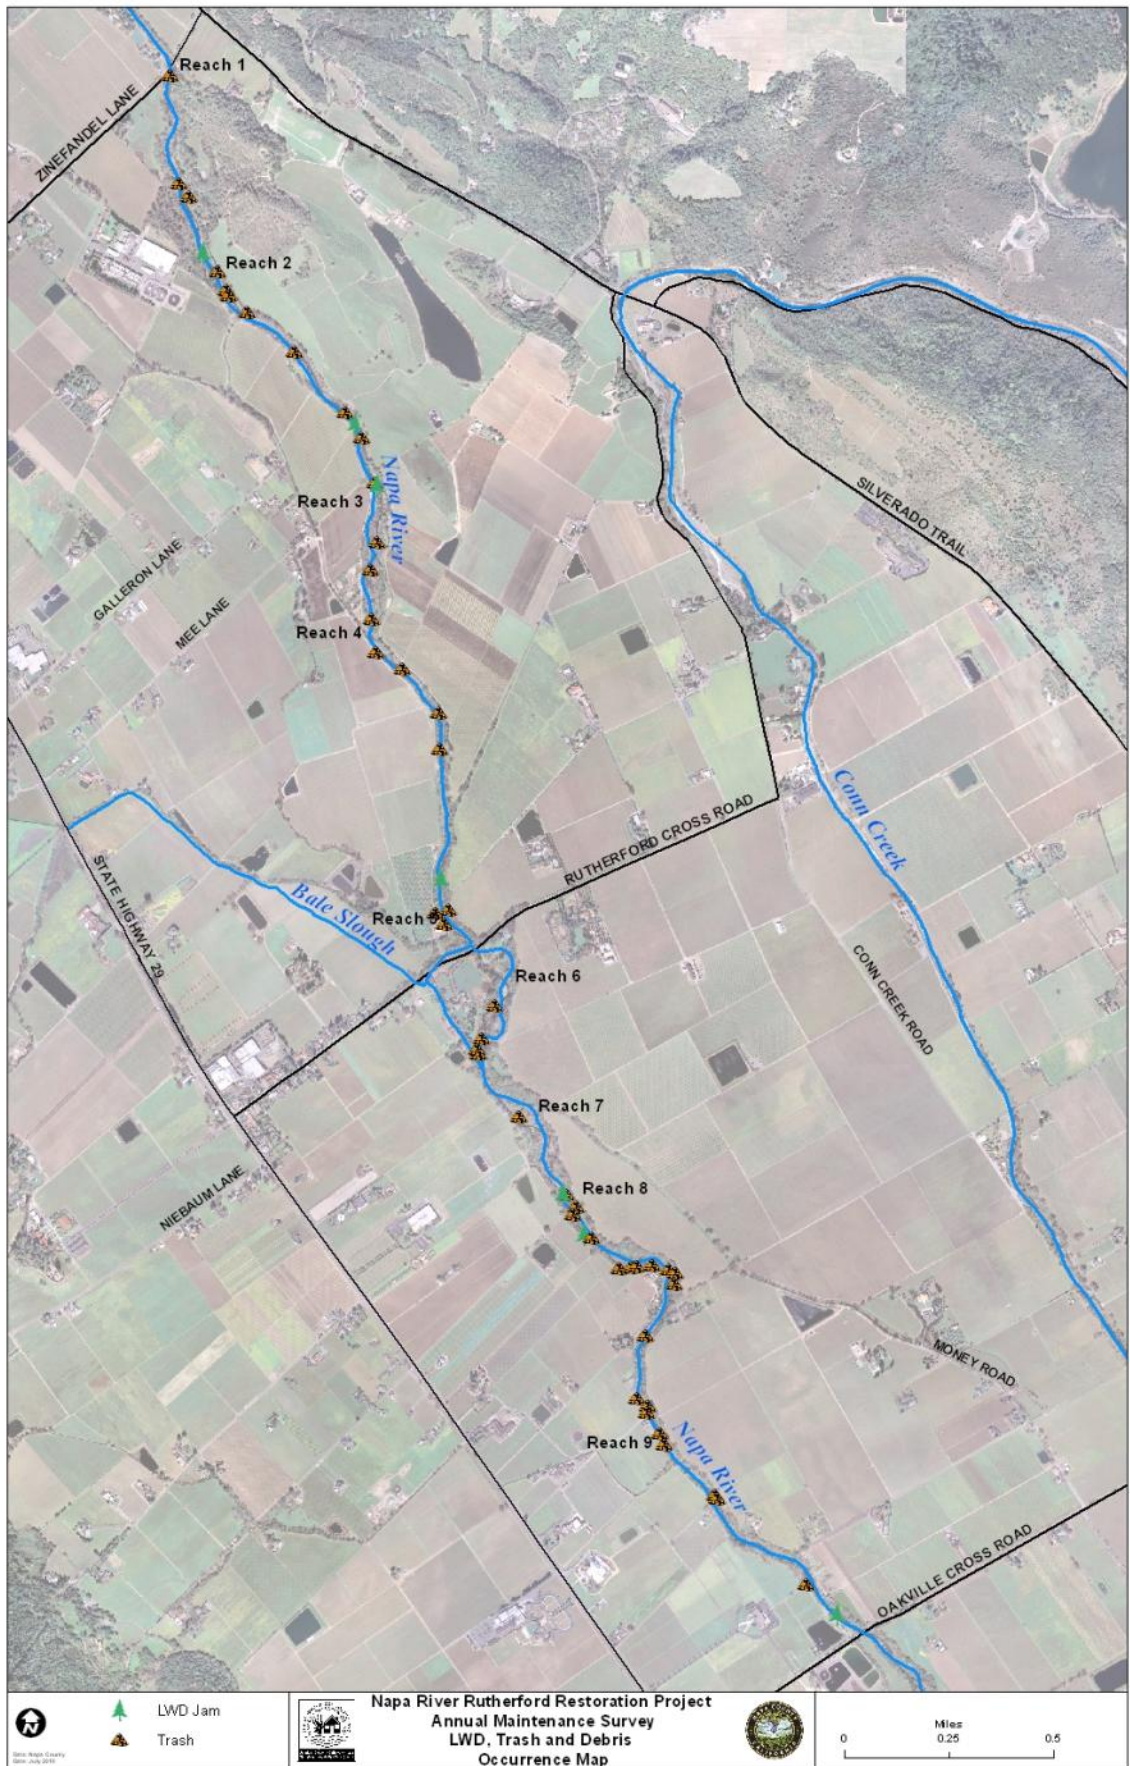
Figure 2: LWD, Trash and Debris Map

144 naturally recruited large woody debris (LWD) occurrences, greater than one foot in diameter and six feet in length, were documented during the survey. Of those 144 LWD occurrences, 7 were ranked as potential maintenance issues, 3 of which have been prioritized for maintenance actions (thin out smaller wood and/ or realign larger wood to reduce flood potential/remove trash from LWD accumulation) in 2011 (Table 2, Figure 2). The remaining 4 LWD occurrences documented as potential maintenance issues will be monitored to track any additional wood accumulation, mobilization, or stream channel scour. The remaining 137 LWD occurrences that were documented are function as significant in-stream fish habitat but do not require maintenance. The distribution and function of all 144 occurrences of LWD will be presented in a separate annual habitat monitoring report.

River Station/Reach	LWD feature	Recommendation	Notes
223+00 (Reach 1)	Wood accumulation (>10), left side of channel, flood deposited	Monitor	Monitor for additional wood accumulation, remove tire from debris
193+00 (Reach 2)	Large single piece of wood, creating large pool	Monitor	Monitor – Documented in 2009, 2010 surveys, appears to not be causing erosion or significant backwatering.
184+70 (Reach 2)	Large wood accumulation/jam (>10), full channel	Maintenance Recommended	Treatment –remove small wood, leave root wad and trunk in place, monitor for backwatering/bank erosion
130+90 (Reach 4)	Medium wood accumulation/jam (>10), full channel	Monitor	Monitor for additional wood accumulation, remove metal debris
80+50 (Reach 7)	Medium wood accumulation/jam (>10), half channel	Monitor	Monitor for additional wood accumulation/bank scour, remove metal debris
74+70 (Reach 8)	Medium downed alder w/ large root wad blocking entire channel, minor bank erosion	Maintenance Recommended	Treatment selectively remove large limbs to increase local channel capacity, leave trunk & root wad in place

4+00 (Reach 9)	Large single piece of wood on riffle crest, pool scour	Maintenance Recommended	Treatment – selectively remove large limbs to increase local channel capacity, leave trunk & root wad in place

- Limb/ thin large branches at two LWD jams (<12-inches-in-diameter and/or <6-feet-long) adjacent to landowners property as recommended by survey team (see Table 2).

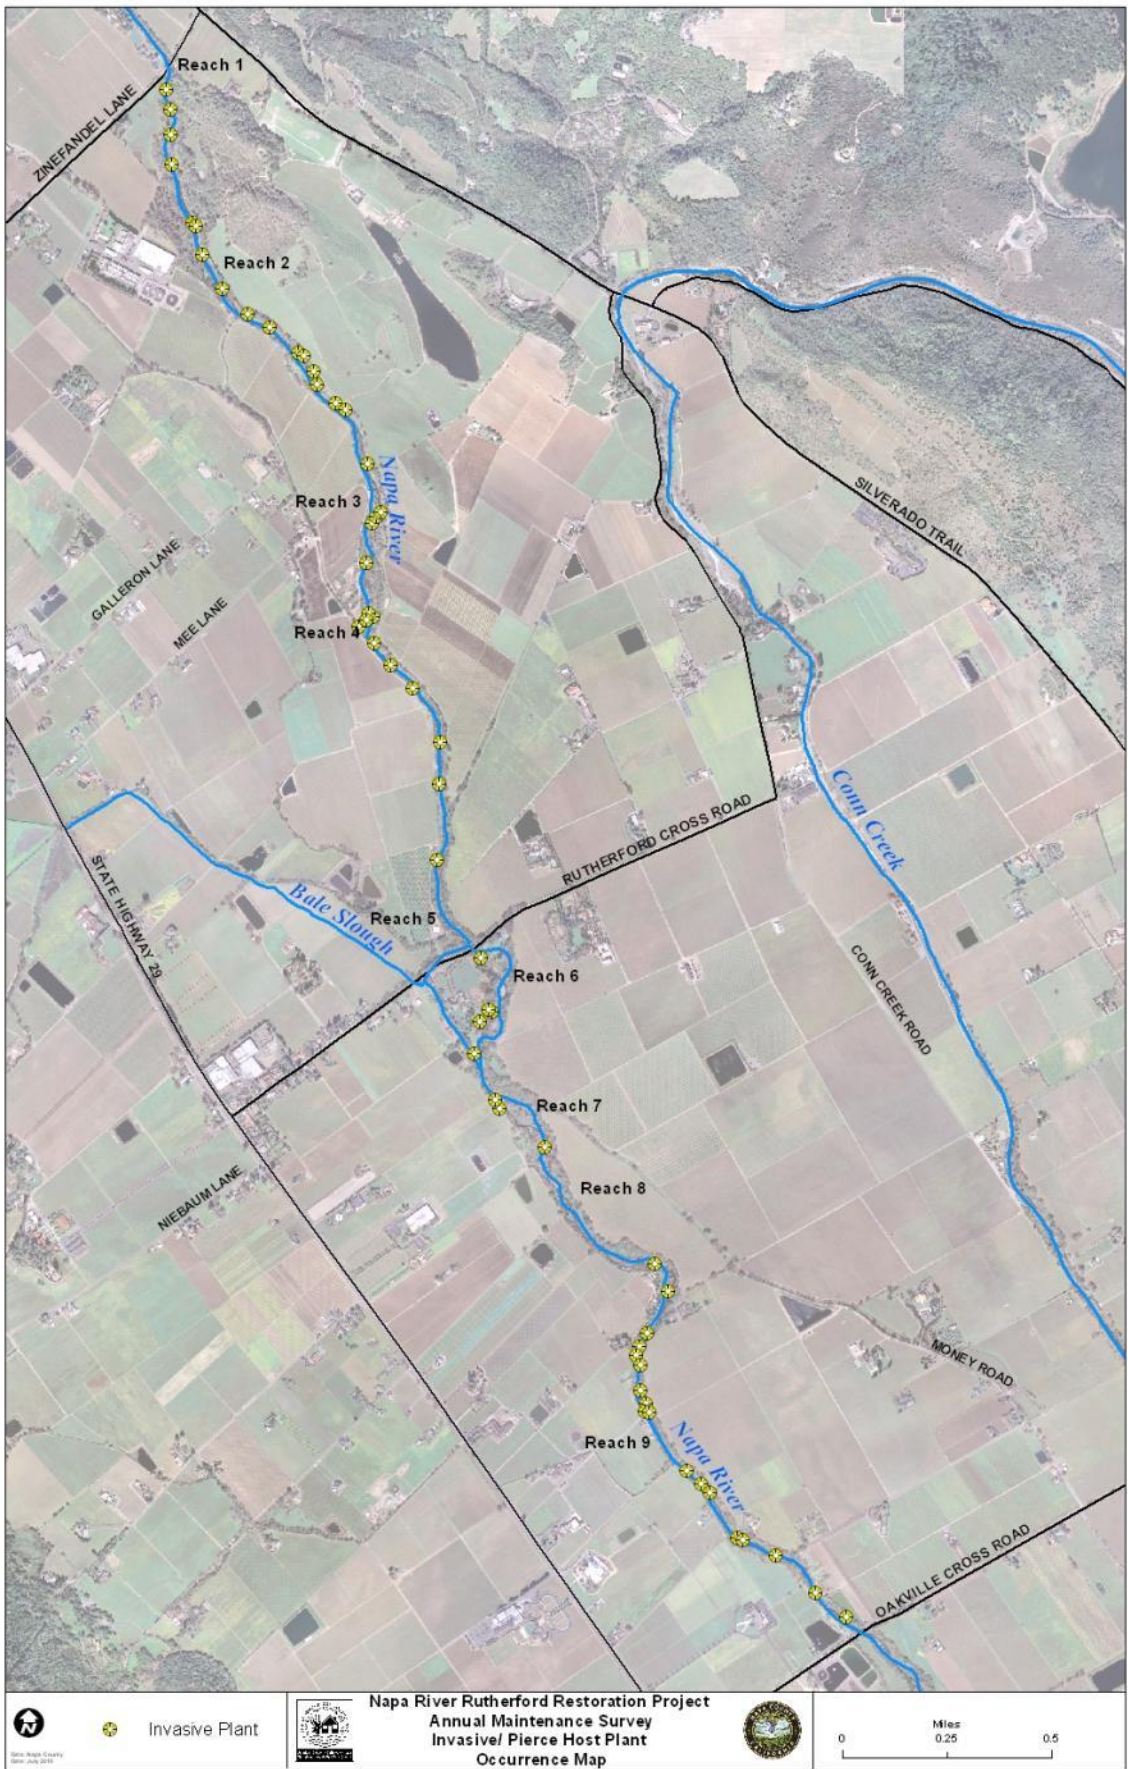
Figure 3: Invasive Plant Occurrence Map

A total of 57 occurrences of invasive non-native and Pierce host plants were identified and will be targeted for treatment within the Project area (Figure 3). Giant reed, Himalaya blackberry, periwinkle (*Vinca sp.*) and native and hybridized grape species were the dominant target plants identified; other target species including tree-of heaven and red sesbania occurrences were limited. Species such as poison hemlock, fennel, etc. were observed but not documented during the survey as a result of land owner’s requests in previous meetings to focus on and use funds for treatment of only invasive plant species that are considered Pierce host’s species as well. Over 29,185 square feet (sqft) of giant reed, 19,166 sqft of Himalaya blackberry, 18,295 of periwinkle and 13,939 sqft of grape species were mapped. However, it is important to note that there is significantly more grape and periwinkle present beyond the river’s top of bank; in general the extent of area that can be funded and treated under the maintenance program extends to the top of bank in the riparian zone. For this reason landowners are encouraged to contact the maintenance lead with requests for maintenance of invasive and Pierce host species in the riparian zone beyond the top of bank. Additionally, to a large extent Himalayan blackberry and grape occur in a near continuous band of various width throughout the entire 4.5 mile Project reach on both the east and west river banks. In general, previous effort to manage and remove giant reed (*arundo*) have been successful and the distribution of giant reed was generally limited to those patches not treated previously due to the inability to secure landowner access agreements for treatment in 2010 or small patches that were treated previously but will require minor re-treatment in 2011. As documented in previous surveys, the largest patches of giant reed were documented within Reach 8. Table 1 summarizes the invasive non-native and Pierce host plants documented during the stream survey. Further, Table 1 lists if the species is a Pierce Disease host and ranks each species as a “high” or “moderate” impact invasive species as defined by the California Invasive Plant council (Cal-IPC); the Cal-IPC list primarily includes plants exhibiting some level of invasiveness in native habitats.

Common Name	Scientific Name	Infested Area (SqFt)	Pierce Disease host	Cal-IPC Ranking
Giant reed	<i>Arundo donax</i>	29,185	No	High
CA & Hybrid Grape	<i>Vitus sp.</i>	13,939	Yes	None
Himalaya Blackberry	<i>Rubus armeniacus</i>	19,166	Yes	High
Red sesbania	<i>Sesbania punicea</i>	N/A	No	High
Periwinkle	<i>Vinca major</i>	18,295	Yes	Moderate

Tree-of-heaven	<i>Ailanthus altissima</i>	N/A	No	Moderate
----------------	----------------------------	-----	----	----------

- Treat large accessible patches of invasive and Pierce host plants that are ranked as either “high” or “moderate” impact species, including periwinkle, Himalaya Blackberry, native and hybridized grape species and giant reed. Control and treat red sesbania and tree of heaven patches with appropriate control measures including mechanical removal and herbicide application; this task also includes some re-vegetation planting and irrigation of treatment sites where treatment has left significant gaps in the riparian under story canopy (see Table 1). Table/reference?

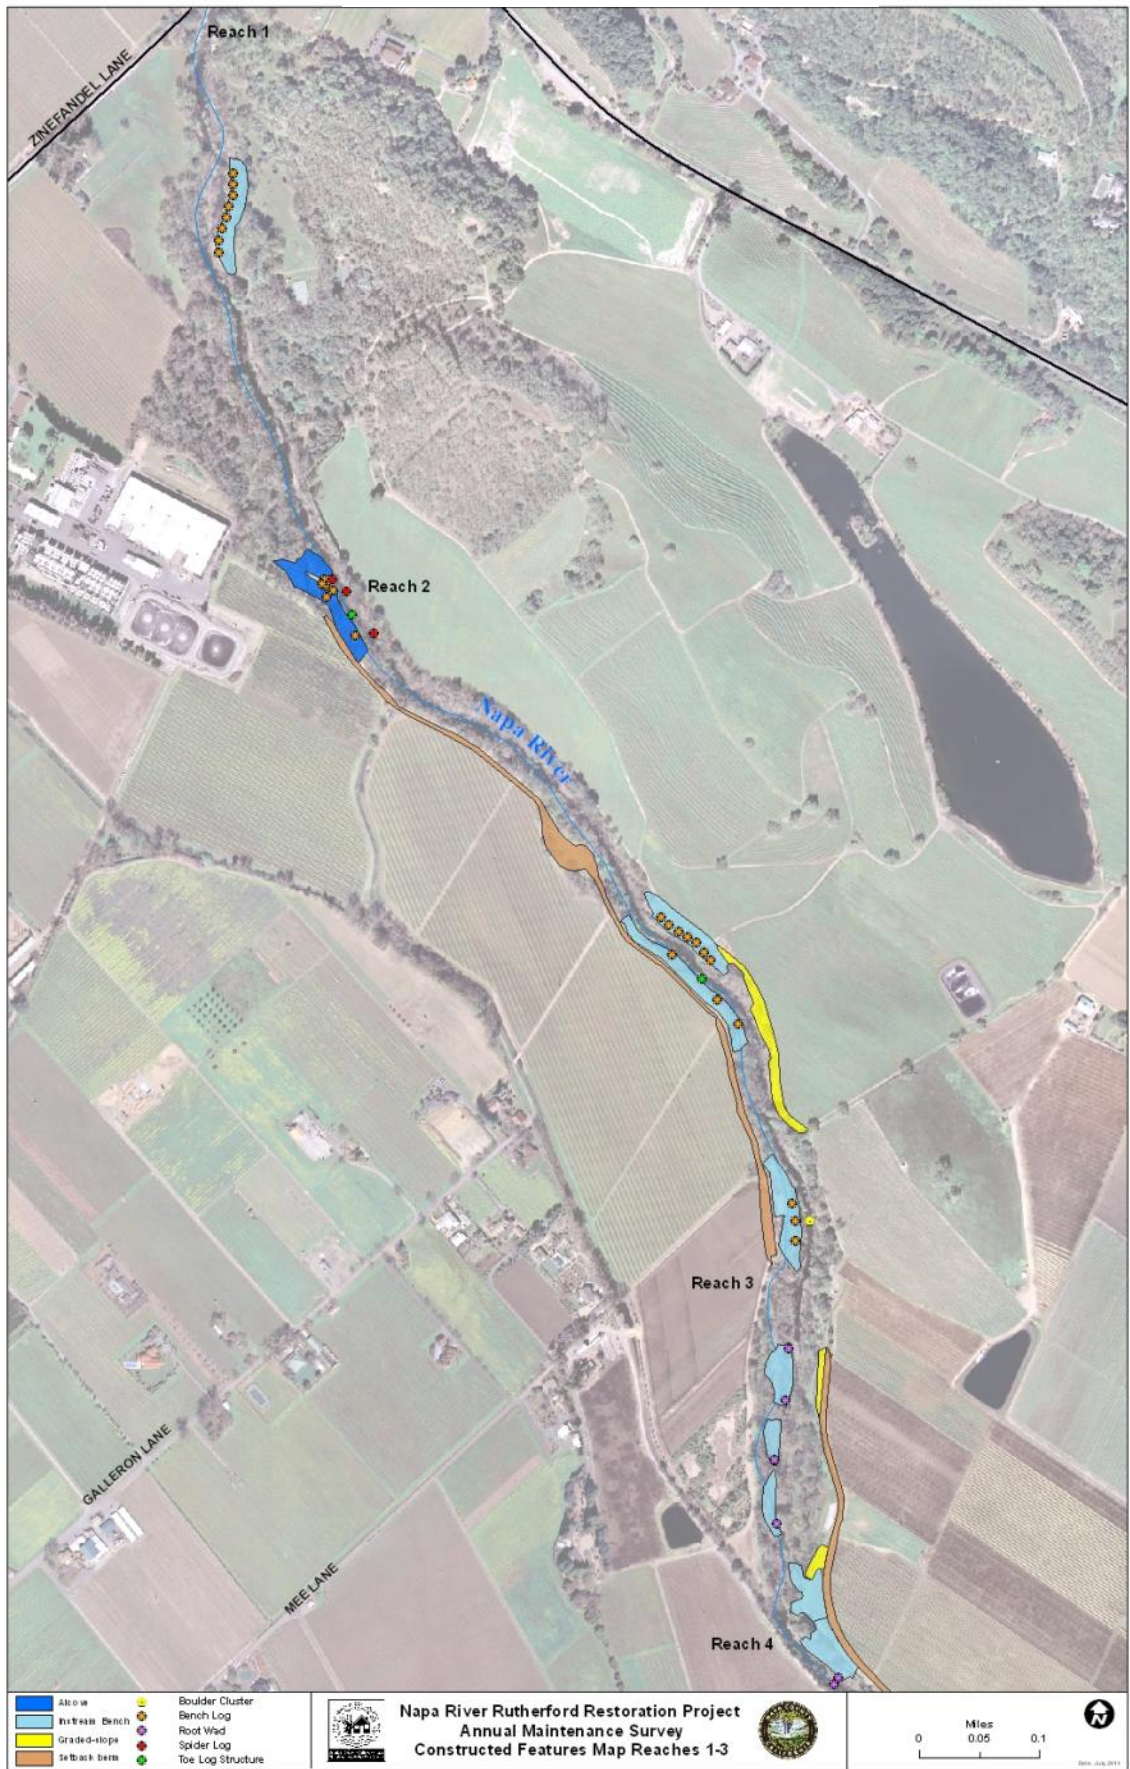
Figure 4: Constructed Features Map

As mentioned previously, at the time of this survey, construction has been completed through Reach 3 resulting in the creation of 9 in-stream benches and 1 backwater alcove, installation of 27 bench logs, 10 rood wad structures, 1 boulder cluster and the setting back of over 8500 linear feet (1.6 miles) of agricultural berms. The 37 LWD structures installed in 2009 and 2010 appear to be functioning as designed and are intact and stable. However, the toe log structure adjacent to the instream bench on the Frogs Leap property experienced significant localized bank erosion that required maintenance in February 2011. Maintenance for this structure included the construction of a willow brush mattress to stabilize the stream bank behind the LWD structure; to date the willow brush mattress is functioning well and proving a bio-technical solution to erosion (Pictures 2 and 3). Reach 1-2 construction funds paid for this work; funds did not come out of maintenance assessment. 2 LWD structures (spider logs) were partially buried by seasonal sediment recruitment in the river, diminishing habitat function. These structures will be monitored to see if next season’s high flows scour the structures out and restore habitat functionality. Additionally, the downstream end of the instream bench constructed on the Caymus Vineyard property experienced scour and erosion around a large willow tree at river station 181+50 during high flow events in winter 2011. It is recommended that this area of erosion be treated by sloping back the stream bank to 3:1 and planting it with a willow brush mattress. Reach 3 construction funds will pay for this work and not; maintenance assessment funds. No other work is proposed or required for built Project features. See Table 3, Figure 4 for location and details of constructed Project features.

River Station/Reach	LWD feature	Recommendation	Notes
219+70 (Reach 2)	Spider Log	Monitor	Partially buried
219+00 (Reach 2)	Spider Log	Monitor	Partially buried
195+50 (Reach 2)	Toe Log	Monitor	Constructed willow brush mattress to arrest localized stream bank erosion
181+50 (Reach 2)	10x 15 square foot erosion area at end of created floodplain bench undermining large mature willow.	Maintenance Recommended	Grade back eroding area to 3:1 slope and replant with willow brush mattress; to be paid for with construction funds

- Repair scour/erosion area at end of constructed instream bench on Caymus Vineyard property by sloping back eroding bank to 3:1 slope and replant with willow brush mattress (see Table 3). This work will be funded using construction funds rather than assessment funds.
