NAPA RIVER RUTHERFORD REACH RESTORATION PROJECT

2011 MONITORING REPORT

Monitoring Studies and Project Summaries

August 31, 2011

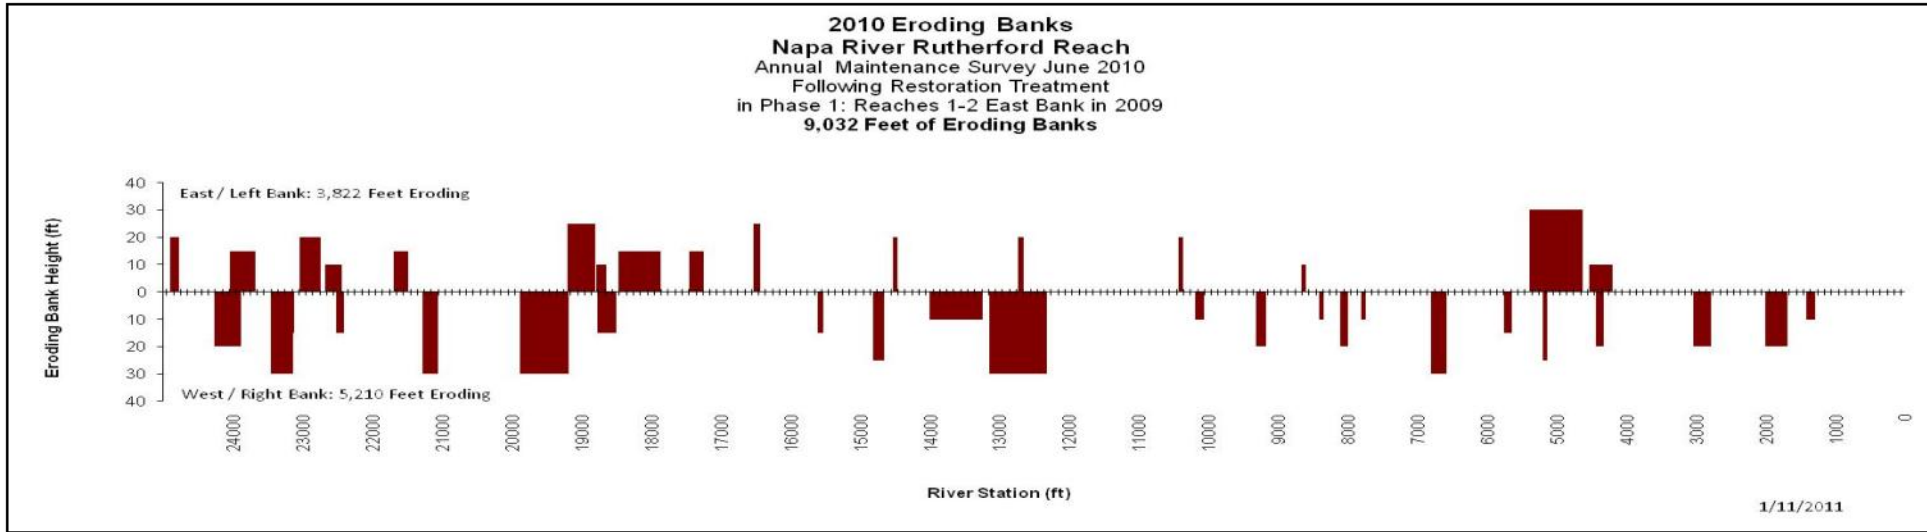
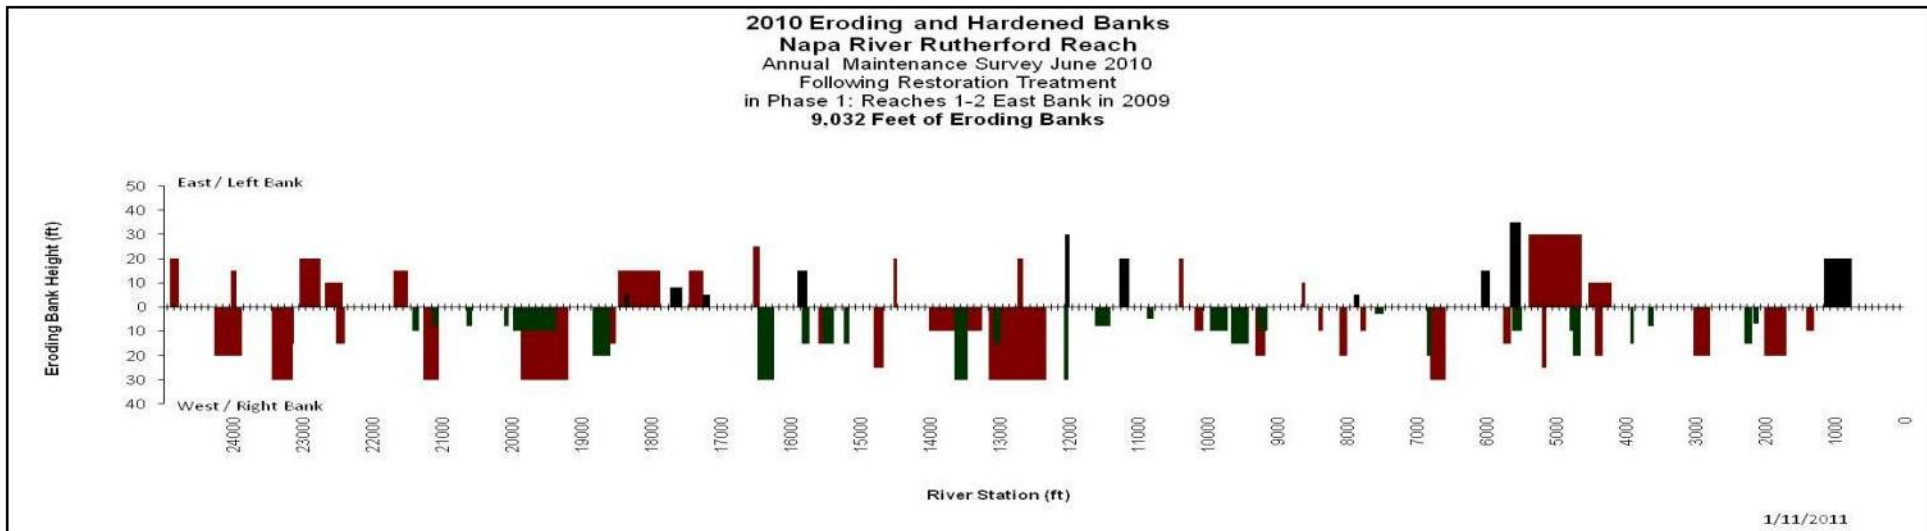
Eroding Streambanks Chart

In June 2010, 9,032 linear feet of eroding banks were mapped throughout the Rutherford Reach: 3,822 linear feet on the left (east) bank, and 5,210 feet on the right (west) bank constituting 18% of the channel bank length in the Rutherford Reach. This constitutes a reduction of 12% compared to the 2009 baseline. A minimum further reduction of 11% in total eroding bank length is required to meet the goals of the project. Eroding bank sections ranged from 10 to 30 feet high.

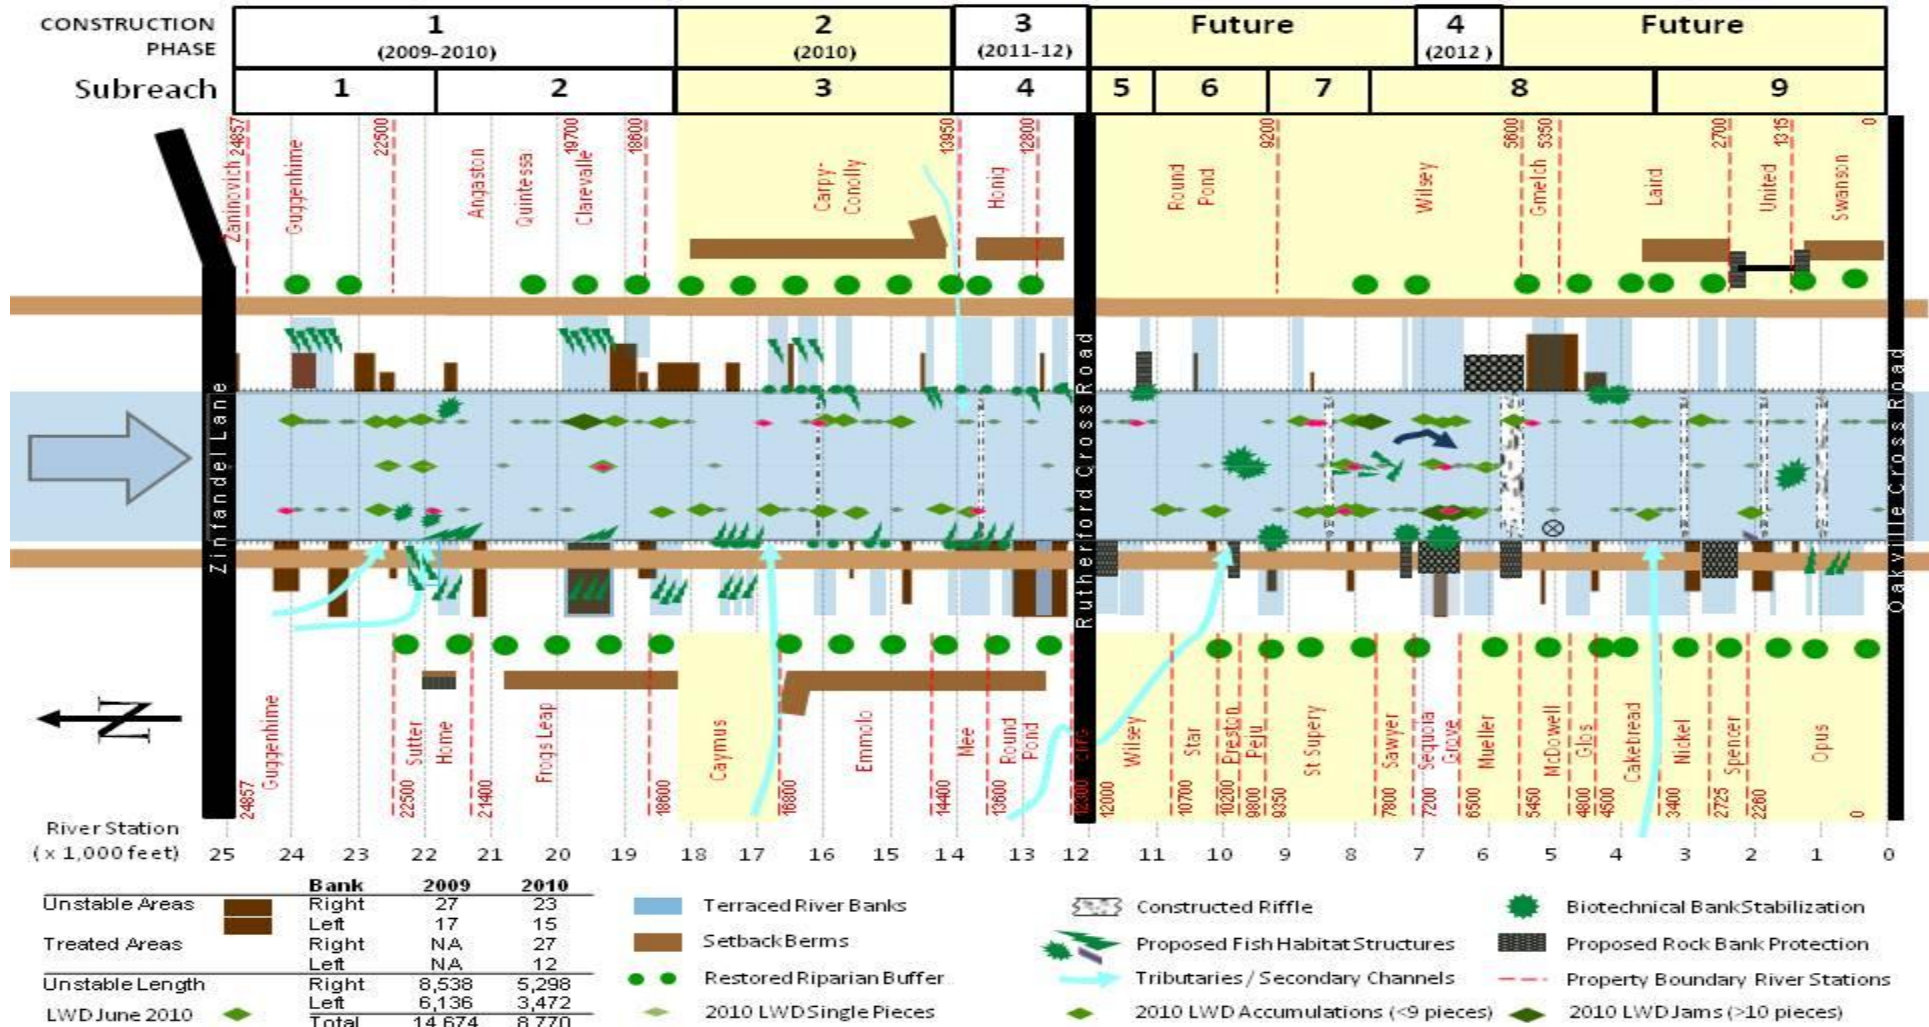
Restoration Project Schematic with 2010 Eroding Banks and Large Woody Debris

Bank	2009	2010
Unstable Areas	Right	27	23
	Left	17	15
Treated Areas	Right	NA	27
	Left	NA	12
Unstable Length	Right	8,538	5,298
	Left	6,136	3,472
LWD June 2010	Total	14,674	8,770

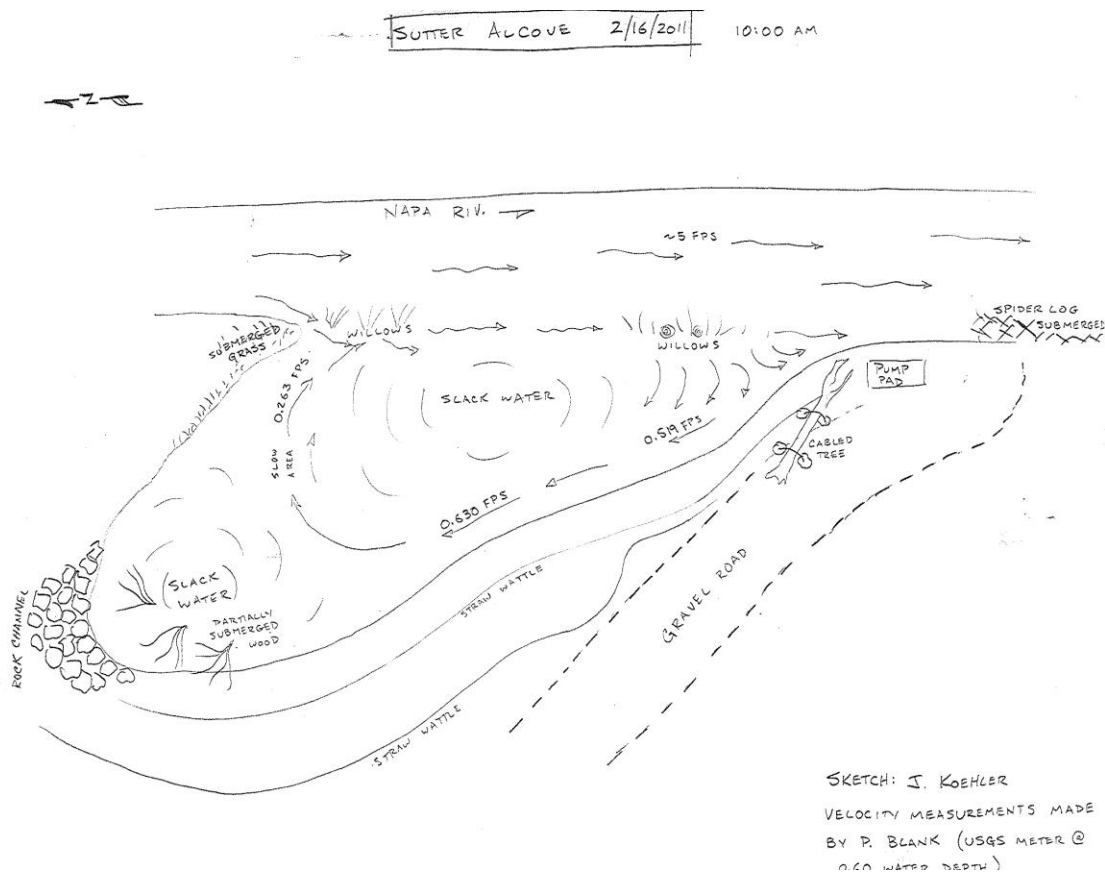
Water Surface Elevation: 159.96 ft (NAVD 88)

Monitored velocities of 0.26 – 0.63 fps at 0.6 ft water depth in this created alcove are suitable for steelhead fry and small juvenile rearing.

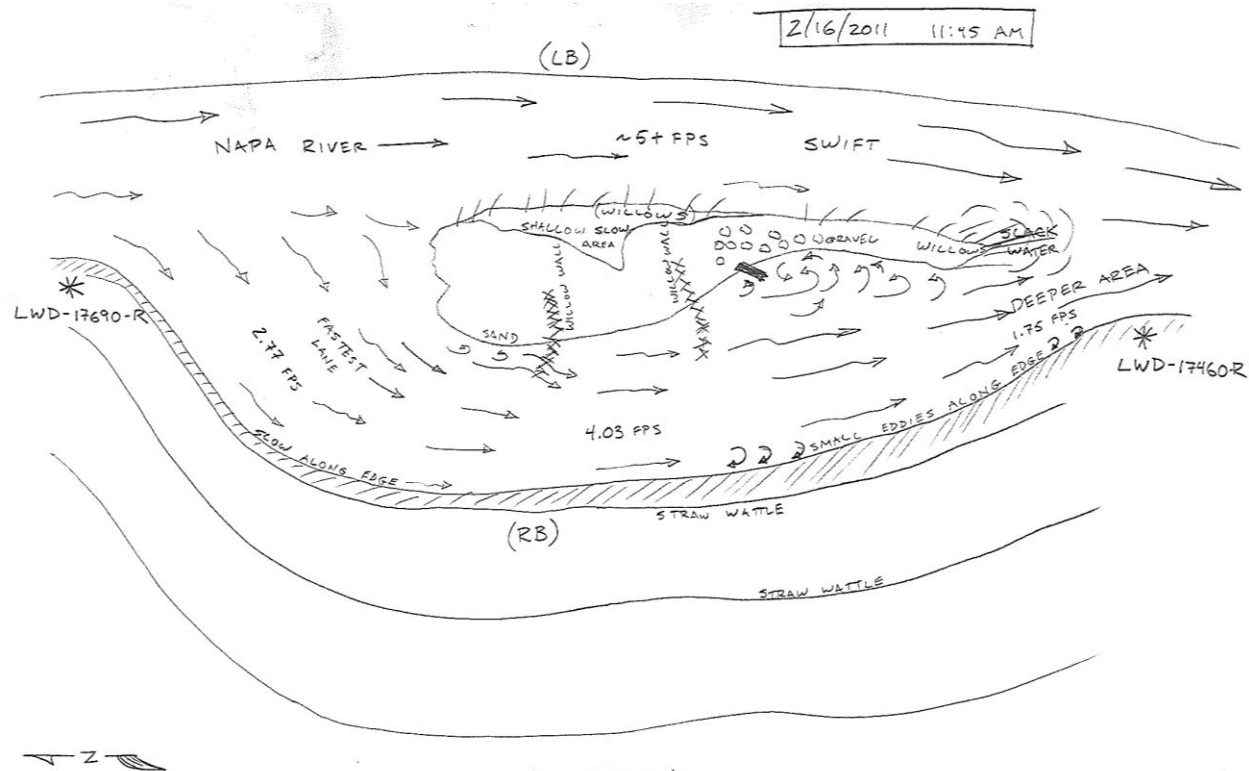
Water Surface Elevation: 150.18 ft (NAVD 88)

Monitored velocities of 1.75 fps at 0.6 ft water depth in the downstream end of this created secondary channel are suitable for small and large juvenile steelhead rearing. Gravel recruitment at the downstream end may create BMI riffle habitat.

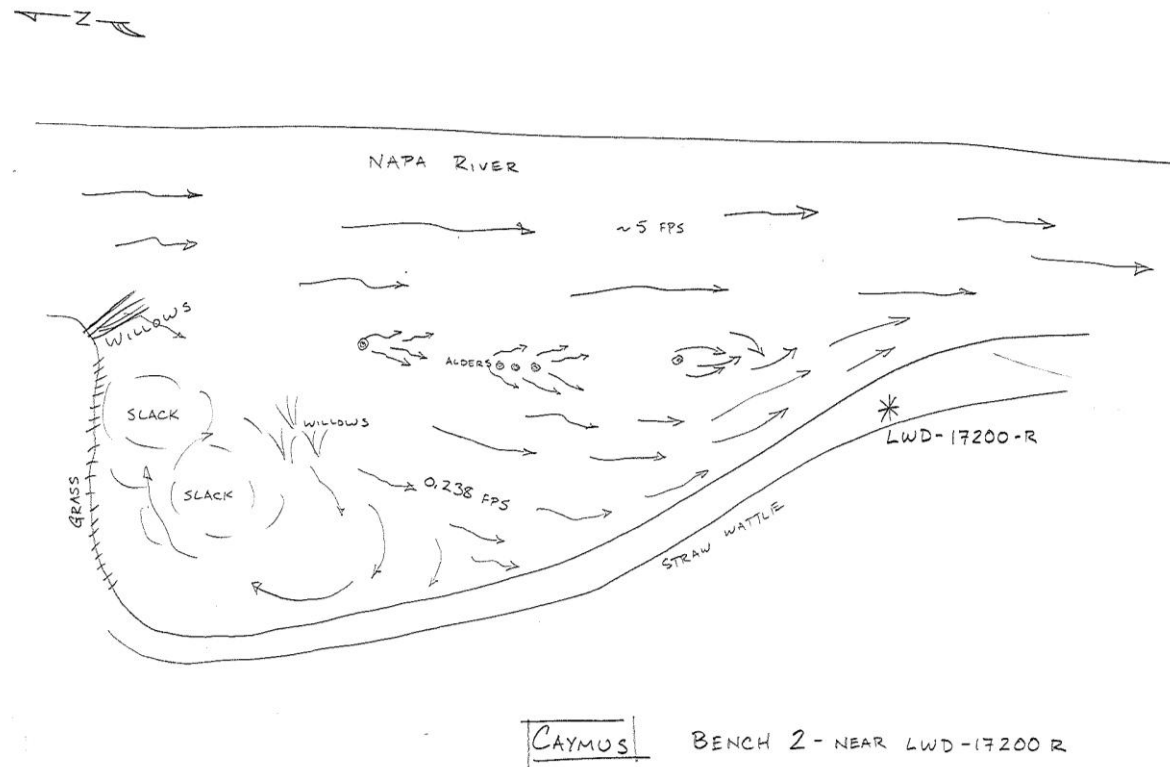
Monitored velocities of 0.24 fps and slack water at 0.6 ft water depth in this created edgewater habitat are suitable for steelhead fry.

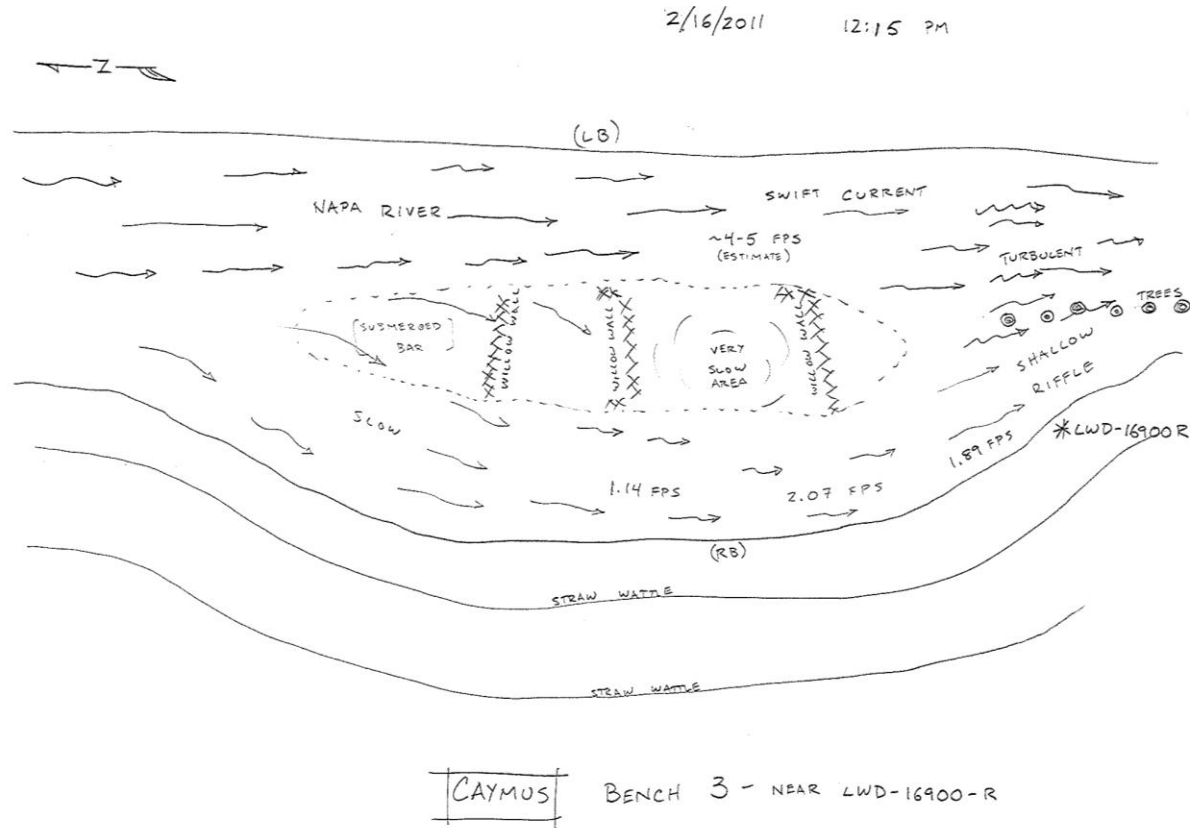
Bench 3: Caymus: Right/West Bank Stations 17,150-16,850 Sketch

Water Surface Elevation: 149.2 ft (NAVD 88)

Monitored velocities of 1.14-1.89 fps at 0.6 ft water depth in this created edgewater habitat are suitable for small and large juvenile steelhead rearing.
