Napa River Rutherford Reach Restoration Project Annual Maintenance and Monitoring Survey

Napa River June 2012

July 2012

*Napa County Flood Control and
Water Conservation District
Napa County, California*

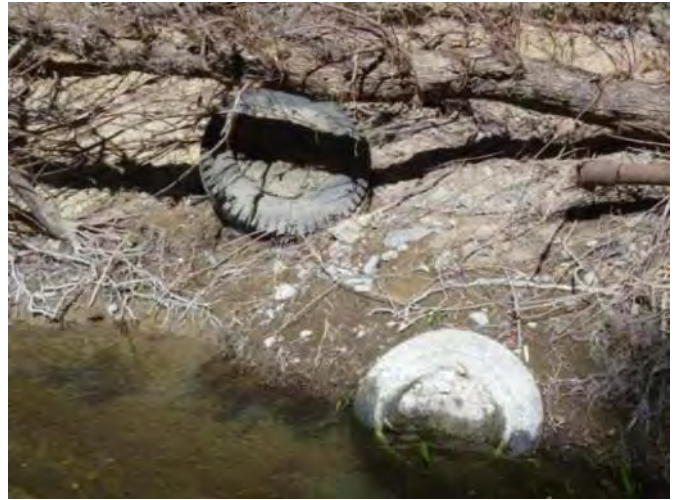
A total of 24 occurrences of trash and debris (Picture 1) were documented in the Project area with the dominant trash and debris type being tires (18) and the remaining (6) occurrences of trash and debris being various objects including irrigation drip lines, agricultural containers and large residential electronic appliances. This represents a significant decrease in the amount of trash and debris documented and removed from the three prior maintenance surveys. Figure 2 shows the location of the trash and debris documented; accumulation of trash was fairly consistent throughout the Project reach with the exception of Reach 9 having a fairly low amount of trash documented. Graph 1 below represents the amount and types of trash documented during the stream survey.

Picture 1: Trash and Debris

- Removal of all trash and debris from the stream channel that can be readily accessed and accomplished with hand labor, pulley or winch assisted mechanisms.

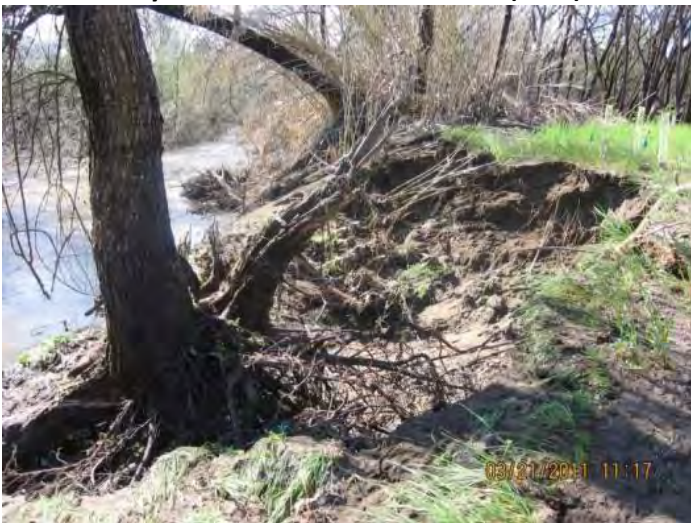
Picture 3: Caymus stream bank erosion site (2011)

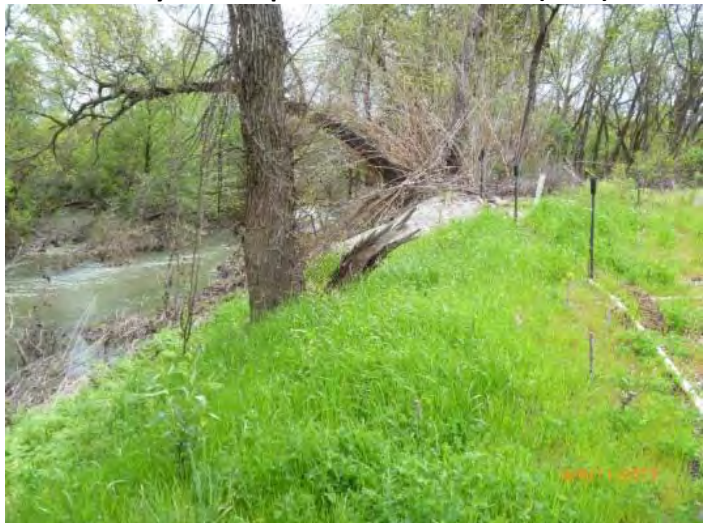
As mentioned previously, at the time of this survey, construction has been completed through Reach 4, east bank (Zinfandel Lane downstream to Rutherford Cross Road), resulting in the installation of 14 flood plain benches, 1 backwater alcove, 27 bench logs, 18 root wad structures and 6 boulder clusters. At the time of the survey, all LWD and boulder cluster structures appeared to be functioning as designed and will not require maintenance in 2012. Additionally, the LWD structure adjacent to the instream bench on Frogs Leap property that was repaired in 2011 by constructing a willow brush mattress to stabilize the stream bank behind the LWD structure appears to be holding up well; to date the willow brush mattress is functioning and growing vigorously and providing a bio-technical solution to erosion. Winter high flows have scoured fine sediment from the 2 LWD structures in Reach 2 that were partially buried in 2011 by sediment and now have small pools surrounding the structures and are once again functioning as in-stream fish habitat. The downstream end of the flood plain bench constructed on the Caymus Vineyard property that experienced scour and erosion around a large willow tree was treated in the summer 2011 by sloping back the stream bank to 3:1 grade, covering with erosion control fabric and planting willow and cottonwood stakes. This bio-technical solution appears to be growing and holding well (Pictures 3 and 4). However, as previously mentioned, there are additional areas of localized bank erosion related to the previously treated giant reed (*Arundo*) sites that the District intends to address/stabilize using a combination of bio-technical methods such as those utilized above. See Table 3 for the location and details of the proposed bank stabilization work to be conducted at these sites.

Picture 4: Caymus site post bank stabilization (2012)

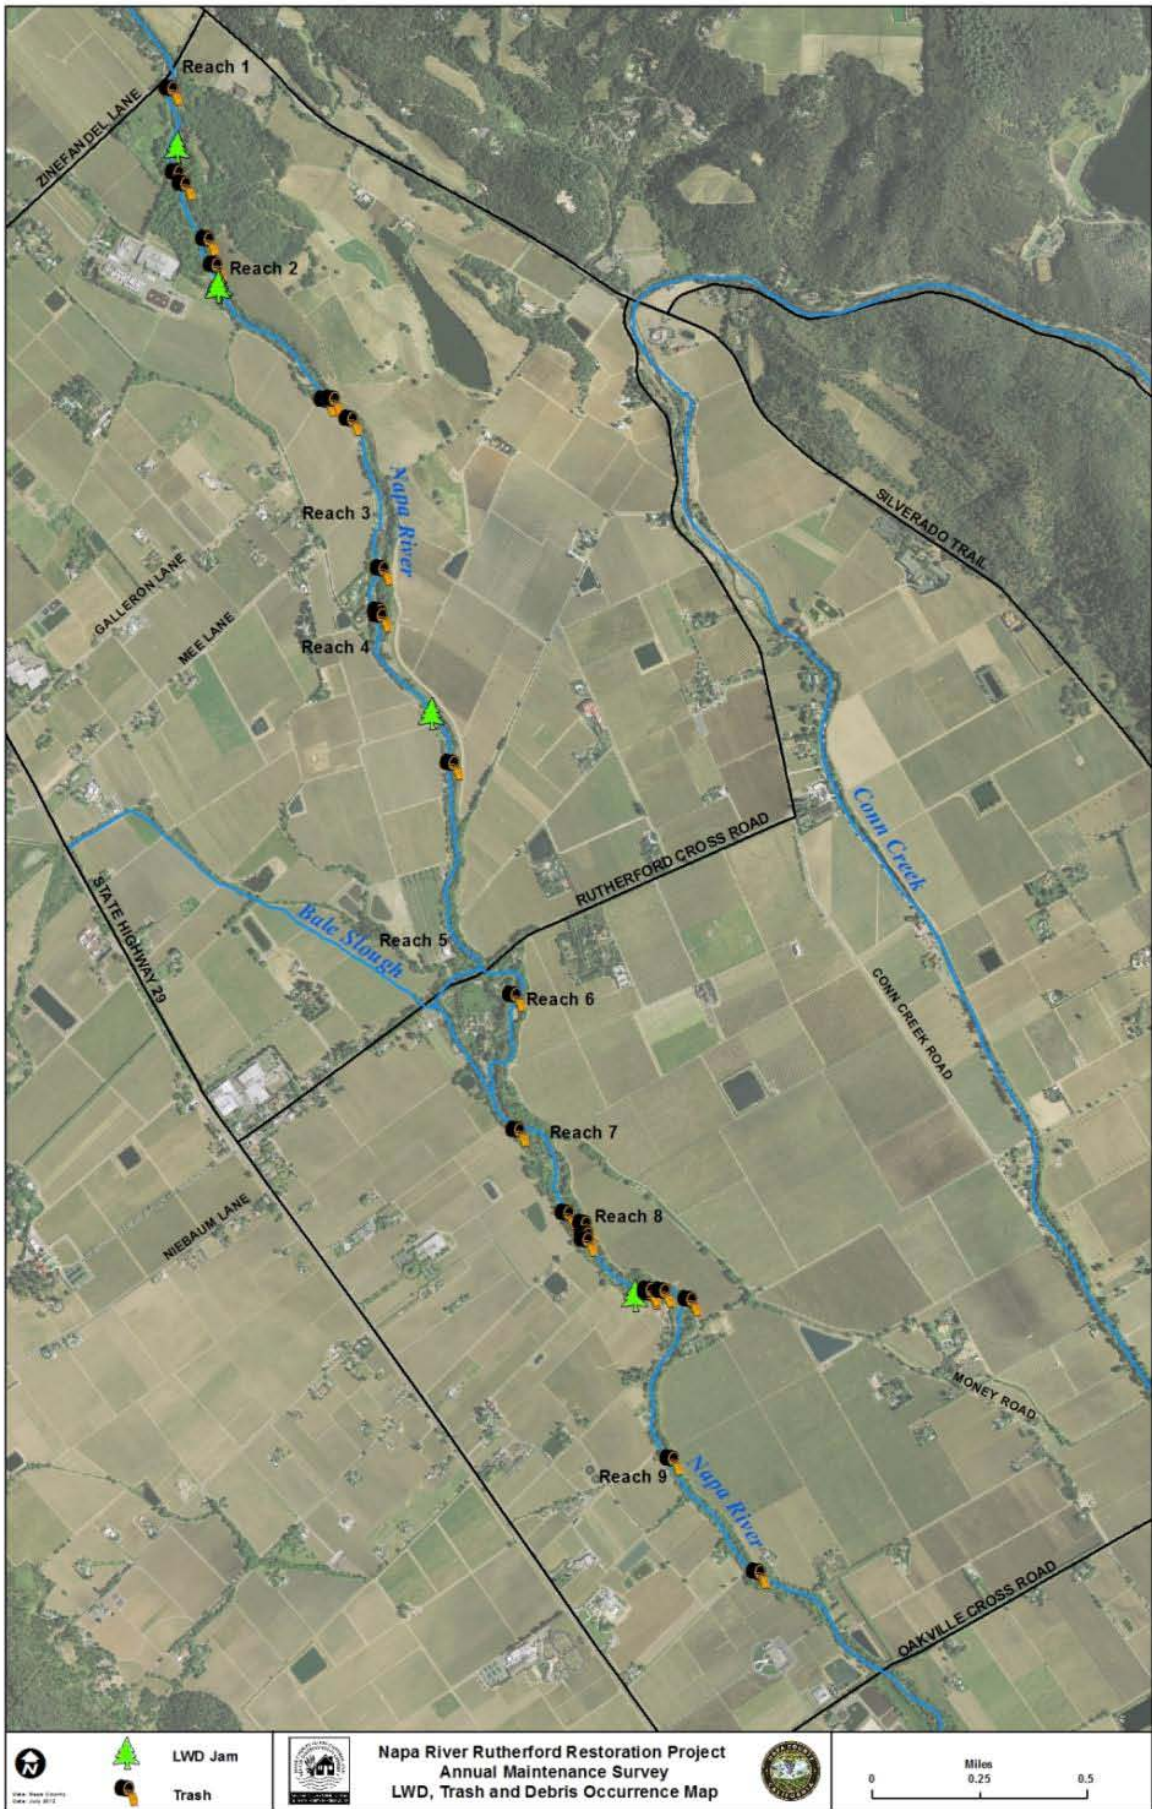
Figure 2: LWD, Trash and Debris Map

145 naturally recruited large woody debris (LWD) occurrences greater than one foot in diameter and six feet in length were documented during the 2012 stream survey. Of those 145 LWD occurrences, 5 were ranked as potential maintenances and have been prioritized for maintenance action (thin out smaller wood, trim trunk and/or realign larger wood to reduce flood potential or erosion) in 2012 (Table 2, Figure 2). One of the LWD occurrences documented as a potential maintenance issue will be incorporated into Reach 8 construction activities during summer 2012 as an in-stream habitat structure. The remaining 140 LWD occurrences that were documented (functioning as important in-stream fish habitat) will not require maintenance pursuant to the goals of the maintenance survey. The distribution, habitat function and accumulation trends of the 145 occurrences of LWD will be presented in a separate annual habitat monitoring report.

River Station/Reach	LWD feature	Recommendation	Notes
238+00 (Reach 1)	Large single trunk tree, center channel, causing erosion on left bank	Maintenance Recommended	Treatment – remove large limbs, leave trunk, to increase channel flow capacity, leave root wad in place
219+00 (Reach 2)	Large single trunk alder, center channel, root wad and branches causing erosion on right bank	Maintenance Recommended	Treatment – remove large branches/trunk to increase channel flow capacity/relieve pressure from right bank, relocate root wad to wider section of channel
219+30 (Reach 2)	Medium alder root wad right bank	Maintenance Recommended	Treatment –trim root wad and trunk to deflect flow from right bank, monitor for bank erosion

154+70 (Reach 4)	Medium wood accumulation/jam (>10), full channel	Maintenance Recommended	Treatment –trim root wad and trunk to deflect flow from left bank, remove debris accumulation, monitor
67+80 (Reach 7)	Medium wood accumulation/jam (>10), full channel	Maintenance Recommended	Treatment – large wood to be incorporated into Reach 8 project construction as in stream habitat structure

- Limb/ thin large branches and/or root wads at LWD jams (<12-inches-in-diameter and/or <6-feet-long) adjacent to landowners property as recommended by survey report (Table 2).
