XI. Seasonal Salmonid Habitat Surveys

Seasonal Salmonid Habitat Surveys

At the request of the Napa County Flood Control and Water Conservation District and in accordance with the Monitoring Plan for the Rutherford Reach Restoration of the Napa River, Napa County Resource Conservation District (RCD) completed assessments of recently-installed in-stream restoration features in Reaches 1,2, and 3 of the Rutherford Reach Restoration Project on the Napa River Two assessments were completed: one at a winter flow high enough to inundate new bench cuts, and one at a low spring flow to evaluate new wood and rock habitat structures. The assessments included site sketches of surface flow patterns, collection of photographs, water velocity measurements, water-level elevation surveys, and evaluation of habitat function by a fisheries biologist.

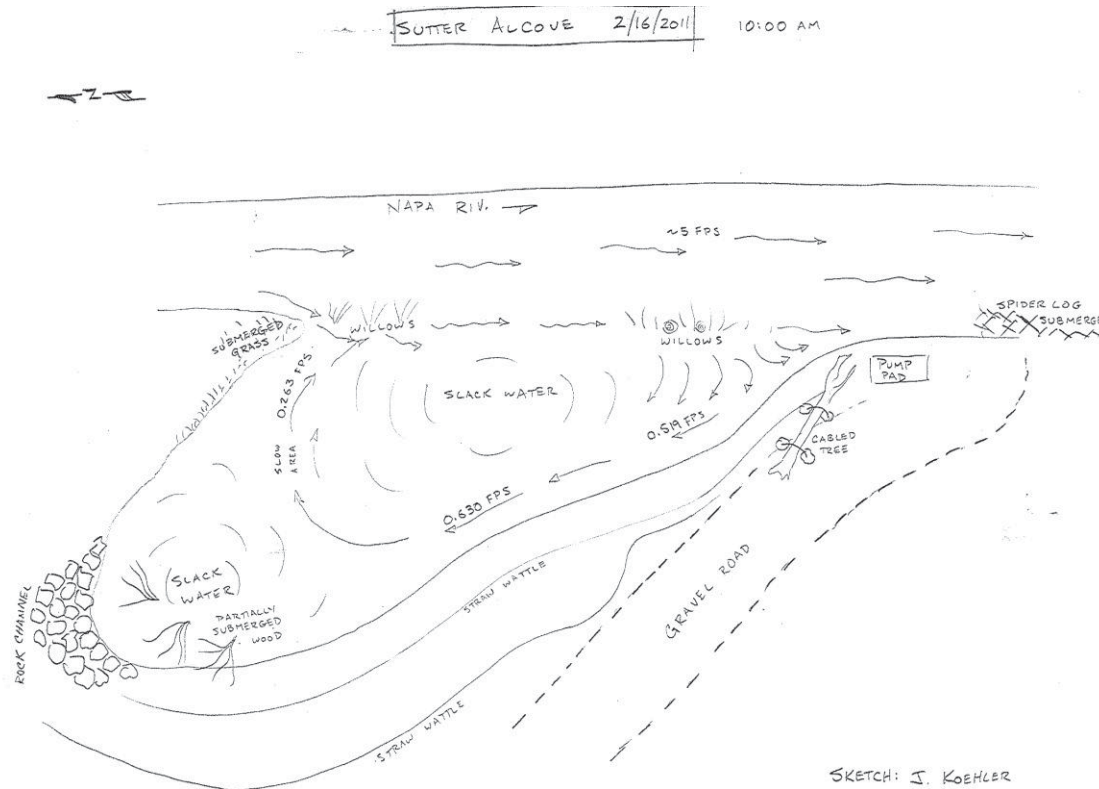
Alcove: Ranch Winery / Sutter Home: Right Bank Stations 22,225-21,900 Sketch

Feature Name	River Station	Feature Type	Assessment	Fisheries Biologist Evaluation
Sutter Alcove	21950-R	Alcove	High-flow	The alcove appears to be functioning very well to provide off-channel refuge habitat for juvenile salmonids during high flow events. Areas of slack water were observed in this feature during a large winter storm event.
Frogs Leap Bench 1	19680-R	Bench Cut	High-flow	This bench is only inundated during large winter events, during which time it offers a limited amount of lower velocity refuge habitat for juvenile salmonids. However, it is only engaged for a very short period in any given season. The bench appears to drain well as flows recede and does not create a significant stranding hazard for young fish.
Caymus Bench 0	18300-R	Bench Cut	High-flow	This bench is only inundated during large winter events, during which time it offers a limited amount of lower velocity refuge habitat for juvenile salmonids. However, it is only engaged for a very short period in any given season. The bench appears to drain well as flows recede and does not create a significant stranding hazard for young fish.

Monitored velocities of 0.26 – 0.63 fps at 0.6 ft water depth in this created alcove are suitable for steelhead fry and small juvenile rearing.

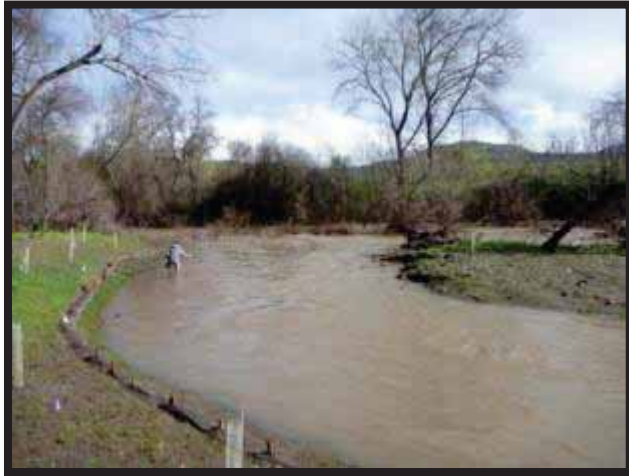
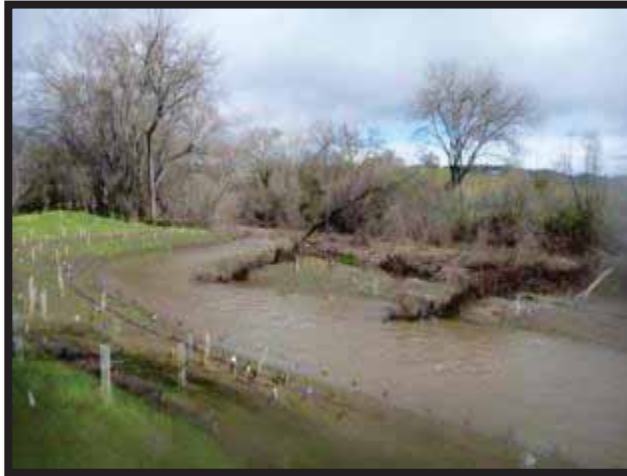
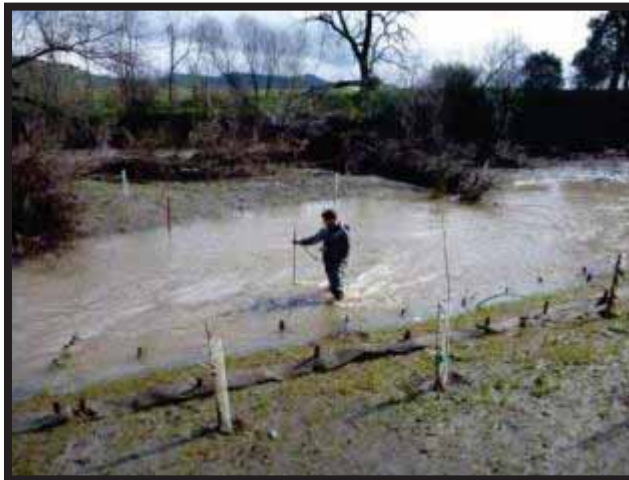
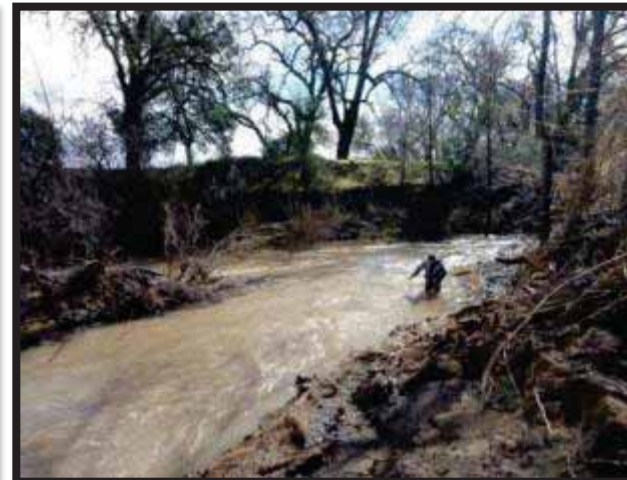
Bench 1: Caymus: Right/West Bank Stations 17,700-17,425 Photos

Caymus Bench 1	17500-R	Bench Cut	High-flow	This bench is functioning well to provide off-channel refuge habitat for juvenile salmonids during high-flow events. During intermediate winter flows, velocities through the secondary channel may be prohibitively fast to provide much habitat for juvenile salmonid rearing.
Caymus Bench 2	17290-R	Bench Cut	High-flow	This bench is functioning very well to provide off-channel refuge habitat for juvenile salmonids during high flow events. Areas of slack water were observed in this feature during a large winter storm event.
Caymus Bench 3	17050-R	Bench Cut	High-flow	This bench is functioning well to provide off-channel refuge habitat for juvenile salmonids during high-flow events. During high winter flows, velocities through the secondary channel remained in the favorable range for juvenile salmonid rearing.

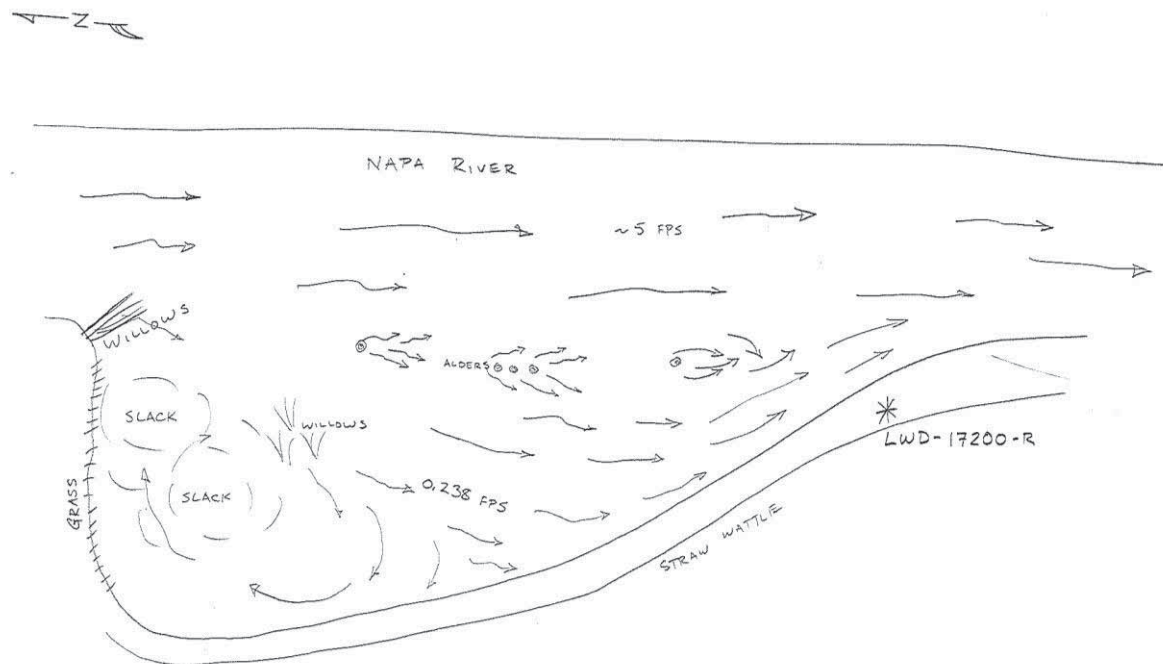
Bench 2: Caymus: Right/West Bank Stations 17,350-17,160 Sketch

Monitored velocities of 0.24 fps and slack water at 0.6 ft water depth in this created edgewater habitat are suitable for steelhead fry.

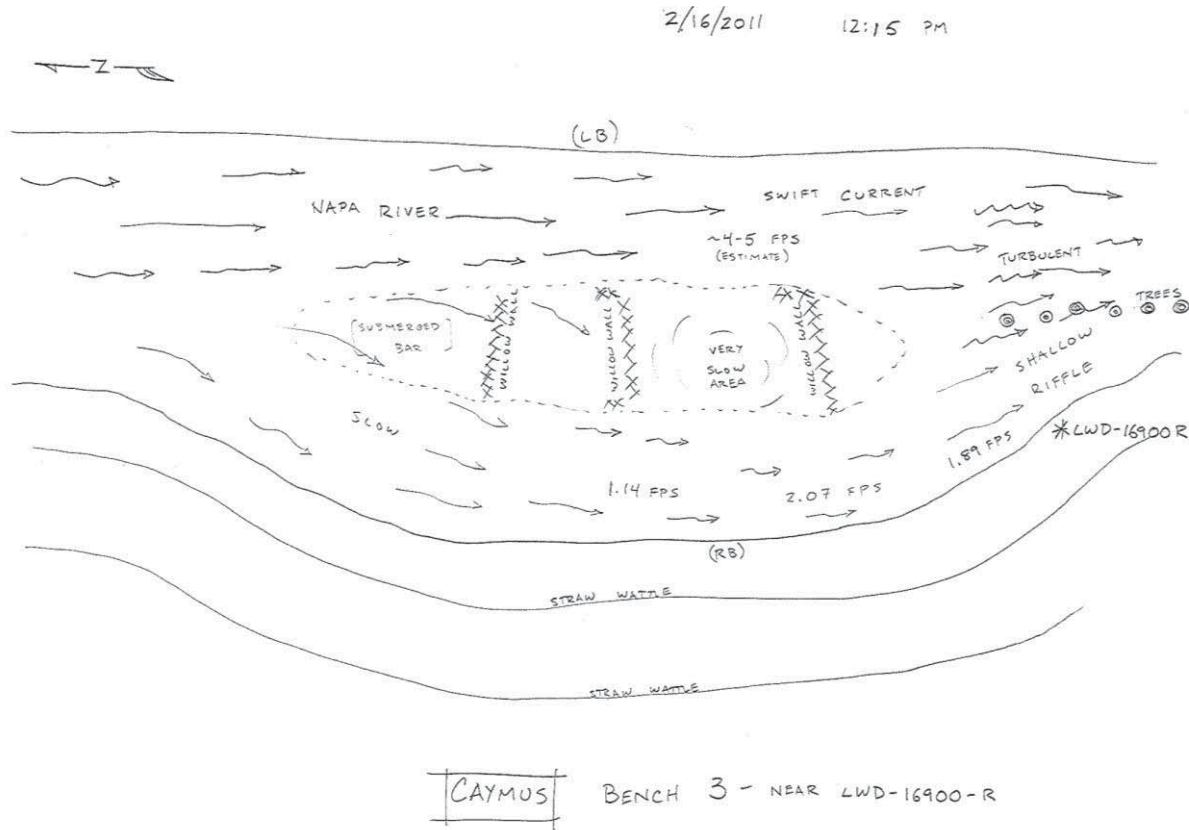
Bench 3: Caymus: Right/West Bank Stations 17,150-16,850 Sketch

Monitored velocities of 1.14-1.89 fps at 0.6 ft water depth in this created edgewater habitat are suitable for small and large juvenile steelhead rearing.

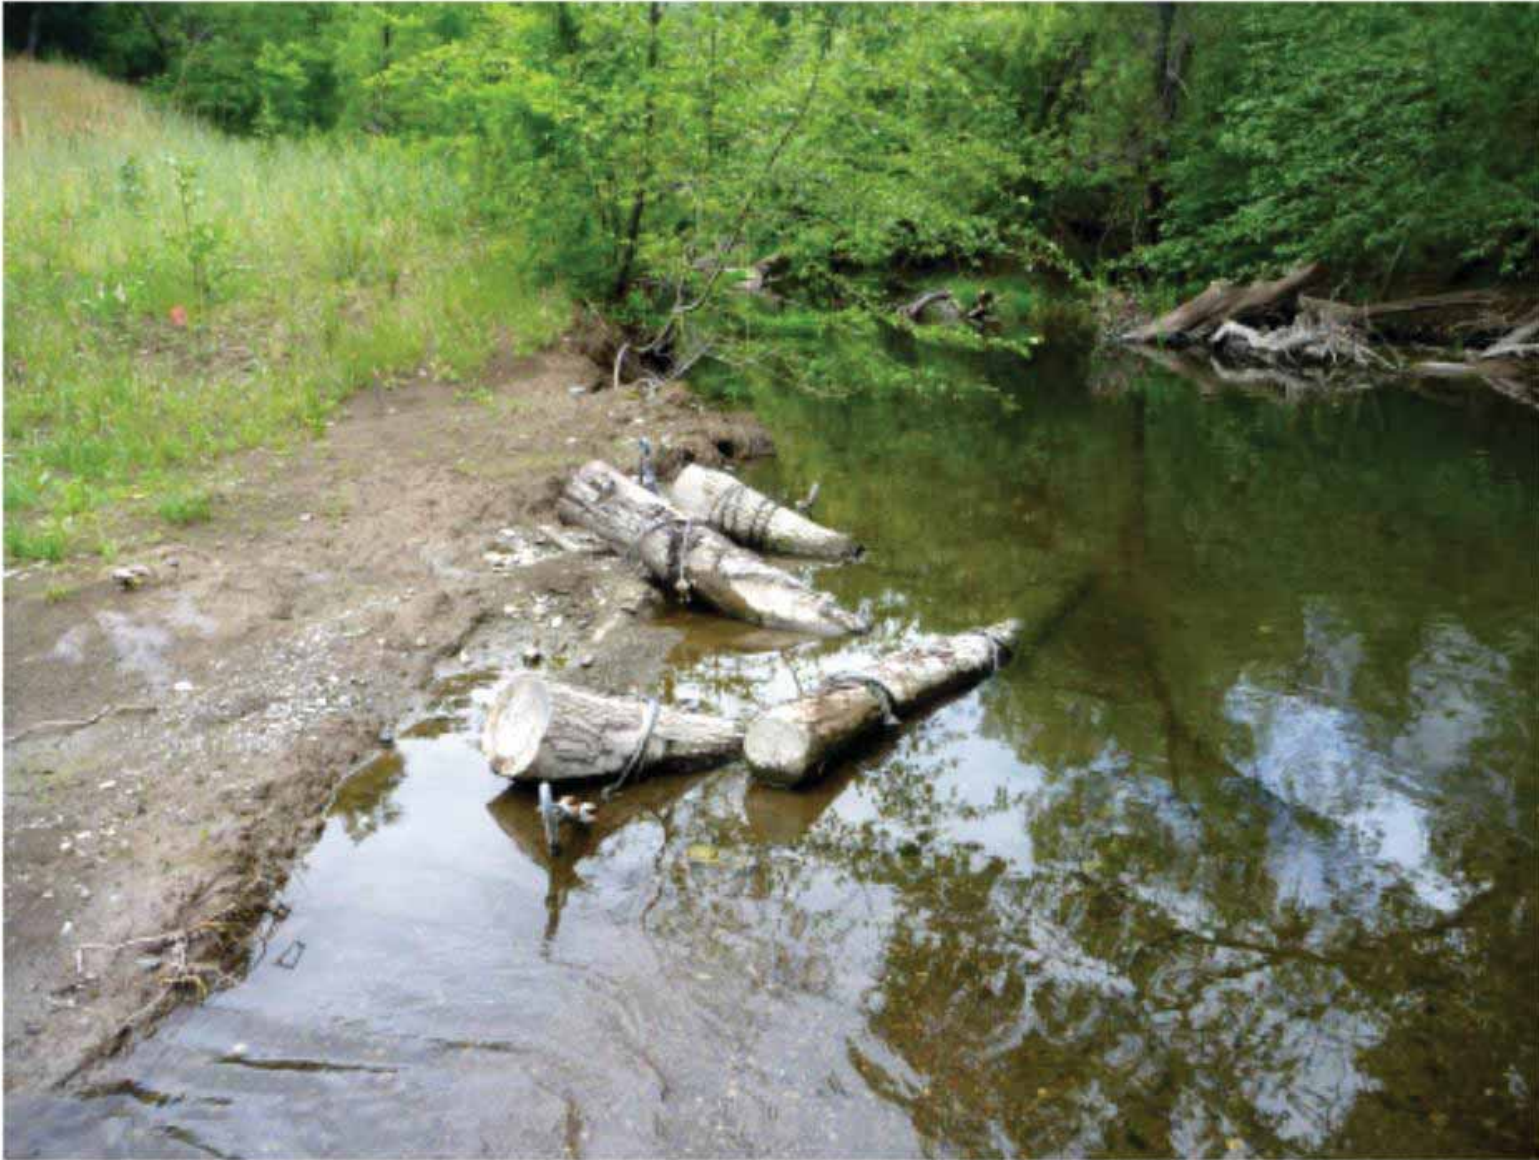
WD-22100-R
6/2/2011

WD-21850-R	21850	Toe-Log Structure	Low-flow	This feature appears to primarily provide instream cover. It is situated on the right bank of a long, low velocity pool, which is not a habitat type that is likely to attract rearing salmonids seeking feeding opportunities. At higher flows, the structure may provide a velocity shelter for small fish, but this was not assessed. No juvenile salmonids were observed around the feature during a snorkel survey on May 26, 2011.
WD-21900-L	21900	Spider Log	Low-flow	Buried. Not assessed.
WD-22100-R	22100	Spider Log	Low-flow	Buried. Not assessed.

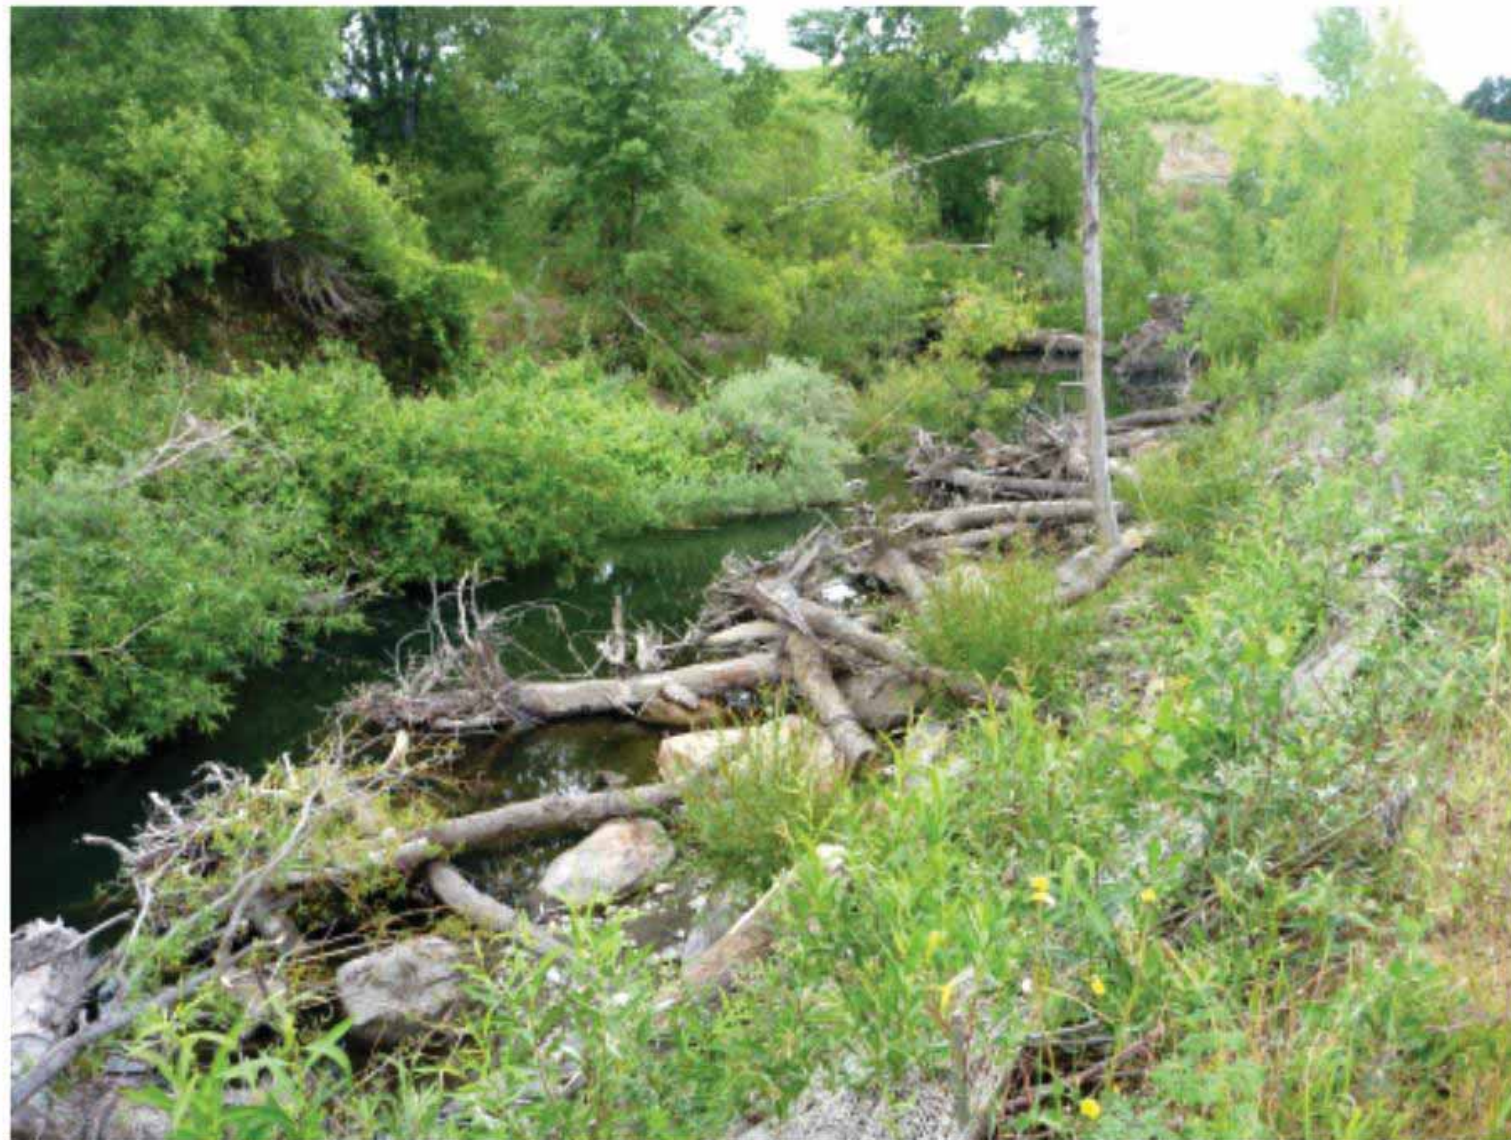
WD-17700-R	17700	Woody Debris	Low-flow	Dry. Not assessed.
WD-19525-R	19525	Toe-Log Structure	Low-flow	At typical spring flows, this feature primarily provides instream cover. It is situated on the right bank of a deep, low velocity pool, which is not a habitat type that is likely to attract rearing salmonids seeking feeding opportunities. At higher flows, the structure may provide a velocity shelter for small fish, but this was not assessed. No juvenile salmonids were observed around the feature during a snorkel survey on May 26, 2011.
WD-21700-L	21700	Spider Log	Low-flow	This feature is functioning well to provide cover and localized pool scour. The feature does not appear to be increasing water velocities, thereby creating feeding lanes for juvenile salmonids. No juvenile salmonids were observed around the feature during a snorkel survey on May 26, 2011.

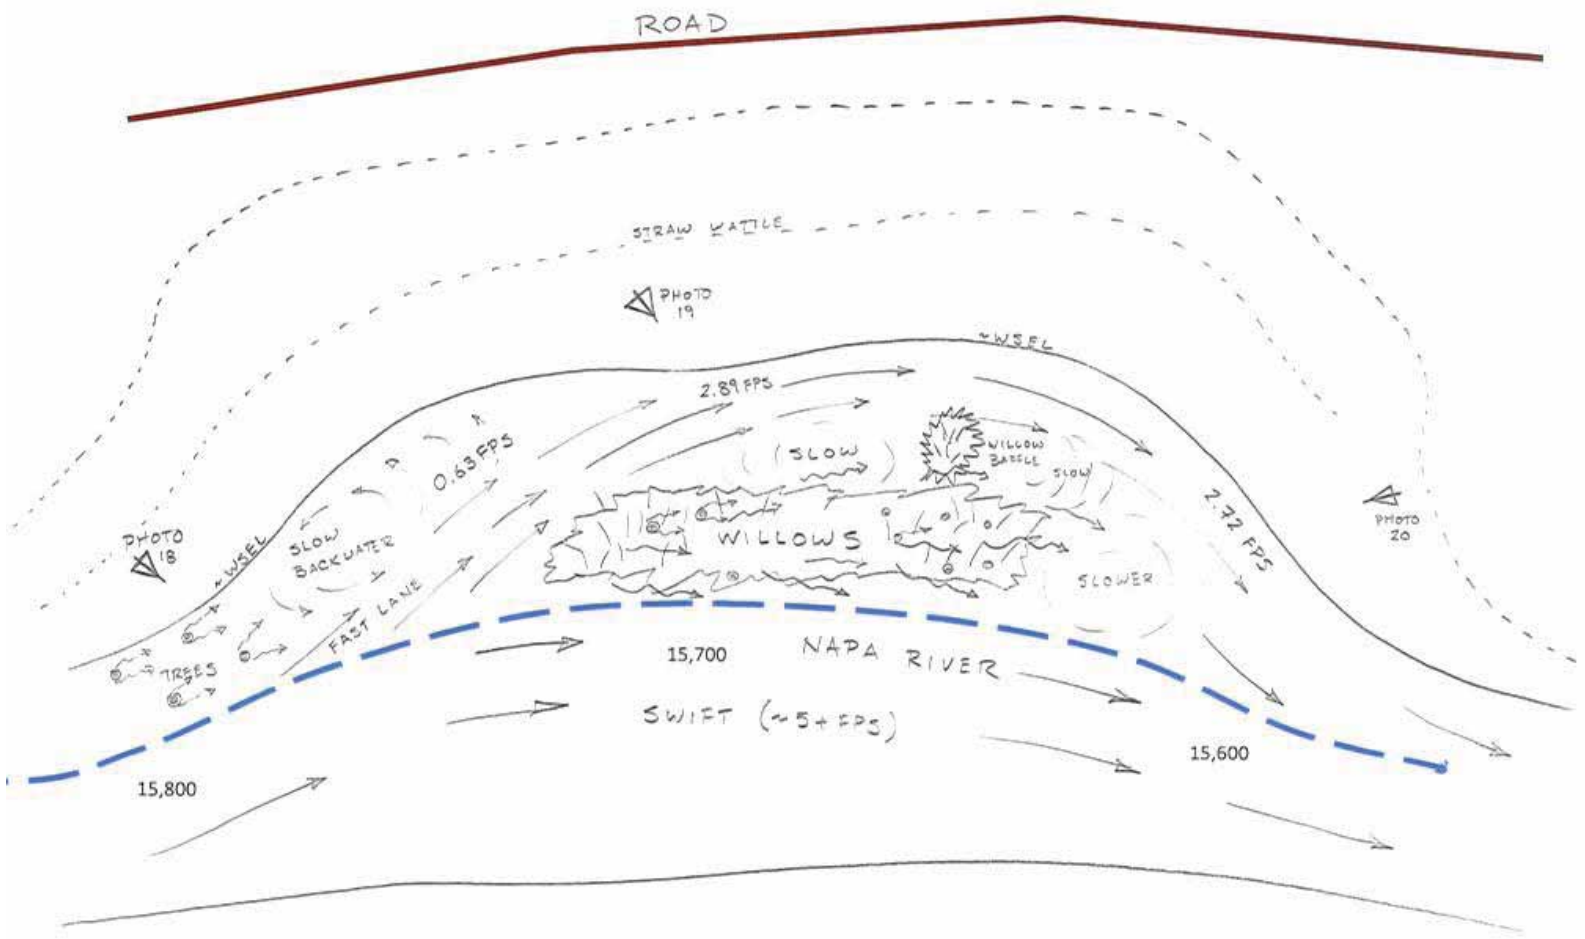
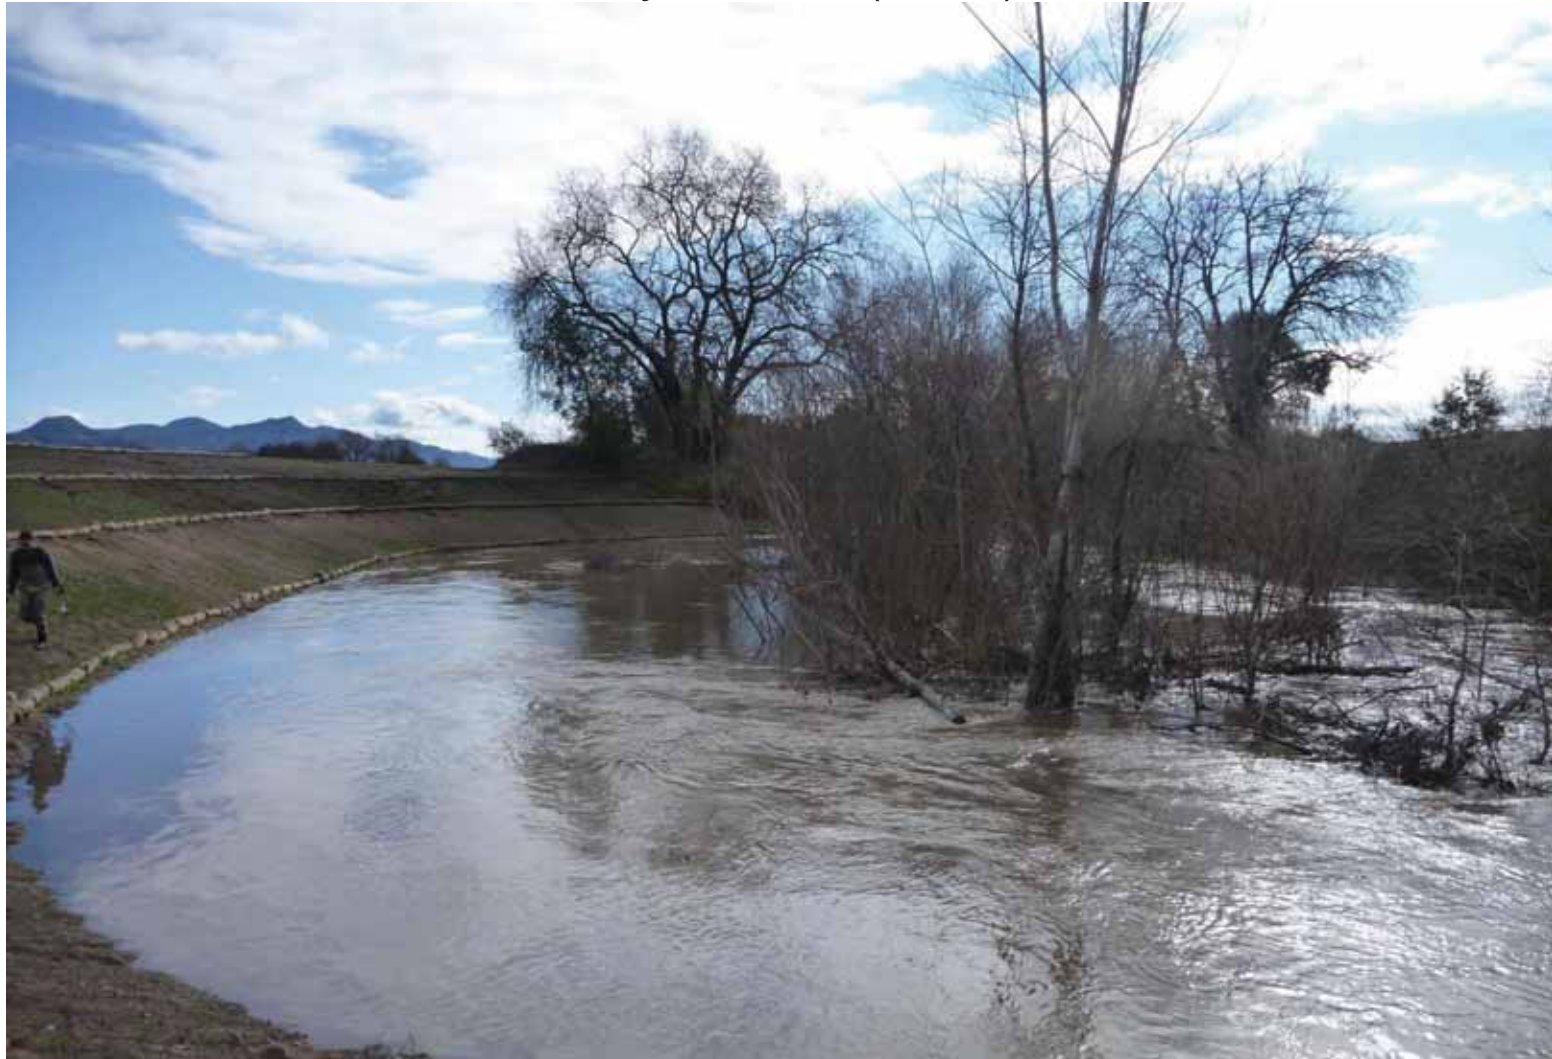
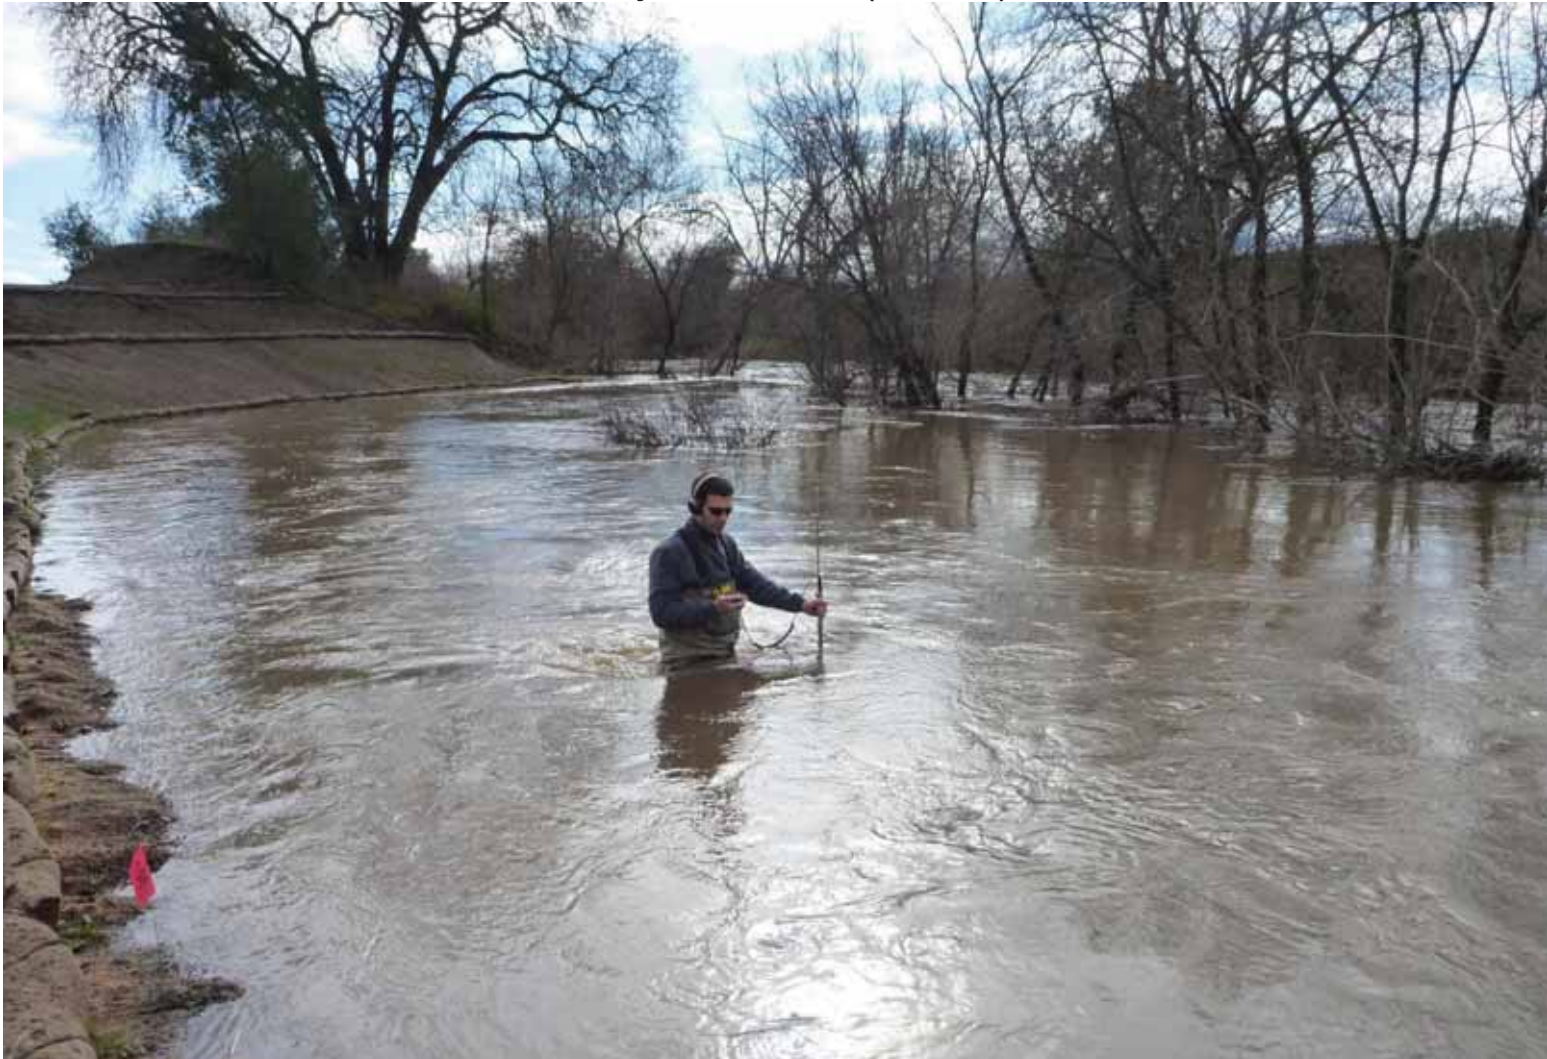
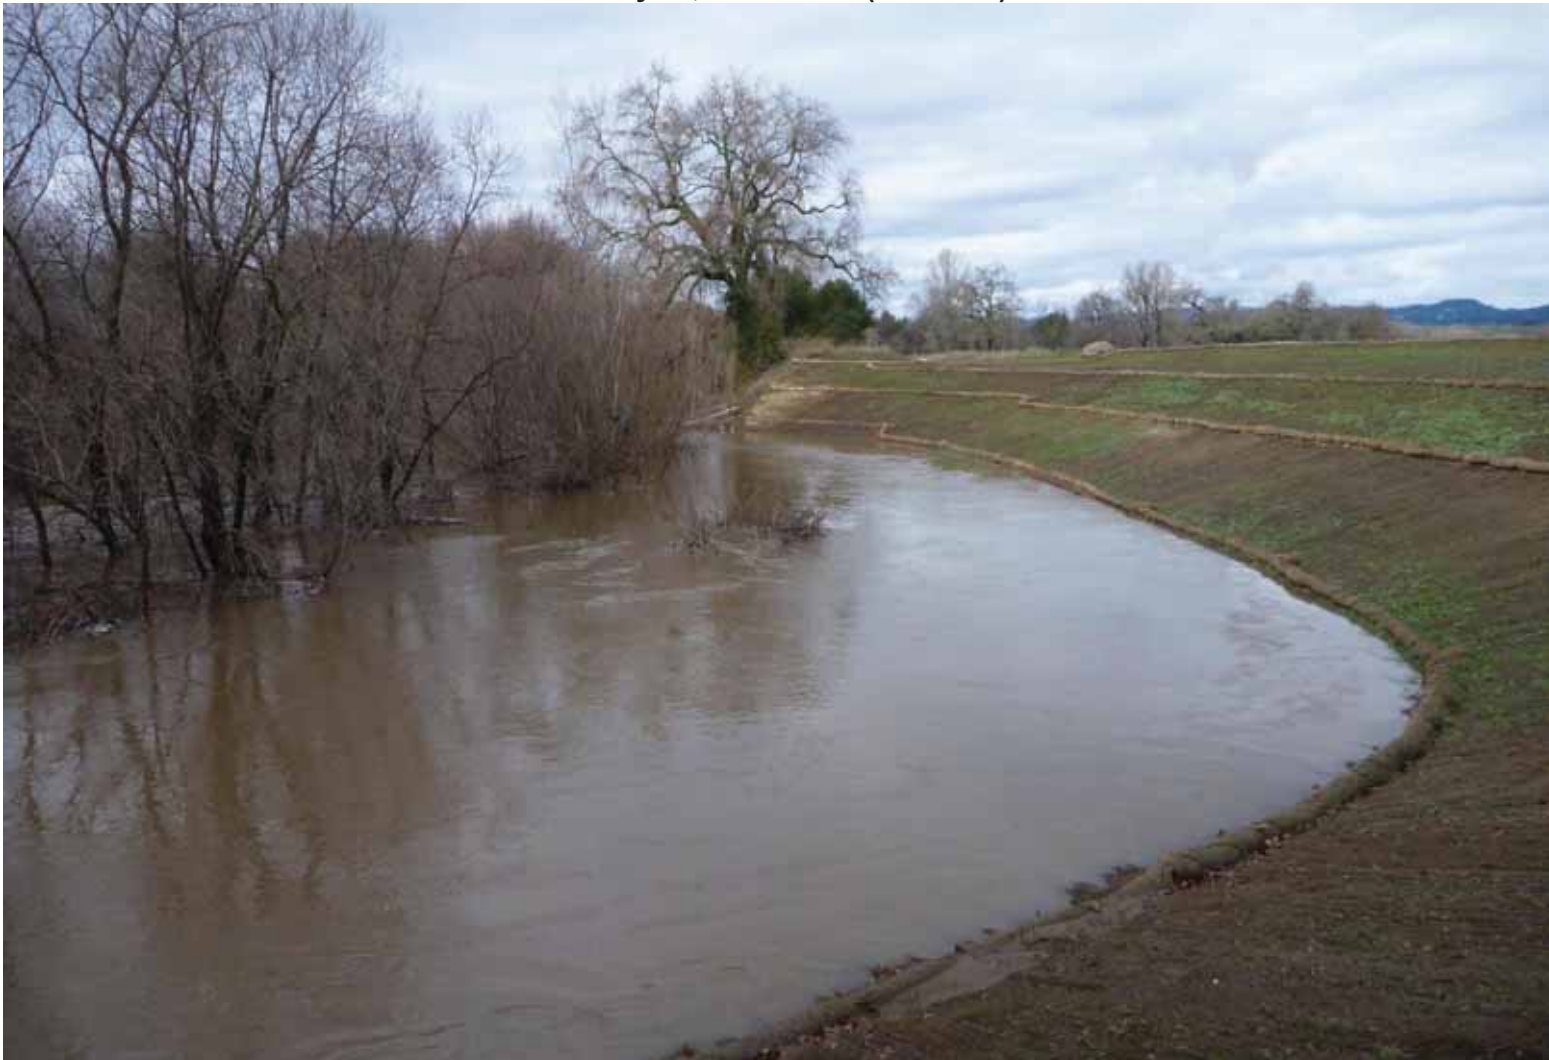
Napa River Rutherford Reach Restoration Project
Phase 3a: Reach 4 East Bank
Bench 7: Carpy-Conolly
Stations 15,575-15,900

Bench 7: Carp Conolly	15700-L	Bench Cut	High- flow	This bench appears to be functioning very well to provide off-channel refuge habitat for juvenile salmonids during high flow events. Areas of slack water were observed in this feature during a large winter storm event.
BC-12400	12400	Boulder Cluster	Low- flow	These three boulders appear to provide a relatively small but effective velocity shelter during low to moderate flows. Measured velocities were significantly slower within the cluster than the surrounding currents. No salmonids were observed around this feature during the snorkel survey. All boulders were covered heavily with filamentous algae.
WD- 12410-L	12410	Root Wad	Low- flow	This rootwad appears to provide good refuge habitat during low to moderate flows. A deep scour hole has developed immediately around the feature, and water velocities measured just downstream of the rootwad were significantly lower than the surrounding currents. During the snorkel survey, no salmonids were present around this feature, but several other native fish species were observed.

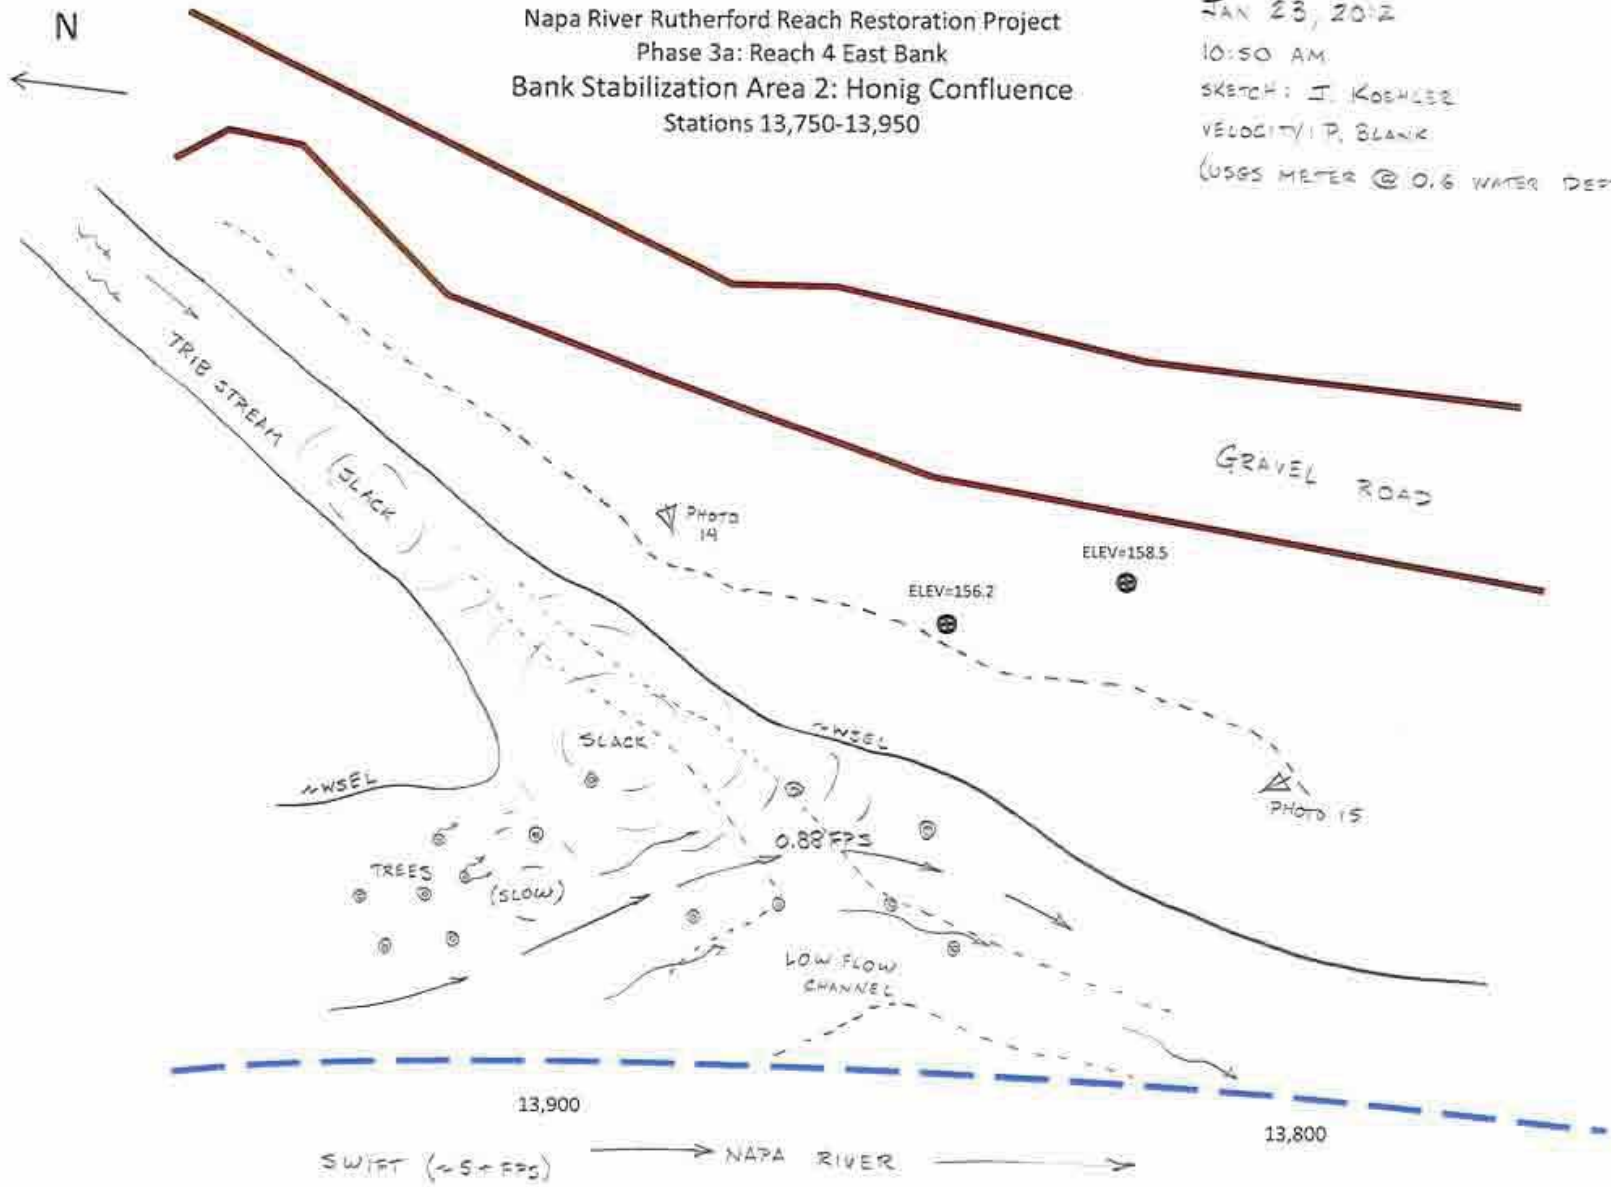
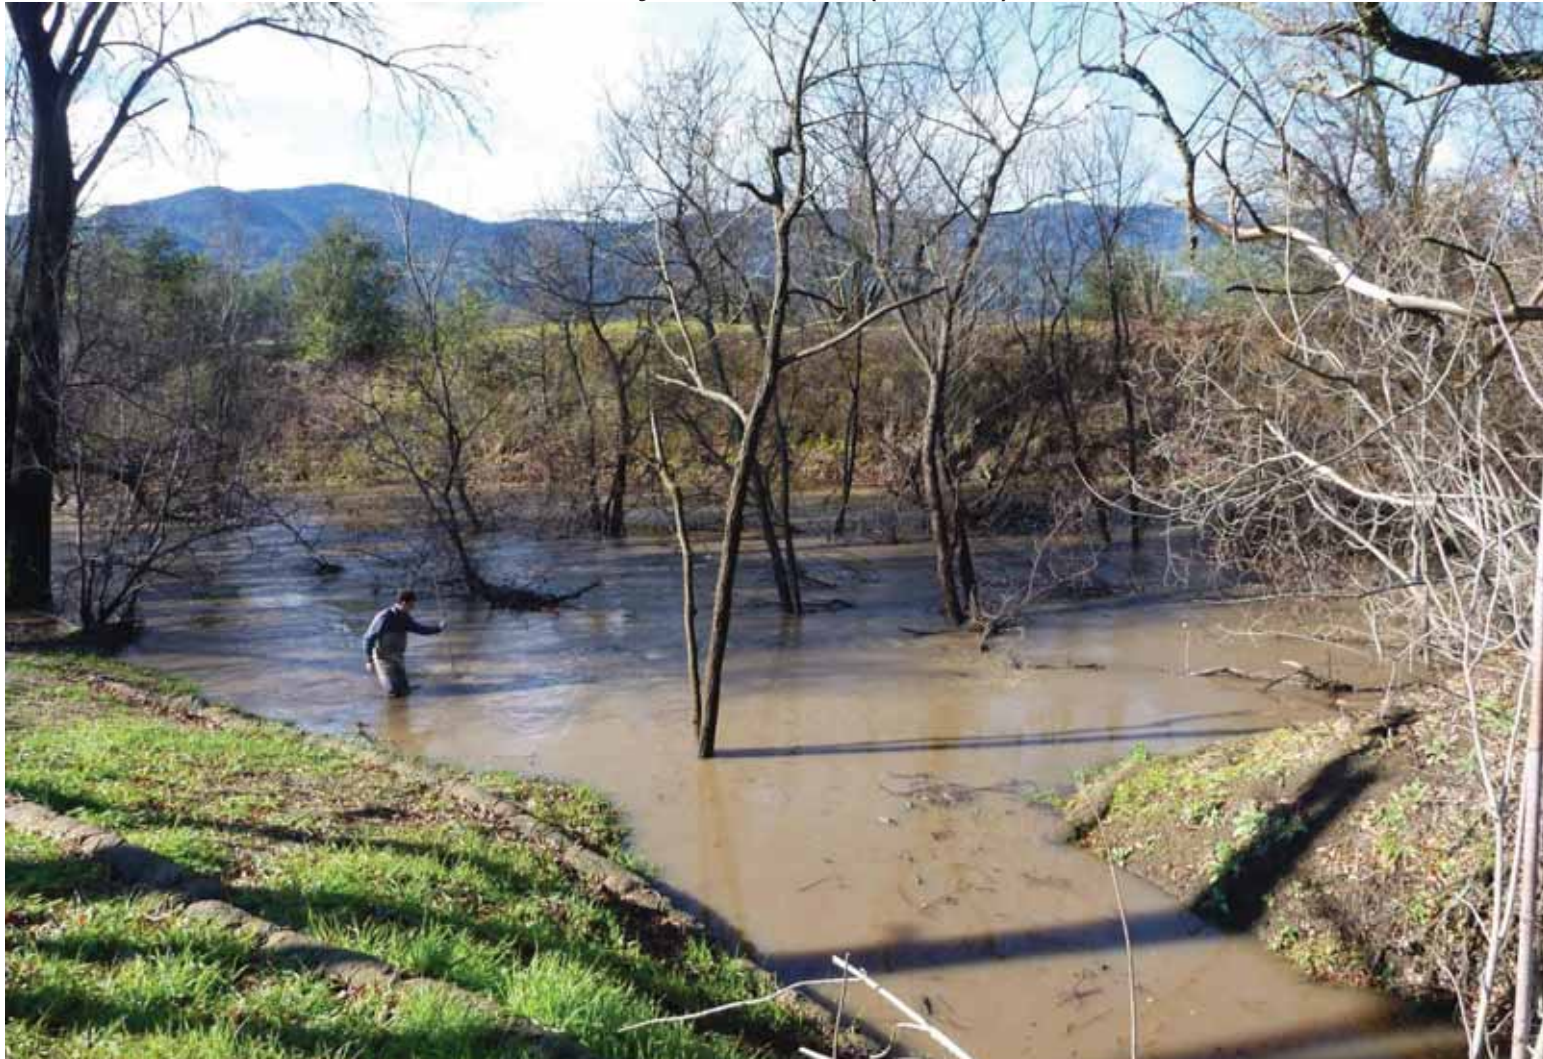
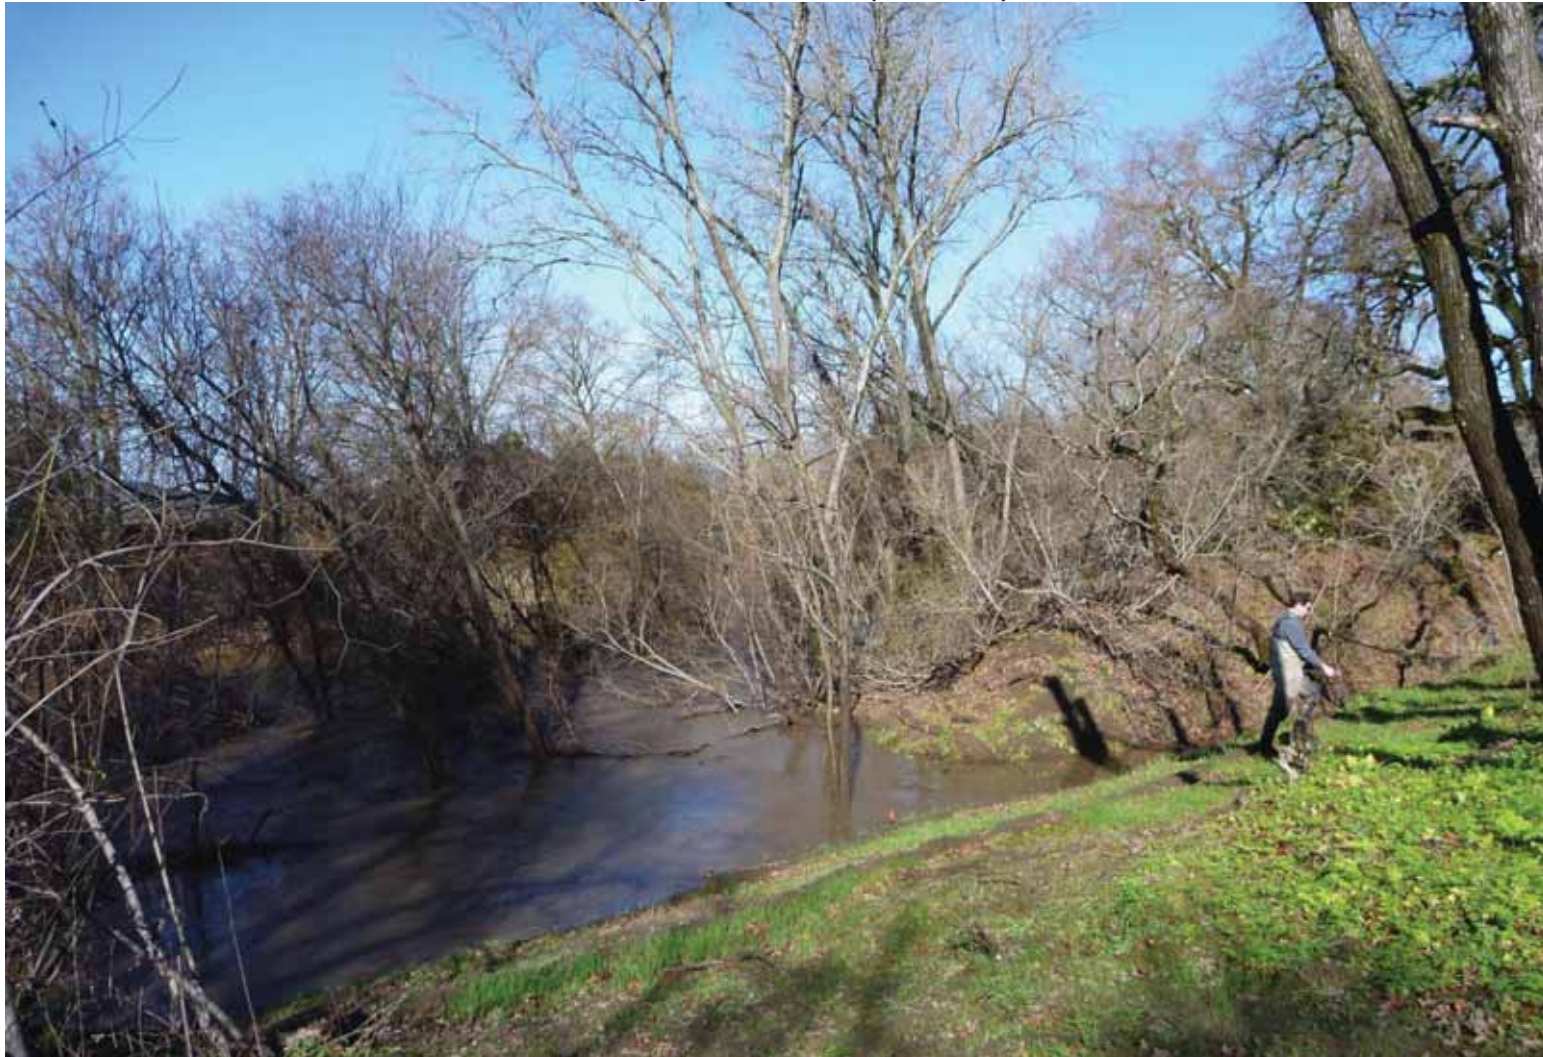
Napa River Rutherford Reach Restoration Project
Phase 3a: Reach 4 East Bank
Bank Stabilization Area 2: Honig Confluence
Stations 13,750-13,950

BSA 2: Honig Confluence	13850-L	Bank Stabiliza tion Area	High- flow	This bank stabilization area and tributary channel junction appear to provide high flow refugia in the form of a backwater and partially inundated tree trunks. Water velocities were generally low during a large winter storm event.
BSA 1: Carp Conolly	14400-L	Bank Stabiliza tion Area	High- flow	This bank feature appears to provide high flow refugia, primarily from willows and other riparian vegetation, which were partially inundated at the time of observation. Although water velocities could not be measured in the heavily vegetated area due to limited access, surface currents appeared to be very slow or completely slack throughout most of the feature.
