XI. Seasonal Salmonid Habitat Surveys

Seasonal Salmonid Habitat Surveys

At the request of the Napa County Flood Control and Water Conservation District and in accordance with the Monitoring Plan for the Rutherford Reach Restoration of the Napa River, Napa County Resource Conservation District (RCD) completed assessments of recently-installed in-stream restoration features in Reaches 1,2, and 3 of the Rutherford Reach Restoration Project on the Napa River Two assessments were completed: one at a winter flow high enough to inundate new bench cuts, and one at a low spring flow to evaluate new wood and rock habitat structures. The assessments included site sketches of surface flow patterns, collection of photographs, water velocity measurements, water-level elevation surveys, and evaluation of habitat function by a fisheries biologist.

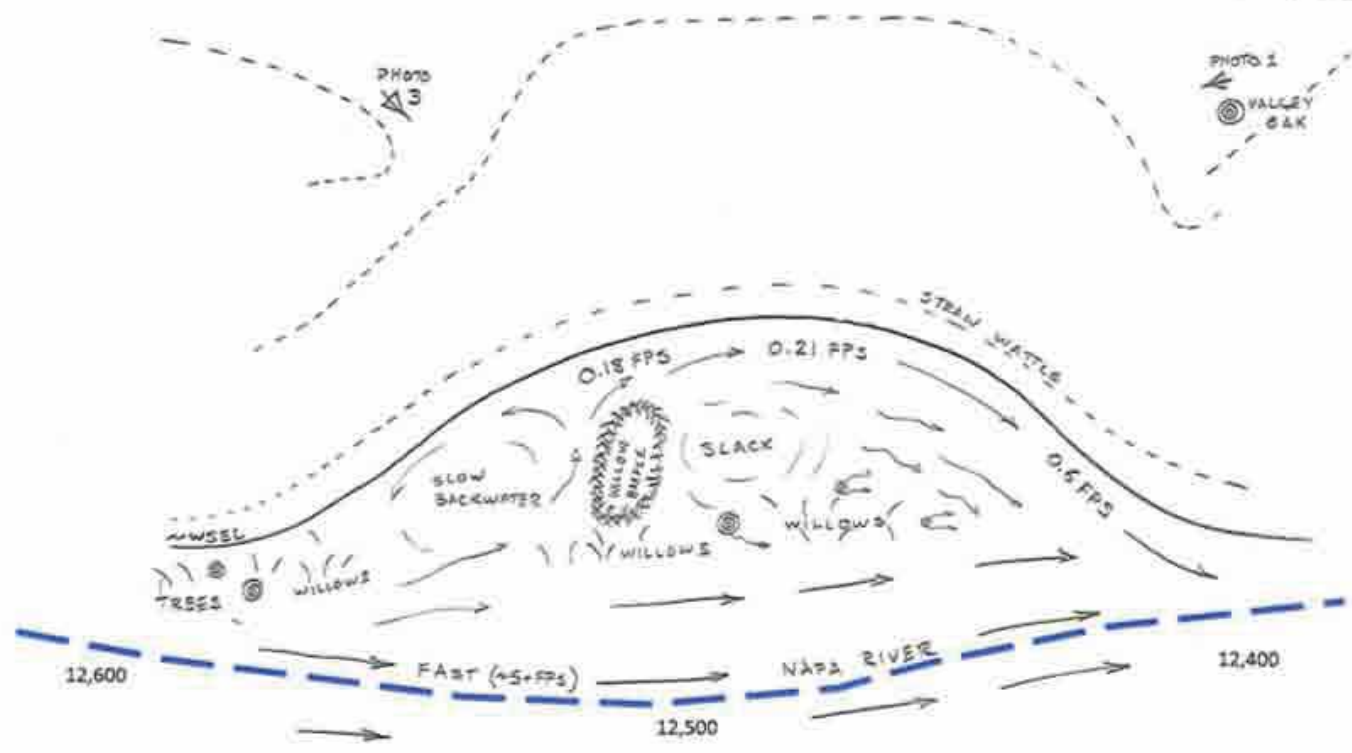
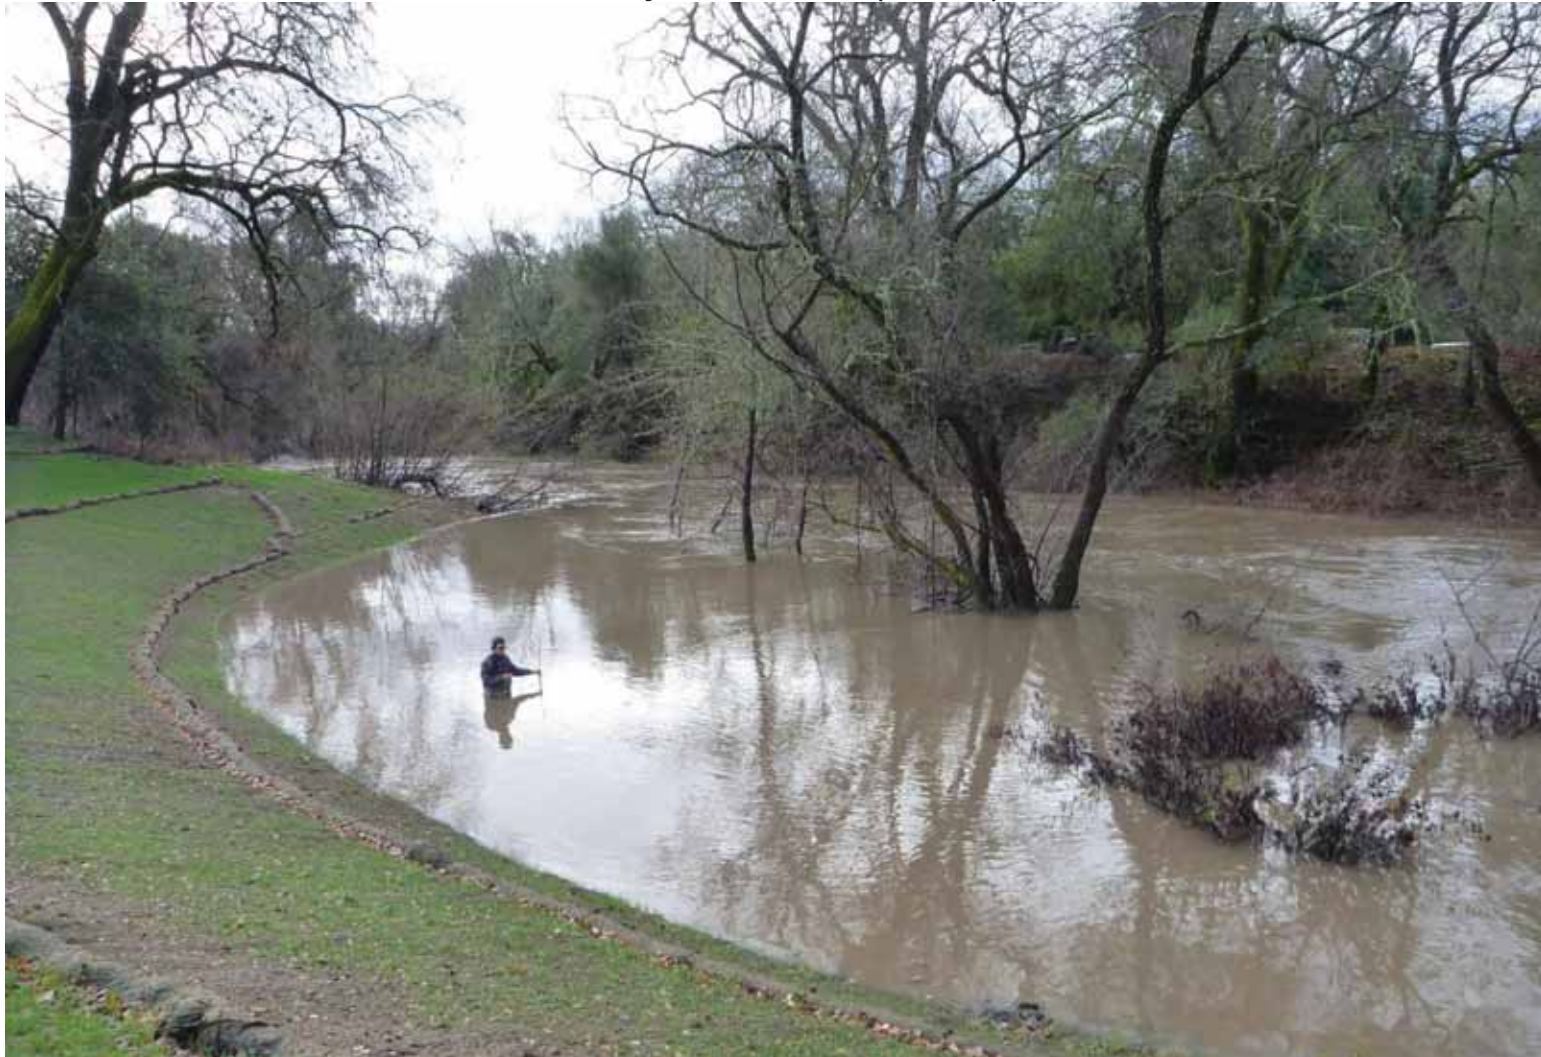
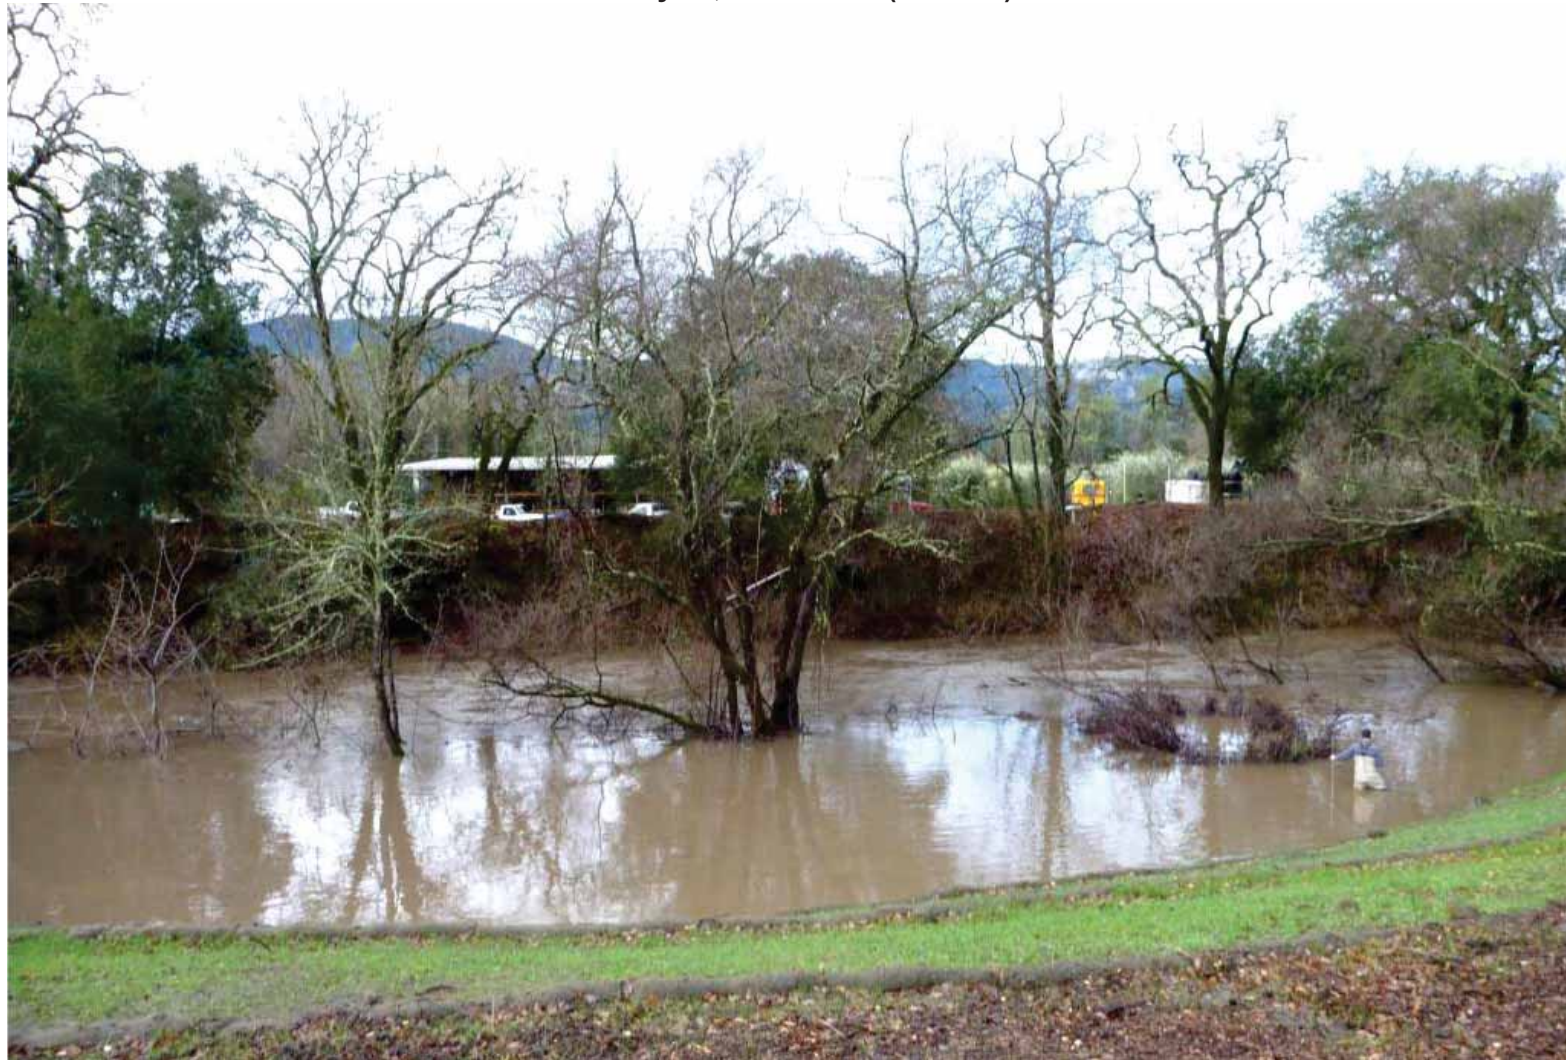
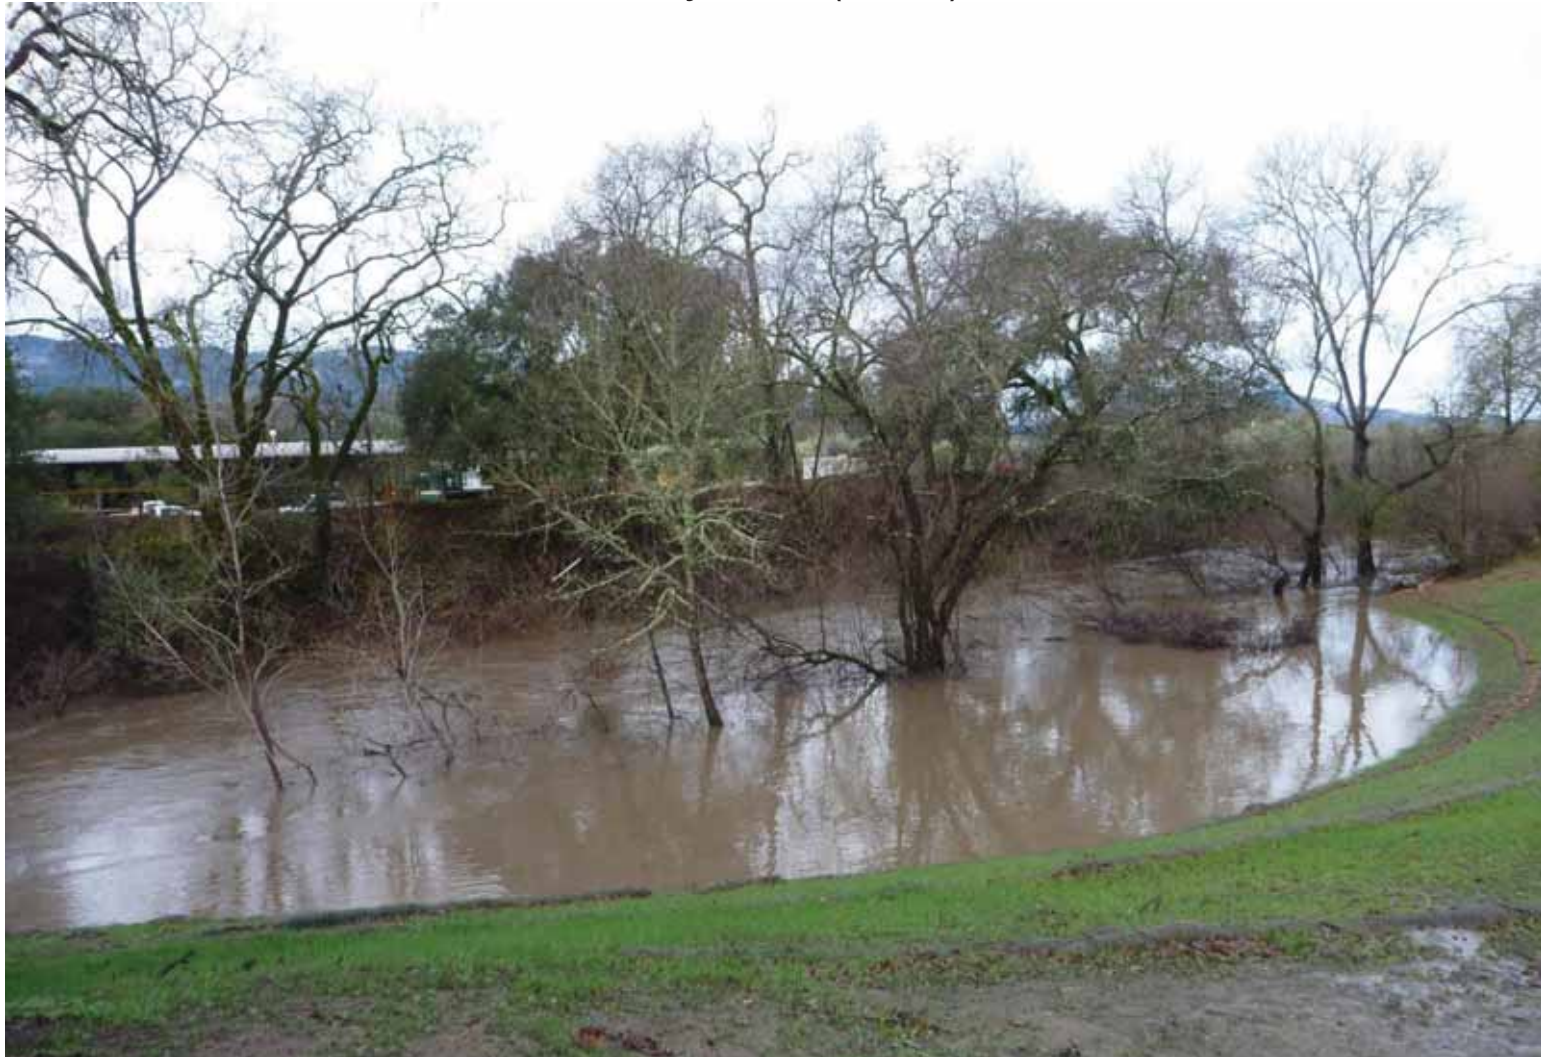
Napa River Rutherford Reach Restoration Project
Phase 3a: Reach 4 East Bank
Bench 14: Round Pond
Stations 12,400-12,600

Feature Name	River Station	Feature Type	Assessment	Fisheries Biologist Evaluation
Bench 14: Round Pond	12500-L	Bench Cut	High- flow	This bench appears to be functioning very well to provide off-channel refuge habitat for juvenile salmonids during high flow events. Areas of slack water were observed in this feature during a large winter storm event.
Bench 13: Honig	13000-L	Bench Cut	High- flow	This bench is functioning very well to provide off-channel refuge habitat for juvenile salmonids during high-flow events. Extensive slow and slack water areas were observed during a large winter storm event. This feature contained a favorable mix of slow resting habitat and swift feeding habitat.
Bench 11: Honig	13600-L	Bench Cut	High- flow	This bench is functioning very well to provide off-channel refuge habitat for juvenile salmonids during high-flow events. Extensive slow and slack water areas were observed during a large winter storm event. This feature contained a favorable mix of slow resting habitat and moderate to swift feeding habitat.

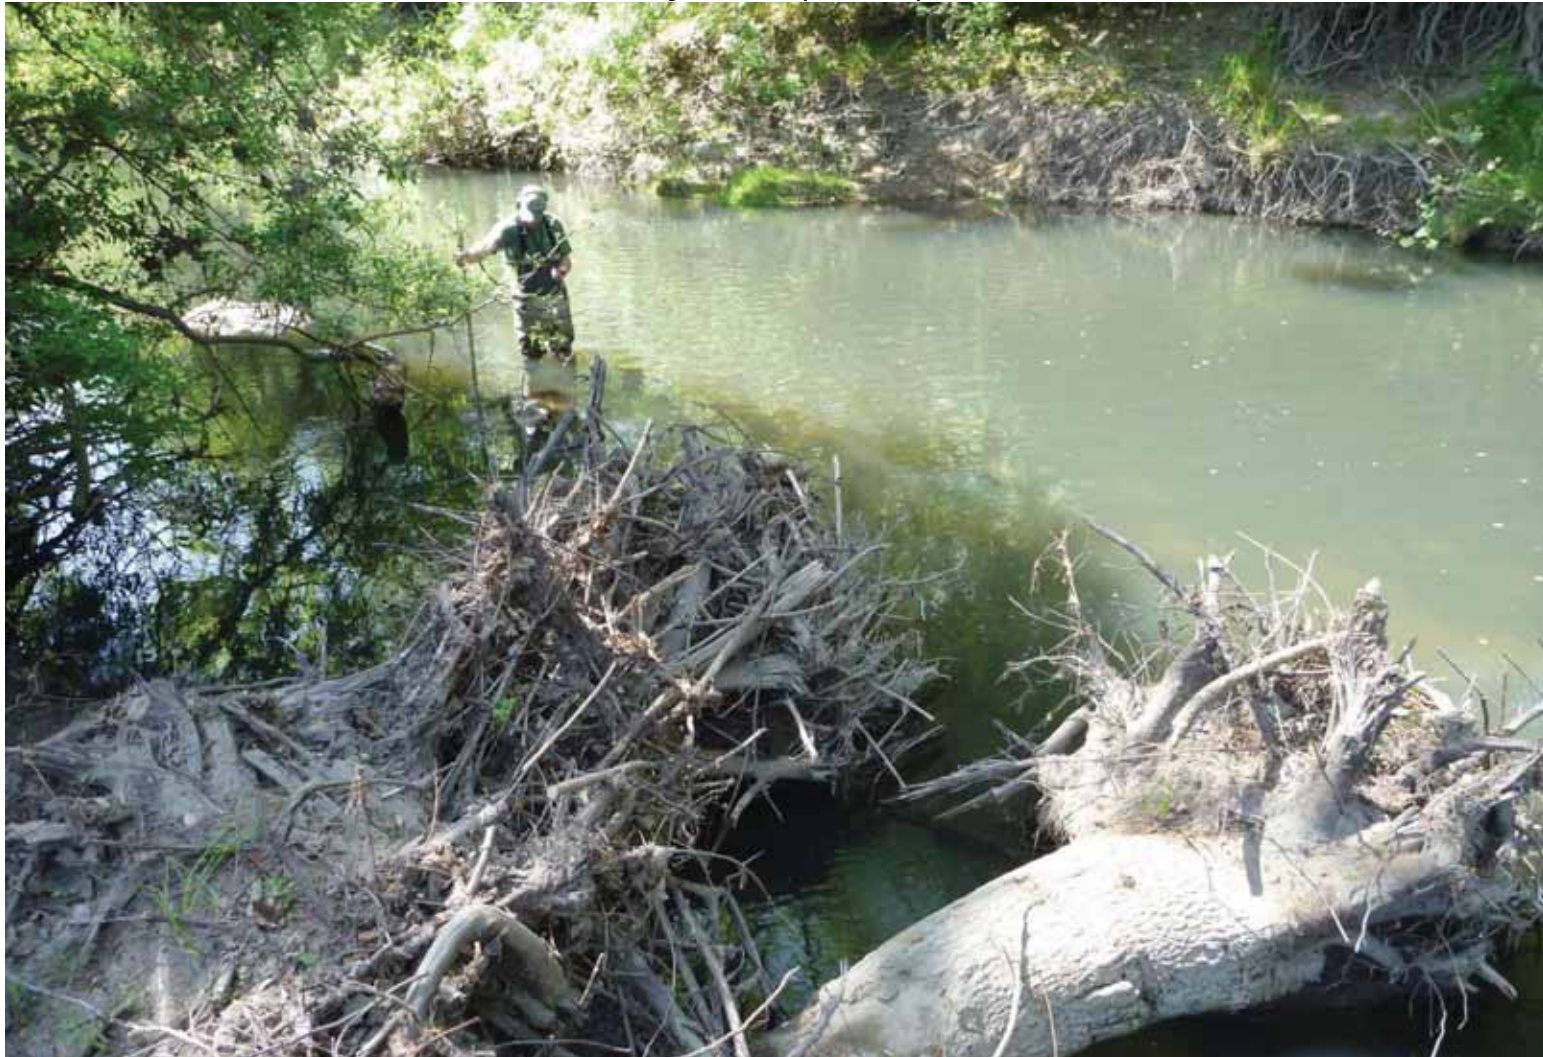
**WD-12420-L Root Wad, BC-12400-L
Bench 14: Round Pond East
May 1, 2012 (Photo 1)**

Bench 7: Carp Conolly	15700-L	Bench Cut	High- flow	This bench appears to be functioning very well to provide off-channel refuge habitat for juvenile salmonids during high flow events. Areas of slack water were observed in this feature during a large winter storm event.
BC-12400	12400	Boulder Cluster	Low- flow	These three boulders appear to provide a relatively small but effective velocity shelter during low to moderate flows. Measured velocities were significantly slower within the cluster than the surrounding currents. No salmonids were observed around this feature during the snorkel survey. All boulders were covered heavily with filamentous algae.
WD- 12410-L	12410	Root Wad	Low- flow	This rootwad appears to provide good refuge habitat during low to moderate flows. A deep scour hole has developed immediately around the feature, and water velocities measured just downstream of the rootwad were significantly lower than the surrounding currents. During the snorkel survey, no salmonids were present around this feature, but several other native fish species were observed.
