NAPA RIVER RUTHERFORD REACH RESTORATION PROJECT 2013 MONITORING REPORT

April 2014

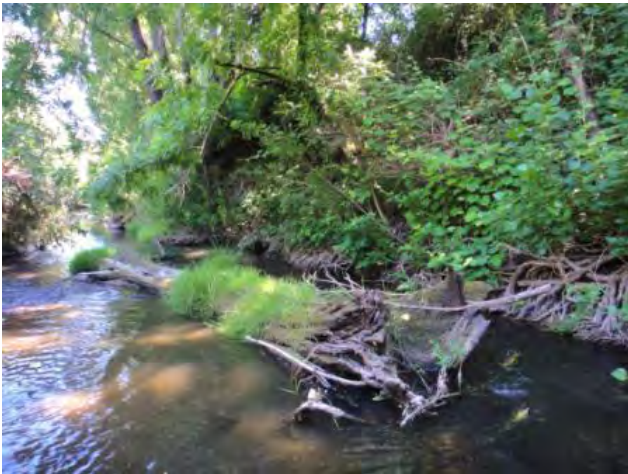
8,270 Cross Section LWD Persisting from prior to 2004 through 2013

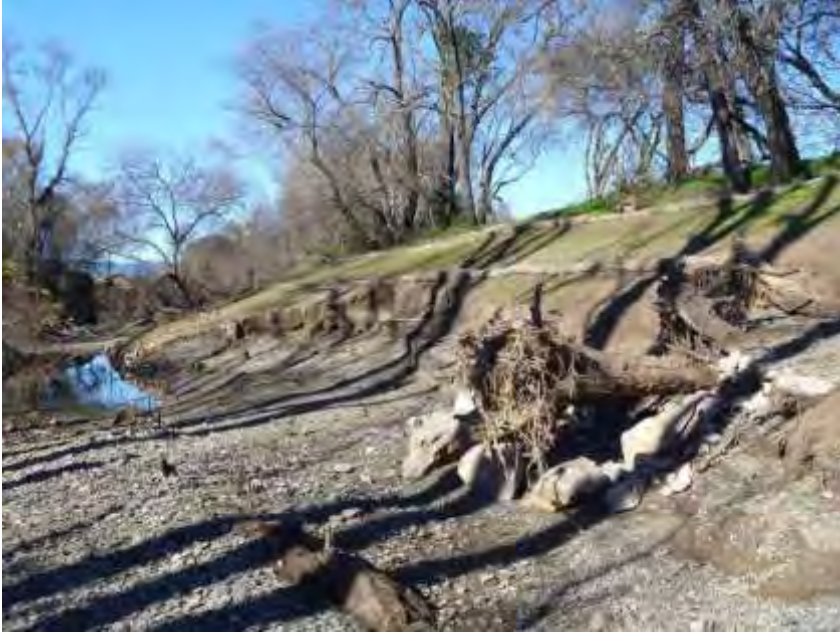
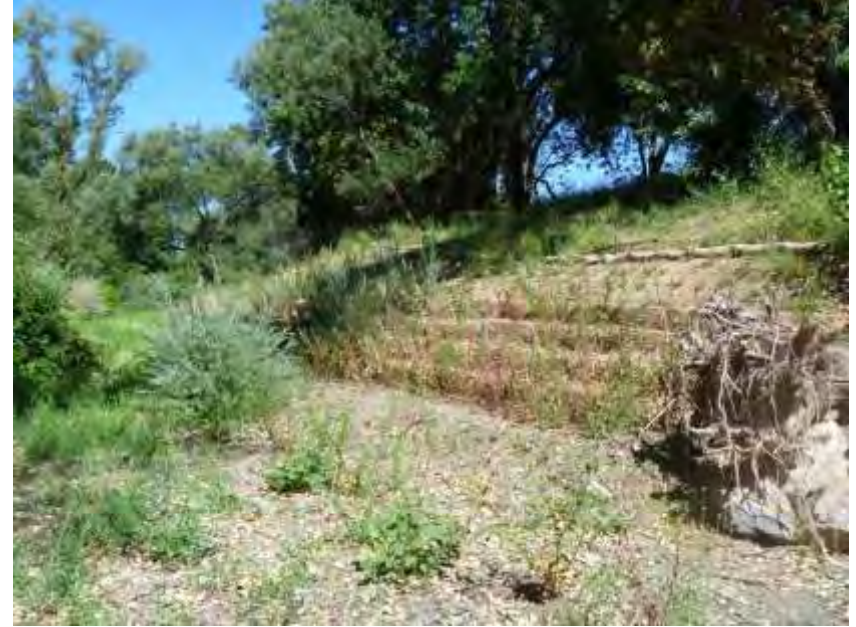
Ritz Carlton Hotel Linear Wetland Mitigation Site Bench 1 Secondary Channel Inlet on Wilsey

The secondary channel constructed on Bench 1 on the Wilsey property in 2012 in Phase 4a Reach 8 North, included the creation of a 589 linear foot wetland to satisfy the mitigation requirements of the Ritz-Carlton Hotel.

Following a series of significant high flow events (5-10 year flows) in December of 2012, bio-engineered elements (vegetated soil lifts, pole planting etc.) along the secondary channel were damaged by storm flows that caused localized erosion and slumping. County staff surveyed the channel with design contractors after these events and developed a series of slope repair recommendations. The contractors repaired the slope by constructing vegetated soils lifts, installing an additional willow brush mattress and willow pole plantings, and re-hydroseeding the area. All repairs were successfully completed in April of 2013. As illustrated in the photomonitoring pairs, the slope repairs remained intact, and the slope remained stable during high flow events in February and March of 2014.
