Napa River Rutherford Reach Restoration Project Annual Maintenance and Monitoring Survey

Napa River June 2014

July 2014

***Napa County Flood Control and
Water Conservation District
Napa County, California***

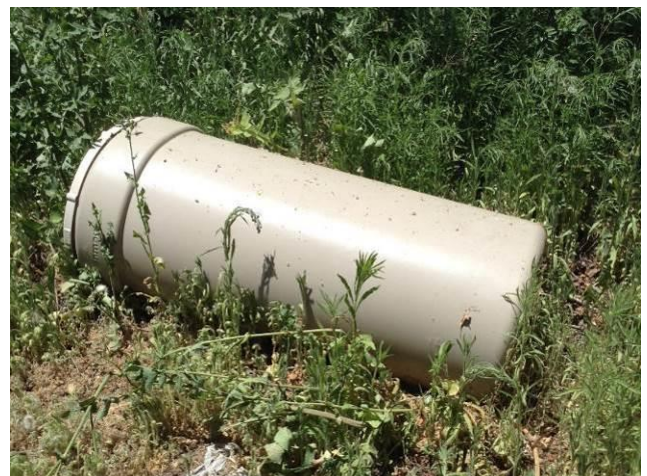
Picture 1: Trash and Debris

A total of 13 occurrences of trash and debris were documented in the Project area. . Graph 1 illustrates the number and types of trash documented during the stream survey, including tires, drip lines, appliances and metal debris, and plastic. Since surveys began in 2009, tires have consistently been the dominant debris documented in the channel. This year 9 of the 13 occurrences were tires. The remaining four (4) occurrences of trash and debris were drip lines, a plastic tarp, a car seat, and a large water filter (Picture 1). Figure 2 shows the locations of the surveyed trash and debris. Overall occurrences of trash and debris continue to decline significantly compared to the peak number (48) documented in 2011.

- Removal of all trash and debris from the stream channel that can be readily accessed and accomplished with hand labor, pulley or winch assisted mechanisms.
- Monitor 4 LWD jams (<12-inches-in-diameter and/or <6-feet-long) adjacent to landowners property and manage as necessary.

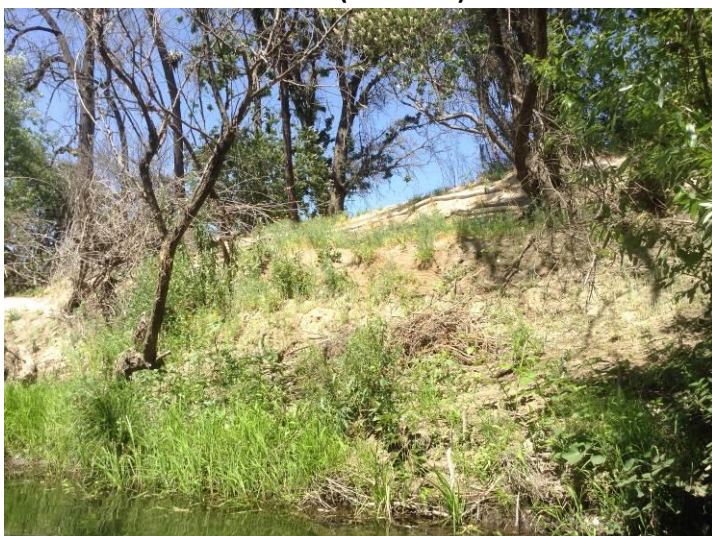
Picture 3: Reach 8 erosion site (June 2014)

Three areas of localized bank erosion (Picture 3) were documented during the survey that the District intends to address/stabilize using a combination of bio-technical methods during the fall of 2014. See Table 3 for the location and details of the proposed bank stabilization work to be conducted at these sites.

River Station/Reach	Property	Proposed Work
156+80 (Reach 4)	Caymus Vineyards	Cover bare slope areas with erosion control fabric, straw wattles and jute net, broadcast erosion control seed mix and plant with live willow stakes in fall.
39+60 (Reach 8)	Laird	Repair scour behind LWD structure with bio block's, willow pole stakes and/or willow brush mat.
36+20 (Reach 8)	Cake bread Vineyards	Cover bare slope areas adjacent to LWD structure with erosion control fabric and jute net, broadcast erosion control seed mix and plant with live willow stakes in fall.

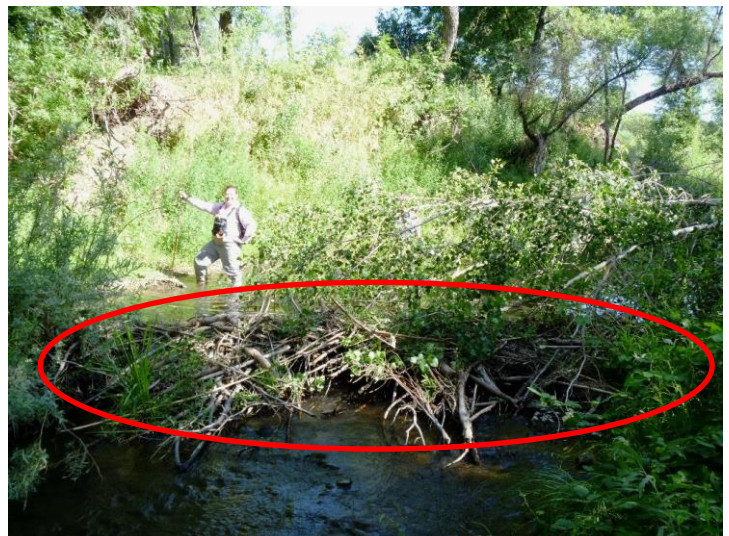
Picture 4: Beaver dam

As documented in previous surveys, an increasing amount of beaver activity (dam building, downing of trees) has been noted in the Project reach. District staff documented six beaver dams (Picture 4) in the Project reach but does not consider these to be an issue that could cause bank erosion or localized flooding. The beaver dams are small and have completely washed away during high winter flows in the past in every instance. During low flow, the dams impound slow water, providing cool pool habitat.

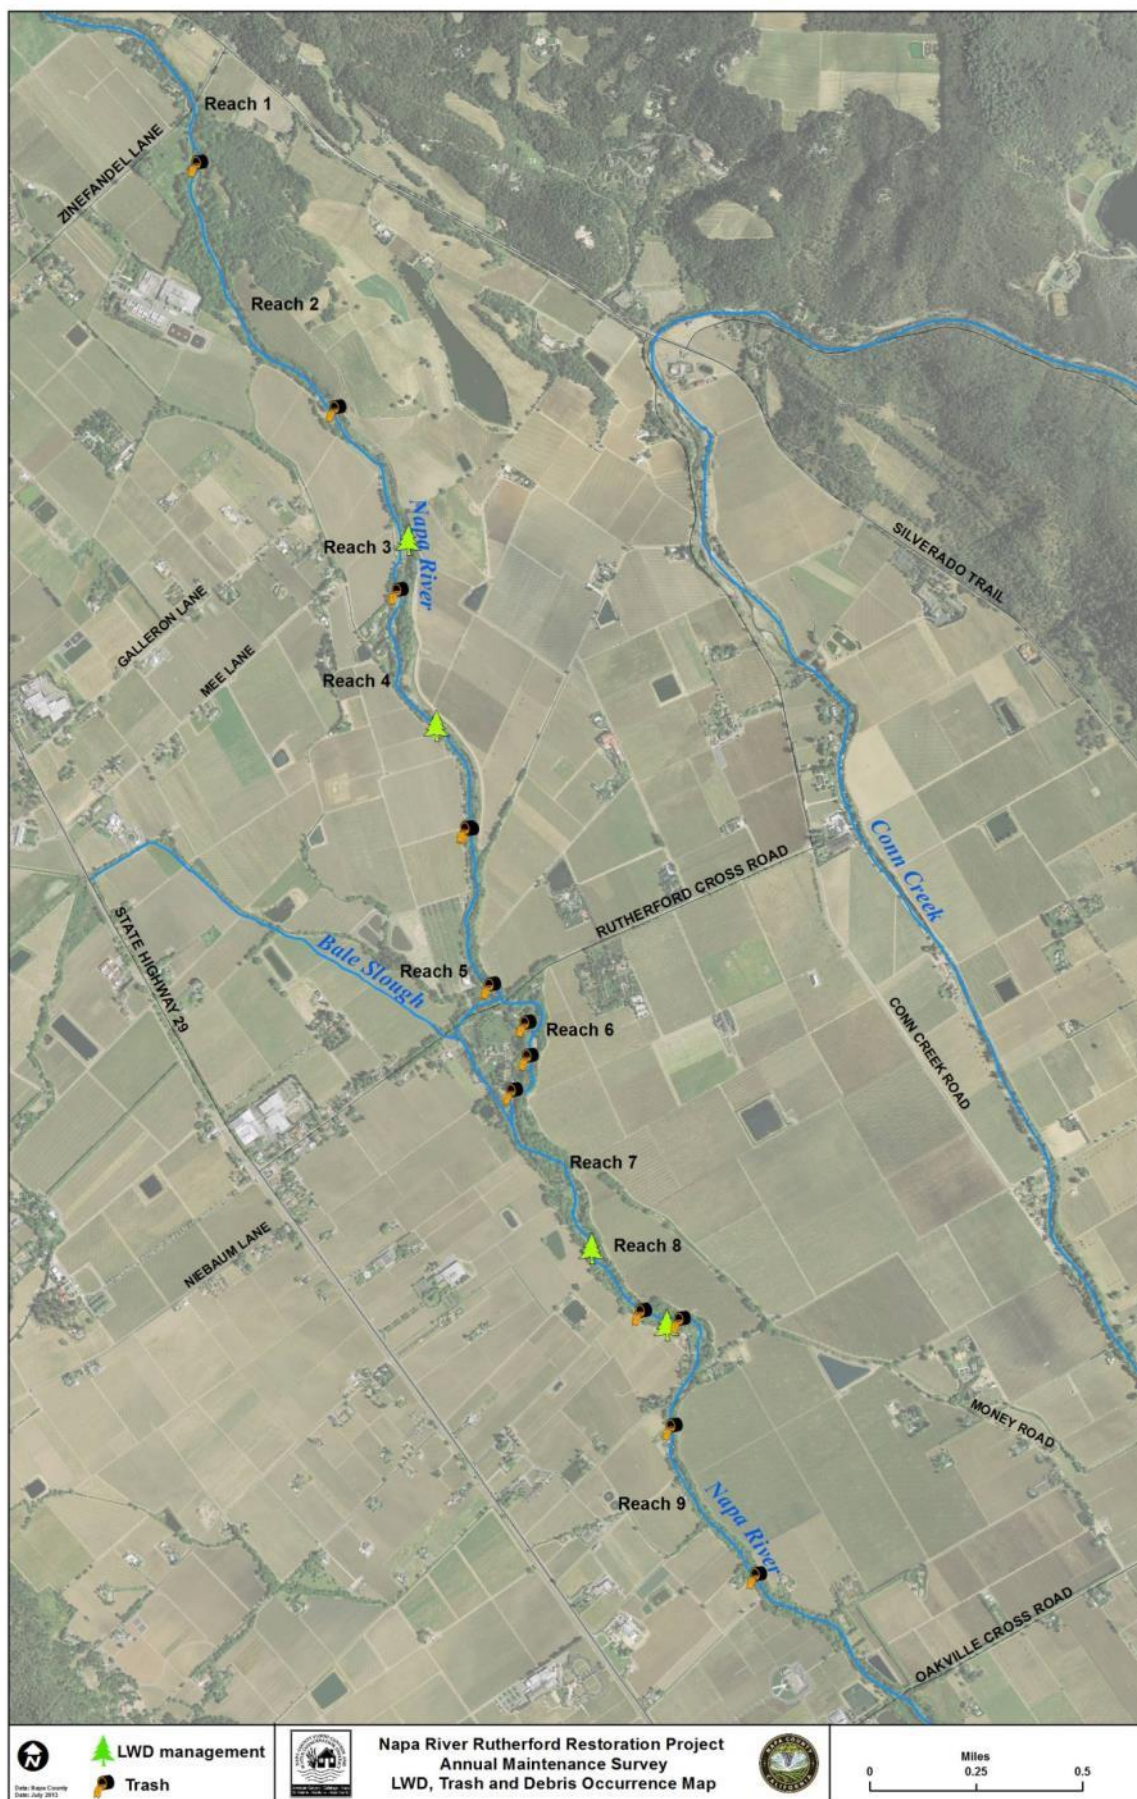
Figure 2: LWD, Trash and Debris Map

A total of 241 large woody debris (LWD) occurrences and boulder cluster installations were documented and evaluated during the 2014 stream survey. Of these occurrences, 137 were instream habitat structures installed as part of the restoration Project. The remaining 104 occurrences were naturally recruited LWD (minimum size: one foot diameter and six feet long. Of the 104 naturally recruited LWD occurrences, none appeared to be contributing to any localized bank erosion. Four (4) of the occurrences (Figure 2) were jams that have been prioritized for monitoring over the winter. If warranted, these occurrences will be managed to reduce channel erosion or flow obstruction by thinning out smaller wood, trimming trunks, and/or realigning larger wood. In general, LWD function as important in-stream fish habitat and the District manages LWD jams only when a clear problem exists. The distribution, habitat function and accumulation trends of all occurrences of LWD will be presented in a separate annual habitat monitoring report.

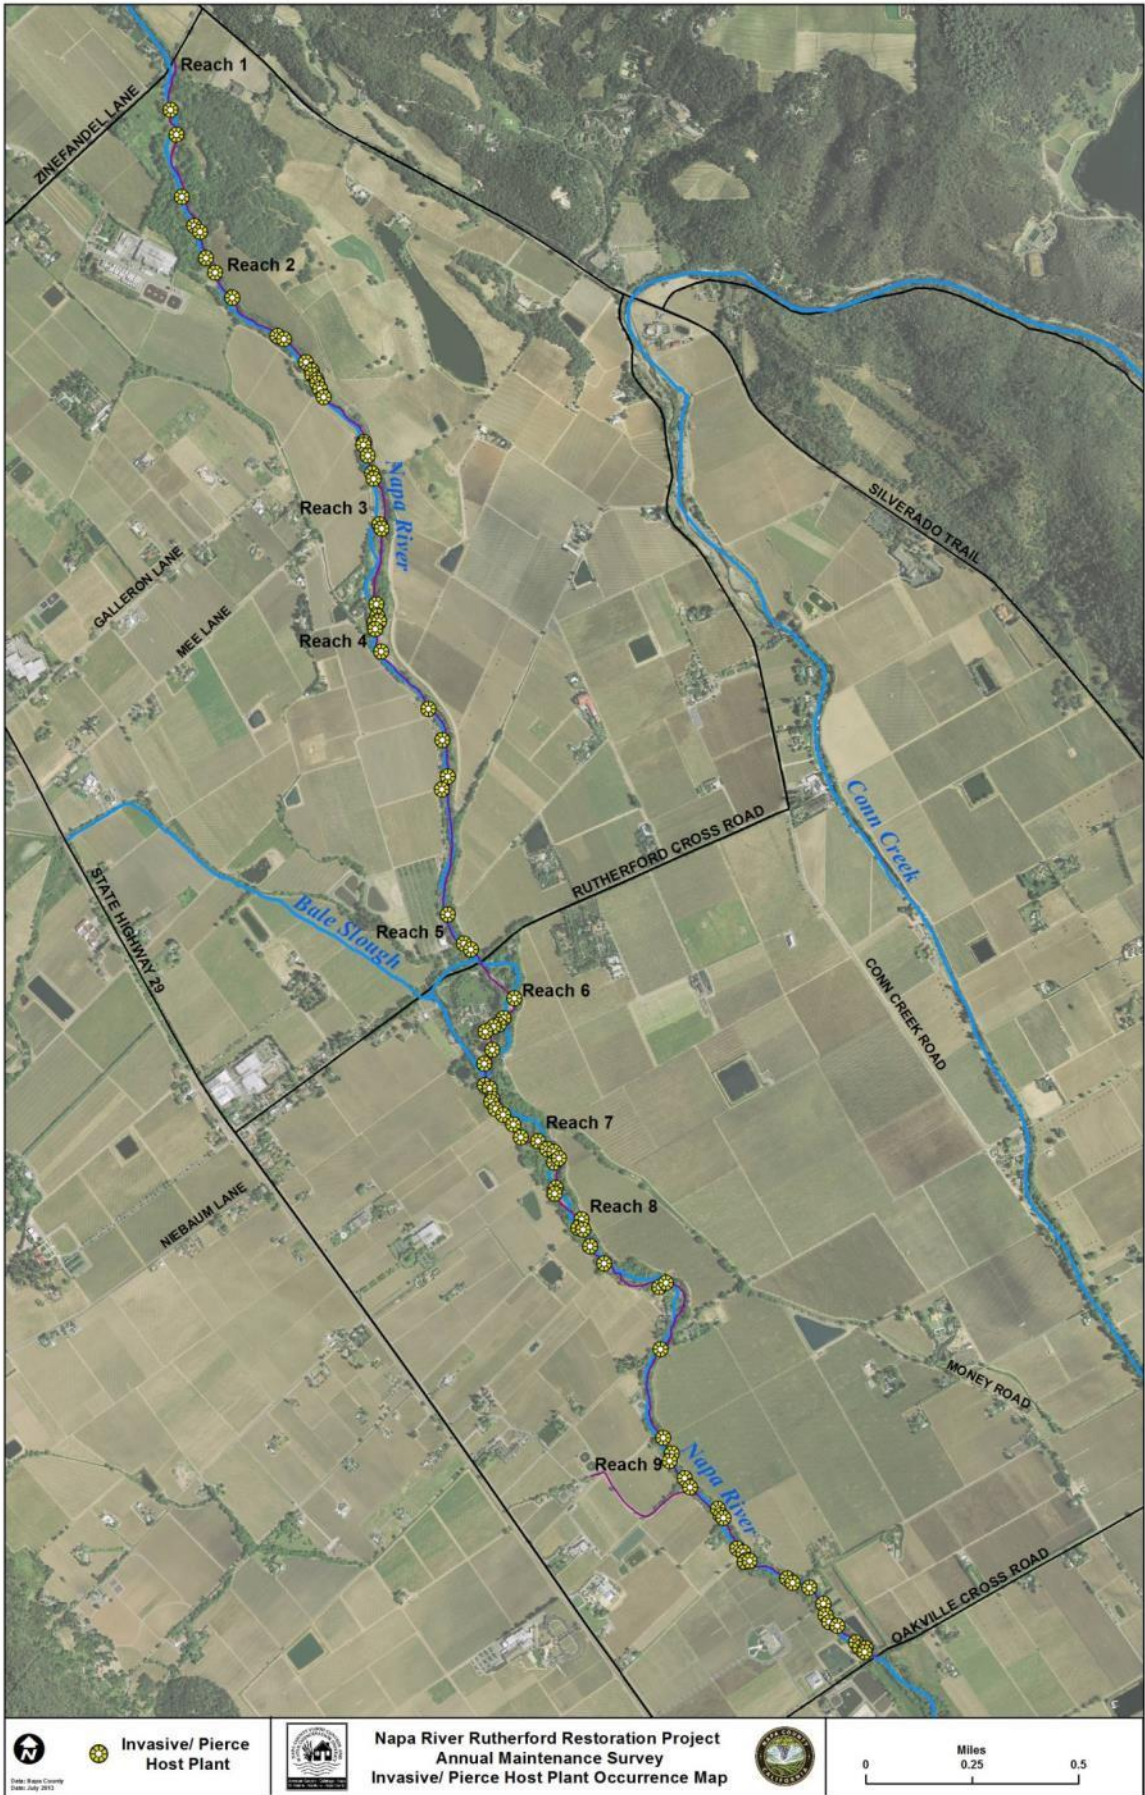
Figure 3: Invasive/ Pierce Host Plant Occurrence Map

Ninety-three (93) occurrences of target plants were identified for treatment within the Project area (Figure 3). Himalayan blackberry, native and hybridized grape and Mugwort (*Artemisia vulgaris*) were the dominant target plants identified; other target species documented include tree-of heaven, red sesbania and black locust but were limited in their distribution. Invasive species such as poison hemlock, fennel, etc. were observed but not quantified during the survey as a result of land owner’s requests in previous meetings to focus on and use funds for treatment of only invasive plant species that are considered Pierce host’s species or priority invasive non-native species.

A total of 115,436 square feet (sqft) of non-native invasive and Pierce host plants was documented including 48,540 sqft of Himalayan blackberry, 24,840 sqft of native/hybrid CA grape, 6,277 of periwinkle (*Vinca major*), 29,073 sqft of Mugwort, and 6,706 sqft of giant reed (*Arundo*). It is important to note that there are additional occurrences of grape, periwinkle and other Pierce host plants present beyond the river’s top of bank, out of view of the in-channel river survey; therefore we request that landowners contact the maintenance lead with any additional requests for management of invasive and/or Pierce host plants in the riparian zone beyond the top of bank that may not be documented during the channel survey.

- Treat large accessible patches of invasive and Pierce host plants including Himalayan Blackberry, Mugwort, native and hybridized grape species and giant reed; this task also includes appropriate re-vegetation planting/seeding and irrigation of treatment of sites where treatment has left significant gaps in the riparian under story canopy.
- Repair and stabilize exposed stream bank erosion areas as proposed in Table 3.
- Conducted annual spring/ summer mowing of non-native grasses/shrubs on constructed flood plain benches as needed.
- Complete maintenance work requested by landowners; continue to respond to maintenance requests for landowners through the calendar year.
