NAPA RIVER RUTHERFORD REACH RESTORATION PROJECT ANNUAL MONITORING REPORT- 2016

Napa County Flood Control and Water Conservation District
804 First Street
Napa, California, 94559
Contact: Jeremy Sarrow
(707) 259-8204

Napa County Resource Conservation District
1303 Jefferson Street, Suite 500 B
Napa, California, 94558
Contact: Paul Blank/Jonathan Koehler
(707) 252-4188

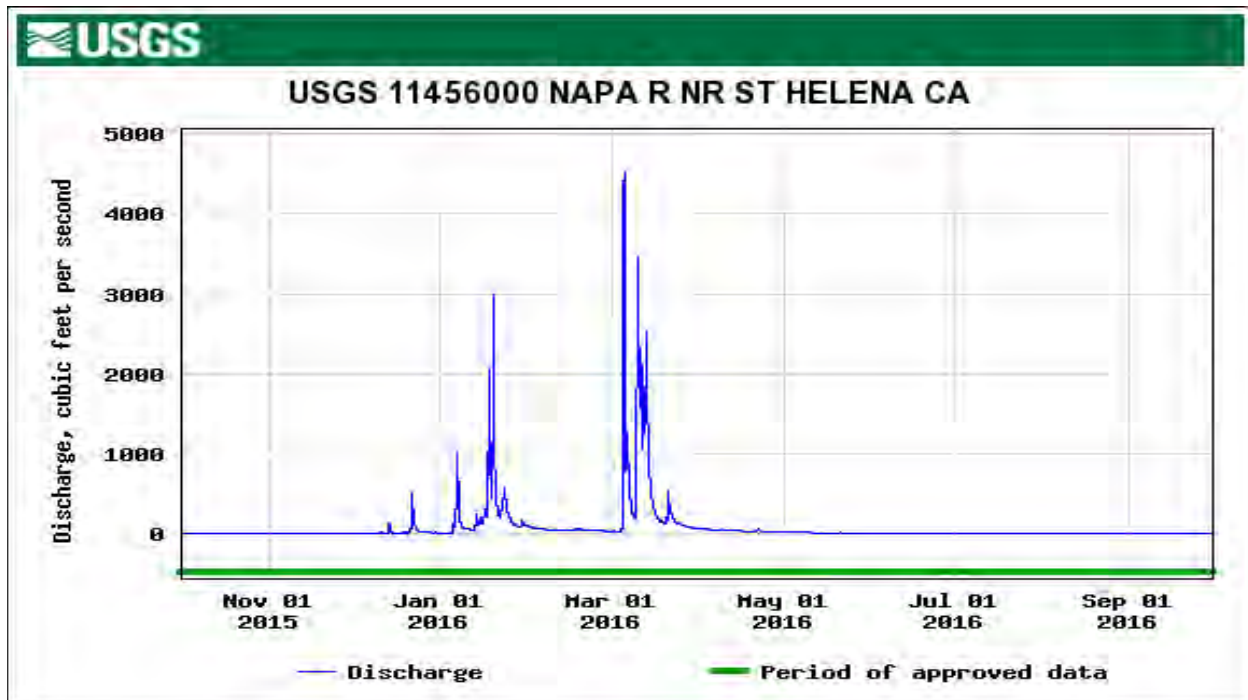
Figure 6. 2015-2016 streamflow, Napa River Rutherford Restoration Reach, USGS Station 11456000.

During the 2015-16 water year (October 1, 2015 through September 30, 2016), measureable streamflow began at Station 11456000 in early December and continued through mid-July. The peak flow of the season occurred on March 6, 2015, and was measured to be 4,520 cfs, slightly less than the 1.5-year peak flood. Following the last significant storm of the season in late March, flows in the river receded until the channel finally dried up in mid-July. A plot of streamflow measured at Station 11456000 during the 2015-16 water year is included as **Figure 6**.

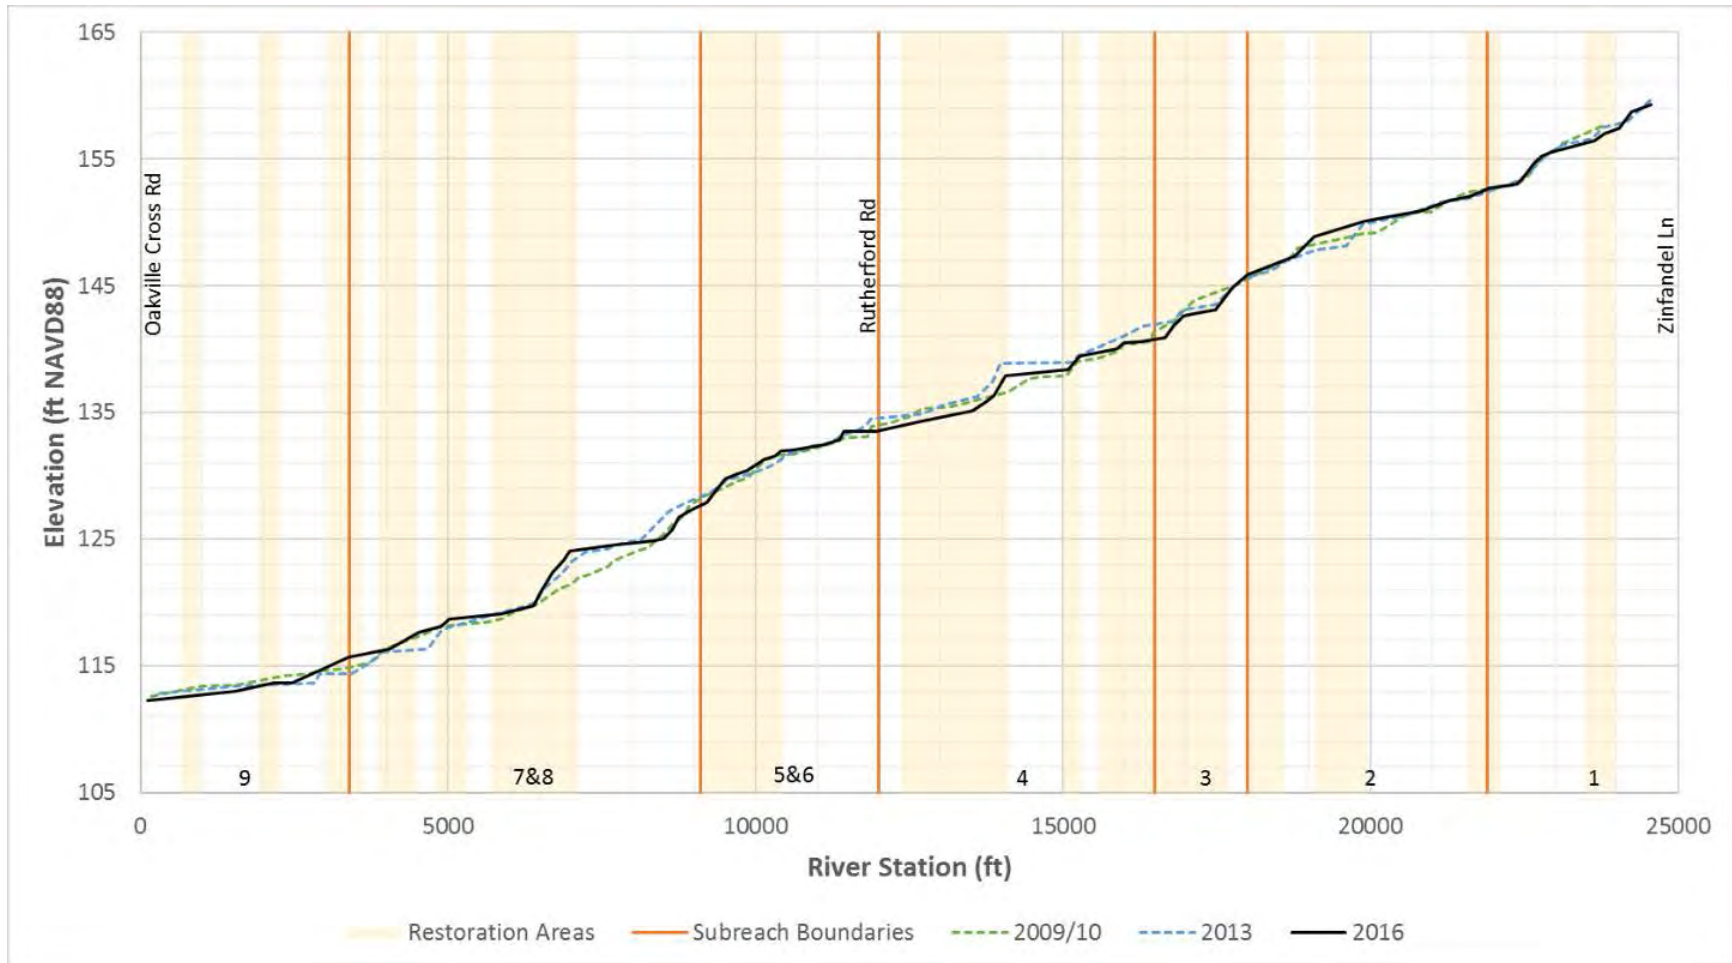
Figure 7. Comparison of recent and historical thalweg survey riffle crests for entire Project reach.

The greatest change has taken place in Subreach 7&8 near river station (RS) 7000. This location coincides with 2012 restoration work on both banks including installation of bench cuts and a secondary channel. Other notable change has occurred in Subreach 4. Restoration in this subreach took place from 2010 through 2012. Typically, the streambed throughout the subreach aggraded prior to the 2013 survey. Under the 2016 survey, the streambed has scoured, partially below 2009/10 levels, in the lower section of the subreach.

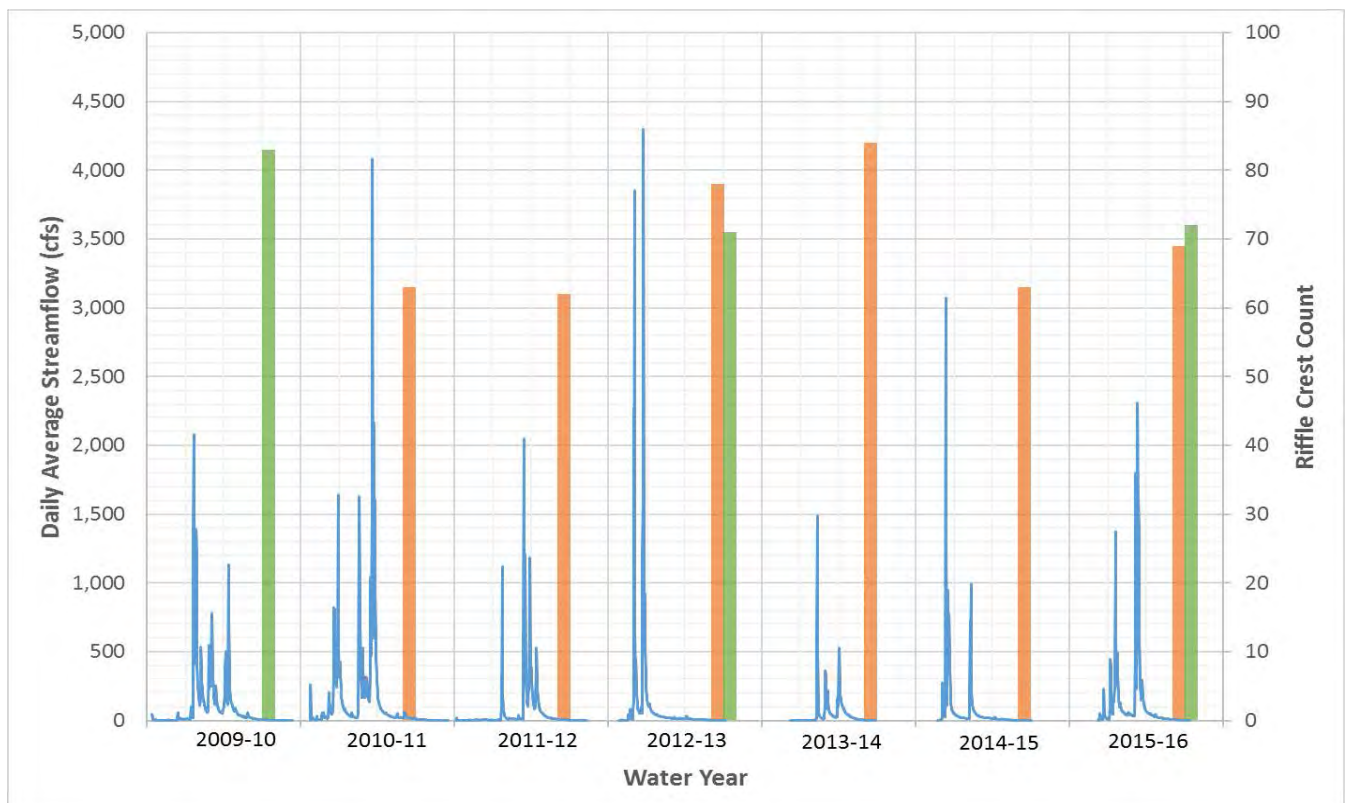
Assuming adequate data quality, a correlation is observed between large stormflows and riffle crest counts. The high count from the 2009-10 channel thalweg survey was followed by large storms in March 2011. Afterwards, the 2011 and 2012 riffle crest mapping totals are lower. Large stormflows in December 2012 are then followed by 2 years of higher riffle counts in 2013 and 2014. A large flow in December 2014 is then followed by lower riffle counts in 2015 and 2016. **Figure 8** depicts streamflow and riffle crest counts for the Project reach for all 7 years of data. It should be noted that the thalweg survey data indicate that there may not have been significant variation in riffle crest counts from 2013 to 2016. High stream flows from major winter storms may be a primary factor influencing the observed variation in riffle crest counts in the Project reach.
