## **ADDENDUM TO ‘A CONCEPTUAL PLAN FOR THE STABILIZATION AND RESTORATION OF THE NAPA RIVER, RUTHERFORD REACH’**

### *1.1.1.1 Reach 9*

*From Oakville Cross Road to the southern boundary of the Cakebread property (west bank) and the Laird property (east bank).*

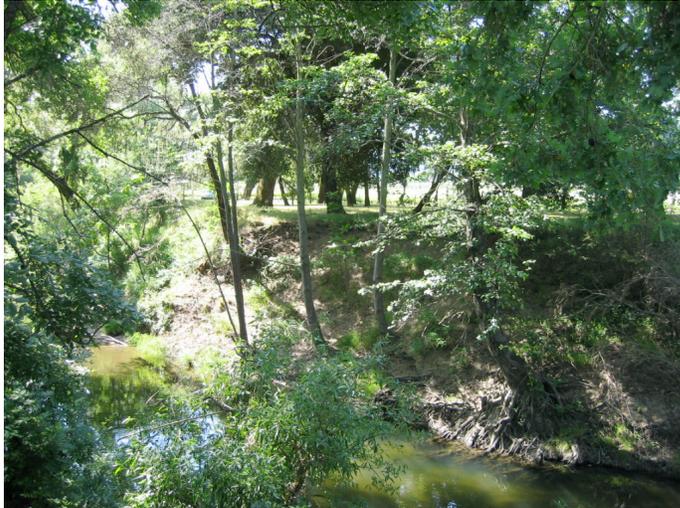
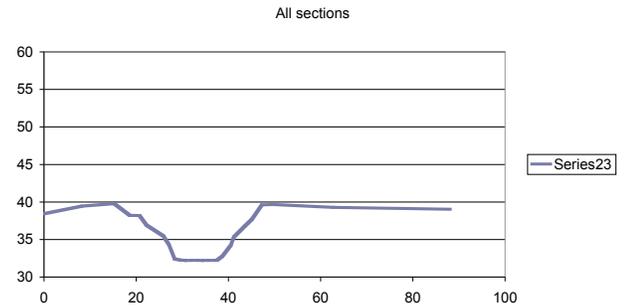
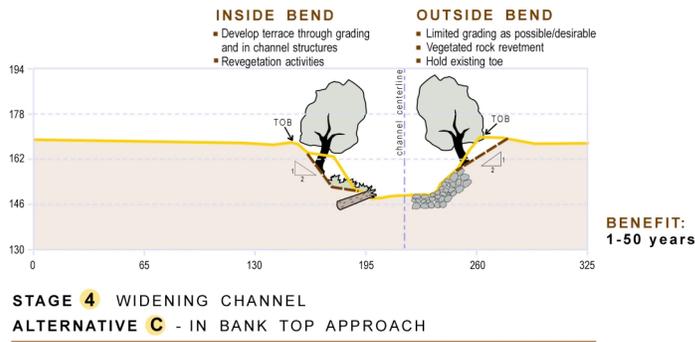
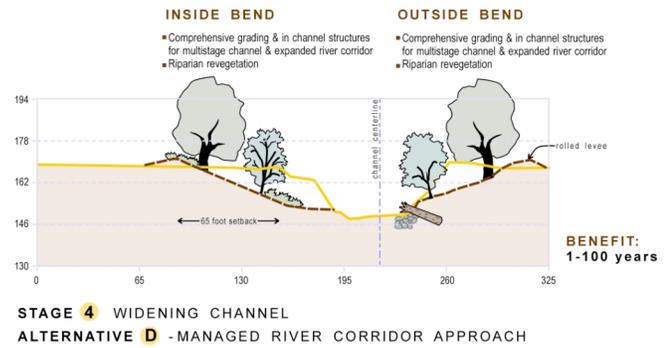
**Figure 1. Typical existing conditions and conceptual design for Reach 9**

This reach is 3,200 feet long. The reach is largely in Stage 4, with evidence of channel widening on both sides of the river, but with sub-reaches in Stage 5 where point bars and low floodplain have developed. There is bank toe and top of bank erosion in most parts of the reach, and much of the reach has been treated with loose riprap. The channel is dominated by a series of long, uniform glides with impaired aquatic habitat. There is a significant shortage of riffle habitat and a slight shortage of deep pools. The bed is gravel with infilling from fine sediment. In general the banks on the west side are steeper and more erosion-prone than those on the east side, which often have high flow terraces and more mature riparian vegetation. Although the channel is overdeepened and would benefit from regrading or terracing, there are numerous mature trees that present a partial constraint on channel and bank reshaping.

We recommend a combination of biotechnical stabilization of local areas of high erosion, use of biotechnical structures such as weirs to increase channel diversity, and limited bank setbacks where constraints allow, with the objective of reducing overall erosive forces in the reach and increasing channel habitat potential. All work should be accompanied by revegetation using appropriate native species. The recommended restoration conceptual alternative is 4C and 5C (see pages 39-40 of conceptual plan), and limited 4D and 5D. The proposed alternative would restore more natural function to the river while working within the constraints of preserving the mature riparian canopy.

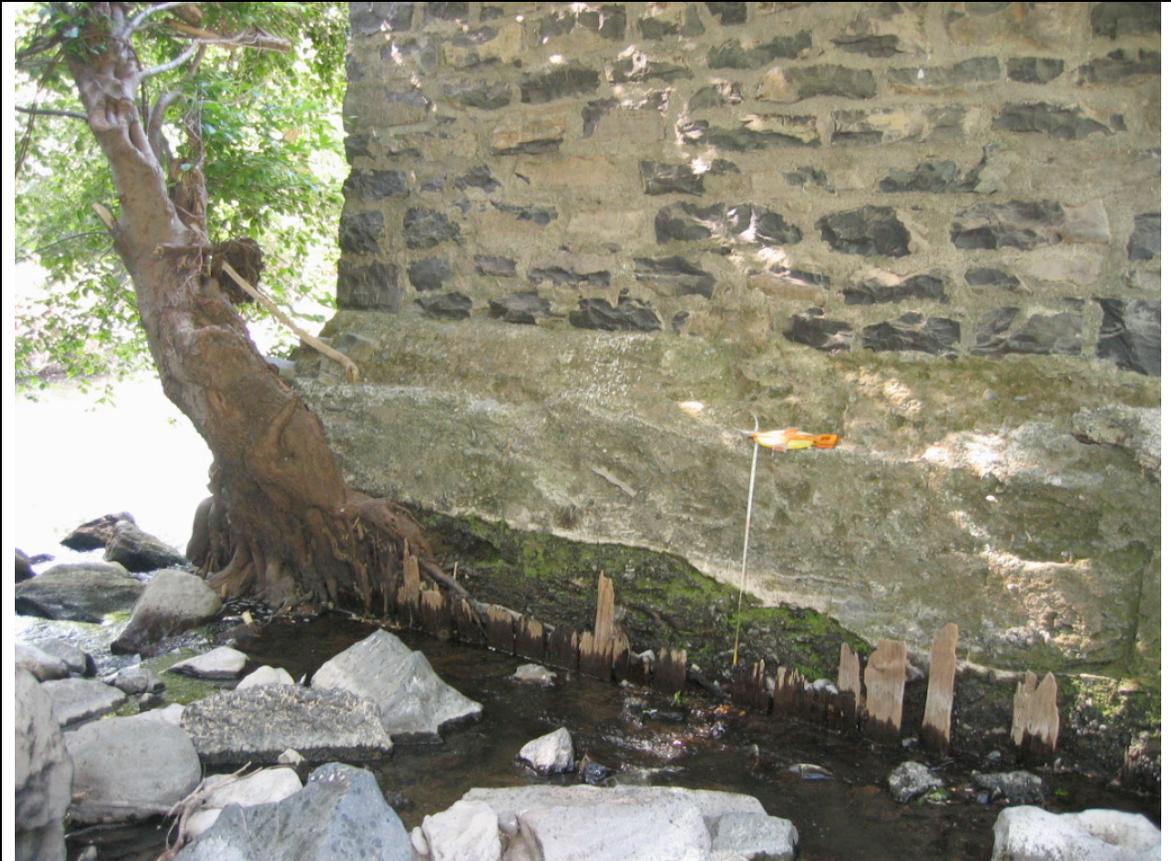
Oakville Cross Road Bridge lies at the downstream end of Reach 9, and forms an important boundary to the restoration project. There appears to have been a total of 2-4 ft of scour under the bridge piers since the bridge was constructed, and a larger depth of scour downstream. The initial scour under the bridge has probably already migrated upstream. Headward migration of the deeper scour below the bridge could threaten the project upstream. Based on an alder tree growing around the base of the pier (see photo) we believe that the piers have eroded by approximately 2 feet in the last 10-20 years. This is consistent with channel incision noted upstream. Currently the bed of the channel is loosely armored with riprap. The riprap is in poor condition and does not appear to have any kind of cut-off sill or impermeable liner to prevent piping of substrate through the riprap. We are therefore concerned that the downstream scour could migrate through the

Scour around the pier of Oakville Cross Road Bridge showing an estimated 2 feet or erosion in 10-20 years, and up to 4 feet of erosion since construction.

bridge, causing channel incision upstream. We recommend that a grade control structure with step-pools to facilitate fish passage be included in this location to preserve the efforts of the Rutherford Reach restoration and the Oakville to Rutherford restoration.
