NAPA RIVER OAKVILLE TO OAK KNOLL REACH RESTORATION PROJECT ANNUAL MONITORING REPORT - 2018

Napa County Flood Control and Water Conservation District
804 First Street
Napa, California, 94559
Contact: Jeremy Sarrow
(707) 259-8204

Napa County Resource Conservation District
1303 Jefferson Street, Suite 500 B
Napa, California, 94558
Contact: Paul Blank/Jonathan Koehler
(707) 252-4189

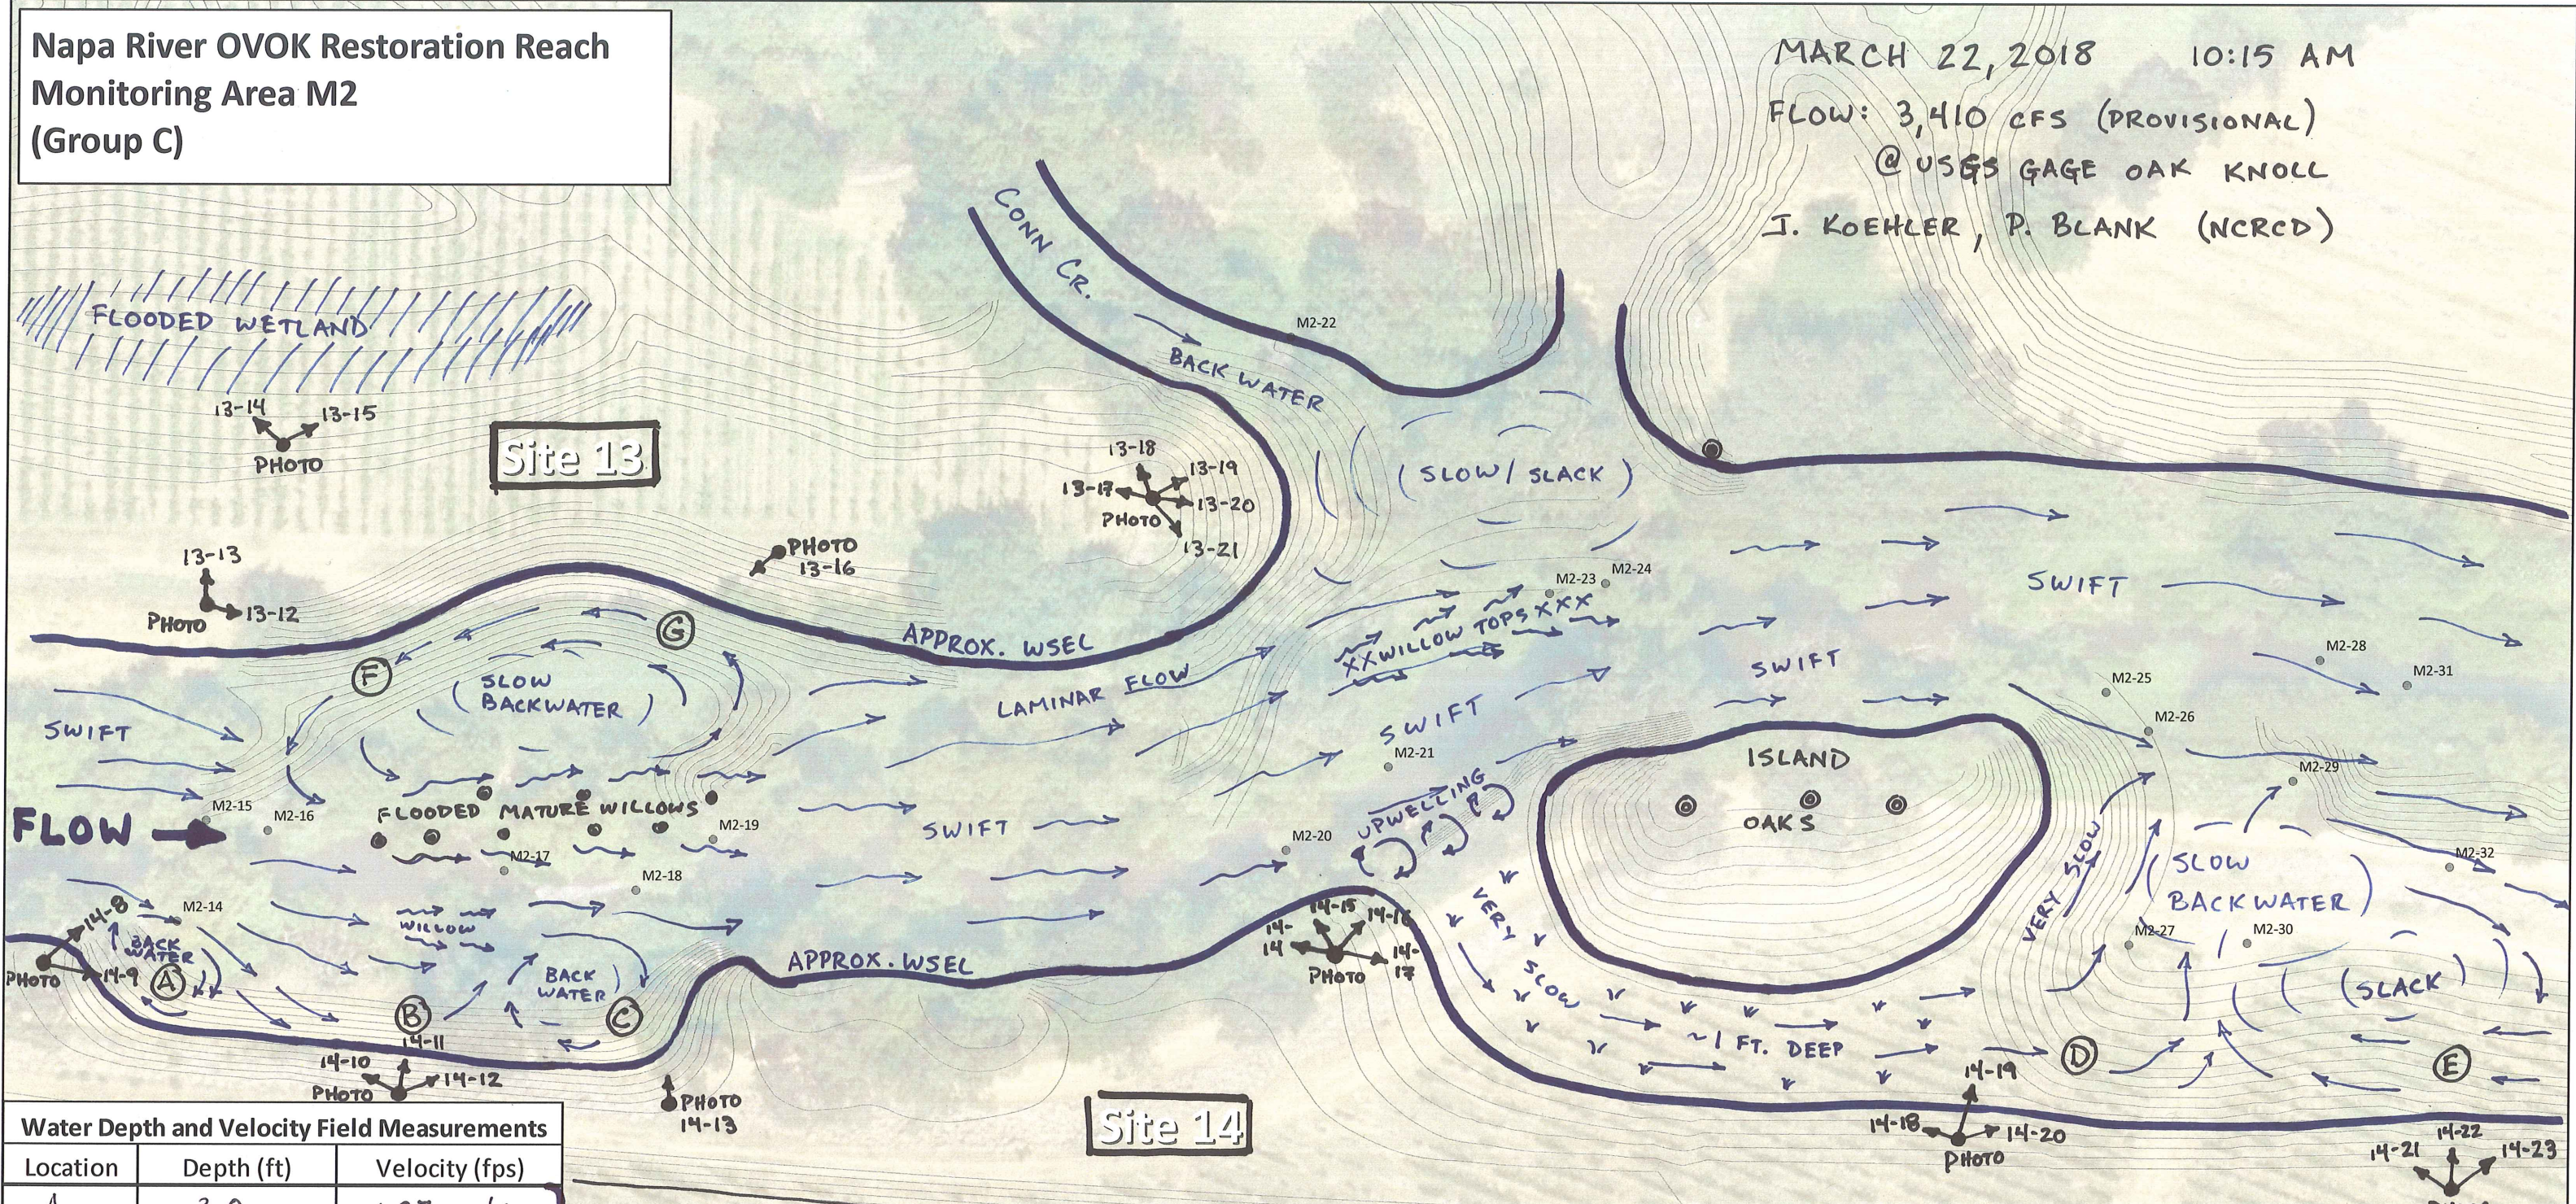
**Napa River OVOK Restoration Reach
Monitoring Area M2
(Group C)**

Site	Monitoring Area	Bank (facing down-stream)	Date, Time	Measured Water Velocities (ft/sec)	Flow at USGS Gage 11458000 ¹ (cfs)	Narrative Evaluation
13	OVOK_M2	Left	March 22, 2018 9:50 - 10:15 AM	0.27 - 3.23	3,010 - 3,410	All graded benches observed during this high-flow event were functioning well to provide slow backwater areas (refugia) and complex hydraulics. Water velocities measured around the margins of each graded bench were favorable for juvenile and adult salmonid resting.
14	OVOK_M2	Right	March 22, 2018 9:50 - 10:40 AM	0.17 - 3.62	3,010 - 3,780	All low-elevation graded benches observed during this event were functioning well to provide slow backwater areas (refugia) and complex hydraulics. The high-elevation benches at the upstream portion of this site were not engaged. Water velocities measured around the margins of each low-elevation graded bench were favorable for juvenile and adult salmonid resting.

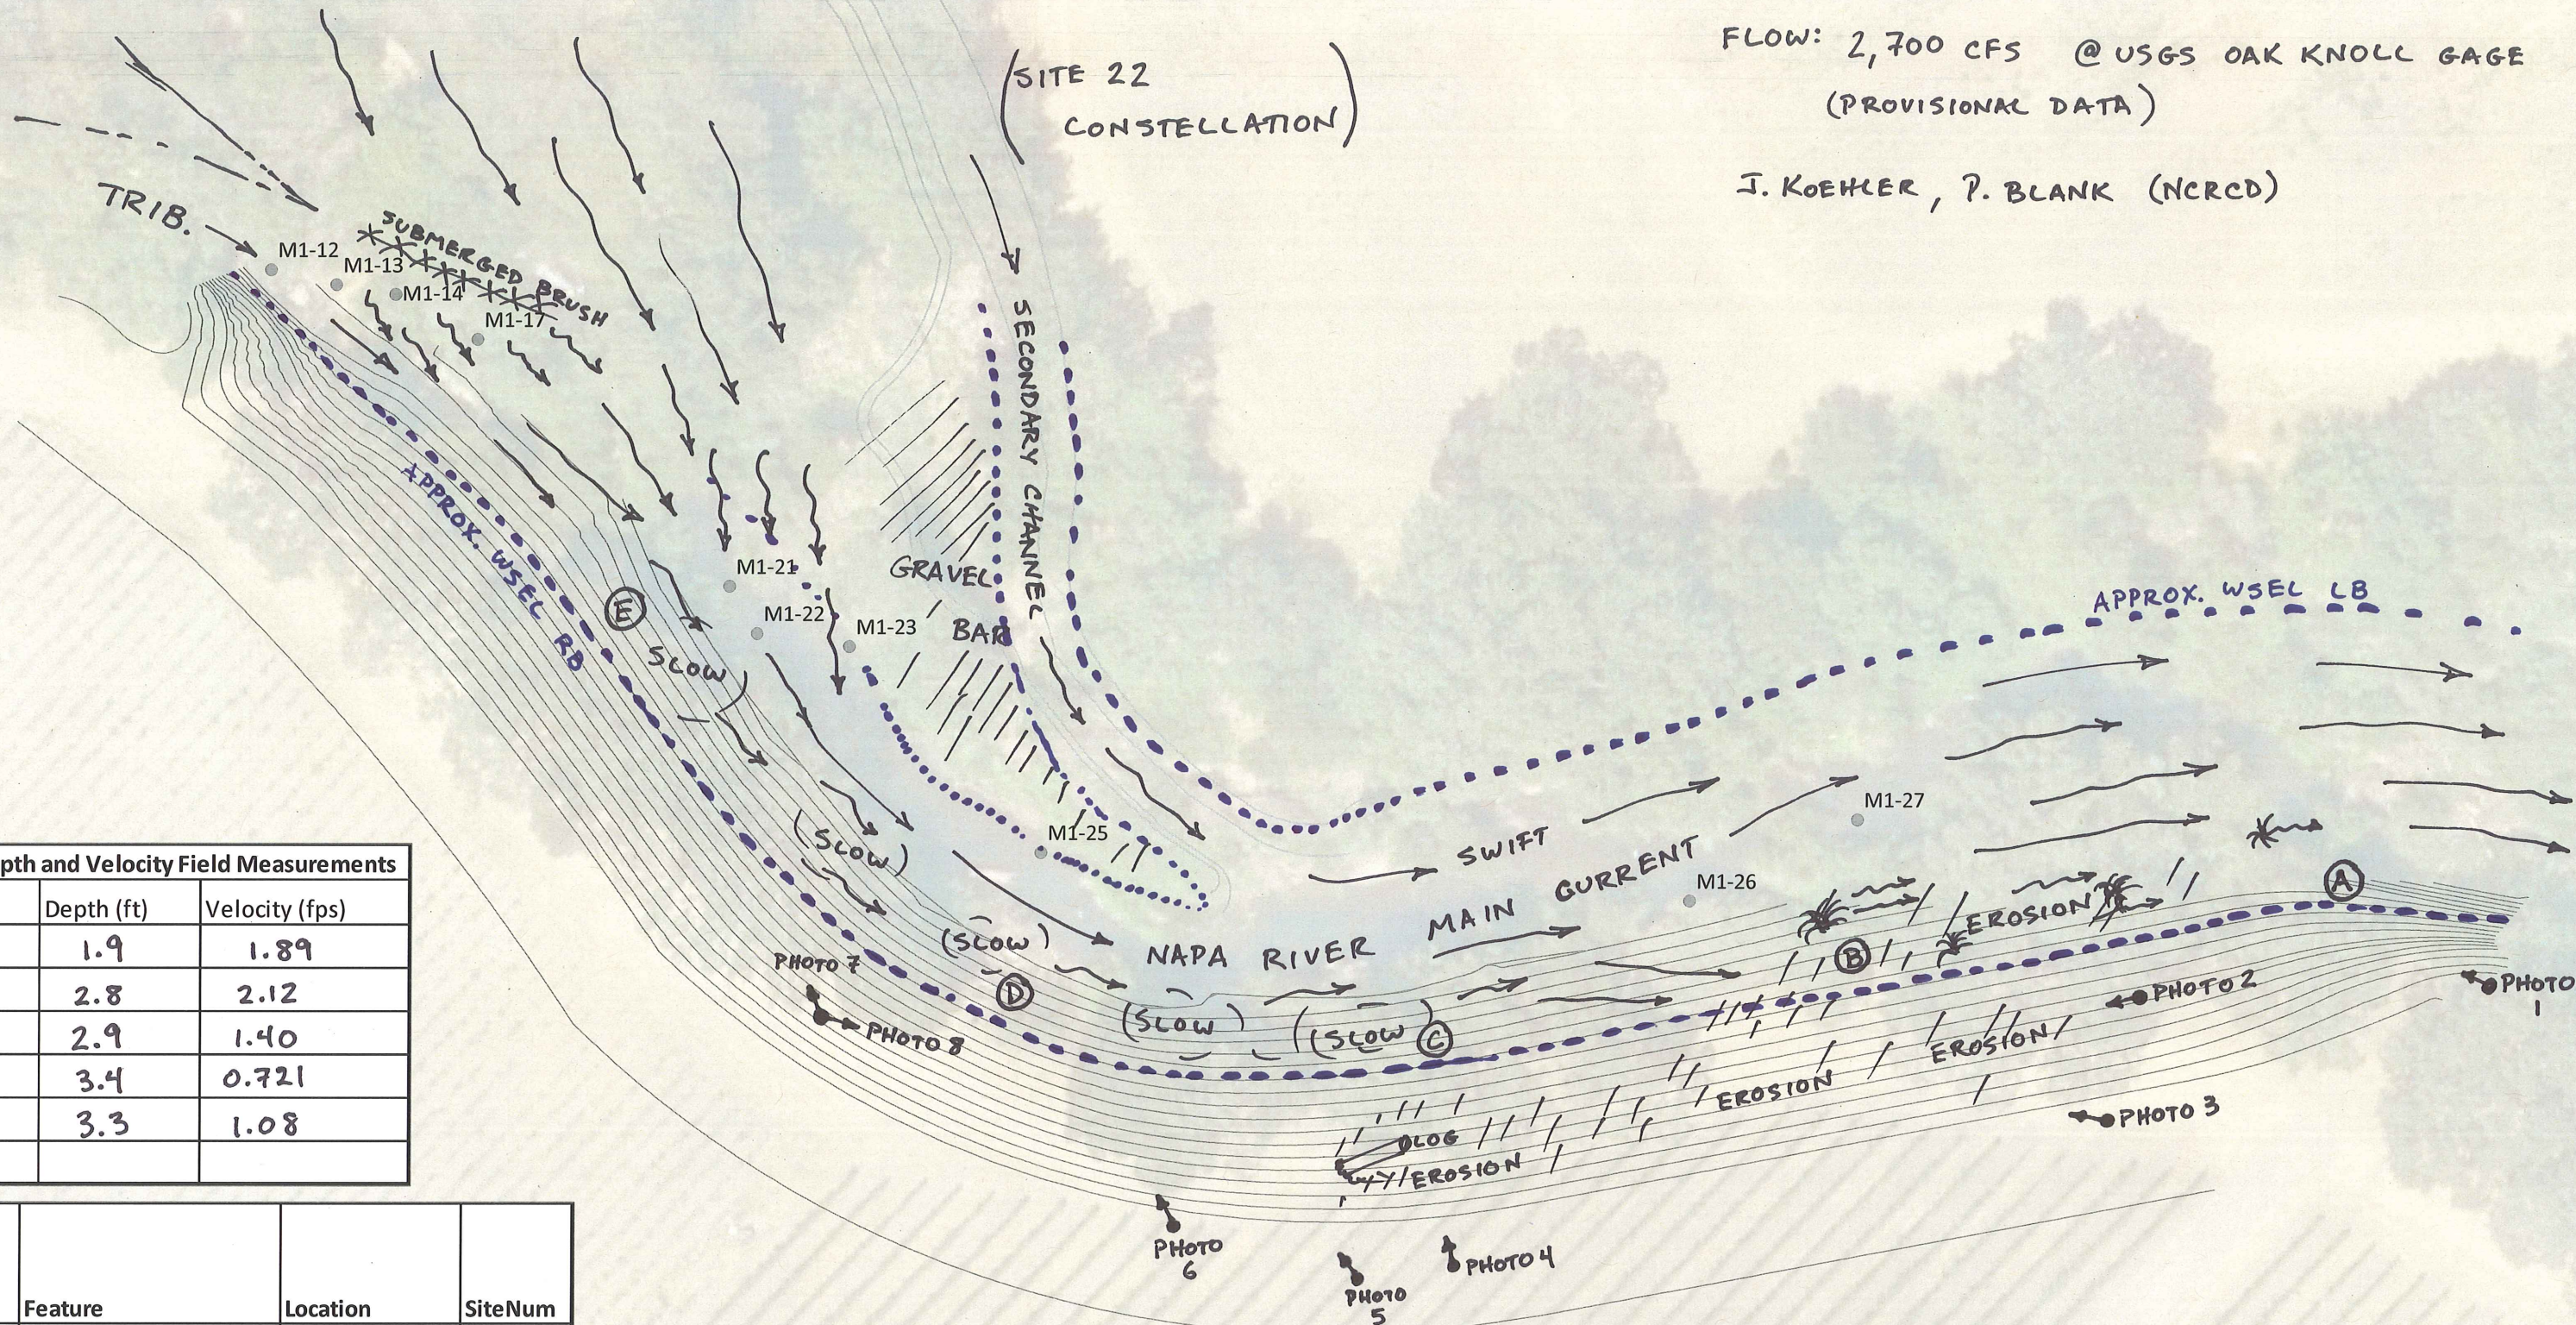
21	OVOK_M1	Right	February 22, 2017 9:30 AM	0.72 - 2.12	2,940	Graded bench sustained some damage from high flows - erosion noted around installed habitat structures above water line. Extensive areas of slow flow (refugia) observed along margins of graded bank with velocities favorable for juvenile and adult salmonid resting.
22	OVOK_M1	Left	February 22, 2017 10:15 AM	0.67 - 4.03	2,910	Graded bench and secondary channel observed during this high-flow event were functioning very well to provide complex hydraulics and gravel sorting/deposition. Few areas of slow velocity refugia were observed; however, a large backwater gyre was present at the upstream extent of the graded area with nearly slack water conditions
23	OVOK_M1	Left	February 22, 2017 10:40 AM	0.37 - 4.22	2,870	The higher-elevation graded areas of this feature were partially engaged during this high-flow event. Several slow velocity areas were observed along the margins of the lower-elevation areas of this feature with velocities favorable for adult and juvenile steelhead resting. Evidence of silt and sand deposition was observed in the higher-elevation graded areas, suggesting the bench was functioning well (as intended) to retain fine sediments outside of the main channel.

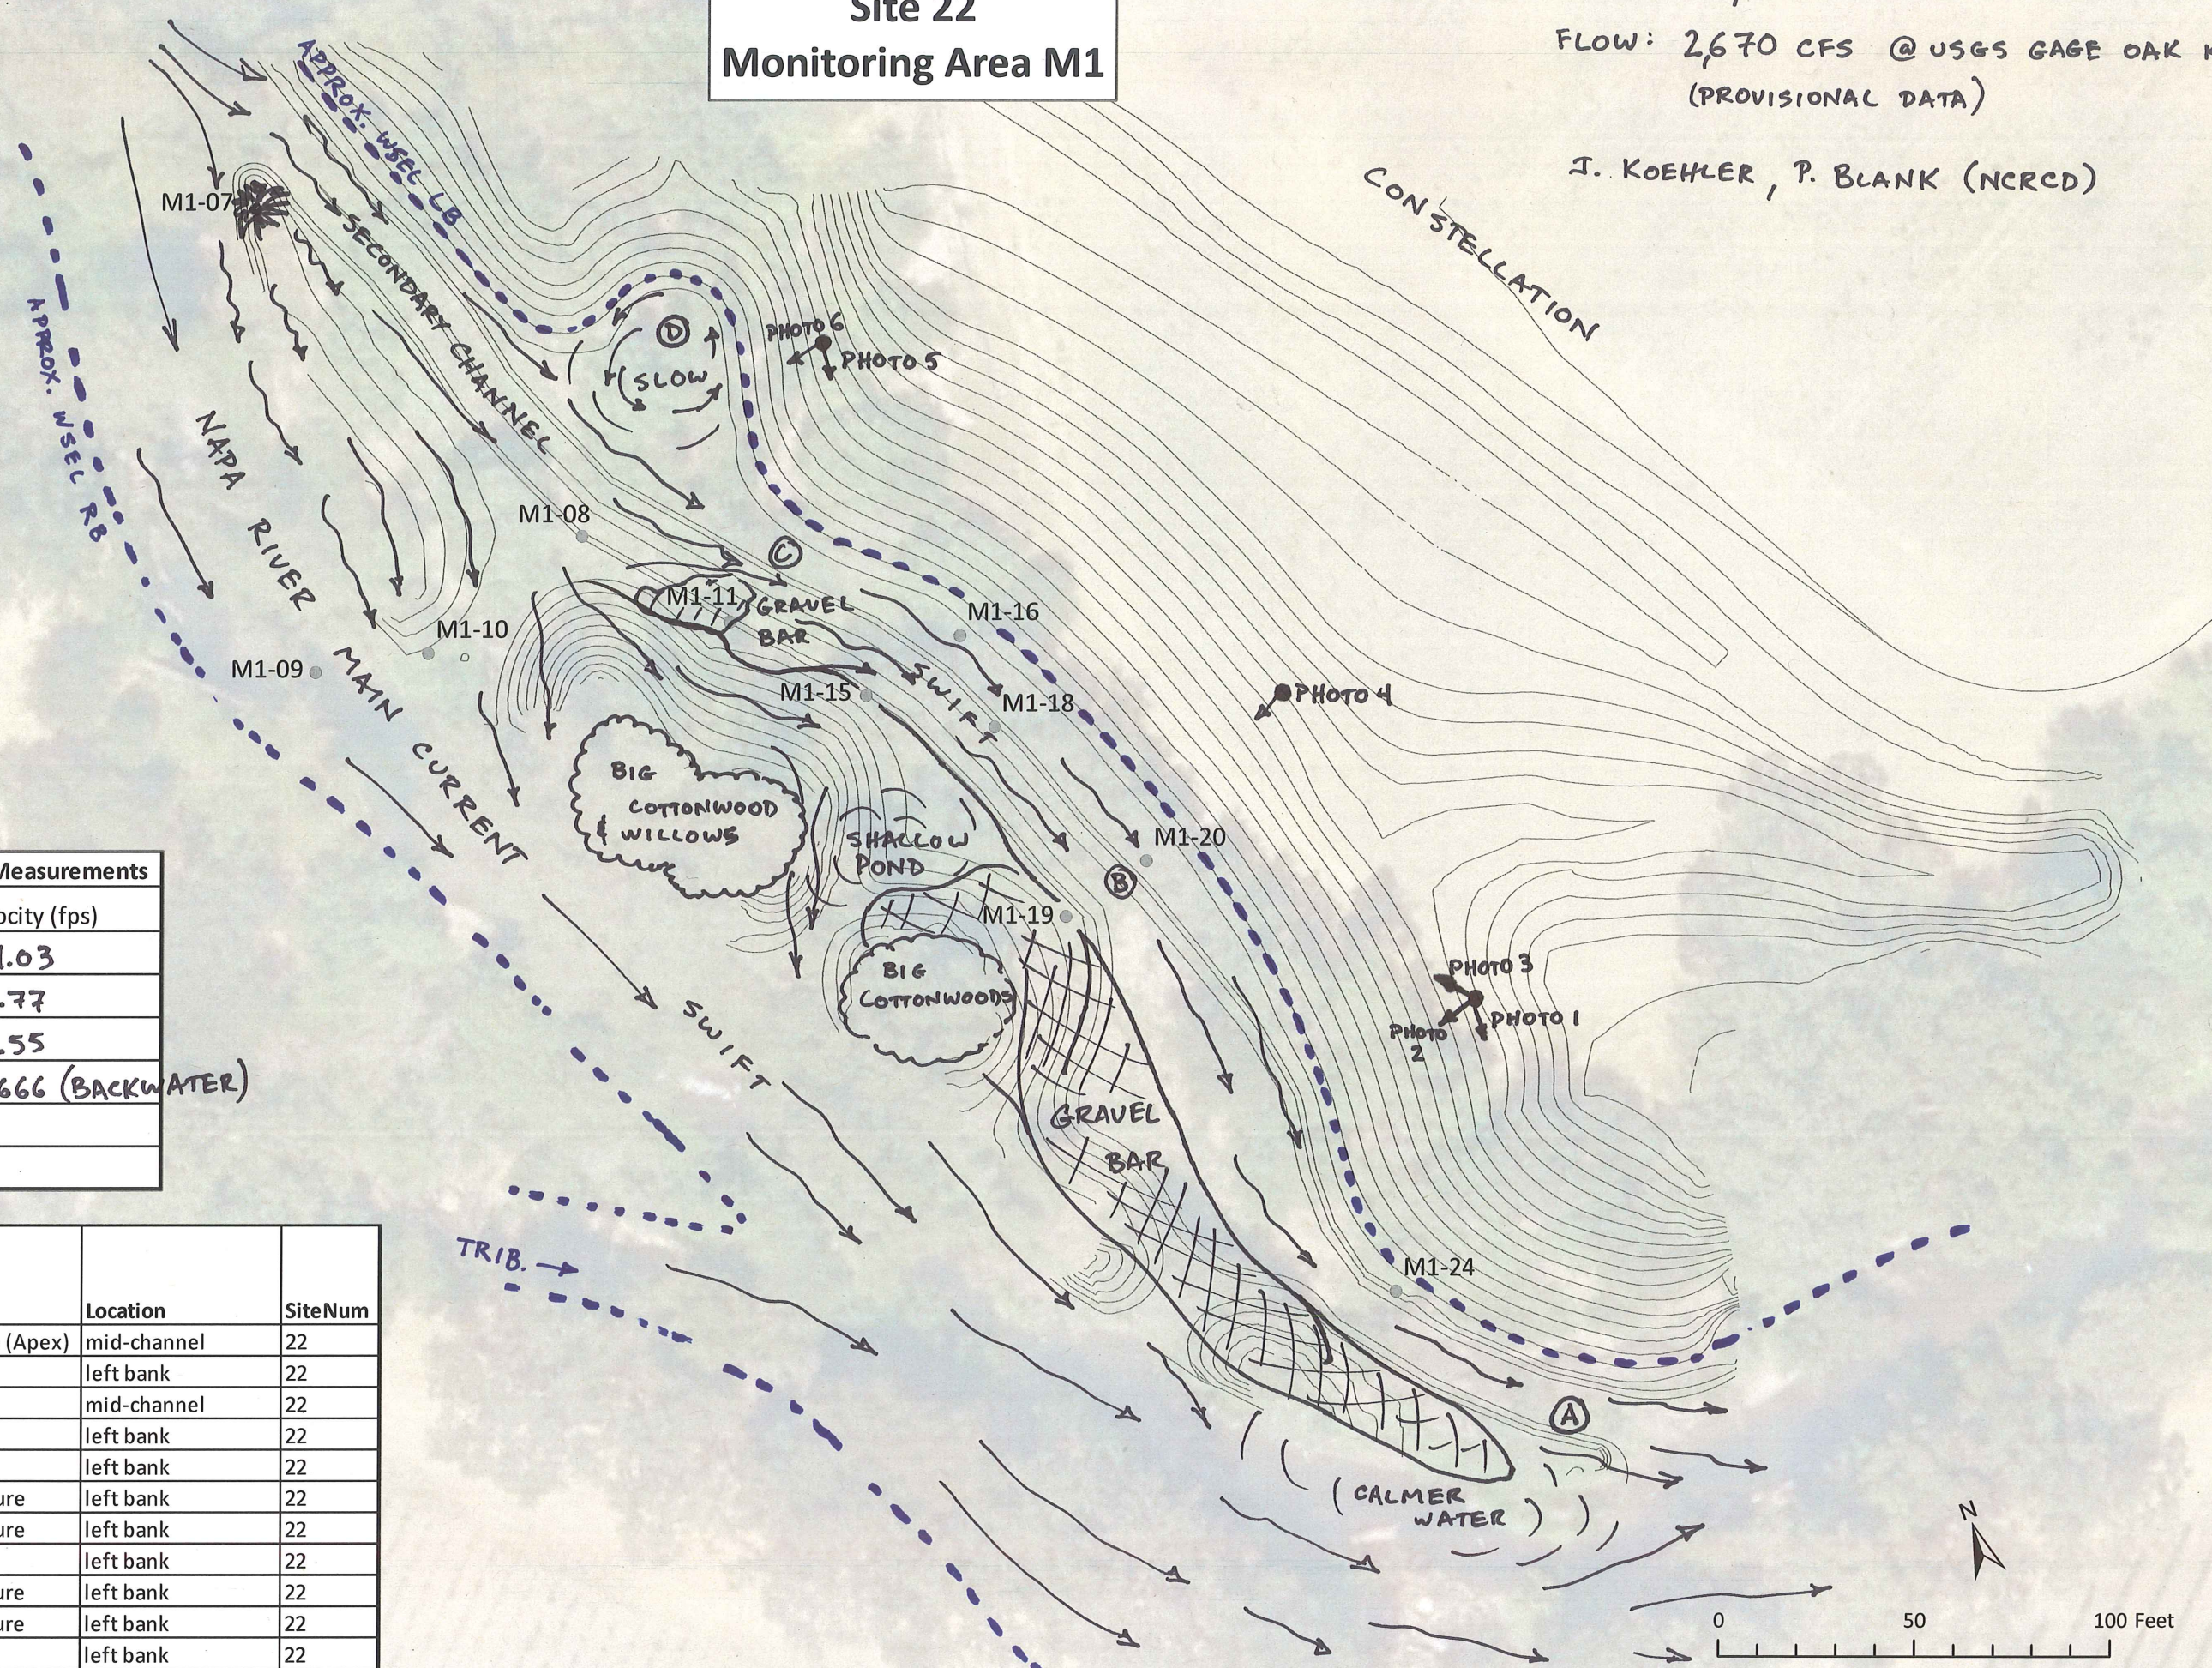
² A large deposit of gravel was observed at Site 22, which likely buried many of the installed habitat structures

3. Large gravel deposits were present in Sites 13, 14, 21, and 22 that likely buried several installed habitat structures that were not found. Future efforts to find these structures and confirm their location and condition is recommended.
