5.2.2.4 Reach 4

Figure 14. Typical existing conditions and conceptual design for Reach 4

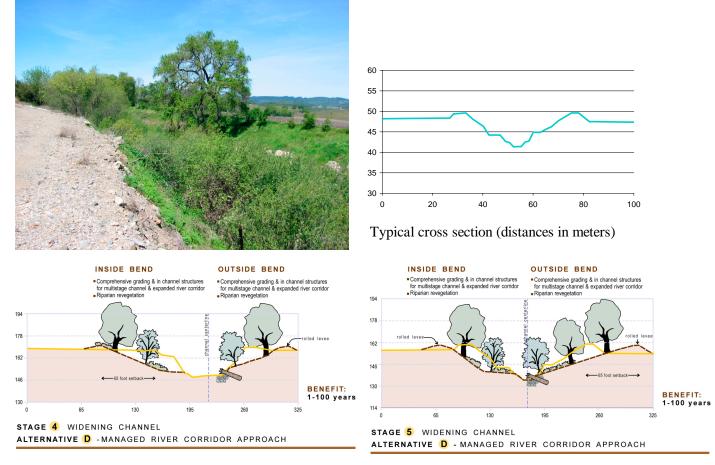
North of Rutherford Road to the southern boundary of the C Mee property (encompassing Round Pond, E Mee and Emmolo on the west bank and McDonnell, Honig and Carpy Connoly on the east bank). In this reach the river is very constricted and confined by levees. The channel has a low width to depth ratio (is narrow and deep) compared with other reaches. The most common condition in this reach is classified as Stage 4 with some 'early' Stage 5, indicating that the channel is incised and widening, but has not yet widened sufficiently to form a new floodplain within the old banktop margins. The reach has excess energy during high flows as water cannot escape laterally onto the floodplain and dissipate erosive energy. This excess energy is expended in bank erosion and mass failure, contributing fine sediment to the river.

We recommend that for Reach 1 the preferred alternative is a setback of approximately 65 feet on one side (in general the west side to preserve mature riparian vegetation on the east bank) and the creation of a new floodplain at bankfull level, accompanied by bank regrading to a stable angle and revegetation using appropriate native species. Though there will be temporary disruption of the channel banks during construction, the net effect of setbacks will be greatly beneficial. It will greatly increase the underlying geomorphic stability of the Napa River, reducing bank erosion rates and fine sediment problems. It will restore a high degree of natural physical function to the river, leading to more diverse and valuable aquatic habitat and improved conditions for several listed species including Chinook salmon and steelhead. The restored river will require less human intervention and maintenance than the current channel. Flood levels will be lowered in the wider channel, reducing flood risk and improving drainage from the floodplain. The recommended restoration conceptual alternative is 4D and 5D (page 39 and page 40). The total length of channel involved is 3,500 feet. The area for a 65-foot set back over the entire reach would be 227,500 square feet (5.2 acres).

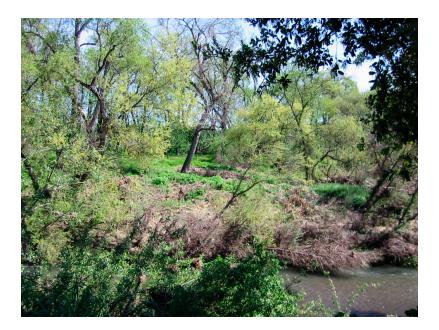
The reach is 2,140 feet long. This reach is a Stage 5 section that has come close to equilibrium. The channel has widened and excess material has formed a new floodplain, reducing excess erosive energy during floods.

Figure 15. Typical existing conditions for Reach 6

This is a suitable reach for a combination of natural recovery and local biotechnical bank stabilization on eroding hotspots, with some assistance in the form of Arundo removal, vegetation planting and management in places. The recommended restoration alternative is 5B (6.5.2 page 40).

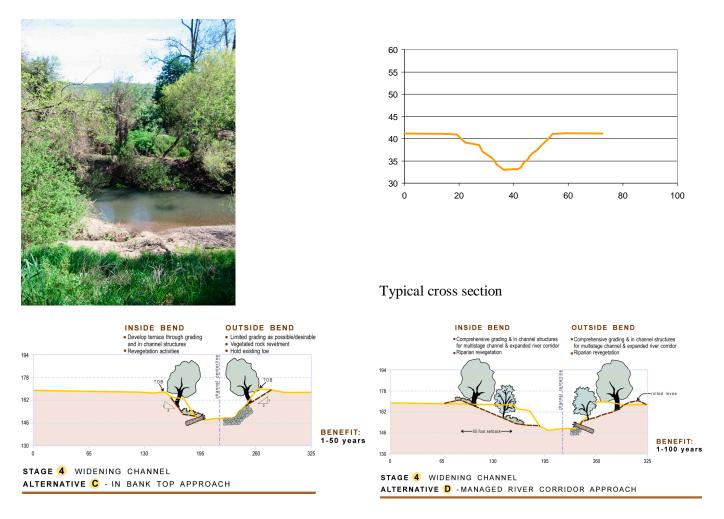
From the southern boundary of the Cakebread property to the northern end boundary of the Sawyer property (west bank) and the Laird, Gmelch and southern Wilsey properties (east bank). This reach is 4,350 feet long. The northern portion of this reach is in Stage 5, with point bars developing into a new floodplain, but bank erosion behind the bars and on opposing outside bends. The southern

portion of the reach is in Stage 4, with little point bar development and extensive bank erosion. In addition to the priority sites identified in Section 5.2.1 this reach has some smaller scale erosion areas.

Figure 16. Typical existing conditions and conceptual design for Reach 8

We recommend a combination of biotechnical stabilization of local areas of high erosion, use of biotechnical structures such as weirs to increase channel diversity, and limited bank setbacks where constraints allow, with the objective of reducing overall erosive forces in the reach and increasing channel

habitat potential. All work should be accompanied by revegetation using appropriate native species. The recommended restoration conceptual alternative is 4C and 5C (page 39 and page 40), and limited 4D and 5D. The proposed alternative would restore more natural function to the river while working within the constraints of preserving the mature riparian canopy.
