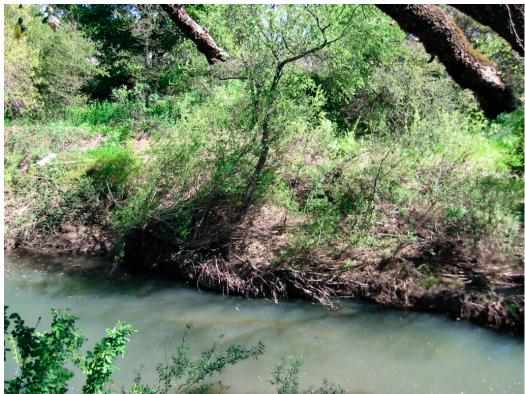
Photograph B-23. MacDonnel property from Round Pond - "Early" narrow stage 5 reach

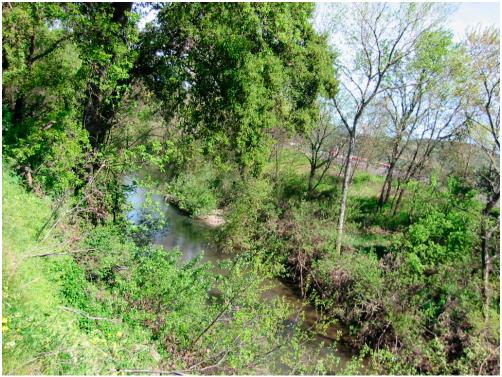
Photograph B-25. Honig property from Round Pond, widening stage 4 Reach

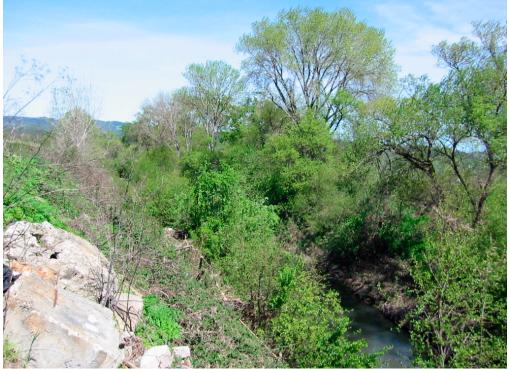
Photograph B-26. Round Pond and Honig properties This confined stage 4 section is the priority reach for restoration.

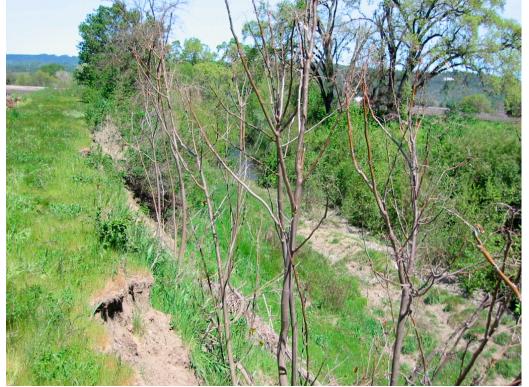
Photograph B-28. Bank erosion on E Mee property opposite Honig, within the priority restoration reach
