Napa River Rutherford Reach Restoration Project Annual Maintenance and Monitoring Survey

July 2010

Prepared by: Napa County Flood Control and Water Conservation District Napa County, California

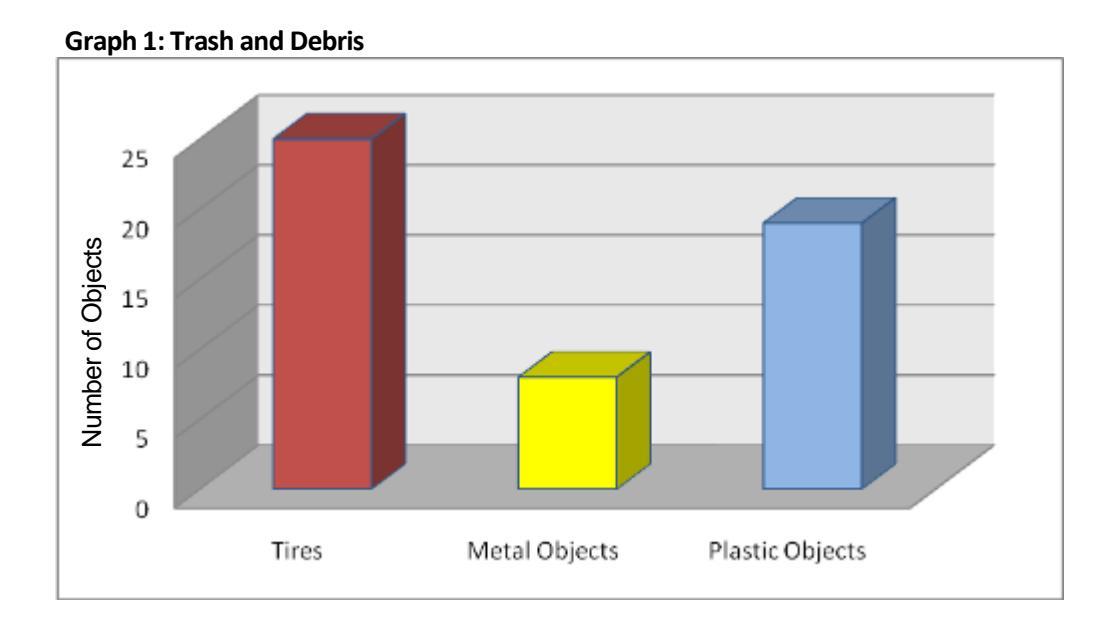
A total of 52 occurrences of trash and debris were documented in the Project area with the dominant trash and debris type being tires (25) and the remaining (27) occurrences of trash and debris were plastic objects including irrigation drip lines, tarps, agricultural field tubs and metal objects such as storage drums, appliances, etc. Figure 2 shows the location of the trash and debris documented while Graph 1 below represents the amount of trash types documented during the stream survey.
