**FINAL REPORT
SUISUN CREEK WATERSHED PROGRAM**

**California Sportfishing Protection Alliance
Laurel Marcus and Associates
California Land Stewardship Institute
April 2011**

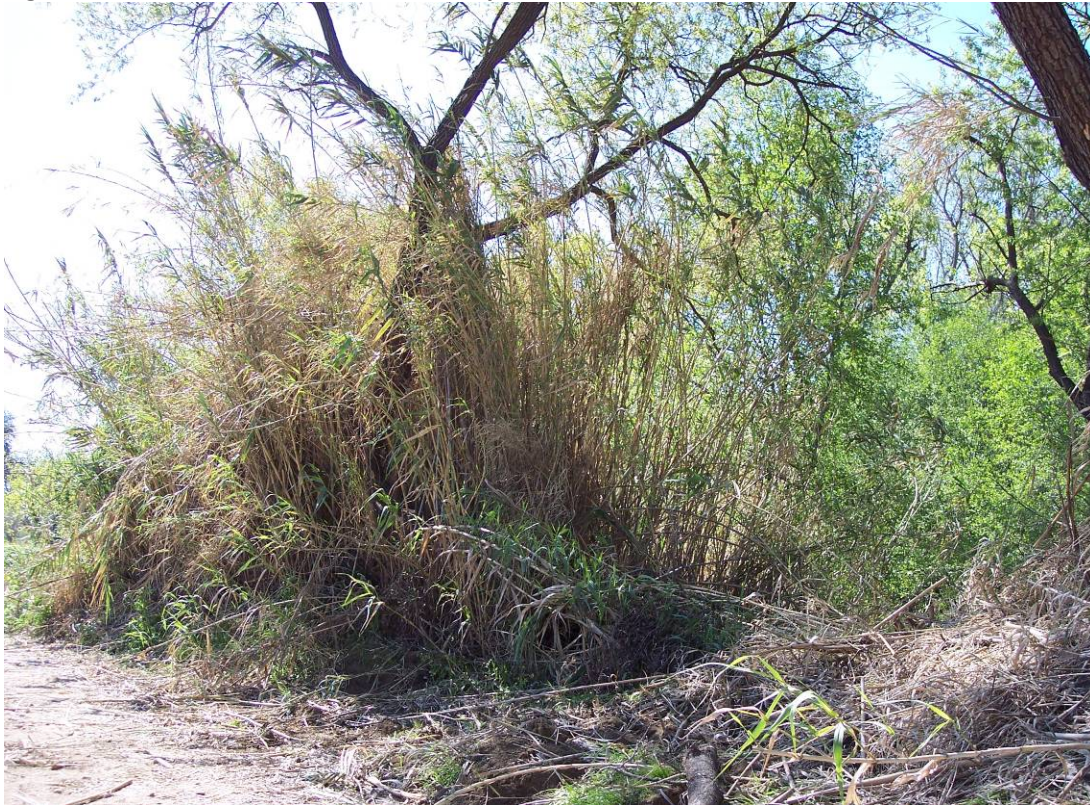
Figure 8: *Arundo donax* Infestation Site prior to Removal

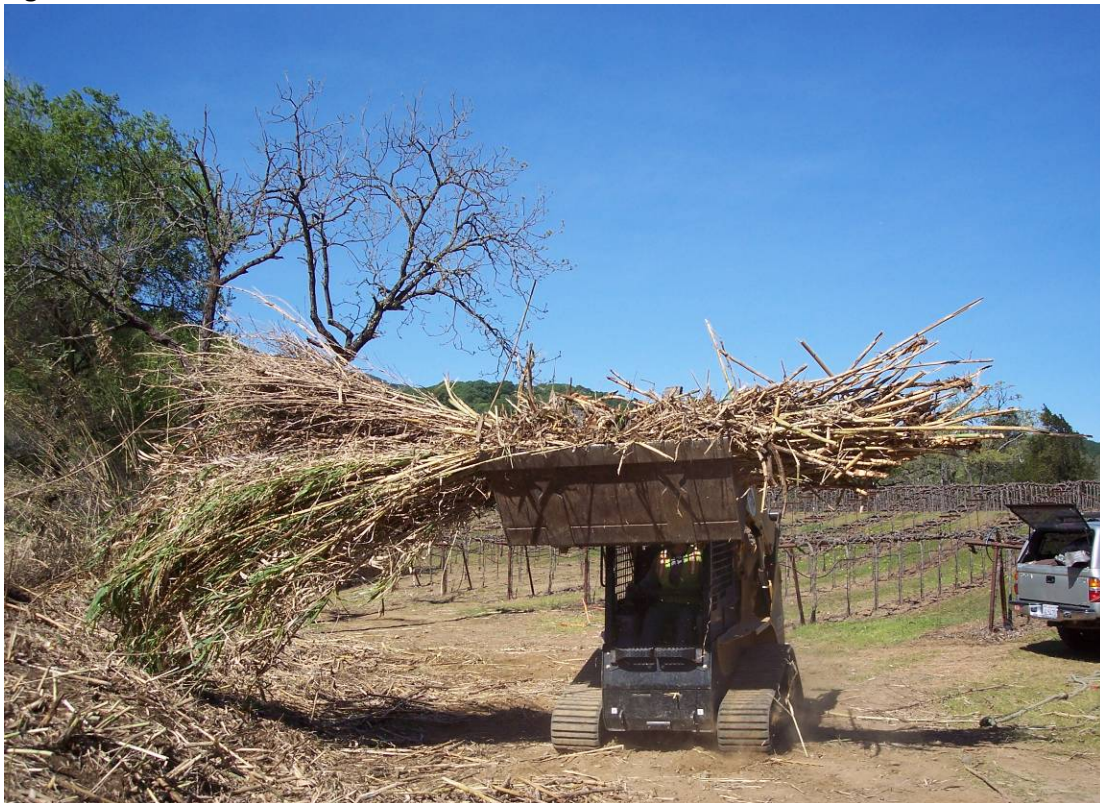
Figure 9: *Arundo donax* Removal

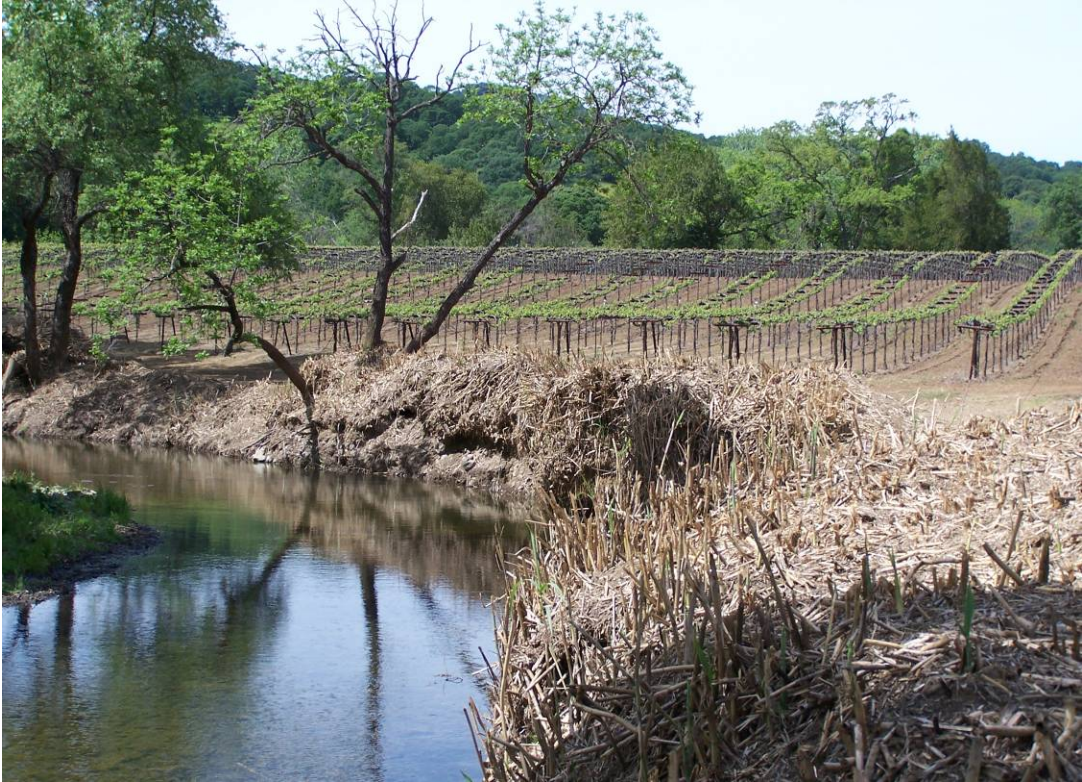
Figure 10: *Arundo donax* Infestation Site after Removal

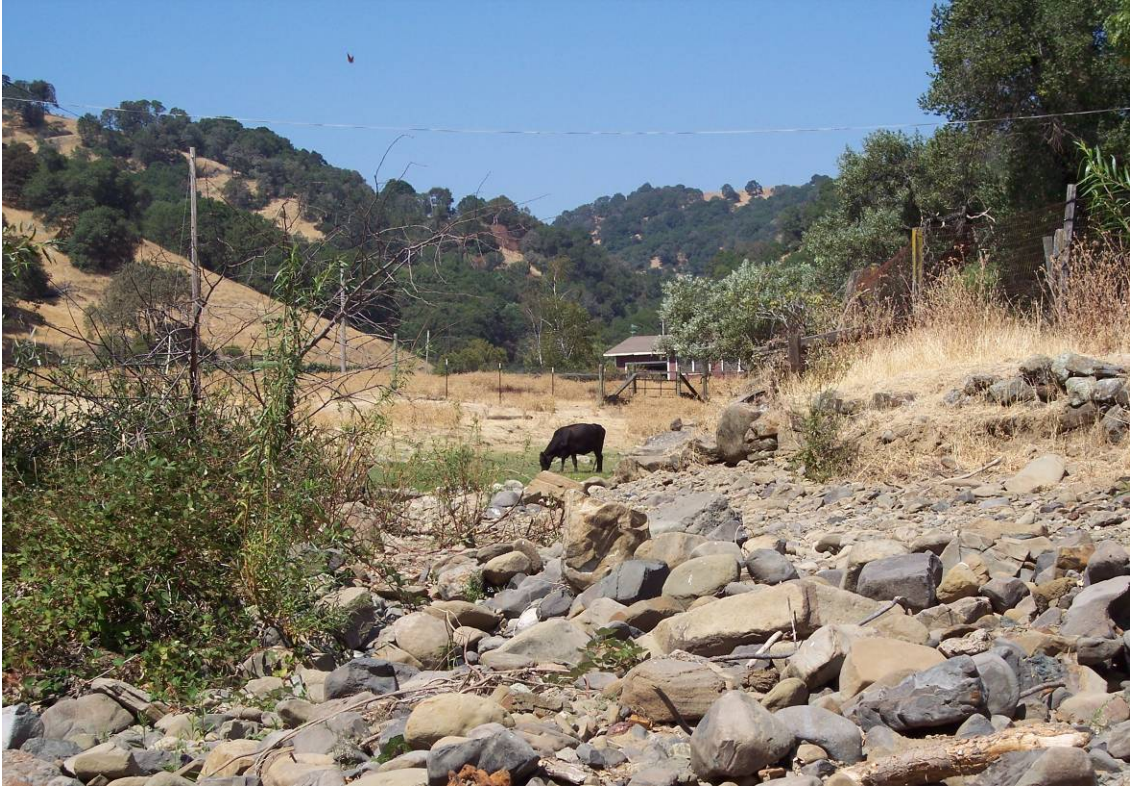
The Wooden Valley Creek Riparian Habitat Enhancement Plan was designed to restore the riparian zone on 1.25 miles of lower Wooden Valley Creek given current hydrologic conditions and land use. Prior to the project, the site was a known thermal reach and contributed sediment due to bank erosion. Typical bank conditions in the upstream part of the project area showed bank erosion and lack of canopy resulting from a long-term history of grazing.

Figure 17: Wooden Valley Creek Riparian Habitat Enhancement Project – Before Project

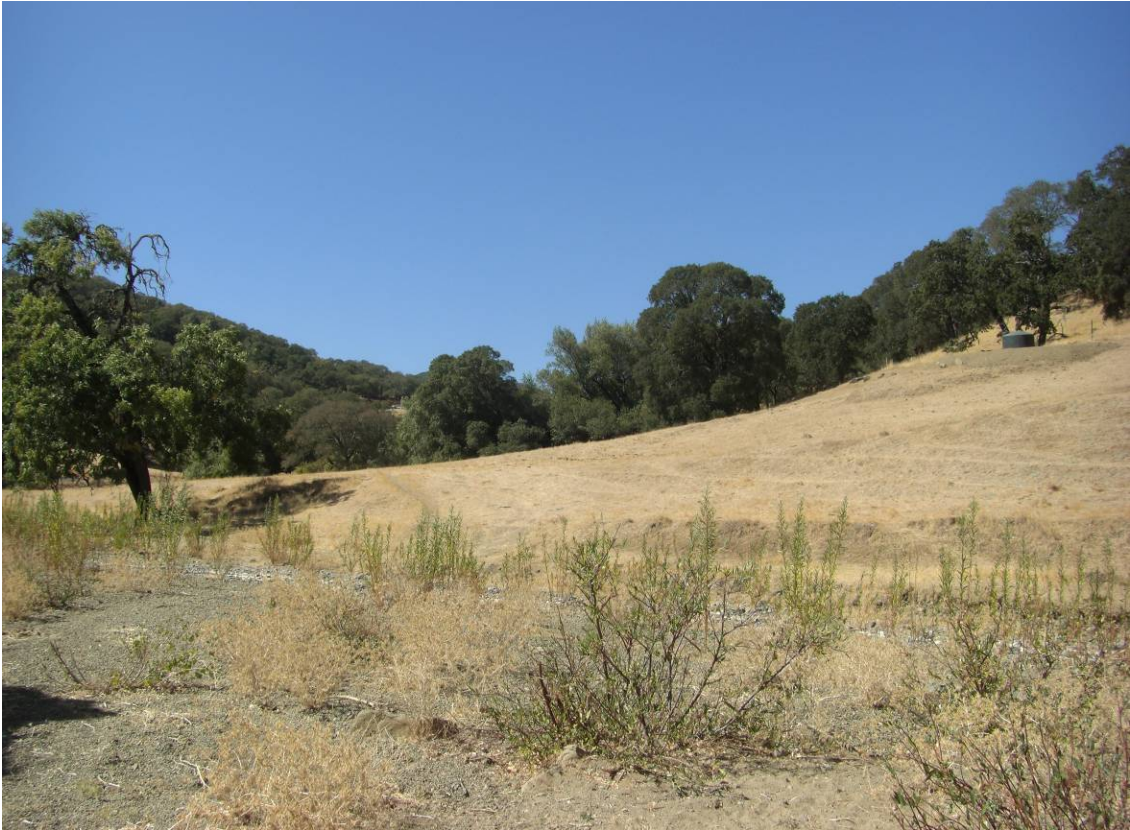
Figure 18: Wooden Valley Creek Riparian Habitat Enhancement Project – Before Project

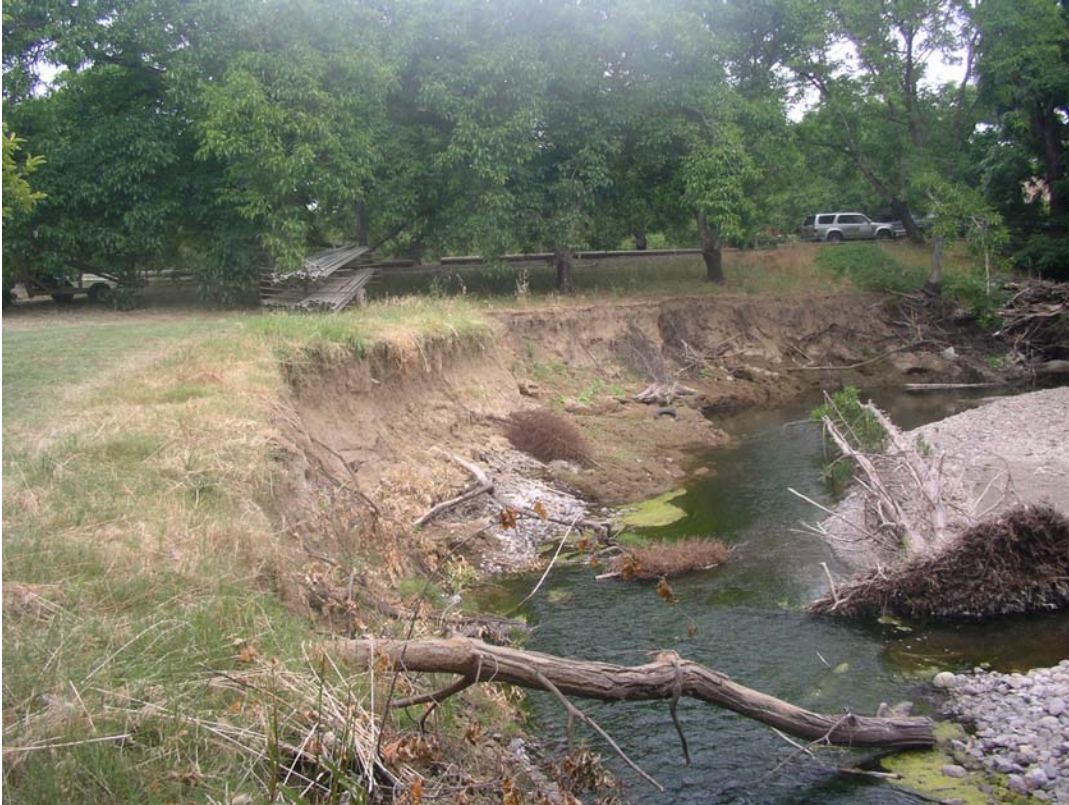
The Suisun Creek Streambank Repair and Riparian Revegetation Project restored a stream bank with active lateral erosion on a point bar in order to reduce fine sediment loading and to revegetate a known thermal reach on Suisun Creek. The reach is approximately 500 feet in length and makes a sweeping right meander from the upstream end of the property to the bottom. As the flow moves through this meander, the left bank (east bank) receives most of the force of flood flows and prior to the project was actively eroding at a rate of several feet per year. Pre-project bank conditions on the site indicated that lateral erosion has been very active recently, and periodic bank failures were likely to continue as the channel undercuts the toe of the slope. The rapid influx of fine-grained sediment was overwhelming the stream channel, leaving pools filled with sediment and gravel embedded with fines. The project goals were to: stabilize a section of stream bank on Suisun Creek that is actively eroding, reducing sediment delivery to the creek; revegetate with appropriate native tree species in order to increase wildlife habitat and reduce water temperatures.

Figure 25: Suisun Creek Streambank Repair and Riparian Revegetation Project – Before Project

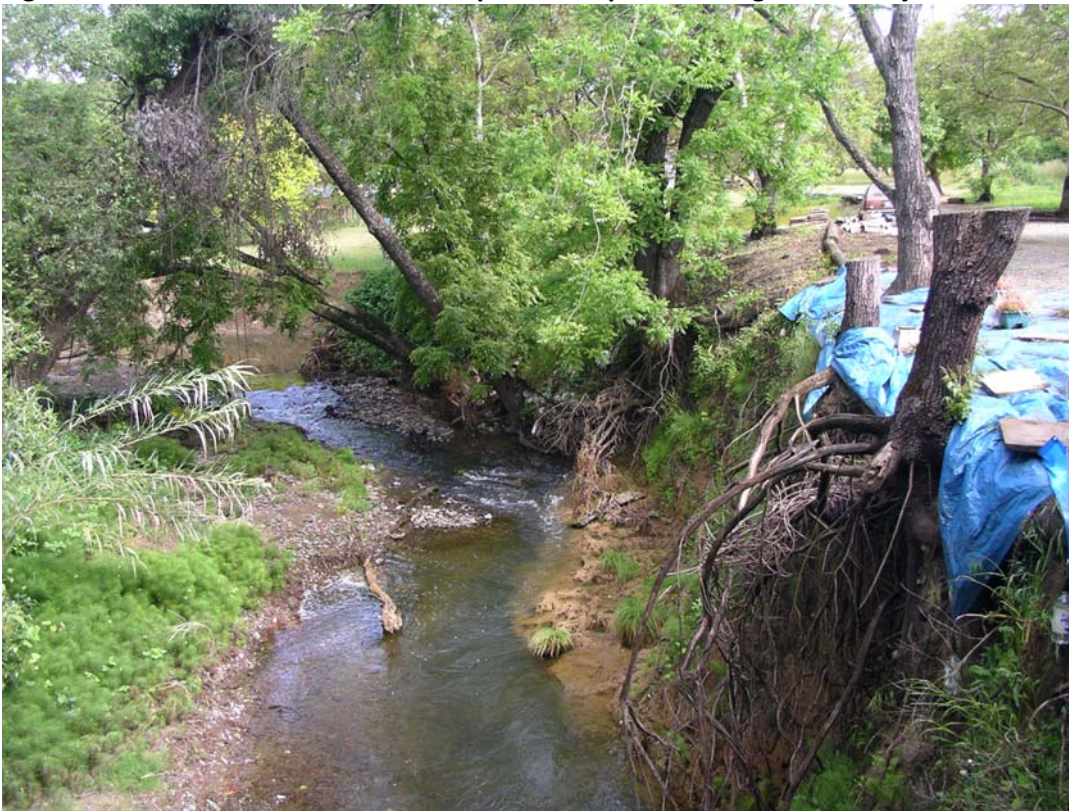
Figure 26: Suisun Creek Streambank Repair and Riparian Revegetation Project – Before Project

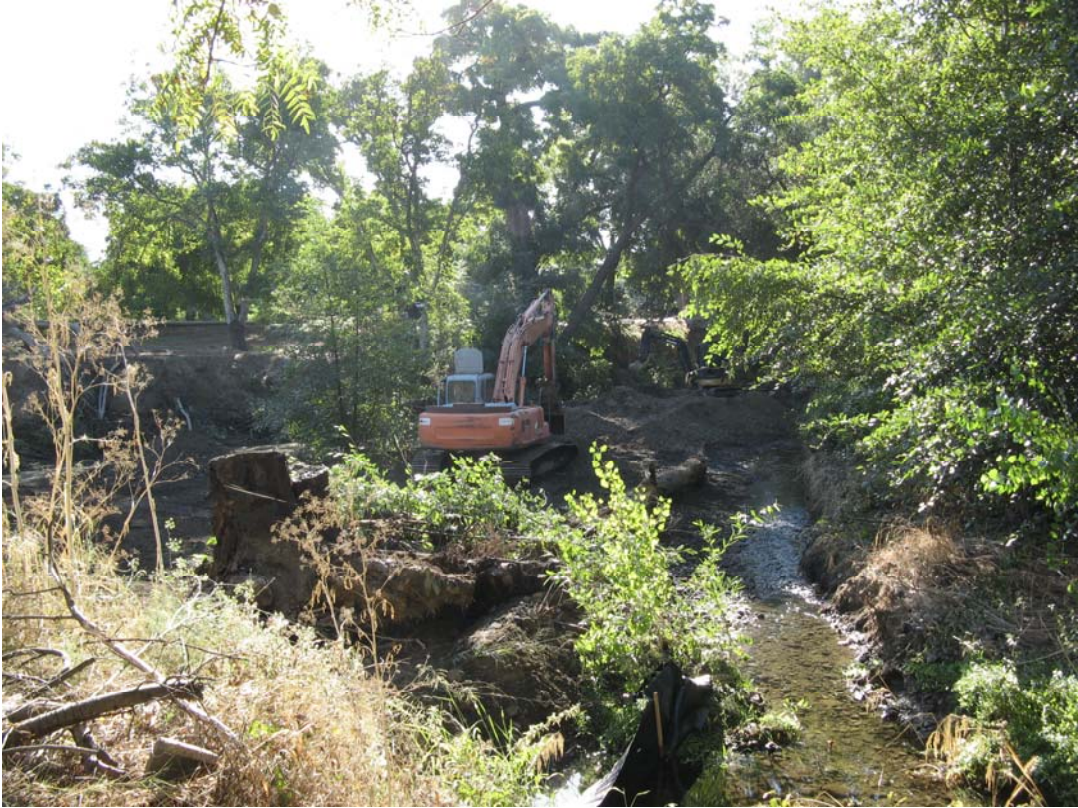
Figure 27: Suisun Creek Streambank Repair and Riparian Revegetation Project – Construction

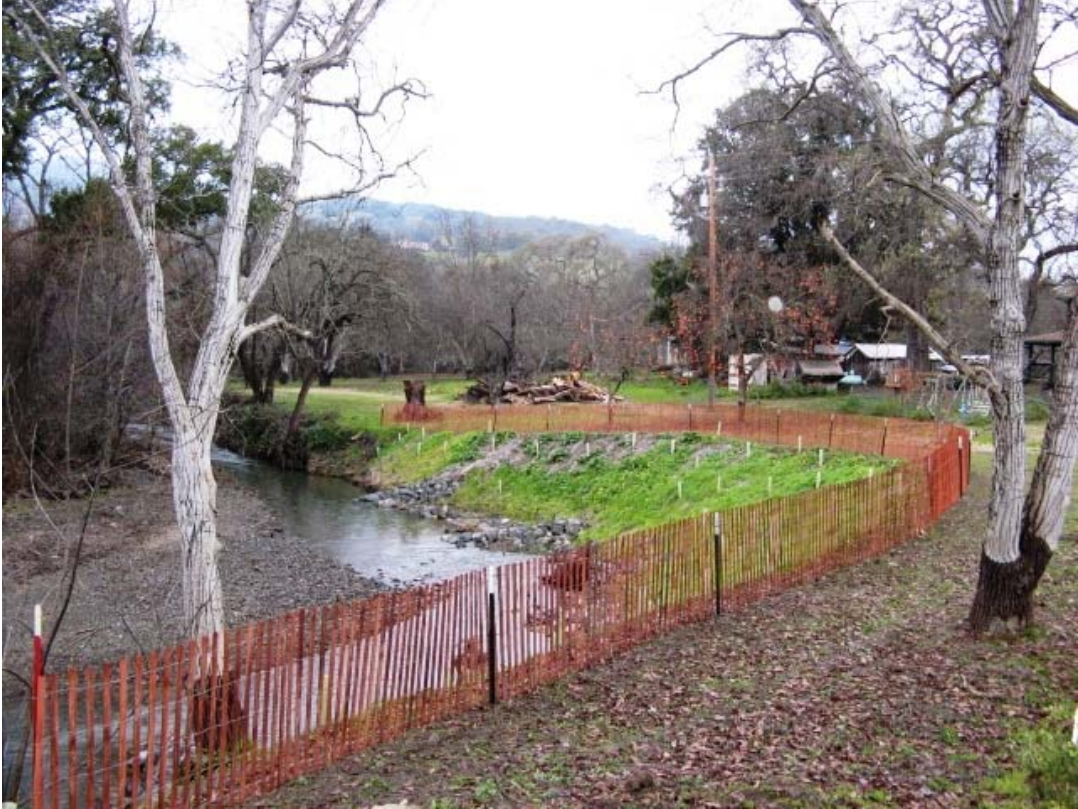
Figure 30: Suisun Creek Streambank Repair and Riparian Revegetation Project – After Project

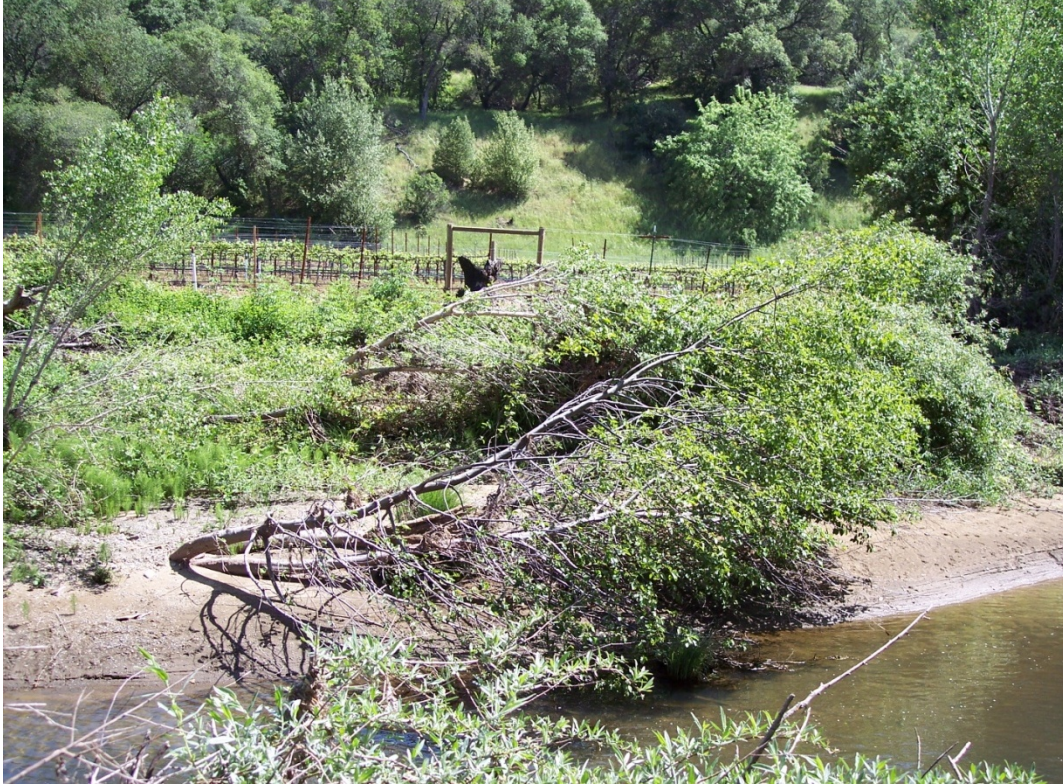
Figure 34: Flooding in 2005-2006 took out many riparian trees on Suisun Creek. On December 31-January 1, 2006, a storm delivered up to 16 inches of rain in several hours in the Suisun Creek watershed resulting in large landslides and the loss of many trees in the riparian corridor. The increase in riparian canopy observed through the surveys can be attributed in part to the natural processes of recovery and regeneration following this storm event.
