Napa River Sediment Reduction and Habitat Enhancement Plan: Oakville to Oak Knoll

April 2011

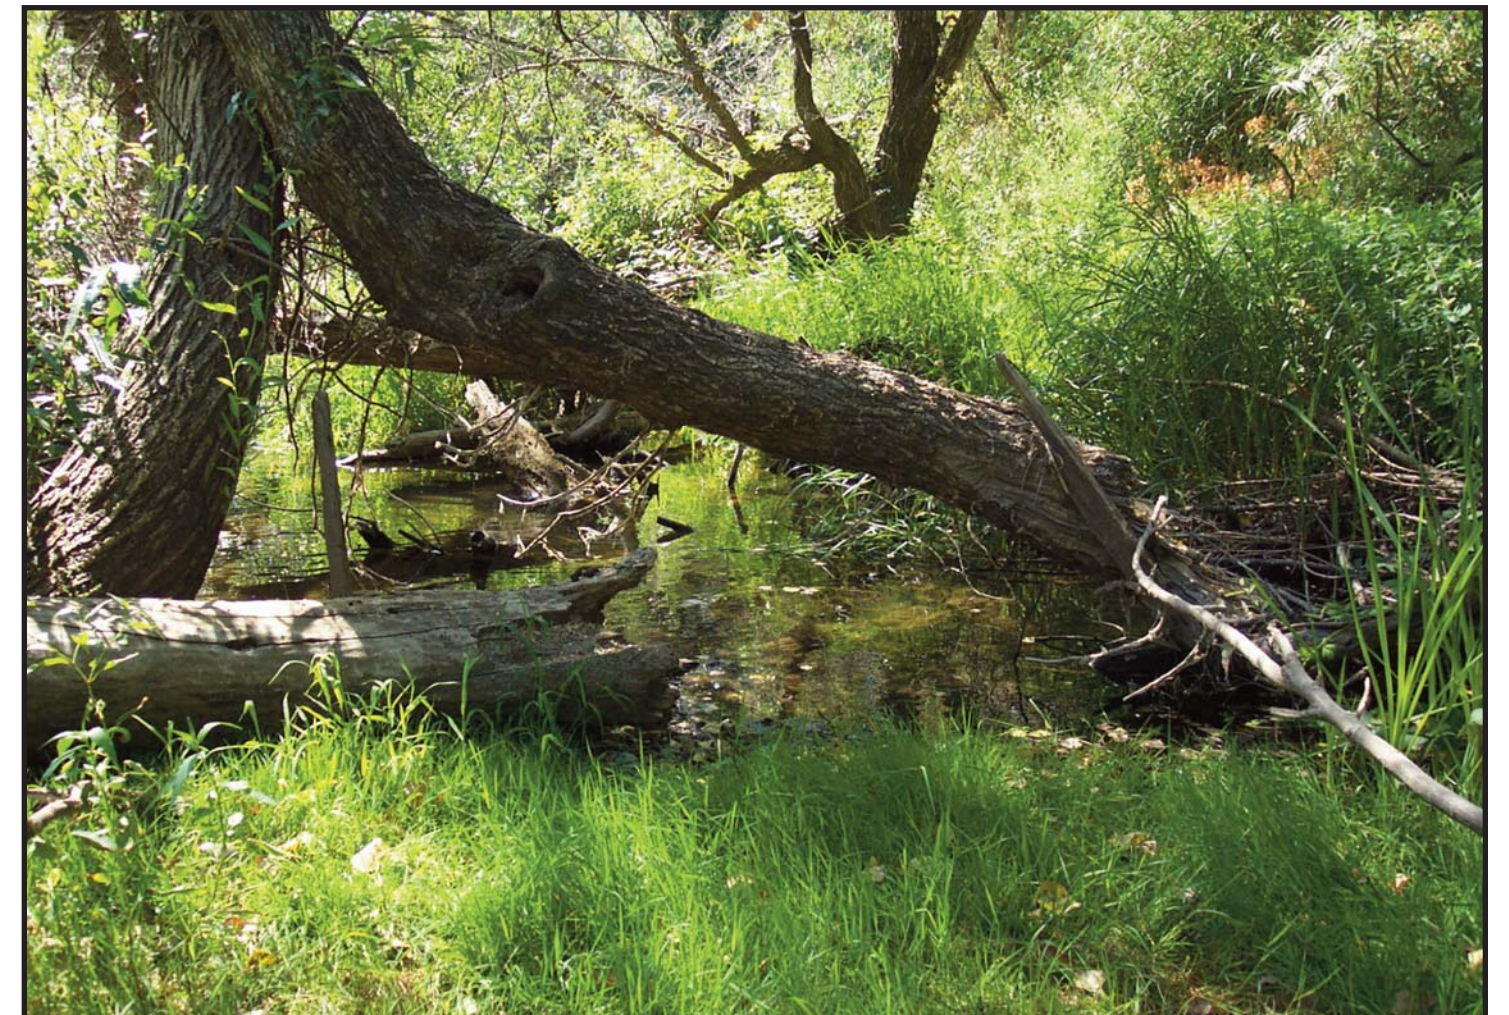
THIS PHOTO SHOWS A SIDE CHANNEL WITH AN ALCOVE OF HIGH HABITAT QUALITY FOR YOUNG SALMON.

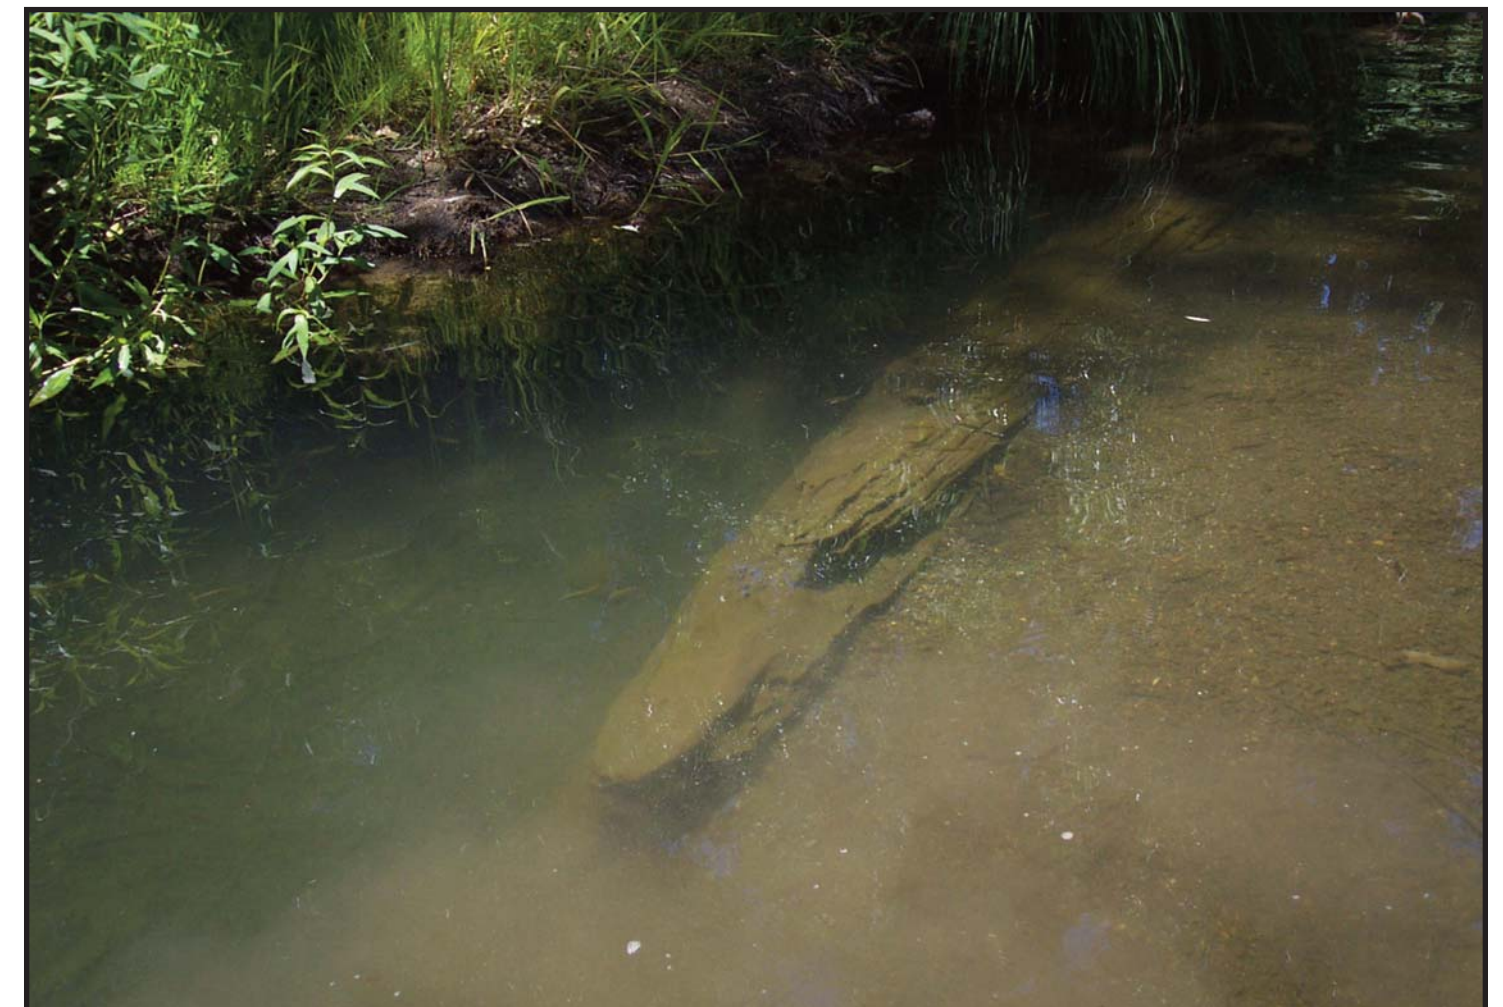
BURIED LARGE WOOD CREATES SCOUR AND UNDERCUT BANK - A HIGH QUALITY HABITAT.

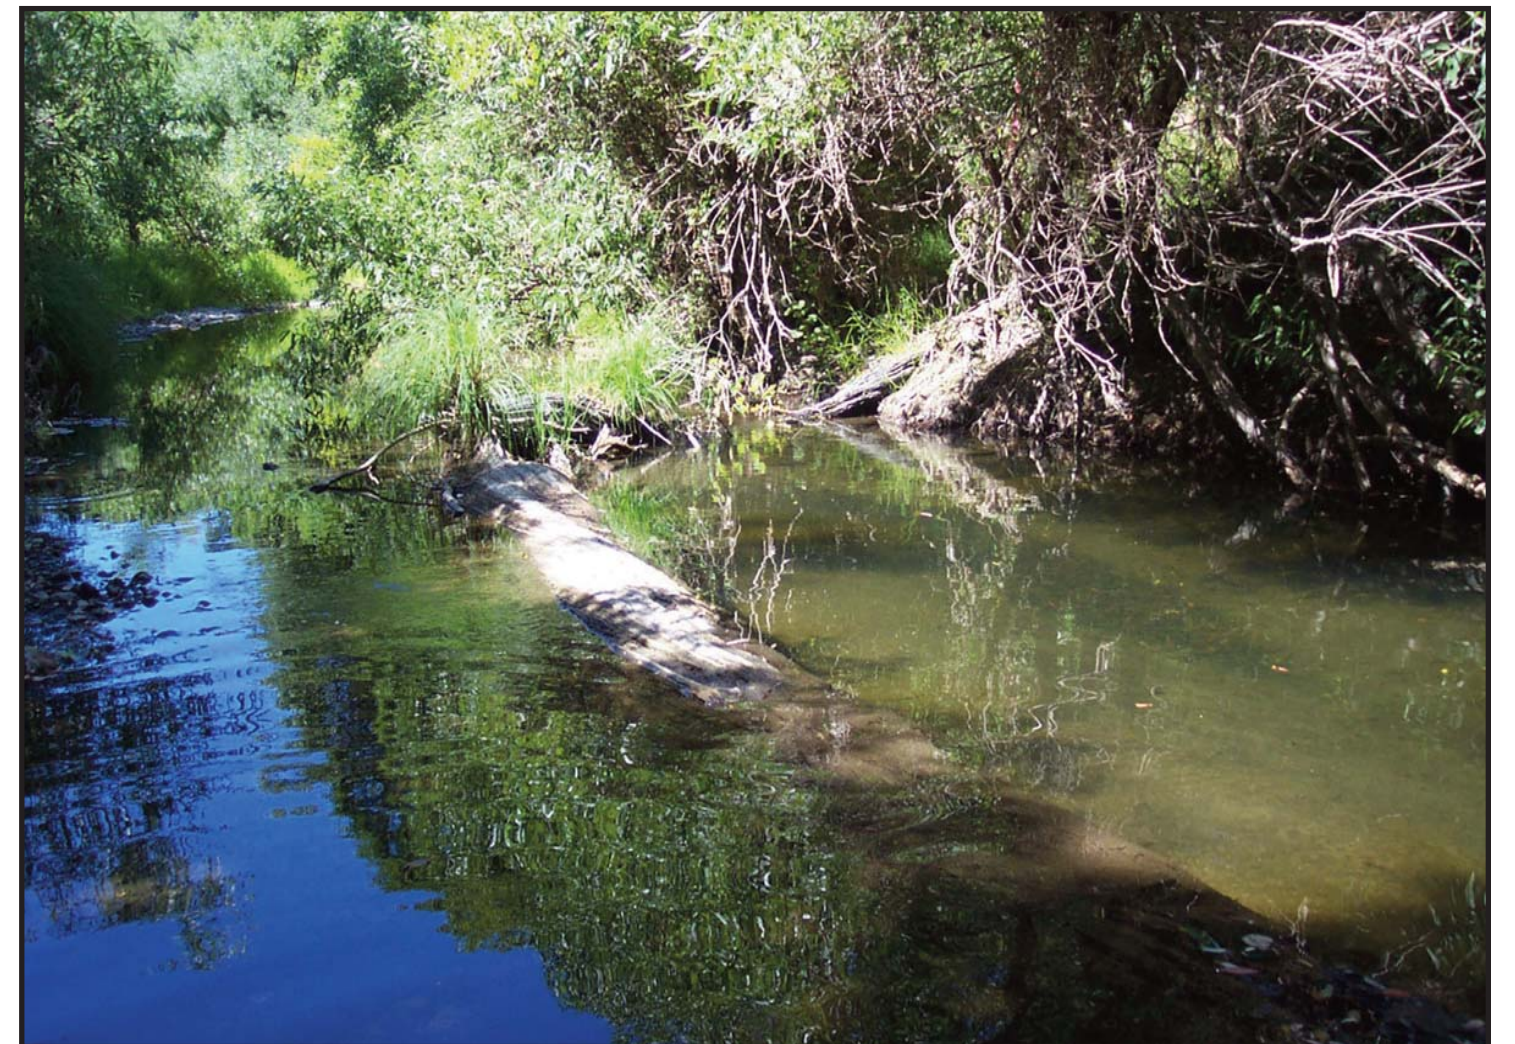
A HIGH QUALITY SIDE CHANNEL POOL WITH LARGE WOOD IN THE UPSTREAM AREA OF REACH 6. 55

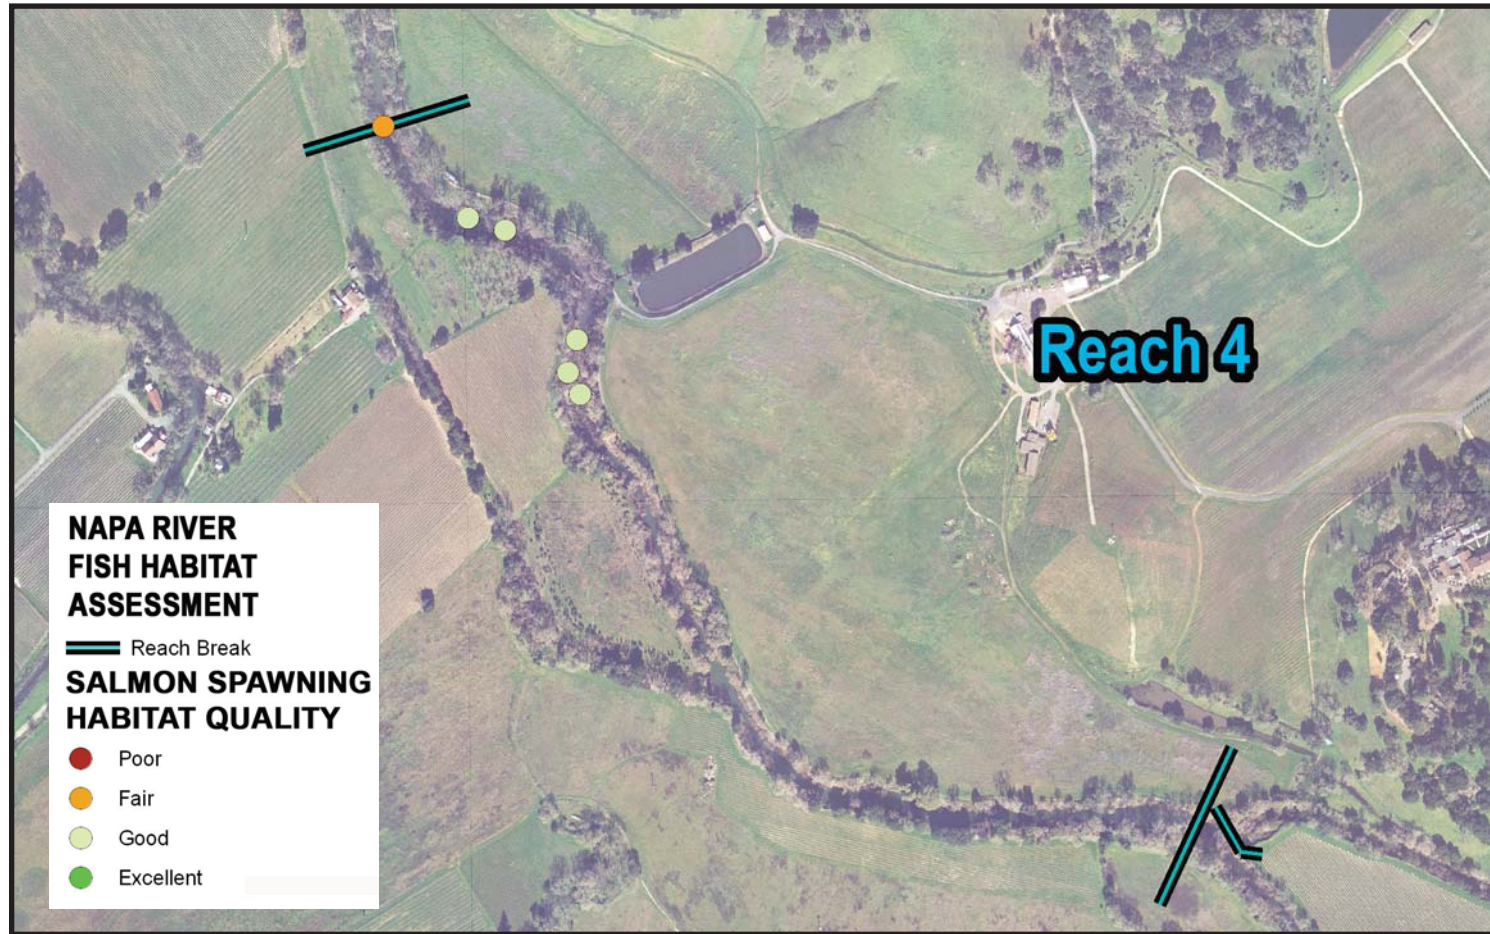
REACH 4 HAS FEW SEEDLINGS IN THE CHANNEL AND LITTLE REGENERATION. RIPRAP IS COMMON ON THE BANKS AS ARE UNDERCUT LARGE TREES.

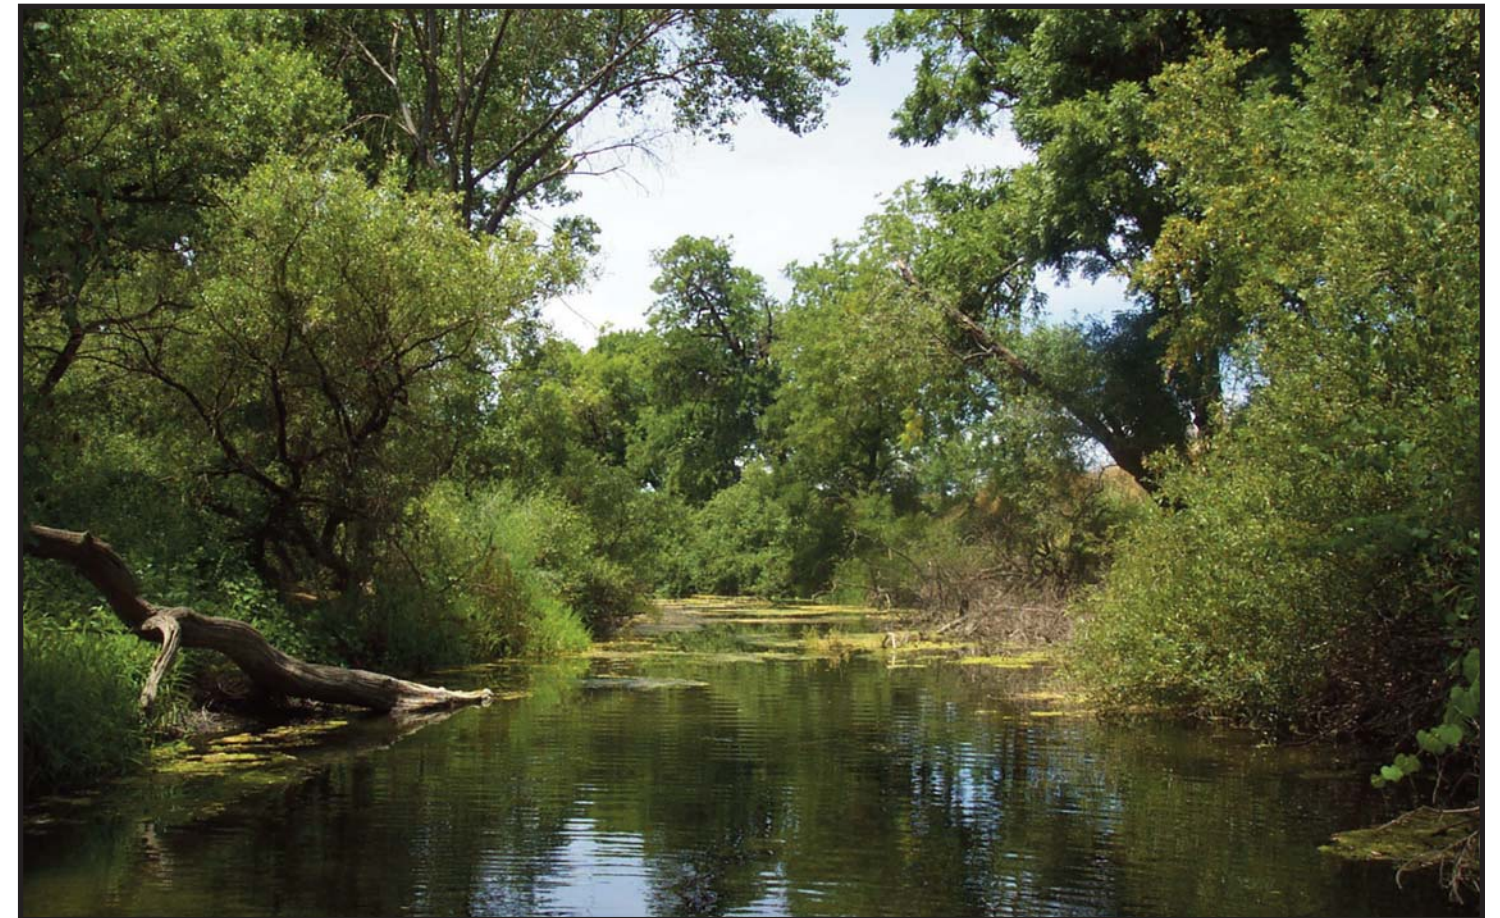
MOST OF REACH 4 IS A LONG POOL/GLIDE SEQUENCE OF LIMITED VALUE TO SALMON.

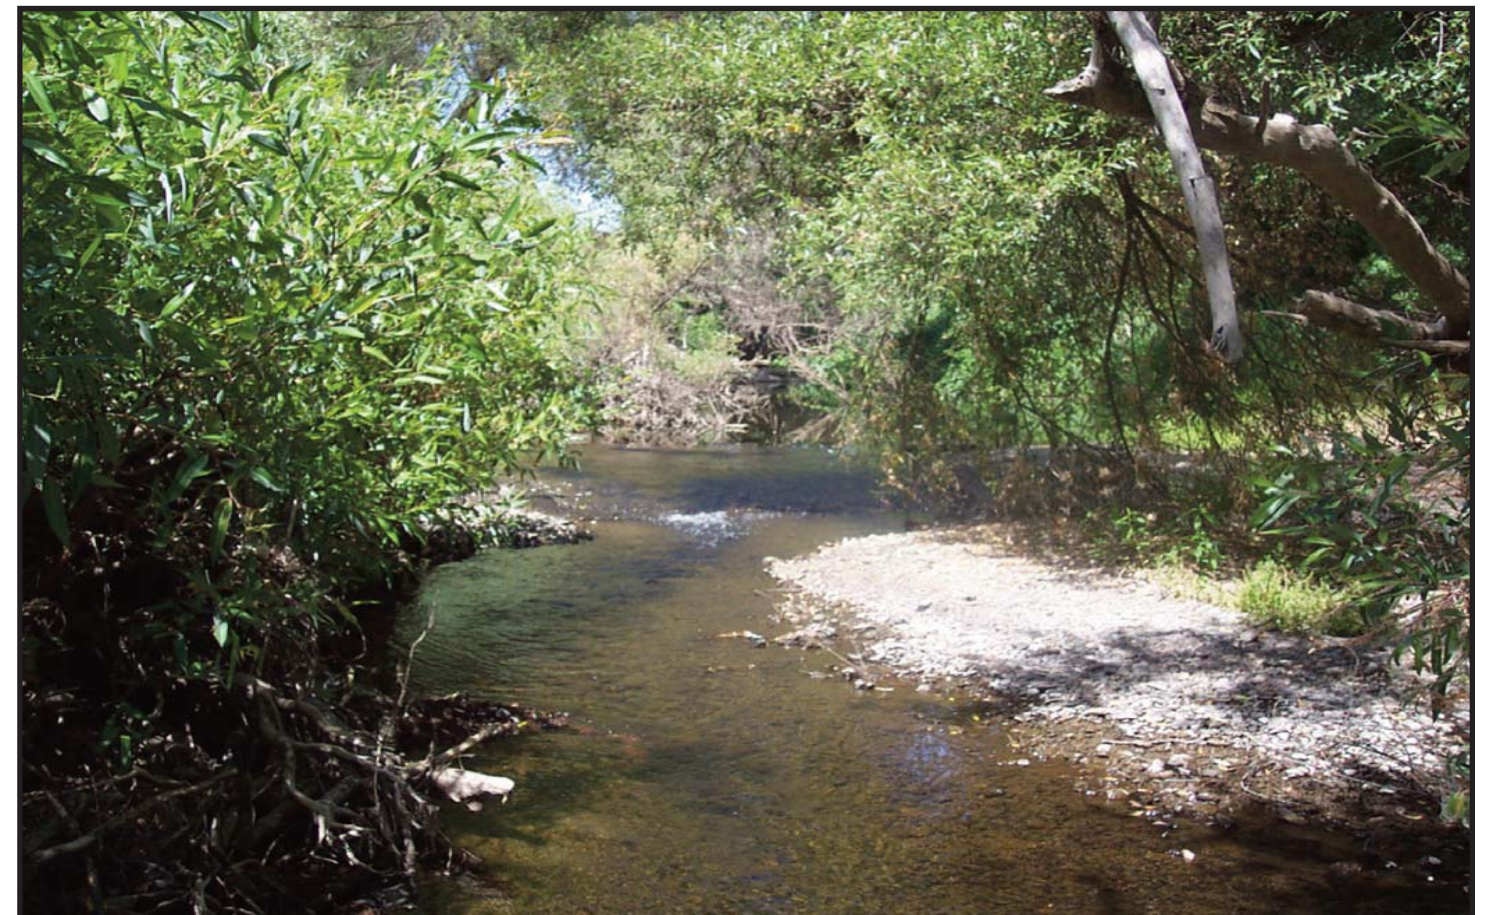
HIGH QUALITY SPAWNING RIFFLES WERE MORE ABUNDANT IN REACH 3A THAN OTHER REACHES. 71

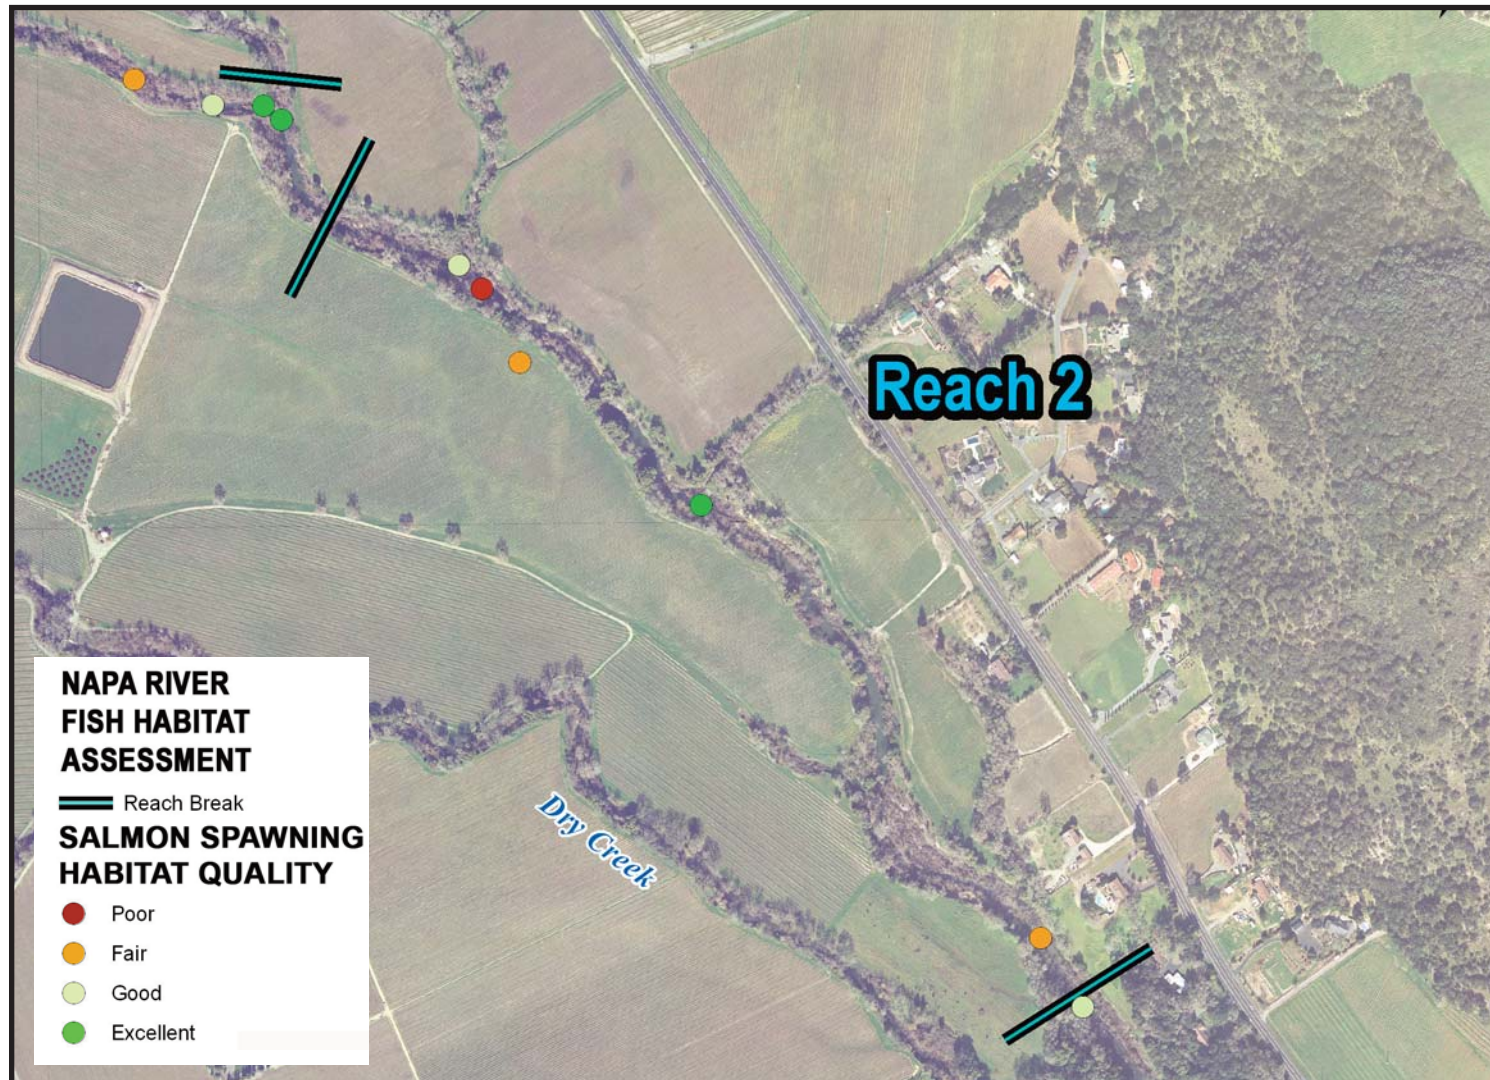
A RESISTANT CLAY LAYER DOMINATES THE CHANNEL IN REACH 2 AND ELIMINATES SEEDLING GERMINATION.

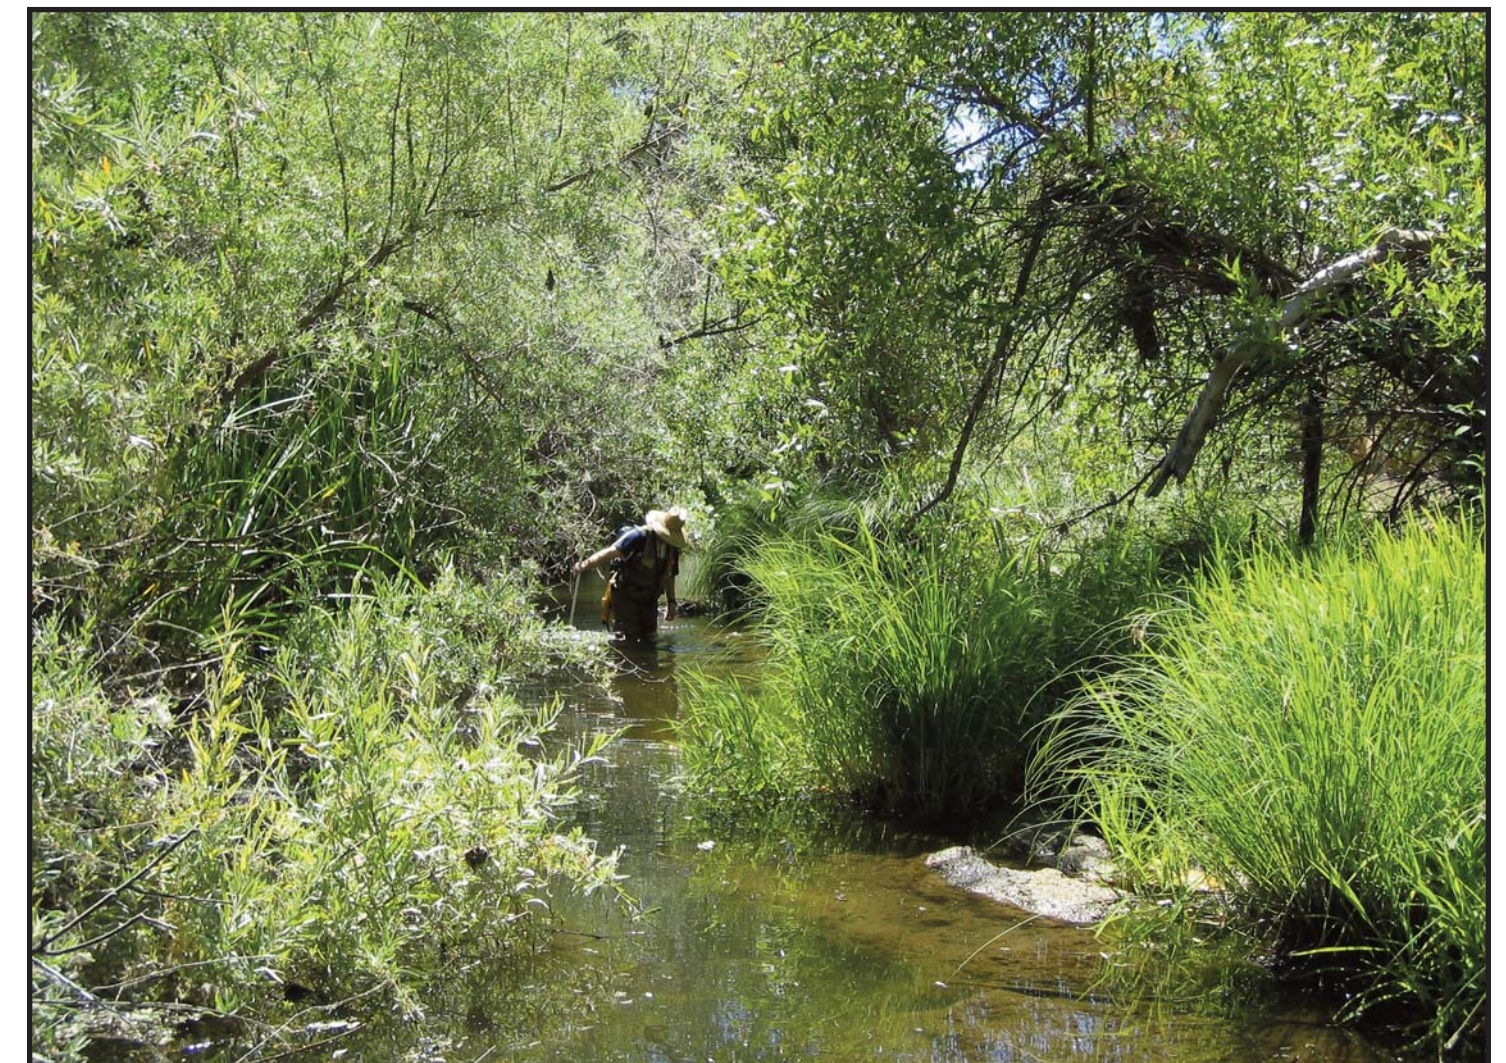
REACH 2 IS DOMINATED BY A RESISTANT CLAY ON THE CHANNEL AND BANKS REDUCING SPAWNING AREAS.

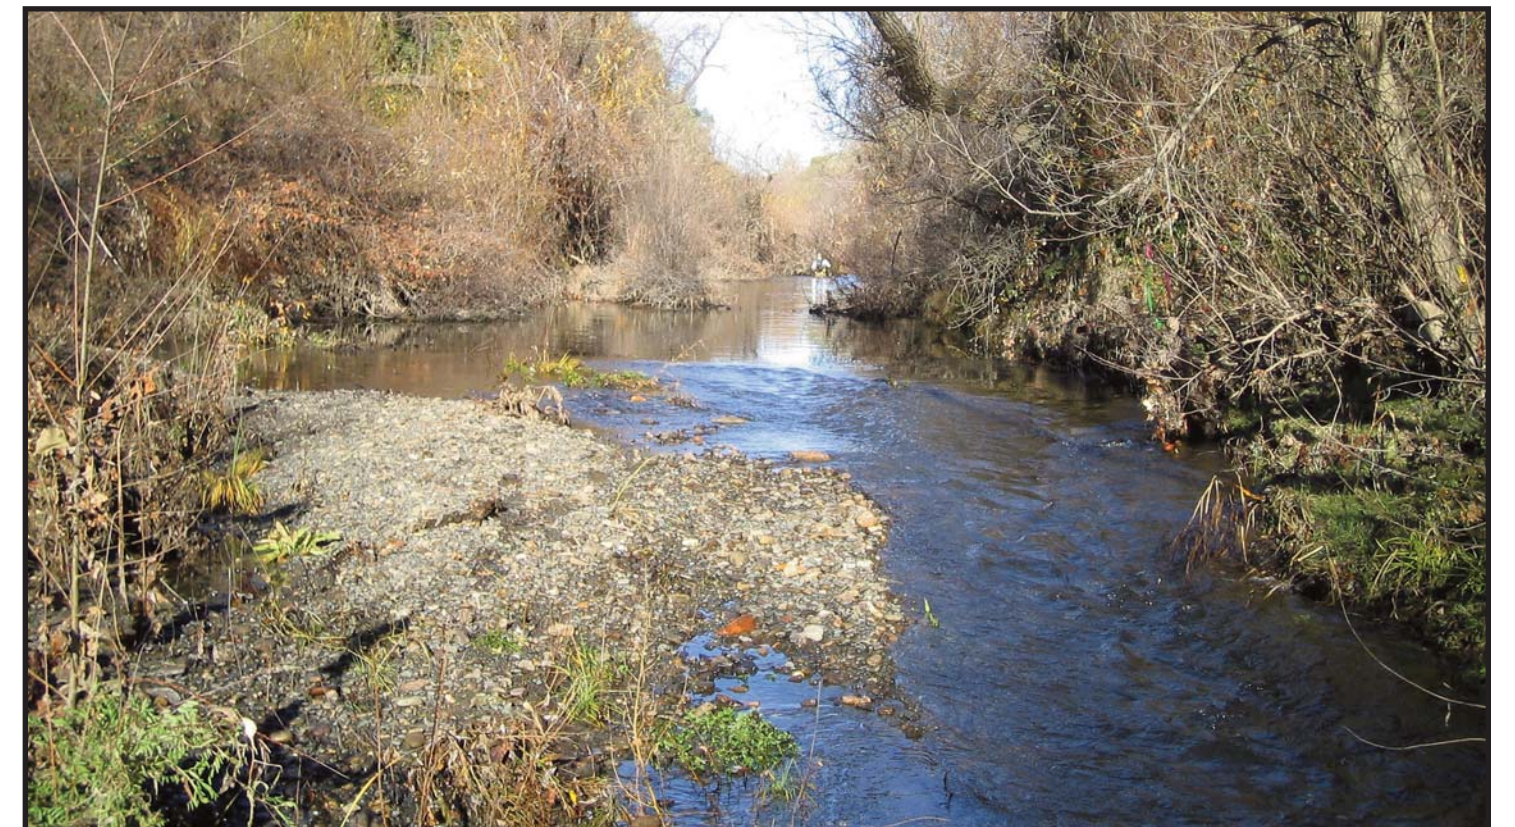
THE AREA OF HIGH QUALITY SPAWNING HABITAT IN REACH ONE OCCURS AT THE CONFLUENCE OF THE RIVER AND DRY CREEK.

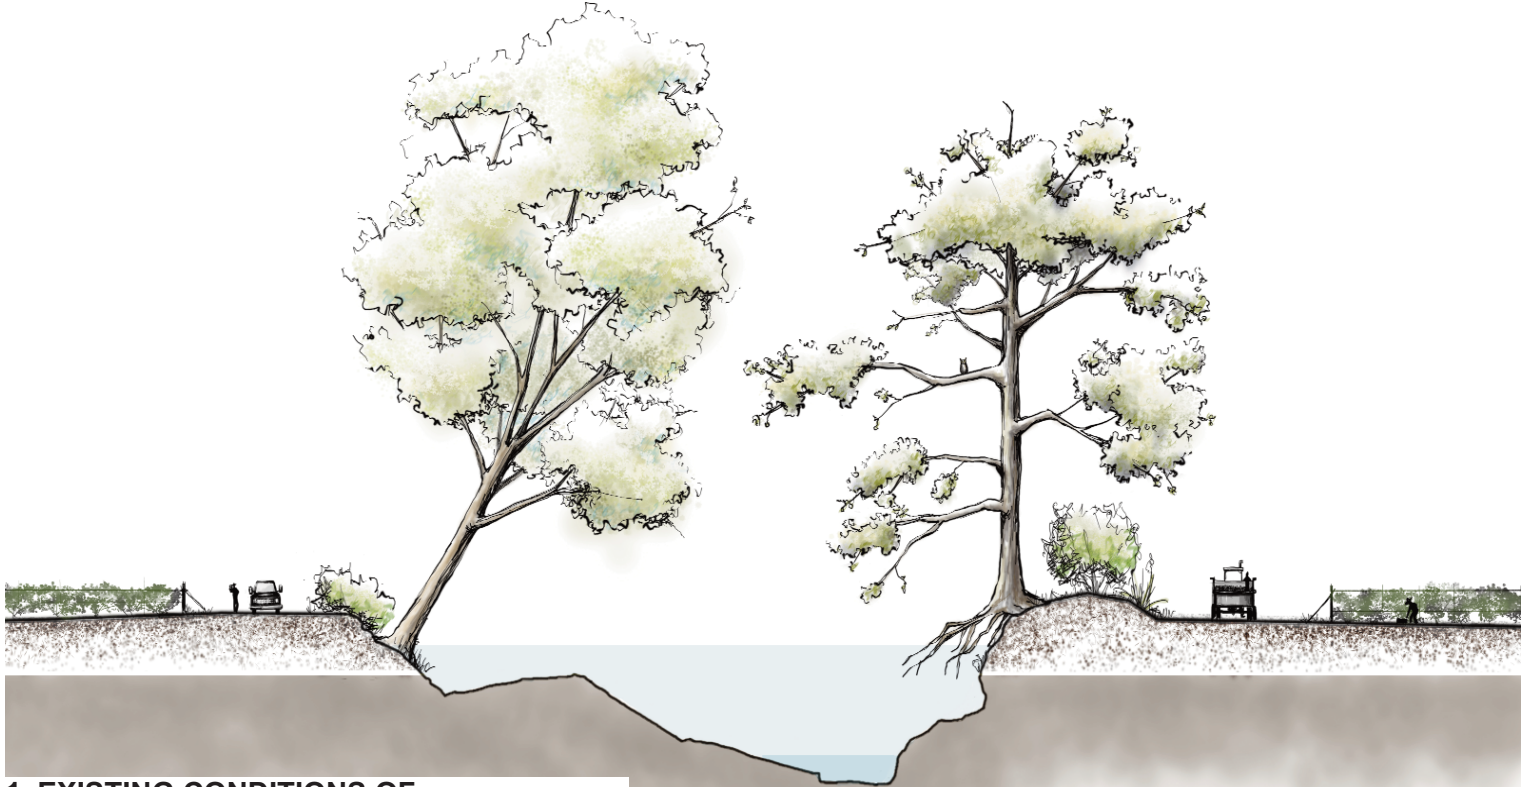
1. EXISTING CONDITIONS OF UNDERCUT LARGE TREES, HIGH VELOCITY FLOWS, DEEP AND NARROW OR ENTRENCHED CHANNEL AND ERODING BANKS

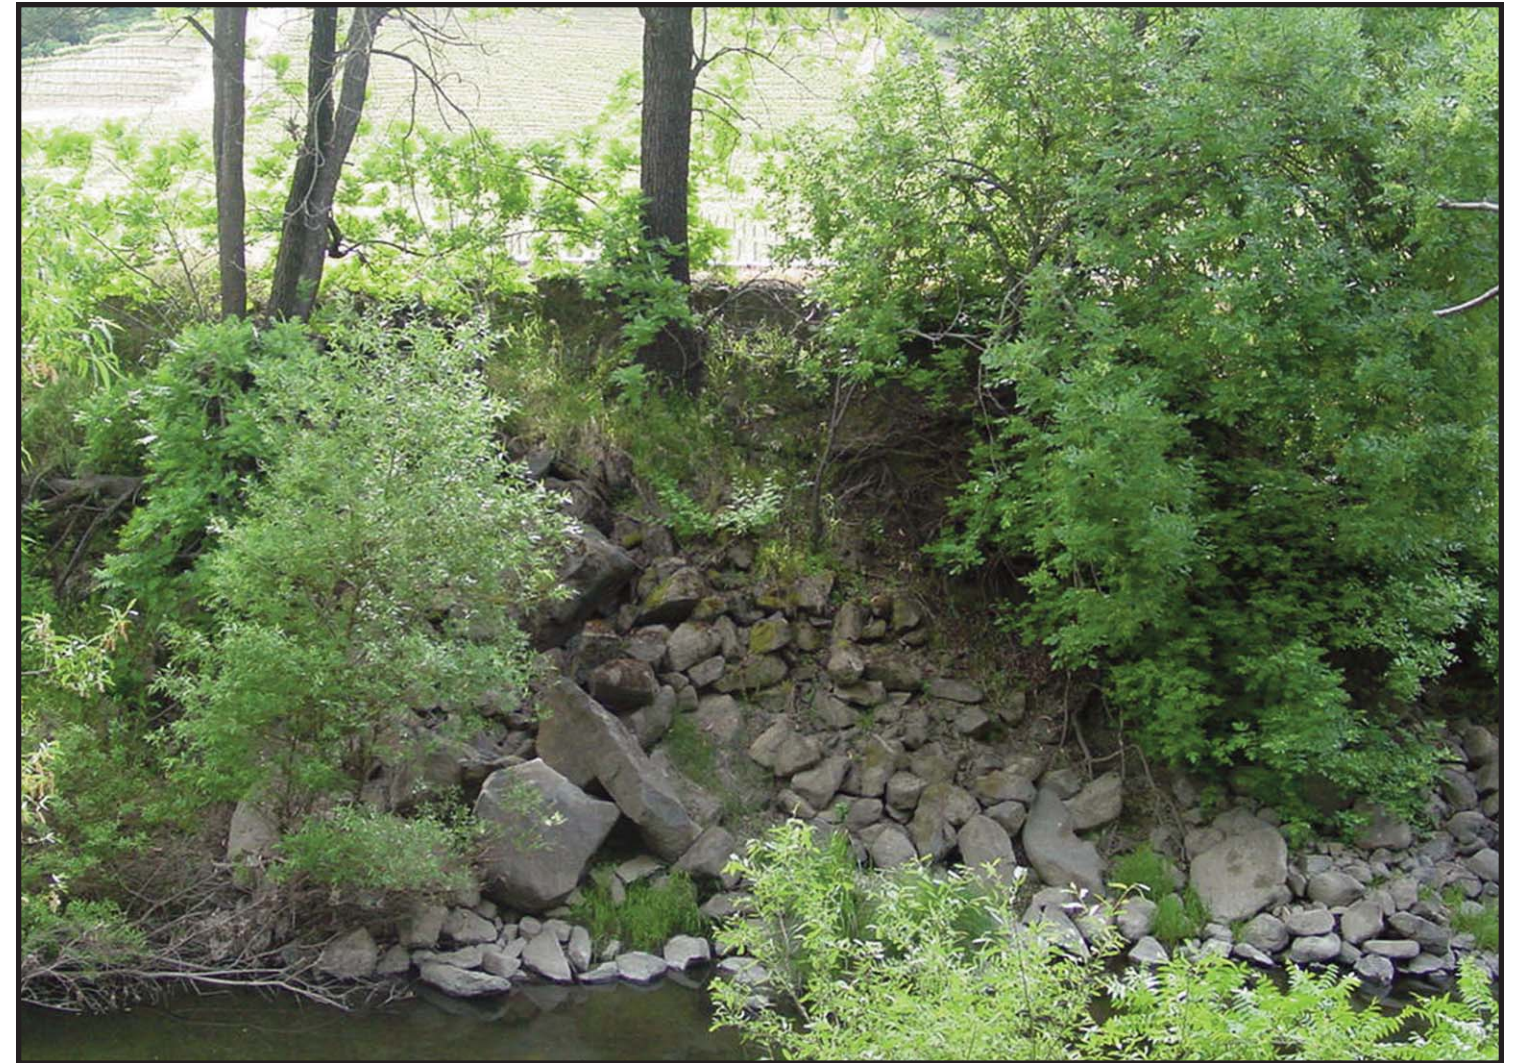
AN ATTEMPT AT BANK STABILIZATION USING ROCK DUMPED FROM THE BANK TOP WILL LIKELY CAUSE MORE PROBLEMS THAN IT SOLVES DUE TO THE LACK OF PROPER CONSTRUCTION AND USE OF THIS TREATMENT IN A REACH THAT IS SO NARROW IT HAS HIGH BANK EROSION RATES. THE RIPRAP WILL INCREASE FLOW VELOCITIES AND EROSION OF DOWNSTREAM AREAS.

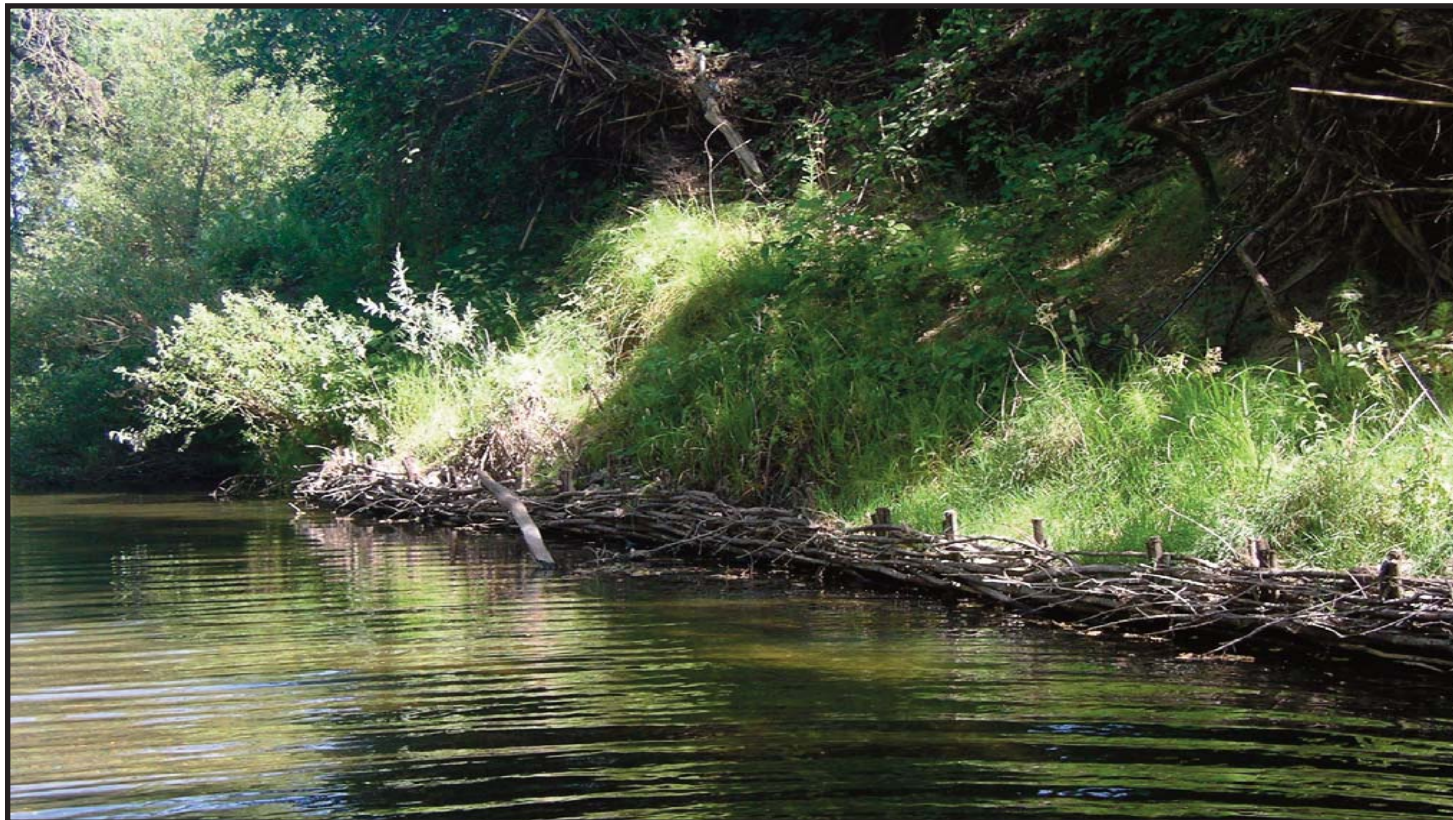
ALONG THE NAPA RIVER THERE WERE NUMEROUS EXAMPLES OF BIOTECHNICAL BANK PROJECTS SUCH AS THIS WILLOW WALL WHICH DID NOT GROW AND PROVIDED LITTLE BANK PROTECTION OR HABITAT

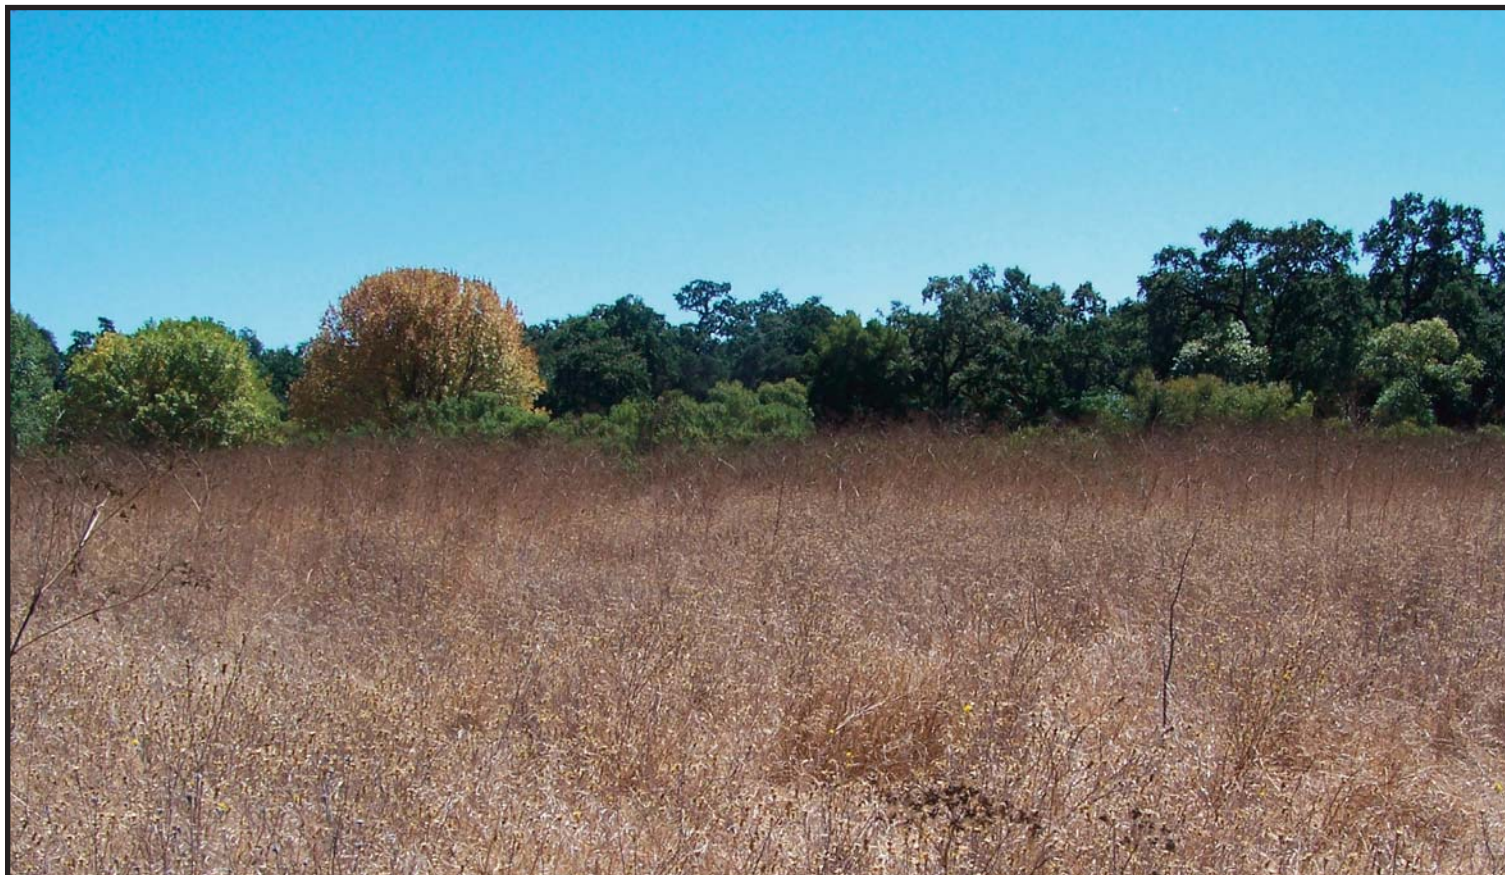
**RESTORATION AREA 19 IS LARGELY INVASIVE WEEDS RATHER THAN
RIPARIAN FOREST DUE TO A LACK OF FREQUENT FLOODING**
