## **5. SUMMARY OF THE EXISTING CONDITIONS AND RECOMMENDED STRATEGY FOR BANK STABILIZATION AND CHANNEL CORRIDOR RESTORATION**

### **5.1 EXISTING CONDITIONS**

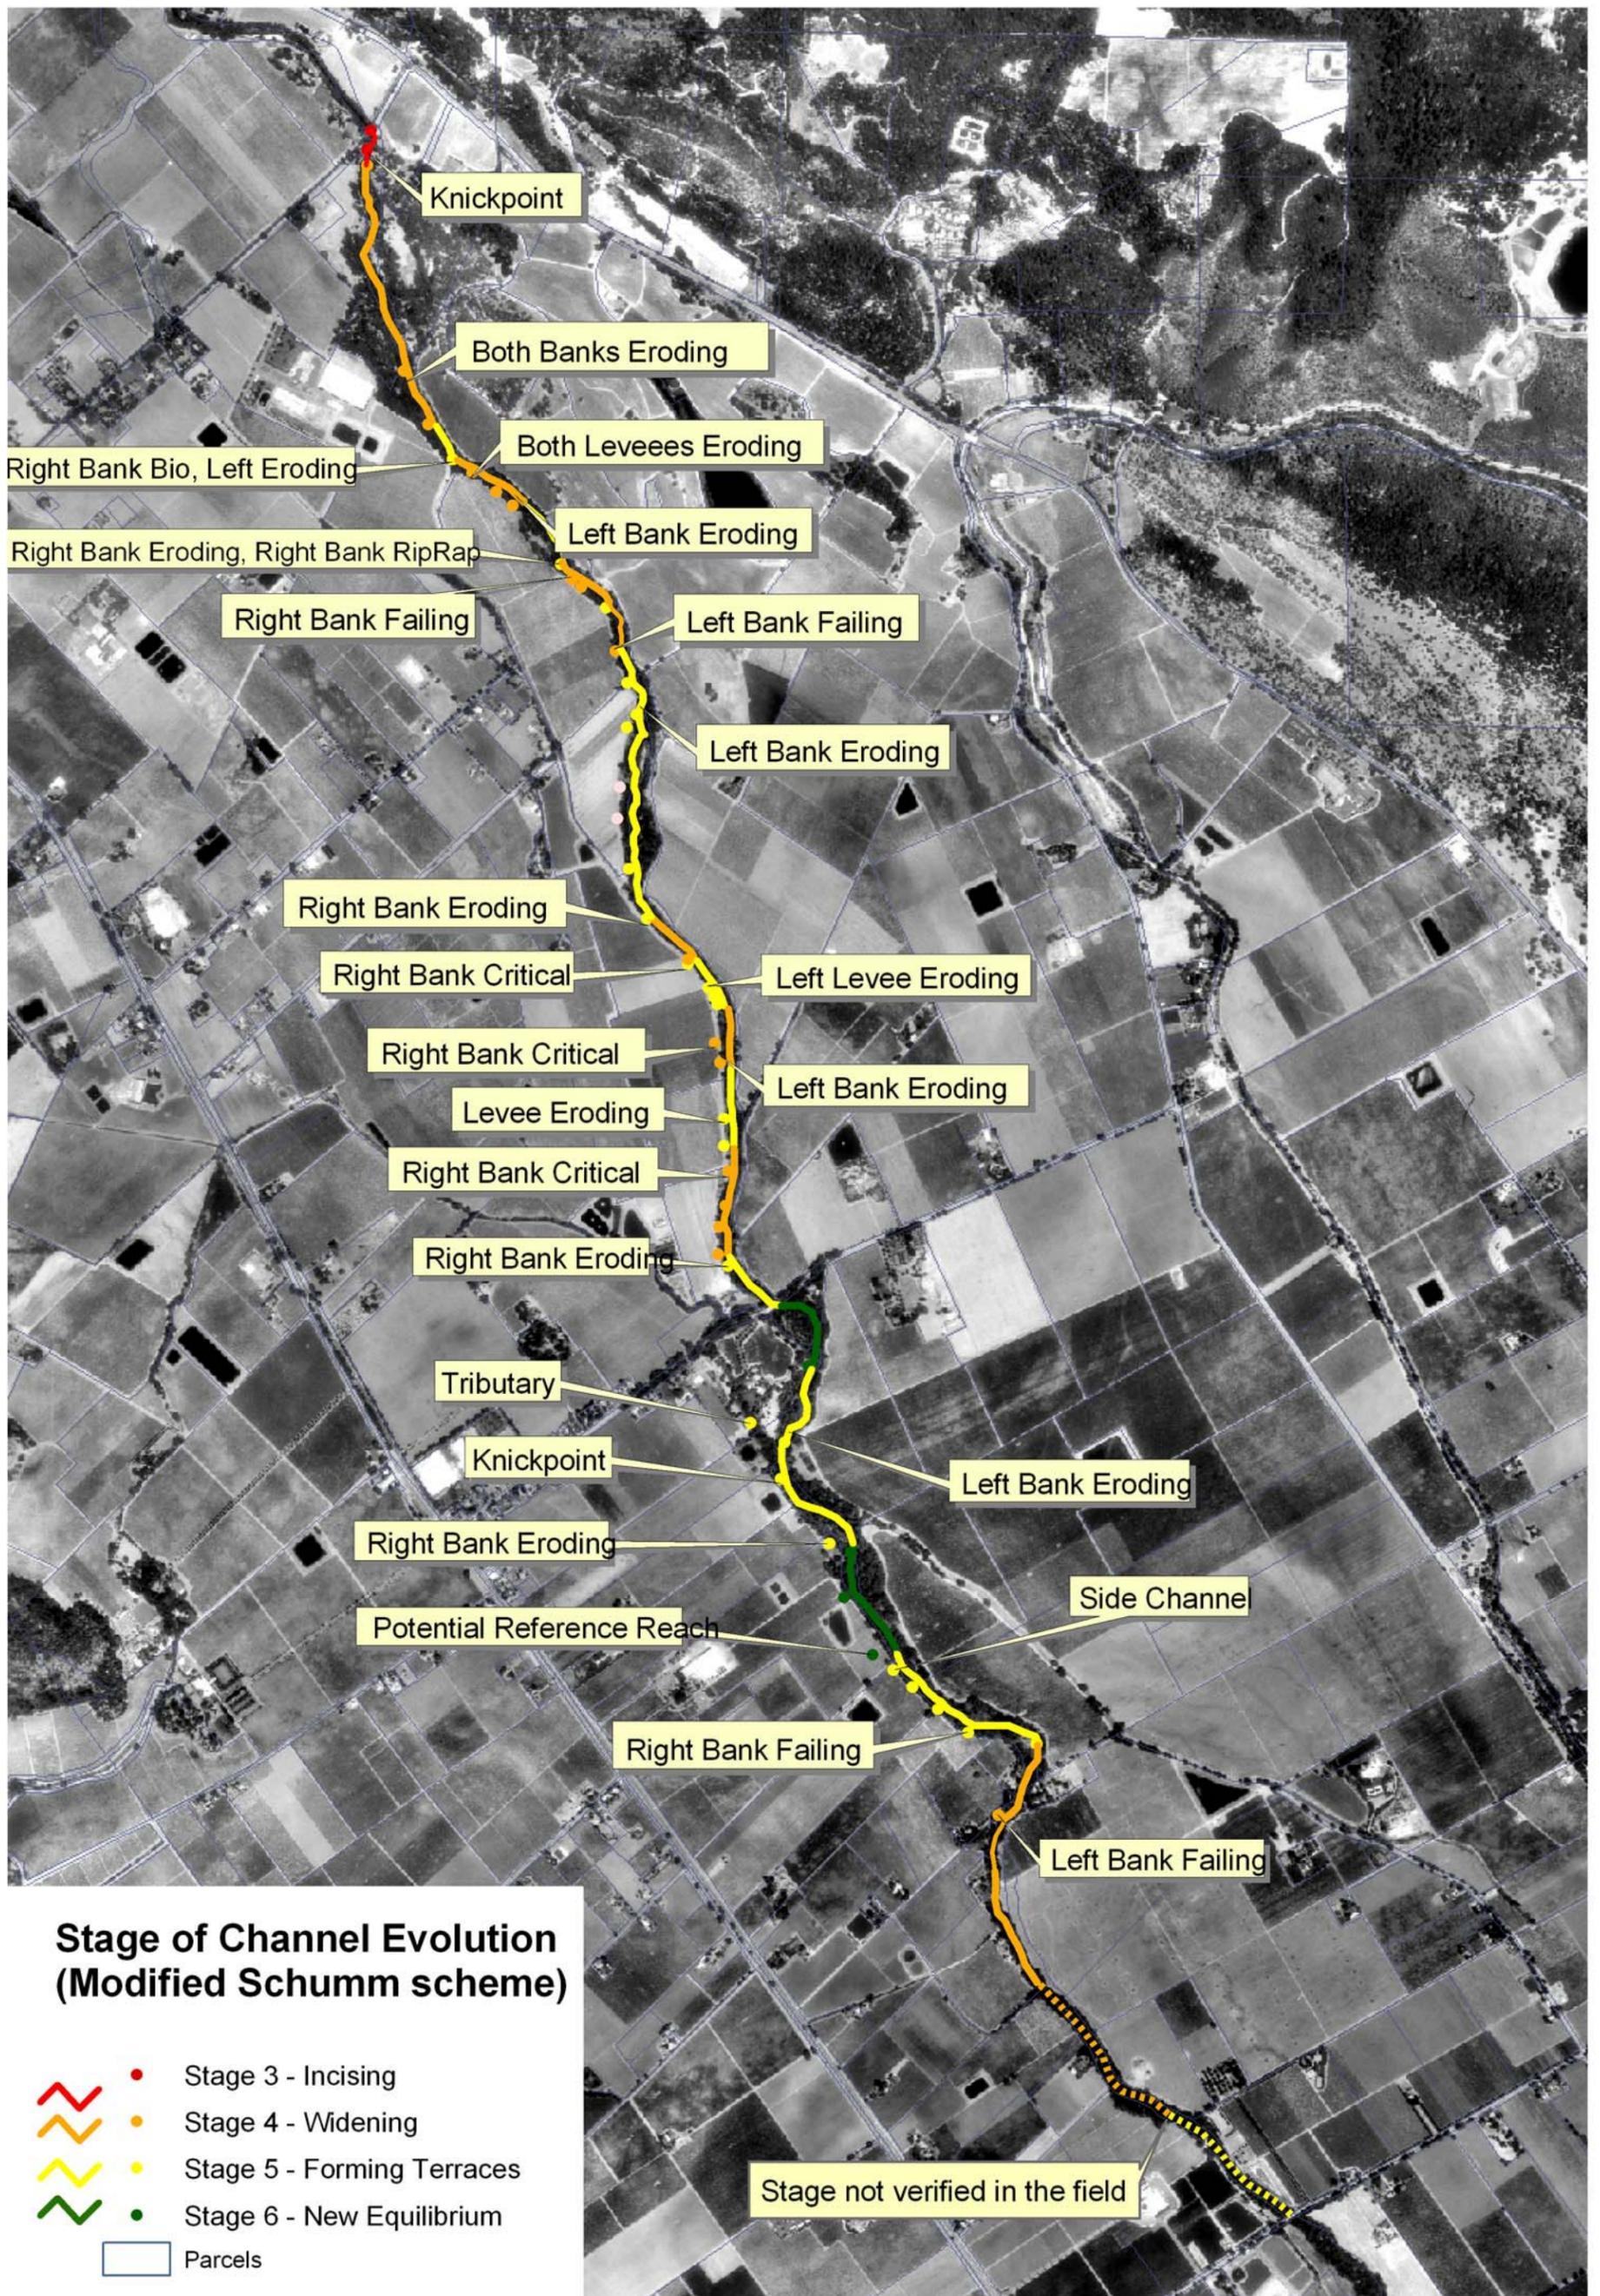
figure 5

The distribution of reaches is shown in Figure 5.

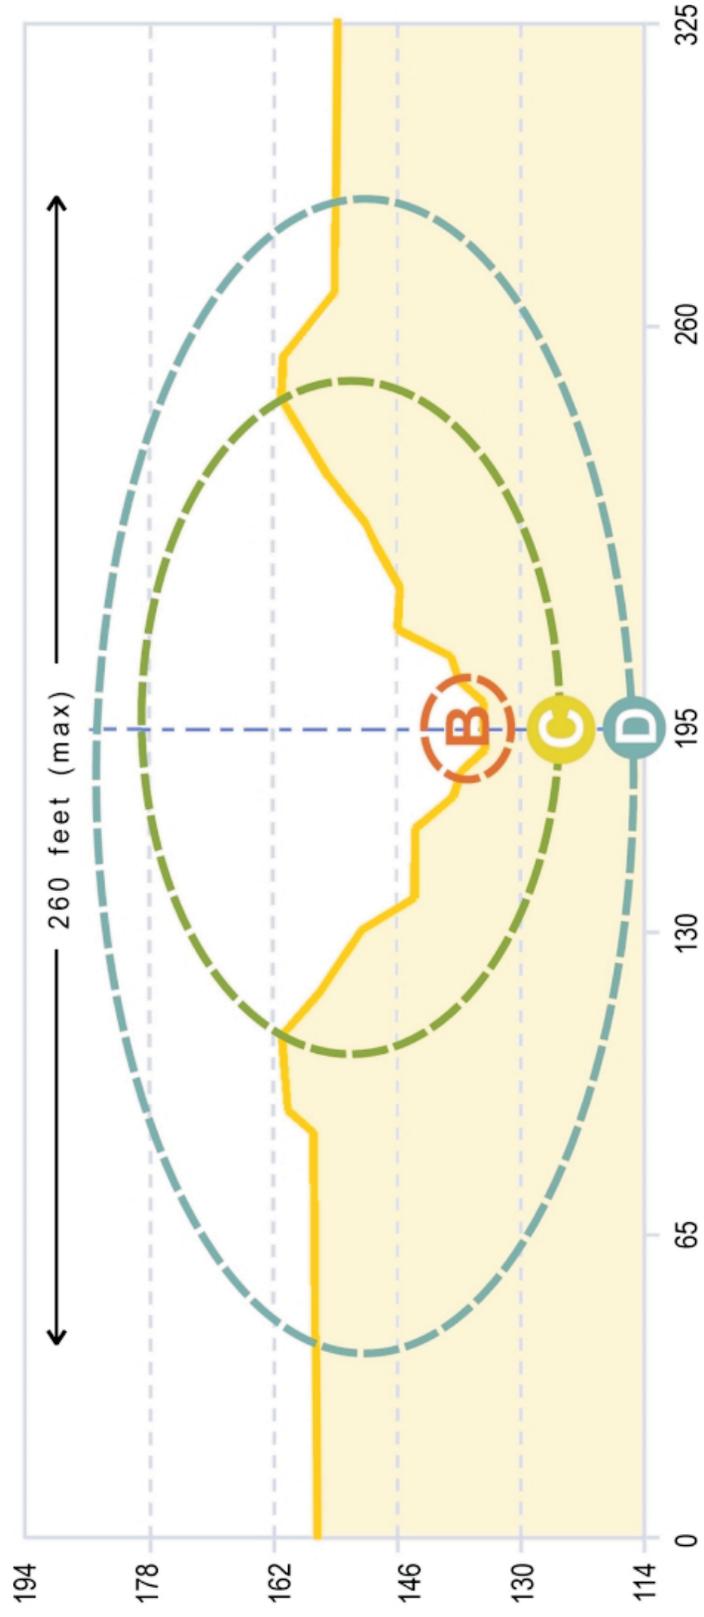
*figure 6*

TYPICAL AREA OF ACTIVITY: **ALTERNATIVES B, C, & D**

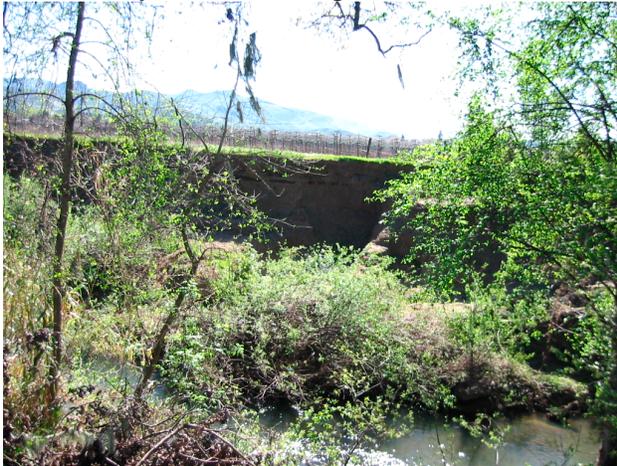
Figure 7. Priority stabilization site 1 - Laird site

Laird property N38°27.082 W122°24.276 East (left) bank slumping; bank requires regrading to stable angle, revegetation and toe protection using biotechnical methods (e.g. large woody debris)

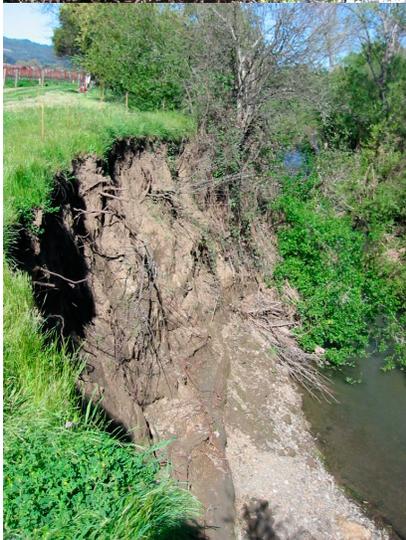
Figure 8. Priority stabilization site 2 – Sequoia Grove site

Sequoia Grove property N38°27.211 W122°24.337 West (right) bank slumping; bank requires regrading to stable angle, revegetation and construction of bendway vanes to deflect flow away from bank toe.

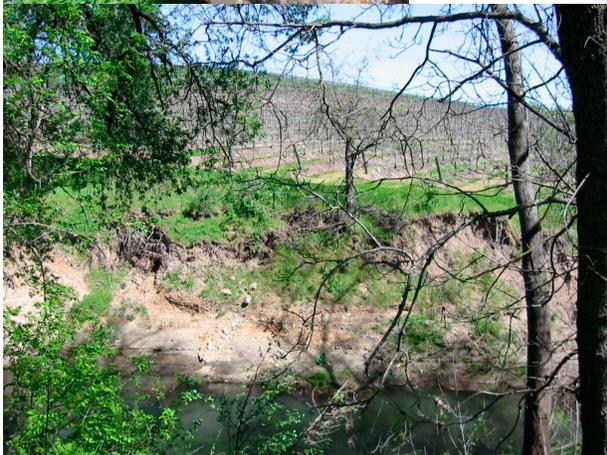
Figure 9. Priority stabilization site 3 - Quintessa site

Quintessa and Frogs Leap properties N38°28.902 W122°25.047 East bank slumping; pull back and regrade left bank, use root wads to stabilize west bank toe.
