Final Technical Report

**Sediment Source Assessment,
A Component of the
Watershed Management Plan for the
Sulphur Creek Watershed, Napa County, California**

**Stewardship Support and Watershed Assessment in the
Napa River Watershed: A CALFED Project
CALFED contract no. 4600001703**

**Pacific Watershed Associates
Arcata, California
(707) 839-5130
May 16, 2003**

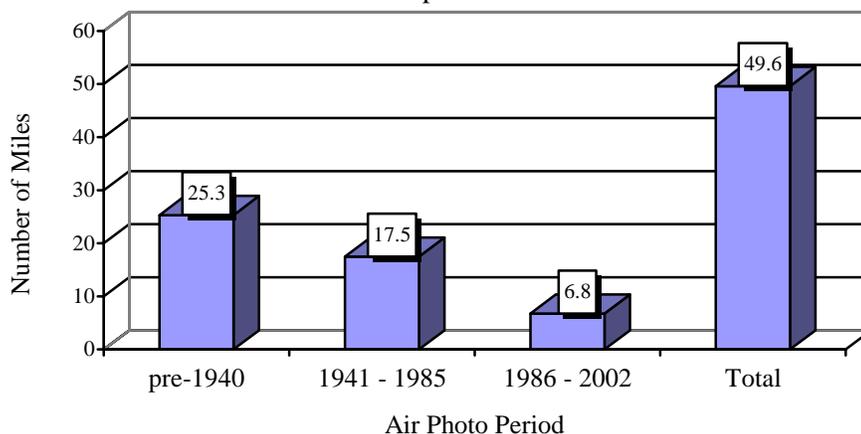
Figure 2. Road construction history, Sulphur Creek watershed, Napa Co.

Between 1940 and 1985, 17.5 miles of road were constructed primarily in Heath Canyon, the lower portion of Sulphur Canyon and the small sub-watershed located north of Sulphur Canyon. Finally, between 1985 and 2002, an additional 6.8 miles of road were constructed, primarily in the upper portions of the Sulphur Creek watershed and in the small northern sub-basin (Map 1).

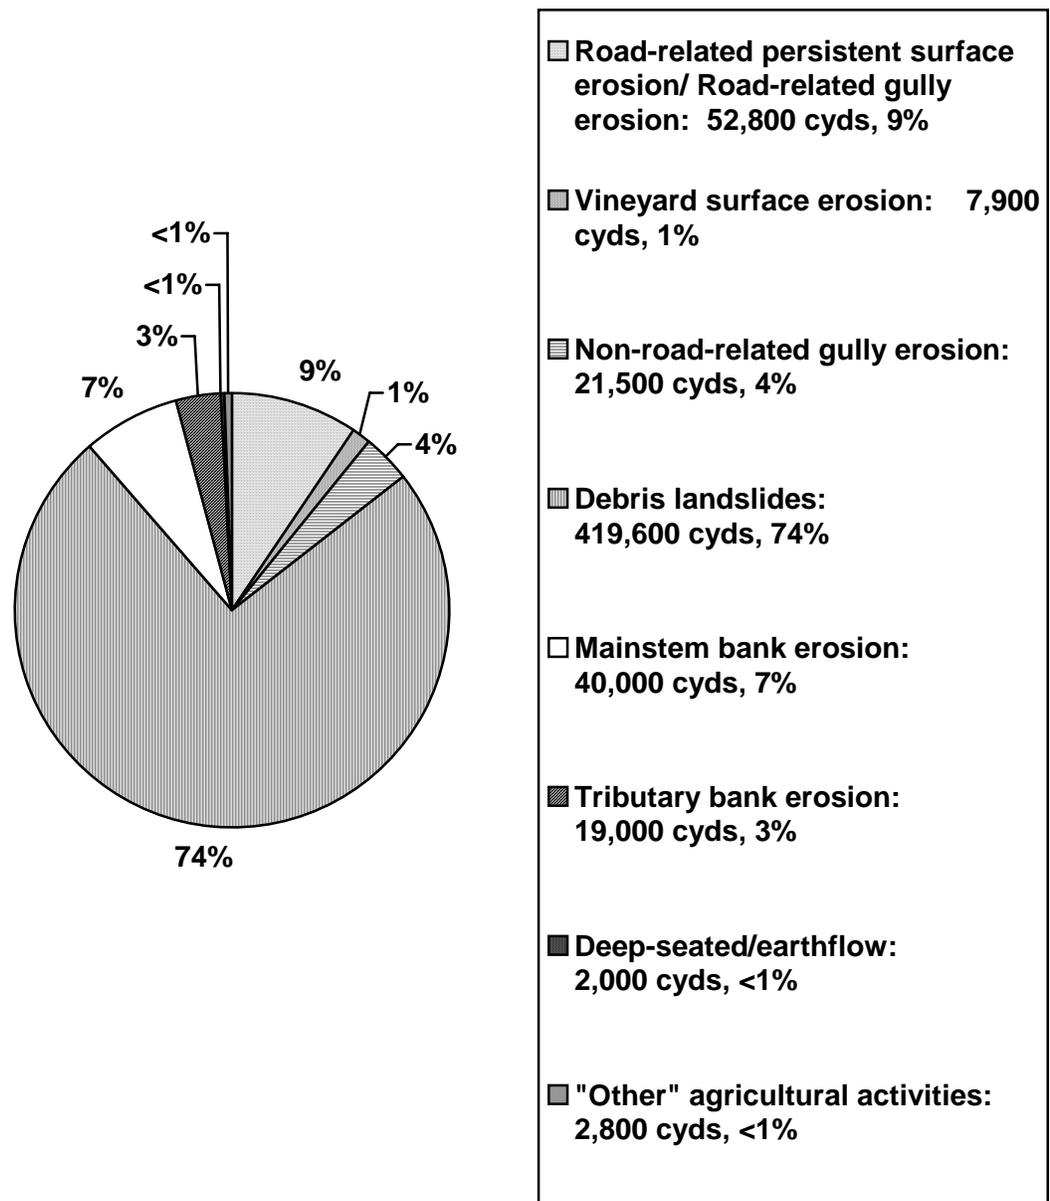
Figure 8. Sediment sources and sediment delivery in the Sulphur Creek watershed.

Approximately 52,800 yds³ of past erosion and sediment delivery from road-related chronic surface erosion and gullies was estimated over the last 50 years. This represents 9% of the total estimated past sediment delivery from sediment sources in the Sulphur Creek watershed (Figure 8).

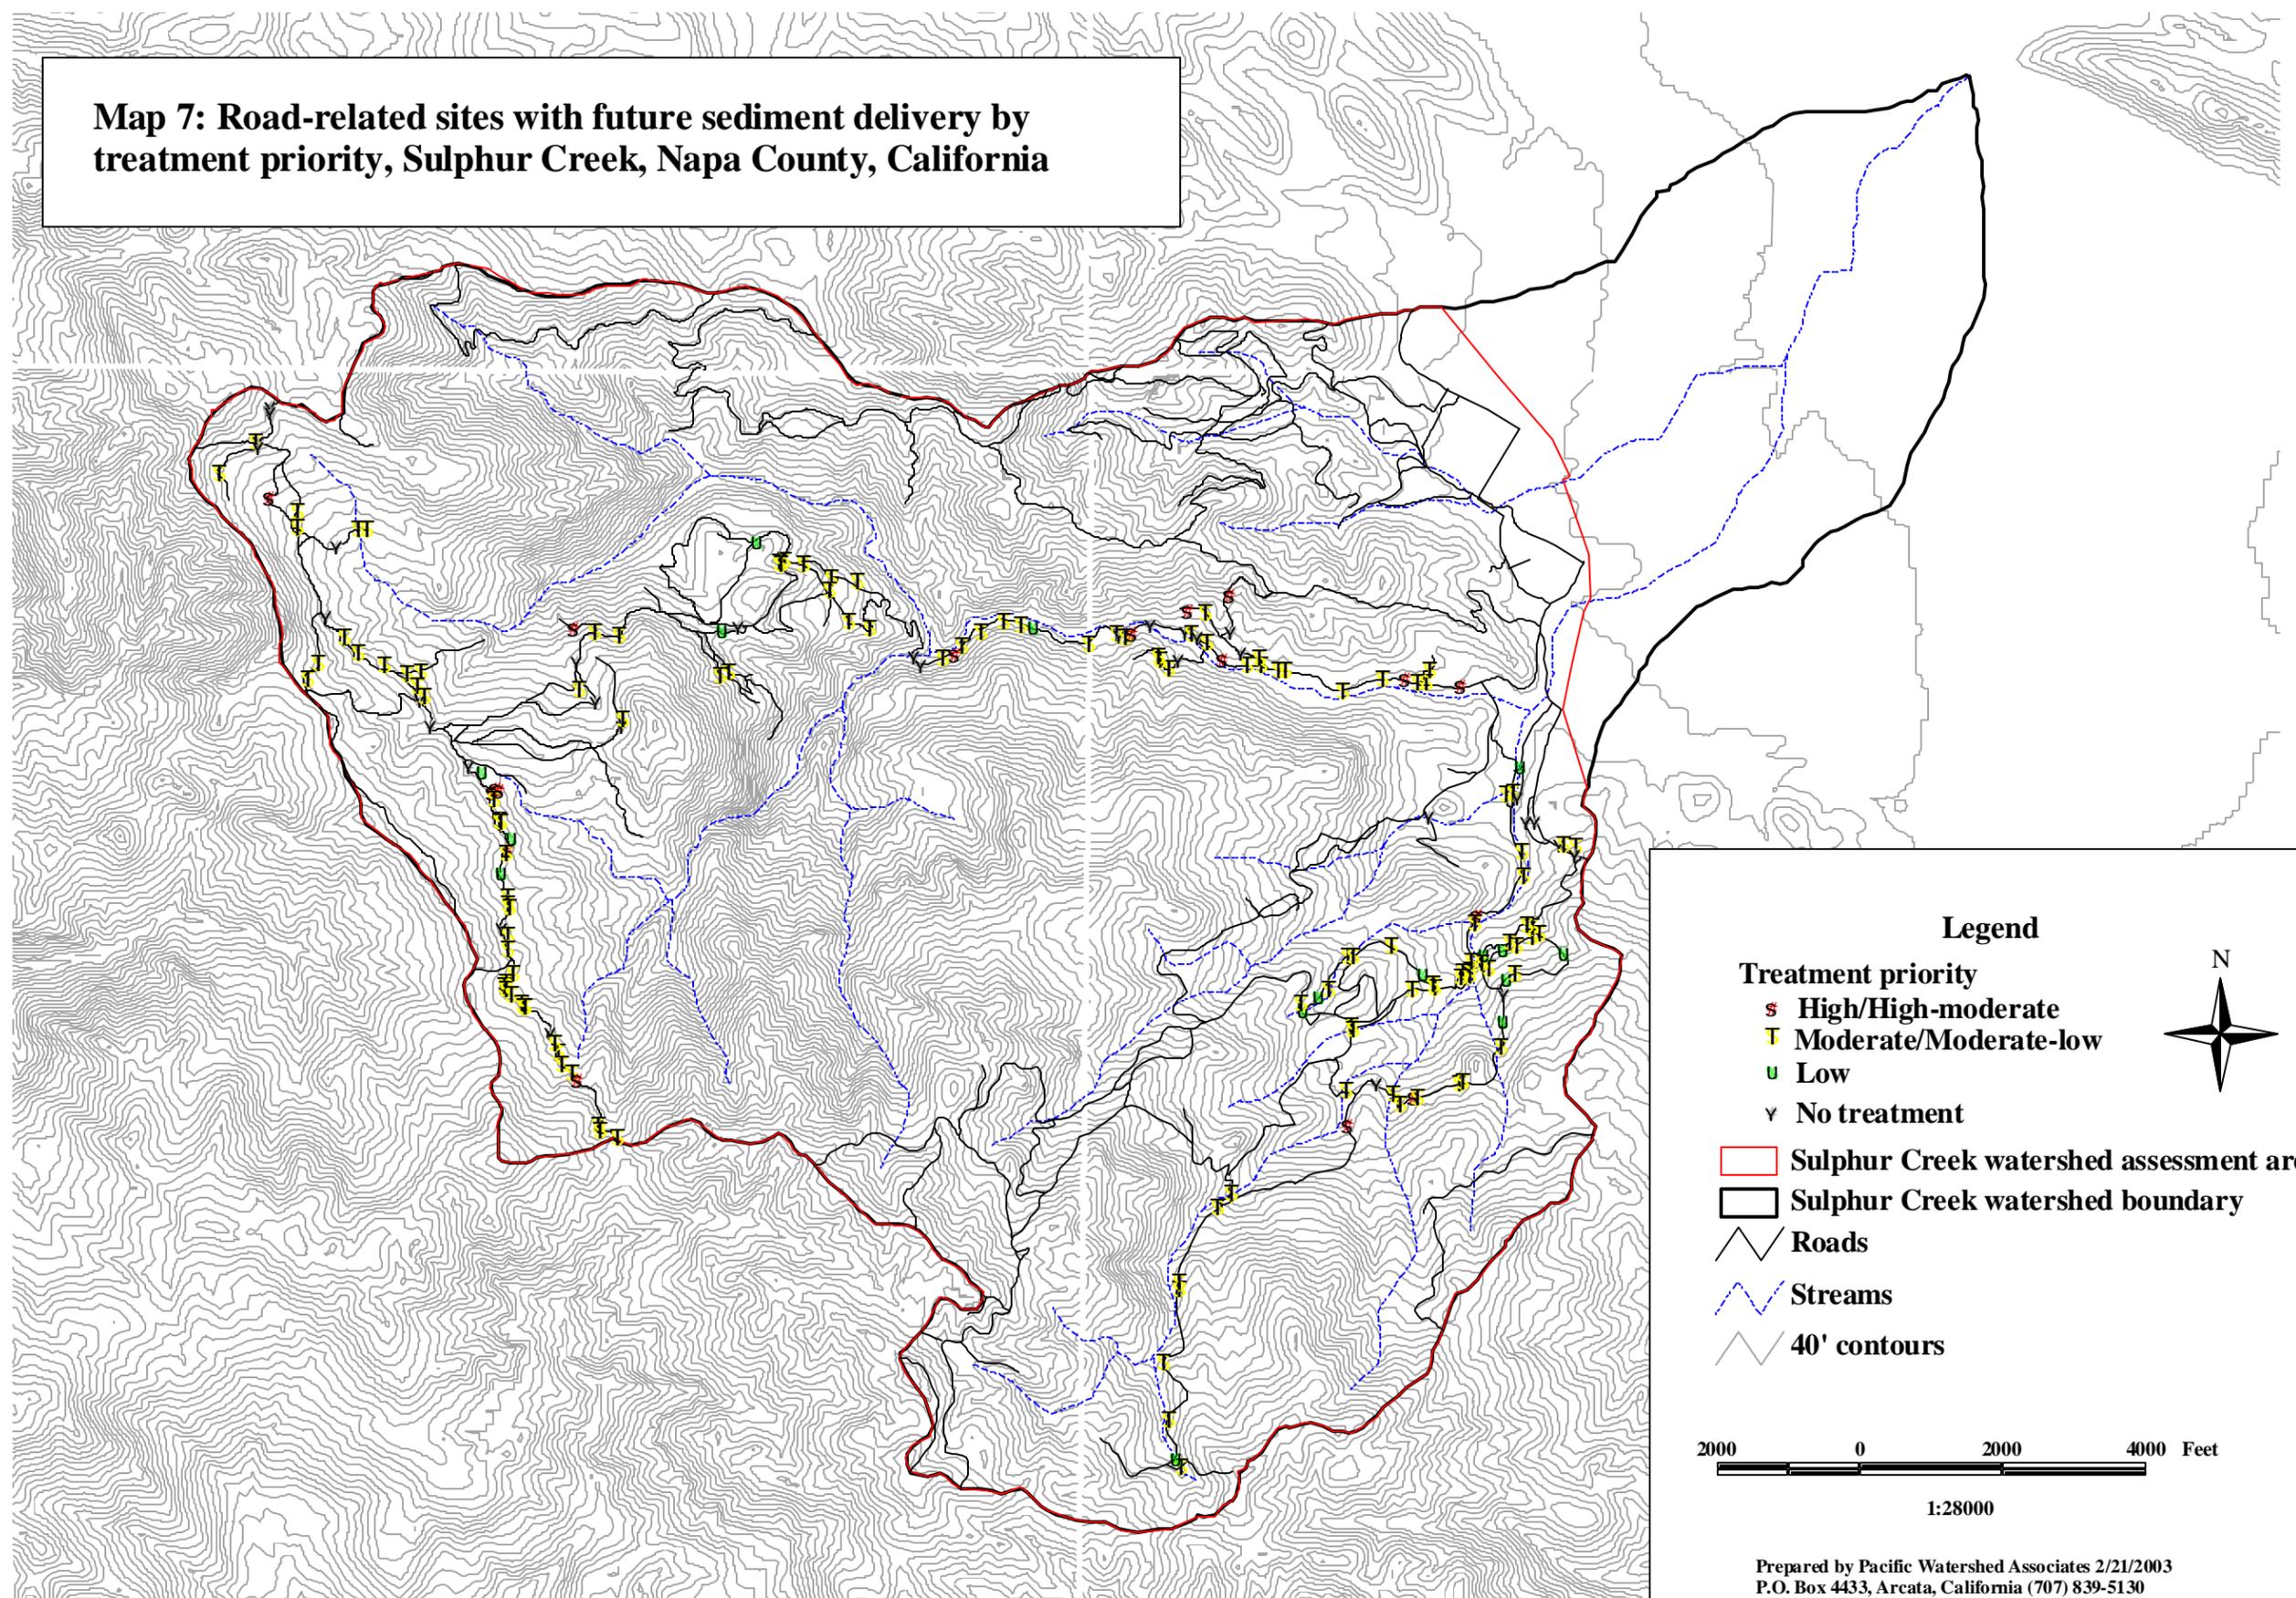
Map 7: Road-related sites with future sediment delivery by treatment priority, Sulphur Creek, Napa County, California

Basic treatment priorities and prescriptions for inventoried roads in the Sulphur Creek watershed were formulated concurrent with the identification, description and mapping of potential sources of road-related sediment yield. Table 6 and Map 7 outline the treatment priorities for all 128 inventoried sites with future sediment delivery that have been recommended for treatment in the Sulphur Creek watershed assessment area. Of the 156 sites with future sediment delivery, seventeen (17) sites were identified as having a high or high-moderate treatment immediacy with a potential sediment delivery of approximately 1,957 yds³. One hundred and twenty-three (123) sites were listed with a moderate or moderate-low treatment immediacy and account for nearly

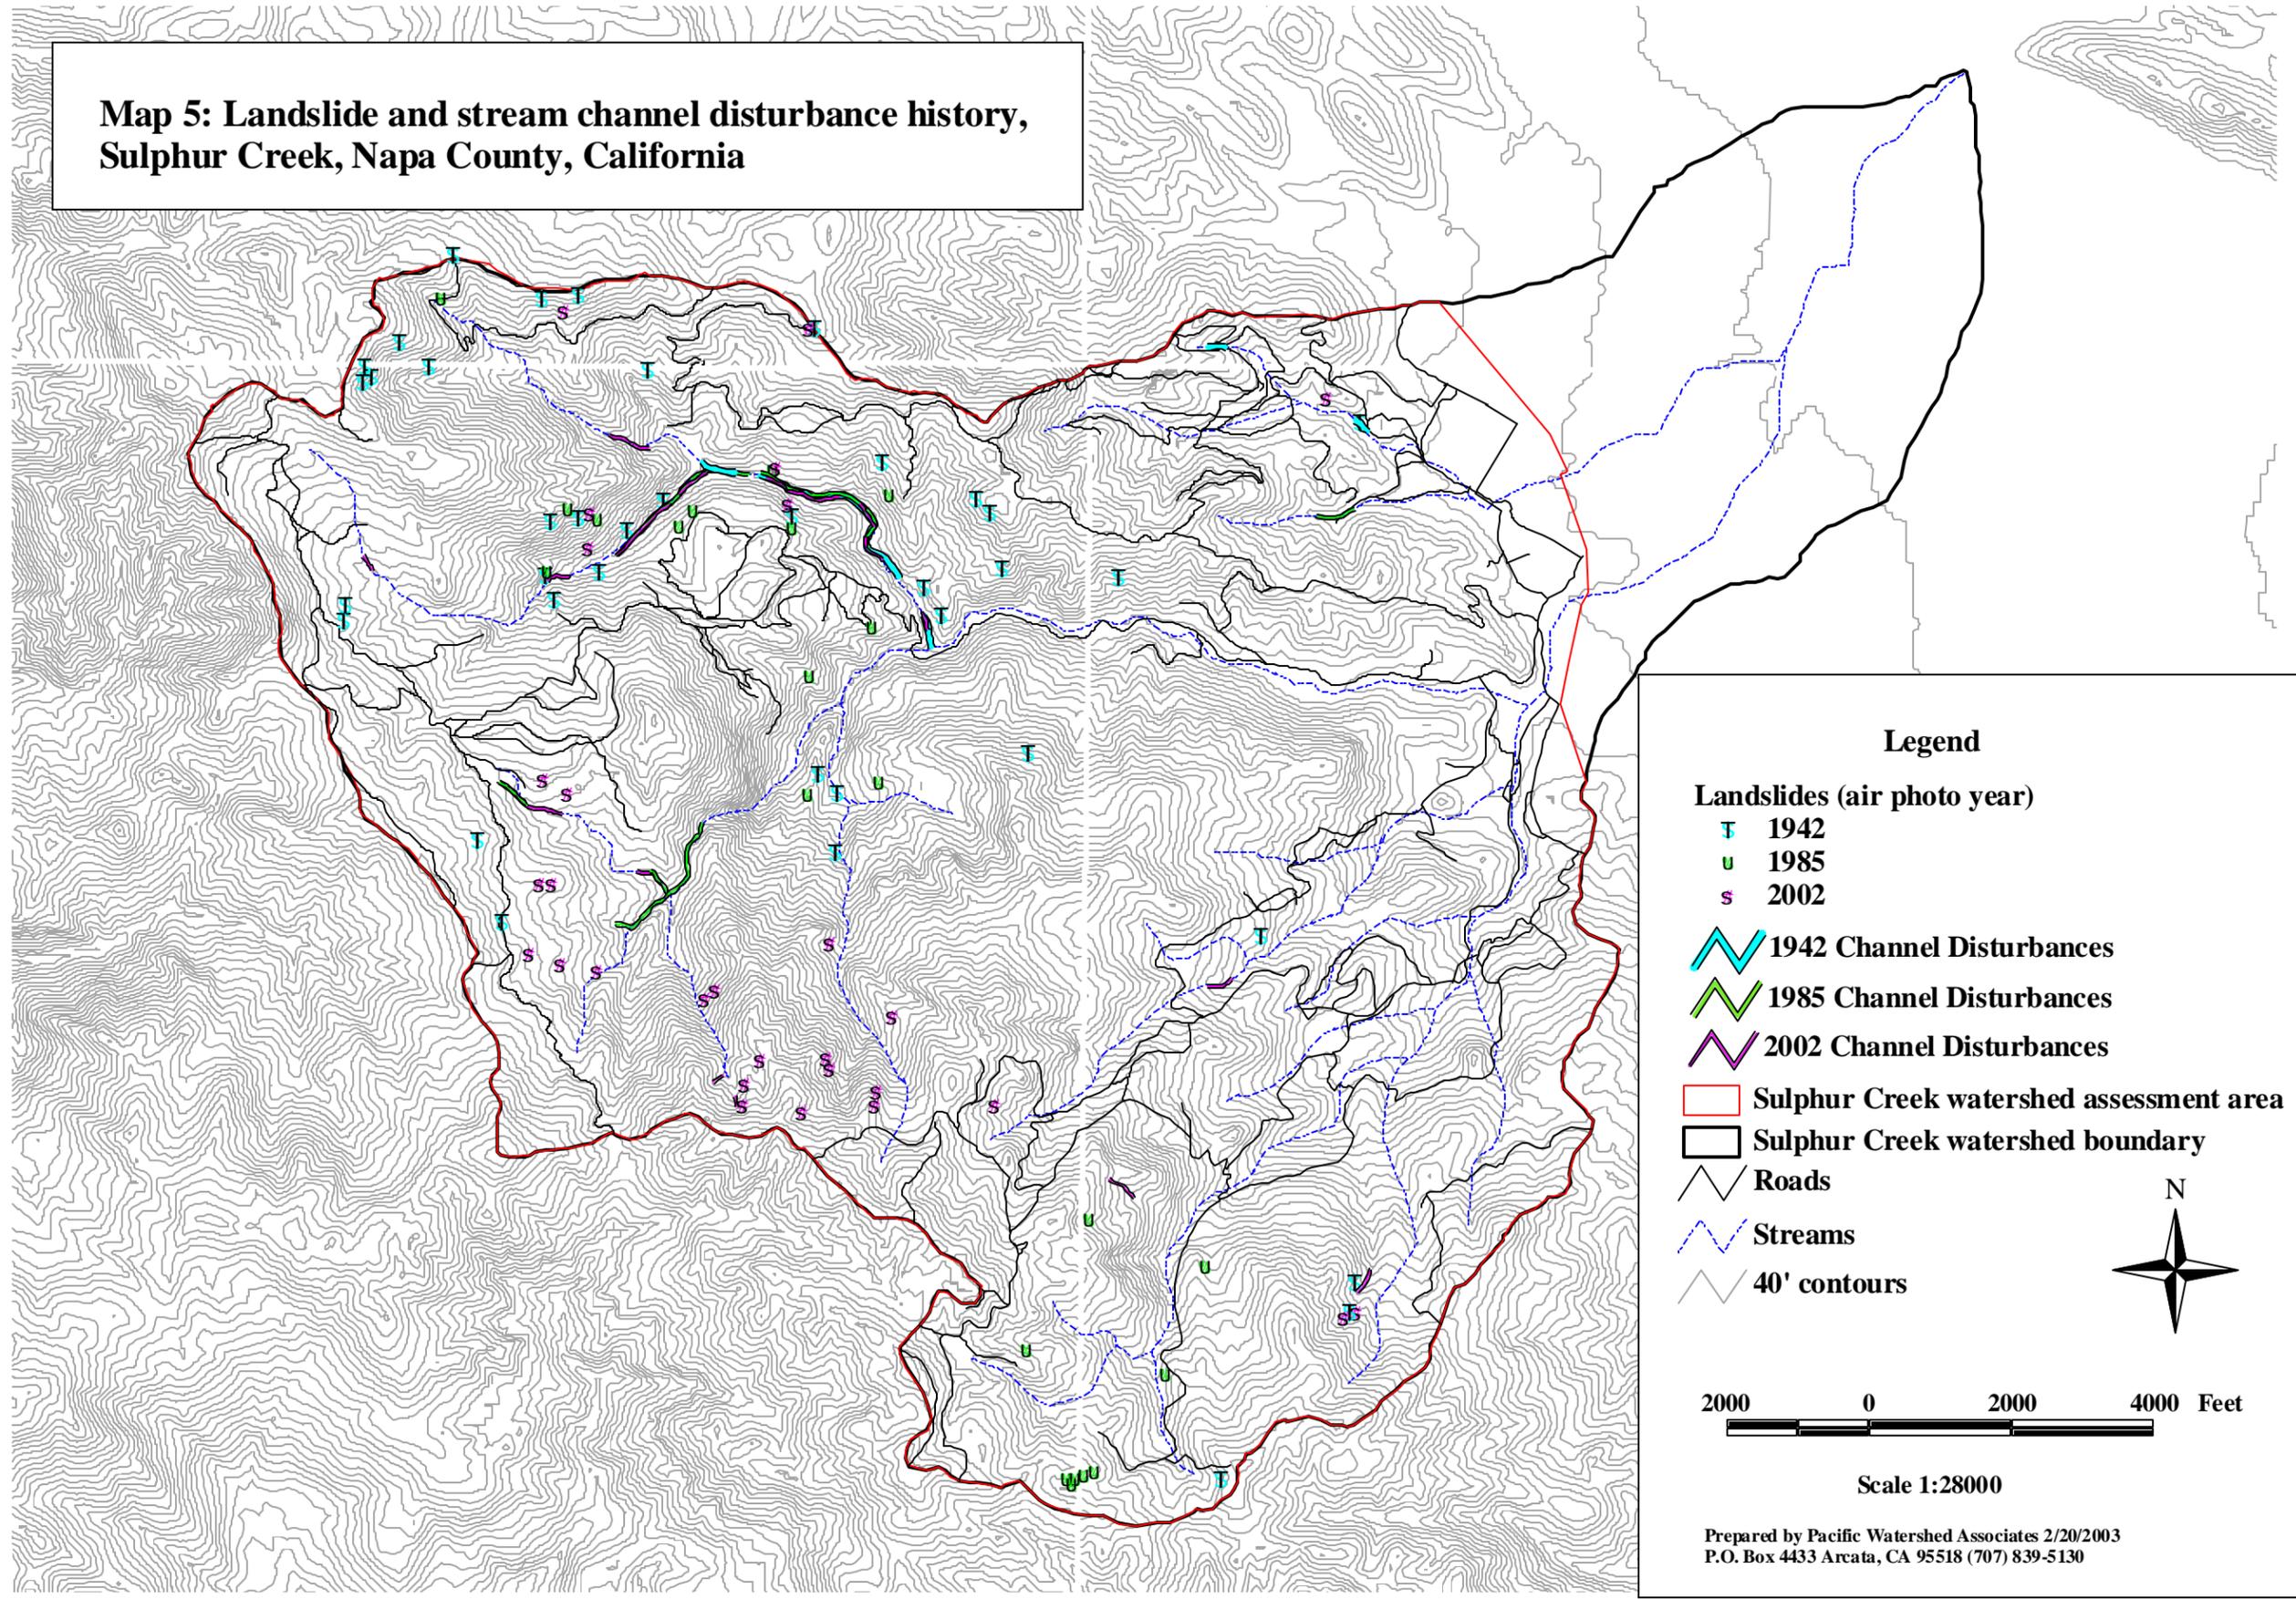
**Map 5: Landslide and stream channel disturbance history,
Sulphur Creek, Napa County, California**

Map 5 illustrates the age and location of stream channel disturbance in the watershed. In total, approximately 3.8 miles of channel in the Sulphur Creek watershed was identified as “disturbed”. This represents approximately 16% of the 24 miles of USGS blue line streams in the basin. Of the 3.8 miles of “disturbed” channel, 3.4 miles (89%) were located in tributaries of Sulphur Canyon, 0.1 (4%) miles were located in Heath Canyon and 0.3 miles (7%) were located in other tributary channels of Sulphur Creek. Possible causes for stream channel disturbance in the mainstem channel of Sulphur Creek include stream channel migration, bank erosion and flood events. Causes for stream channel disturbance in tributary channels appears to result from bank erosion, landslides and flood events.
