Napa River Rutherford Reach Restoration Project

Annual Stream Maintenance Survey

June 2019

Prepared by:
Napa County Flood Control and Water Conservation District
Napa County, California

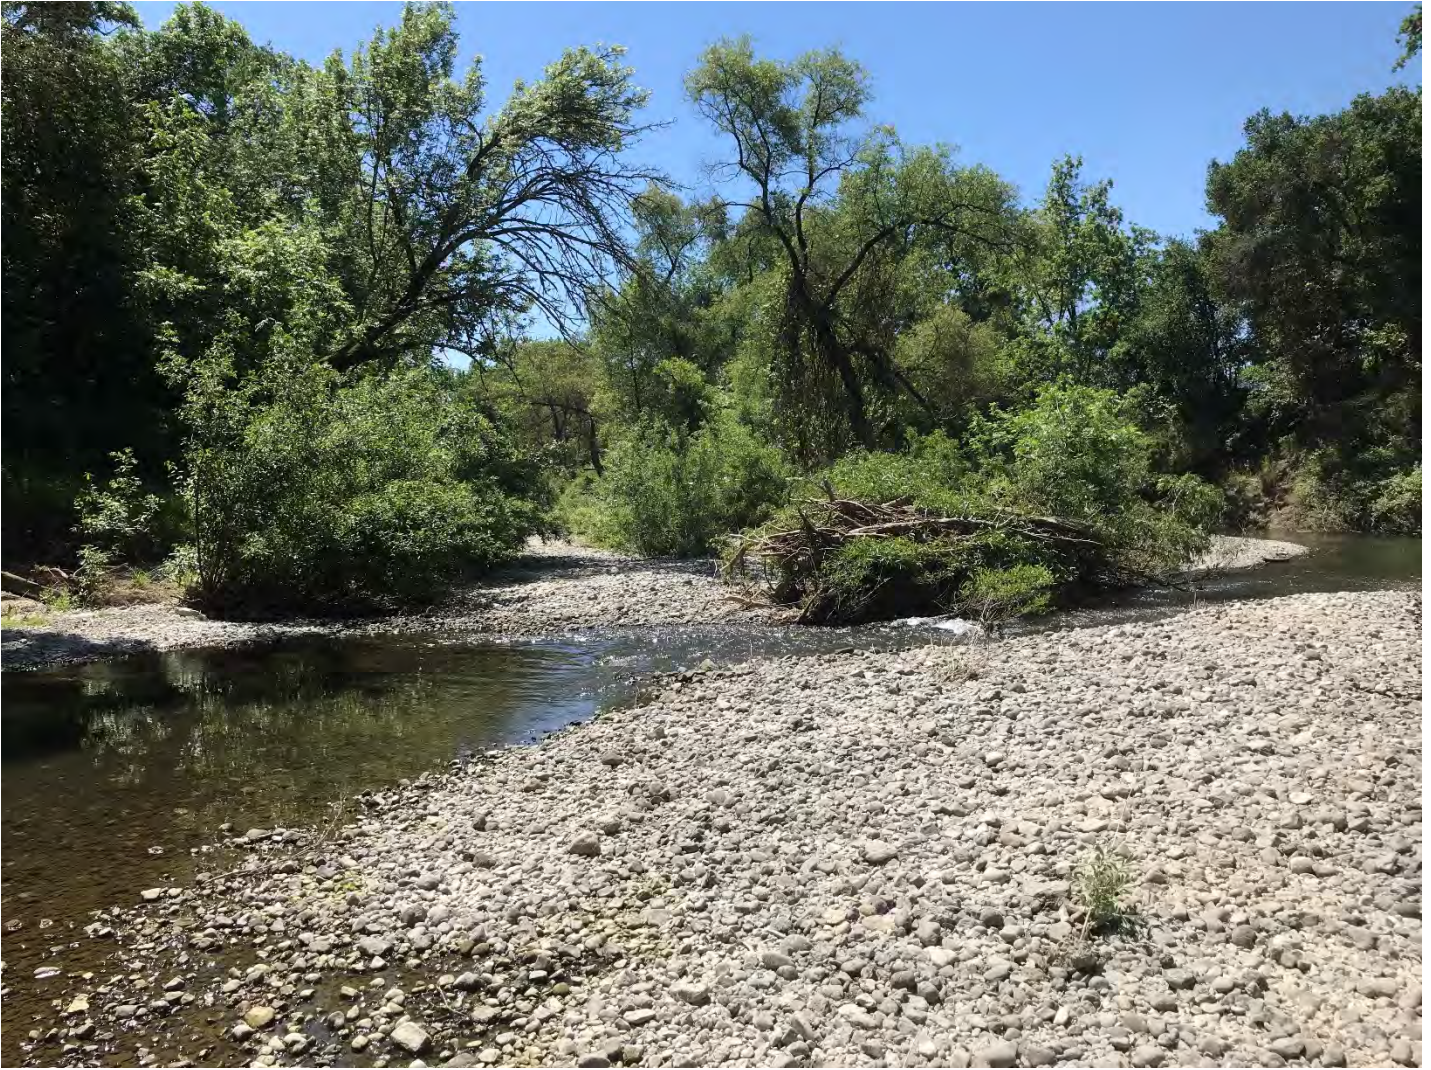
Confluence of Round Pond Secondary Channel with Mainstem Napa River, Reach 5, May 2019

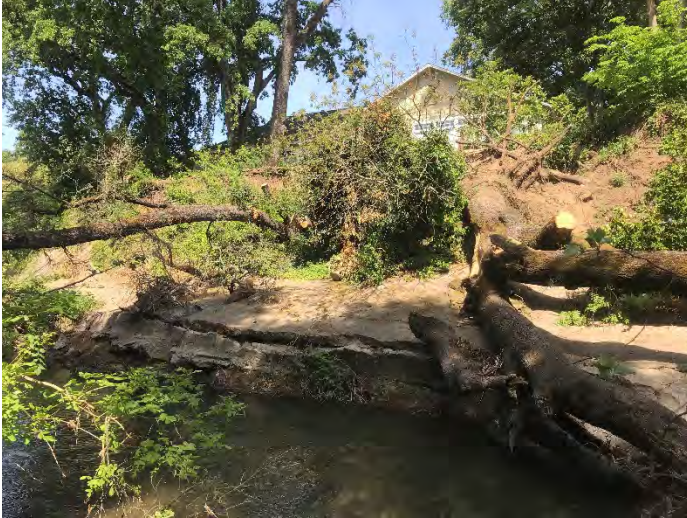
As mentioned previously in section 1 of this report the Napa river watershed received 60.2 inches of rain during the winter of 2018-2019 with a peak flow event occurring on February 27, 2018 (stage height =19.50 ft, flow = 9,570 cfs) measured at USGS stream gauge 11456000. This peak flow event was equivalent to the 10 year reoccurrence interval and was the highest flow recorded in the river since the 2005 New Year's Eve flood. As a result of the high flows significant stream bank erosion occurred throughout the Napa River and two significant sites needing repair within the Project reach were documented during the survey (**Picture 1 and 2**). The District intends to work with landowners to stabilize and remediate the bank erosion at both sites. See **Table 2** for the location and details of the proposed bank stabilization work to be conducted.

River Station/Reach	Description	Proposed Work
55+00 (Reach 8)	Bank Erosion Site adjacent to home/undermined existing concrete wall	Construct soldier pile wall, funds provided primarily from landowner/NRCS with some assessment District funds.
51+50 (Reach 8)	Bank Erosion Site, lower- bank high flow scour	Fabricate live willow brush mattress at lower 1/3 of river bank, pole planting.

Picture 1: Bank Erosion Site Reach 8

1 LWD significant LWD jam in reach 8, related to the bank erosion site shown above in Picture 1, was identified during the Survey that will require management action. County staff will thin out/remove the significant portions of the tree trunk and branches within the channel in order to restore high flow conveyance and prevent potential bank erosion on the adjacent right river bank.

- Remove of all trash and debris from the stream channel that can be readily accessed and accomplished with hand labor, pulley or winch assisted mechanisms,
- Remove/thin/realign the LWD jam within Reach 8,
- Treat large accessible patches of non-native invasive and Pierce host vegetation with mechanical and chemical (glyphosate) methods including Himalayan blackberry, mugwort, vinca, California grape and Arundo; this task also includes appropriate re-vegetation and irrigation of treatment sites where treatment has left significant gaps in the riparian under story canopy,
- Repair and stabilize exposed stream bank erosion areas as proposed in Table 2,

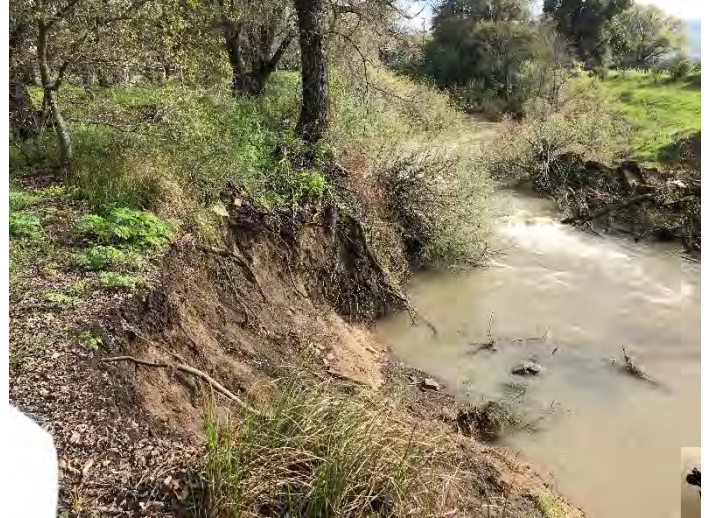
Picture 2: Bank Erosion Site reach 8
