CARNEROS CREEK WATERSHED MANAGEMENT PLAN

prepared for
**Carneros Creek Stewardship
and Bay-Delta Authority Watershed Program**

by
**Napa County Resource Conservation District
Carneros Creek Stewardship**
with
**San Francisco Estuary Institute
Pacific Watershed Associates**

February 2005

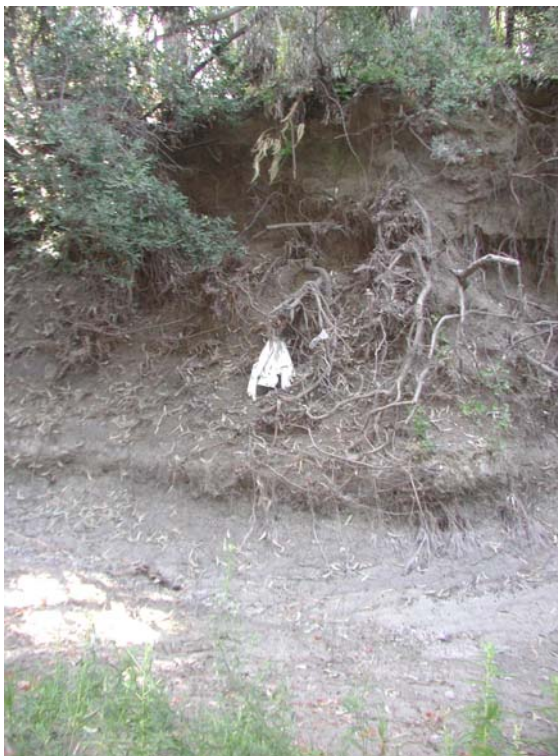
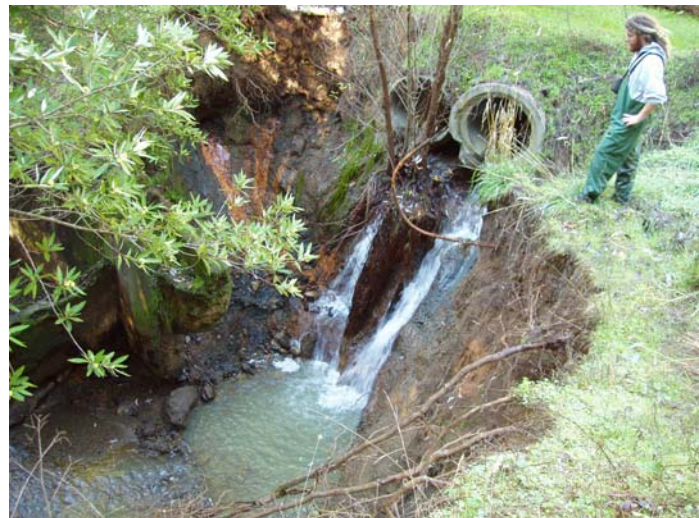
Figure 8: Examples of bank and gully erosion in the Carneros Creek watershed.

Soil erosion is a process that can take many forms including: bank erosion, gully erosion, sheet and rill erosion, and landsliding; all of which are currently occurring in the Carneros Creek watershed to varying degrees. Much of the erosion occurring on Carneros Creek is caused or aggravated by human activities. Finding solutions to minimize erosion induced by human disturbance is essential because property and soil resources are valuable and because excess erosion and the resultant sediment input to the creek can have negative impacts on channel functioning and aquatic habitat. Figure 8 shows examples of bank and gully erosion.

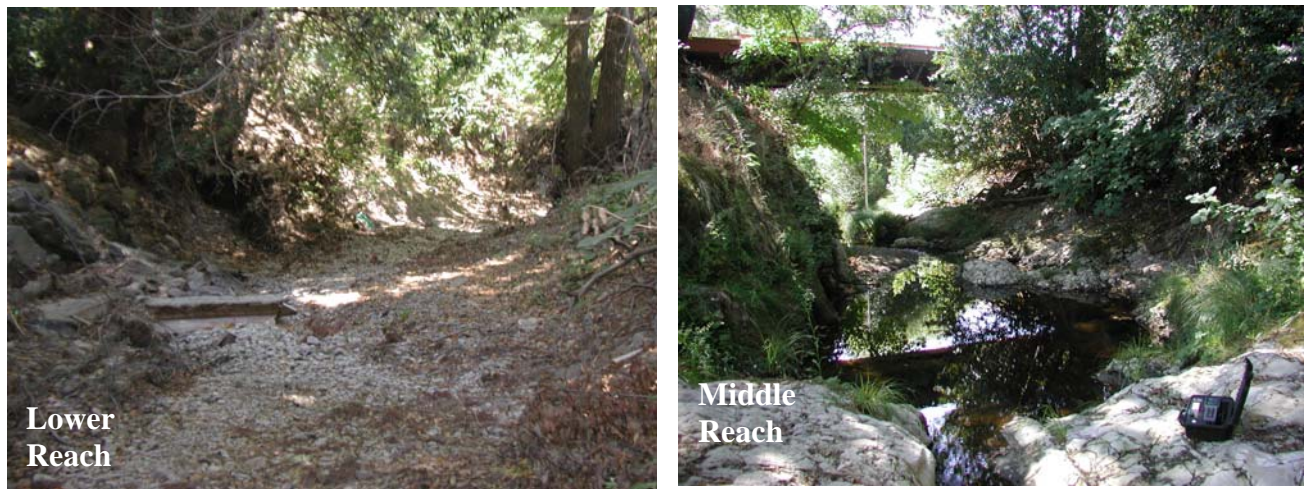
Figure 9: Images from the lower and middle reaches of Carneros Creek. July, 2004.
