SOUTHERN NAPA RIVER WATERSHED RESTORATION PLAN

FINAL REPORT
April 30, 2009

Prepared For
California Department of Fish and Game
Contract # P0530429
Fisheries Restoration Grant Program

SOUTHERN NAPA RIVER WATERSHED PROJECT

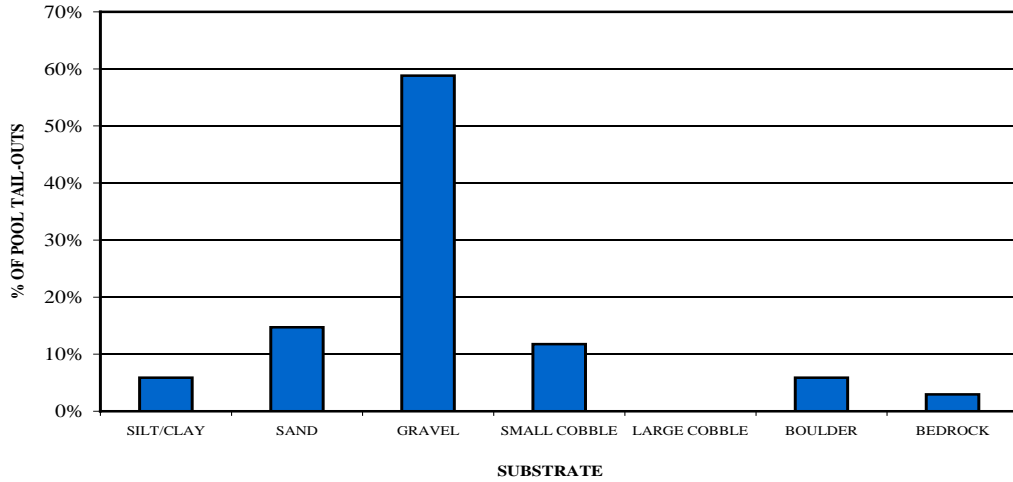
GRAPH 7

Potential spawning sites were generally fine-bedded with sand and gravel being the most common substrate found in pool tail-outs (Graph 7).

SUBSTRATE COMPOSITION IN POOL TAIL-OUTS

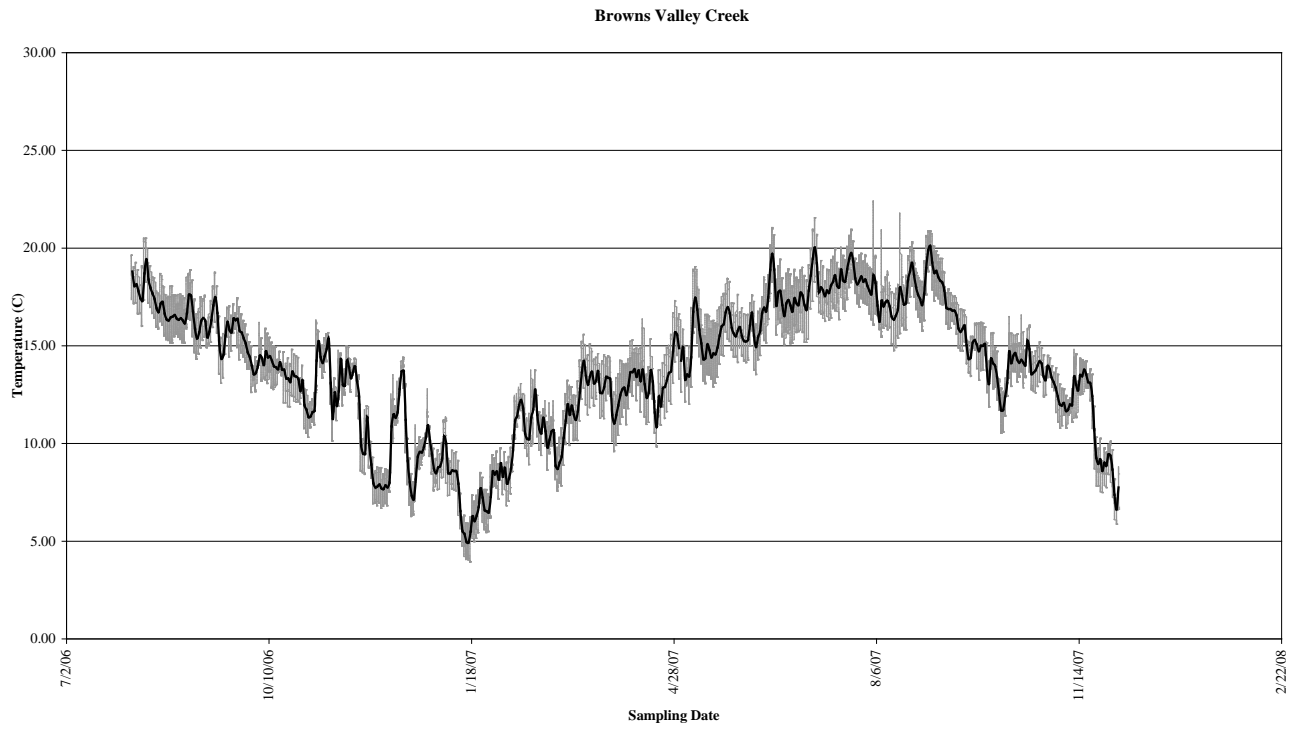
Figure 3.1.4 – Continuous water temperature data from Browns Valley Creek. The dark black line represents the daily average temperature, and the gray line represents daily range.

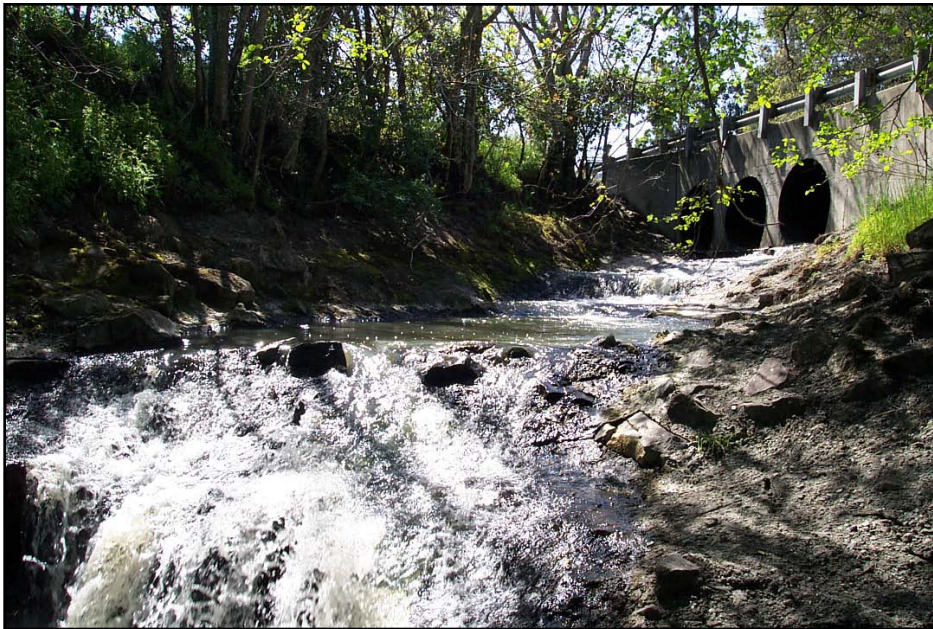
Highway 12/121 culvert crossing over Huichica Creek

The highest priority barrier is the Highway 12/121 crossing, which is located low in the watershed and impedes access to high quality habitat in reaches 2 and 3. The concrete dam located in reach 3, although a severe barrier, is located at the upper end of perennial flow and thus would be expected to have a limited impact on the overall steelhead population distribution. Still, allowing fish to pass the structure more easily would provide upstream spawning opportunities in higher flow years and would therefore be beneficial. It would also allow upstream juvenile dispersal, which is currently completely prevented by the structure.

Both sites are planned for full assessment by RCD in 2009 as part of a watershed-wide effort to develop treatments for the highest priority barriers in the Napa River watershed.

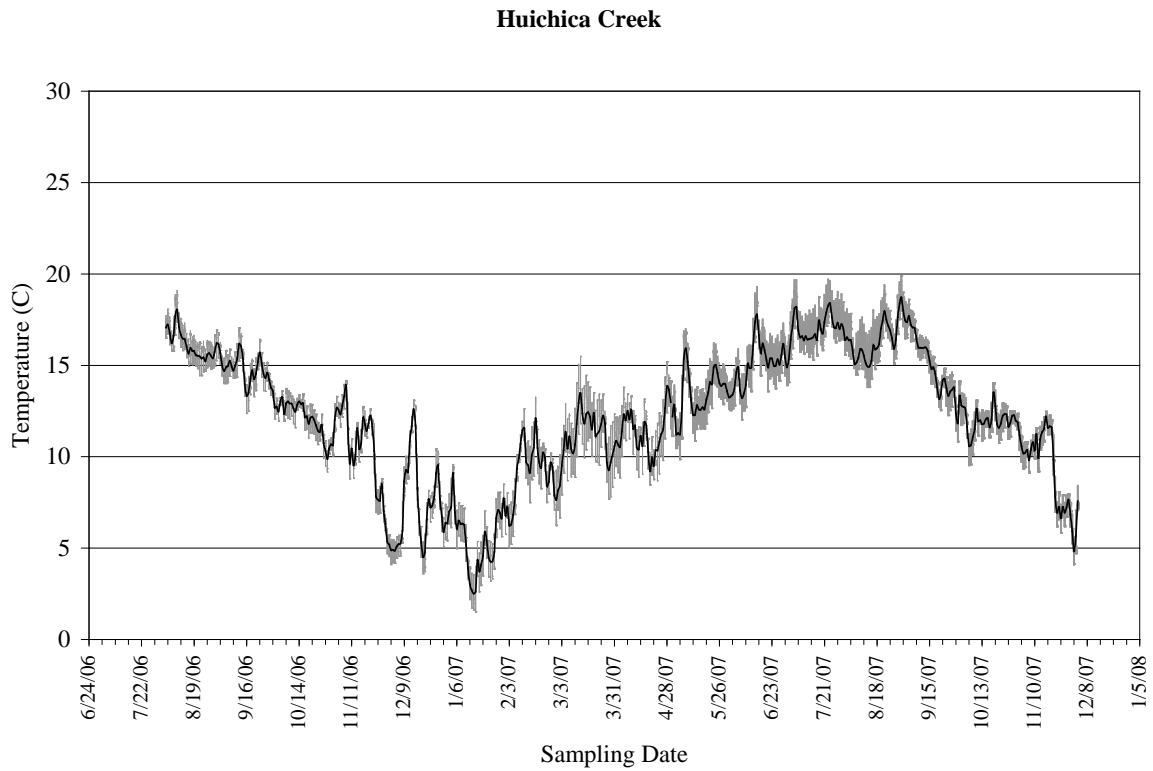
Figure 3.2.4 – Continuous water temperature data from Huichica Creek. The black line represents the daily average temperature, and the gray line represents daily range.
