Napa River Rutherford Reach Restoration Project
Final Memorandum Report for Annual Maintenance Activities
2010 Field Season

Prepared by: Napa County Flood Control and Water Conservation District

December 2010

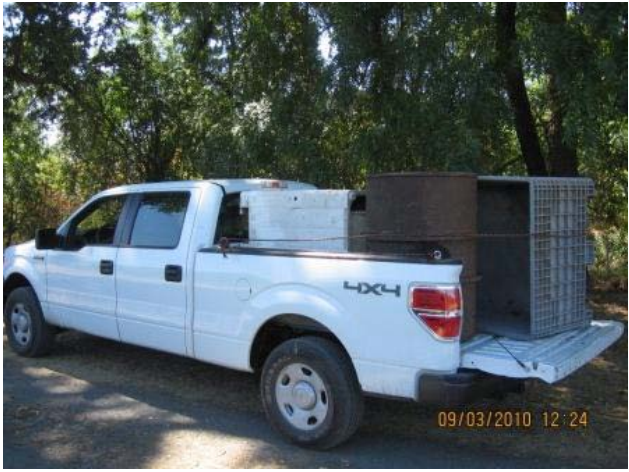
Figure 1: Trash and debris removal

A total of 52 occurrences of trash and debris were initially documented in the Report and 60 items were actually removed from the river channel including 33 tires and 27 "other" items such as appliances, drip lines, tarps, grape carts, metal drums, etc. Interestingly, more tires were removed this year than in 2009 which would suggest that perhaps new tires were scoured out of the stream bank and revealed during high flow events last winter. The Report recommended removal of all trash and debris items documented; all trash and debris items were removed over three days in September 2010, Table 1, (Figures 1 and 2).

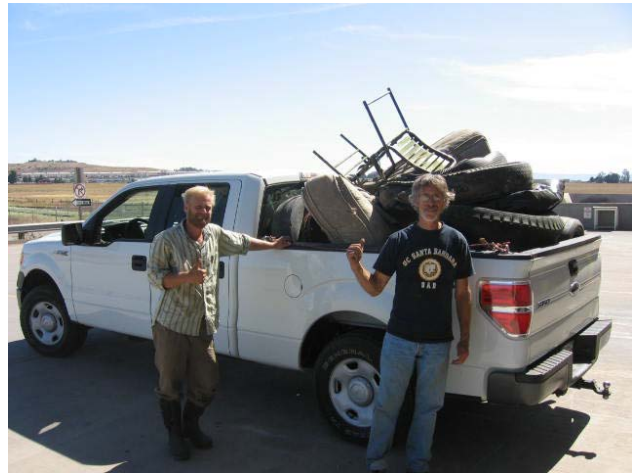
Figure 2: Trash and debris removal

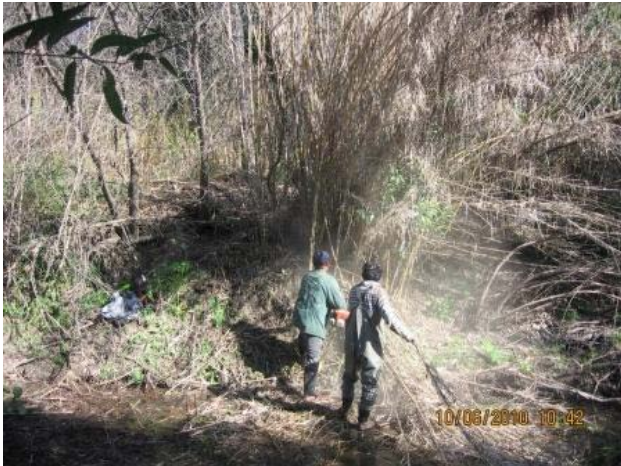
Figure 3: Invasive plant treatment

A total of 86 occurrences of invasive plants were identified and documented during the survey. Giant reed, Poison Hemlock and periwinkle were the dominate invasive plant species detected while tree-of-heaven, and Himalayan blackberry also occurred in relatively high populations while smaller pioneer populations of sesbania and black locust were documented as well. The Report recommended treating the most invasive species (giant reed and sesbania) and Pierce host species such as periwinkle. 58 combined occurrences of giant reed, periwinkle, tree-of-heaven and sesbania were treated during late summer/fall 2010 covering a total area of approximately 1.58 acres or 68,824 square feet (Table1), 17,424 square feet of which was periwinkle (Figures 3 and 4). Occurrences that were not treated were either on properties that the RDRT Team was unable to acquire long-term maintenance access agreements on or were Poison hemlock occurrences, a non-Pierce host species, which the RDRT Team is currently determining how to best eradicate. The remaining occurrences of non-natives that were not treated before the onset of this year's rainy season will be treated in spring/late summer of 2011 when uptake of herbicide will be most effective. Select populations of giant reed that were treated during the 2010 field season and have the potential to cause streambank erosion will be replanted in December/January 2011 with native understory/over story species including valley and coast live oaks , willow cuttings and California rose and/or snowberry shrubs.

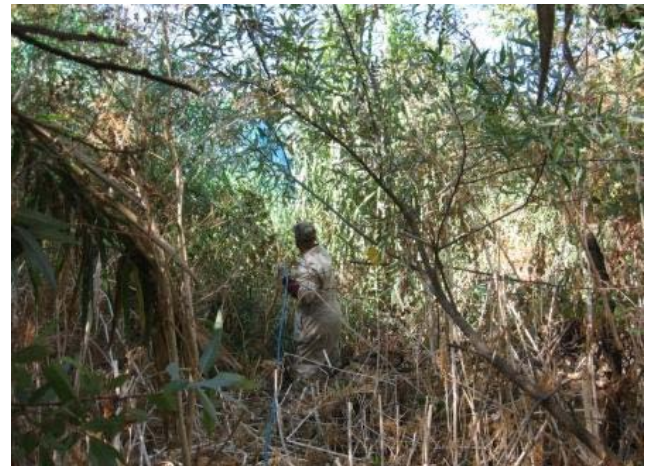
Figure 4: Invasive plant treatment

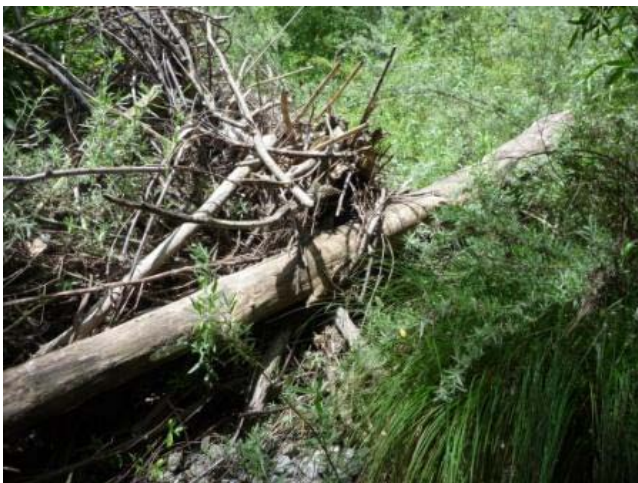
Figure 5: Removal/thinning of LWD (before)

A total of 16 locations of large woody debris (LWD) were documented during the 2010 survey that ranked as potential maintenances issues in the river channel. The Report recommended thinning out and/or realigning 2 of the 16 LWD occurrences (Table 1), however after further conversation with landowners and additional site inspections, two additional LWD jams were treated for a total of 4 treatments sites. All 4 occurrences of LWD that represented a maintenance issue were treated between October 1st and October 15th, 2010 (Figures 5 and 6).

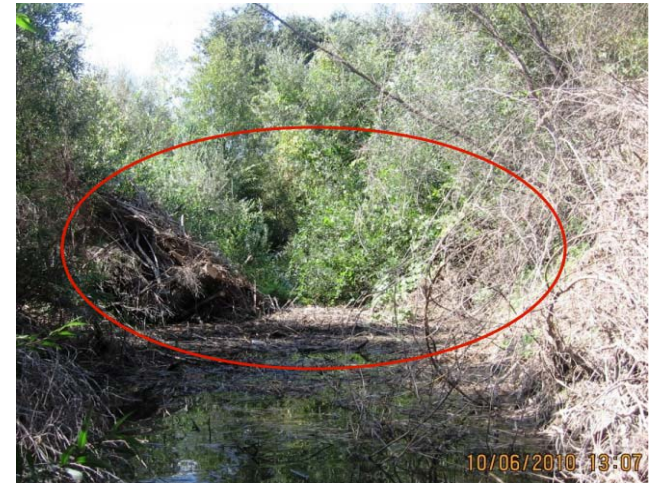
Figure 6: Removal/thinning of LWD (after)
