Appendix A

Demonstrating Road Improvements in the Napa River Basin: Implemented Road Treatments to Reduce Erosion in the Carneros Creek and Sulphur Creek Subwatersheds, Napa County, California

Appendix B

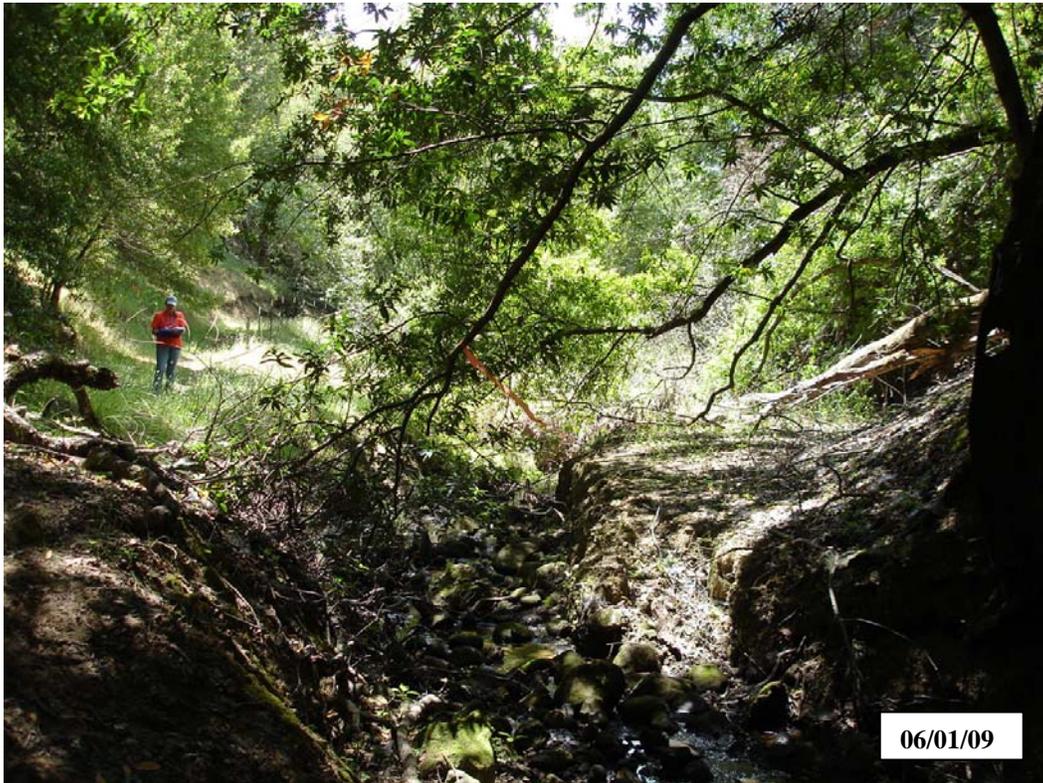
Photo 1a. Saintsbury property, stream crossing site #180, before implementation. View from the left bank, looking towards the culvert inlet and road surface.

0.210	180	CD	Originally a culverted, partially washed out, stream crossing. See typical drawing for construction details. <ol style="list-style-type: none"> 1. Crossing was excavated from TOP to BOT flags within natural channel line and down to natural channel bottom. 2. A 42" x 90' long culvert was installed at base of fill and in the axis of the natural channel. 3. Small berm was left along outboard road to protect fill face from eroding during the first winter. 4. Road was rebuild with dip through crossing to minimize diversion potential. 5. 9 yd³ of rock armor was installed at base of outboard fill slope around culvert outlet. 6. 1 yd³ of rock armor was installed around inlet to buttress unstable fill. 	42" x 90' CMP, 4 couplers 10 yd ³ 1-2' rock

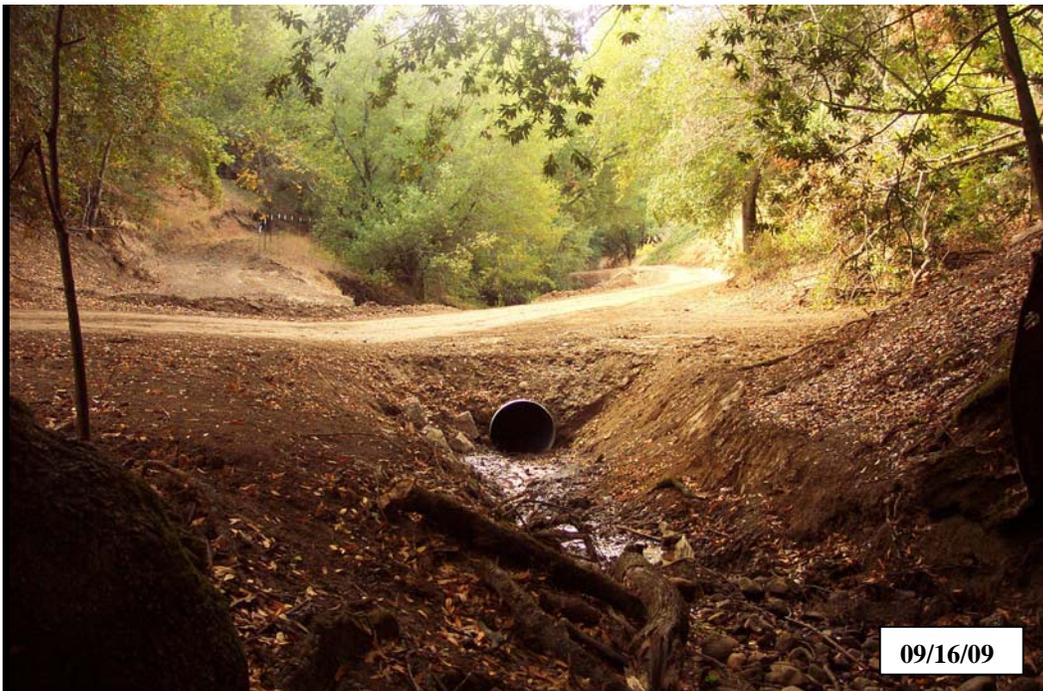
Photo 1b. Saintsbury property, site #180, same view as above, after implementation. A new 42 in. x 90 ft culvert has been installed at the base of fill

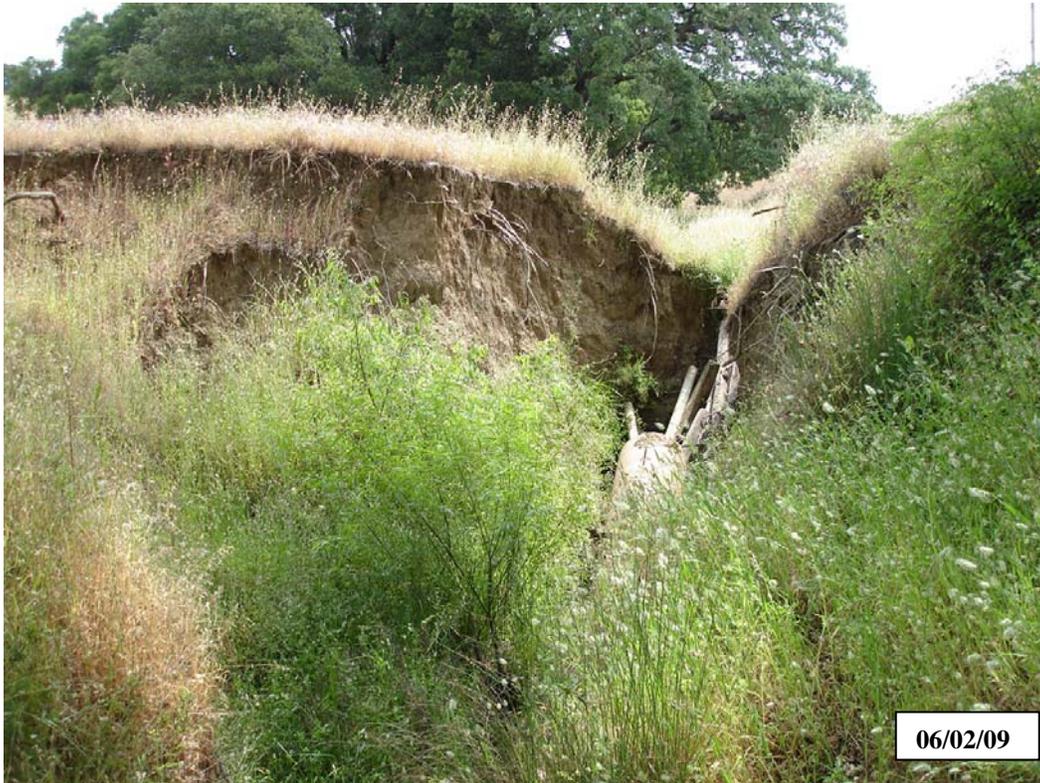
Photo 2a. Saintsbury property, stream crossing site #197, before implementation. View from the right bank, looking up-channel towards the outboard road.

0.601	197		Originally an eroding fill stream crossing. An armored fill crossing was constructed using 10 yd ³ of 1'-2' rock. See typical drawing for construction details.	30 yd ³ 1-2' rock

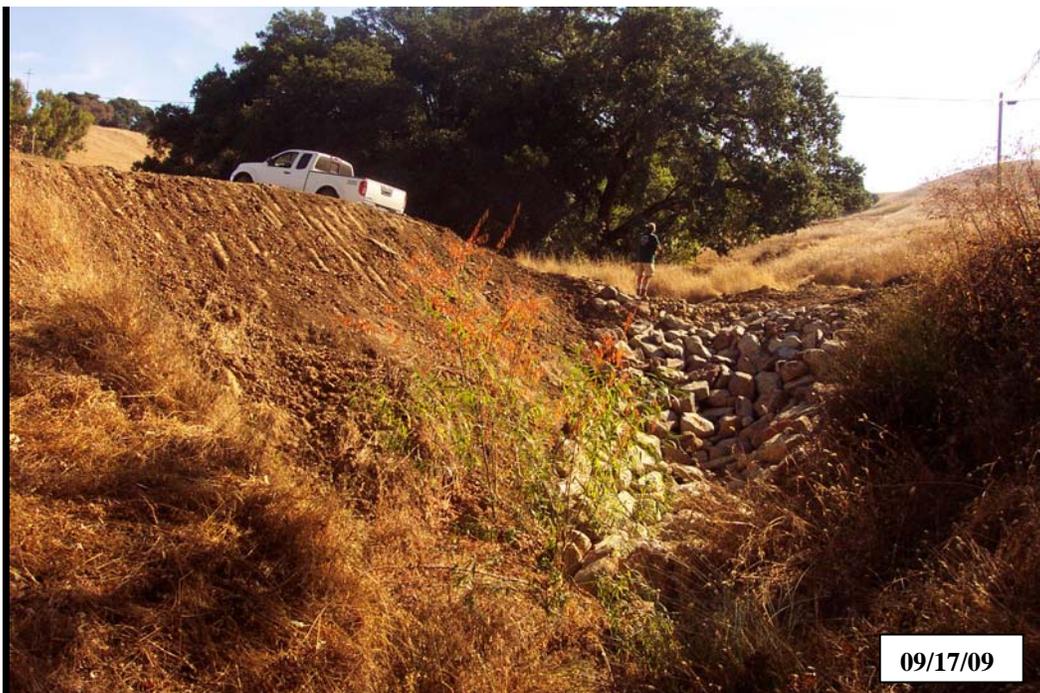
Photo 2b. Saintsbury property, site #197, same view as above, after implementation. An armored fill crossing has been constructed, and channel banks excavated back to stable angles and mulched.

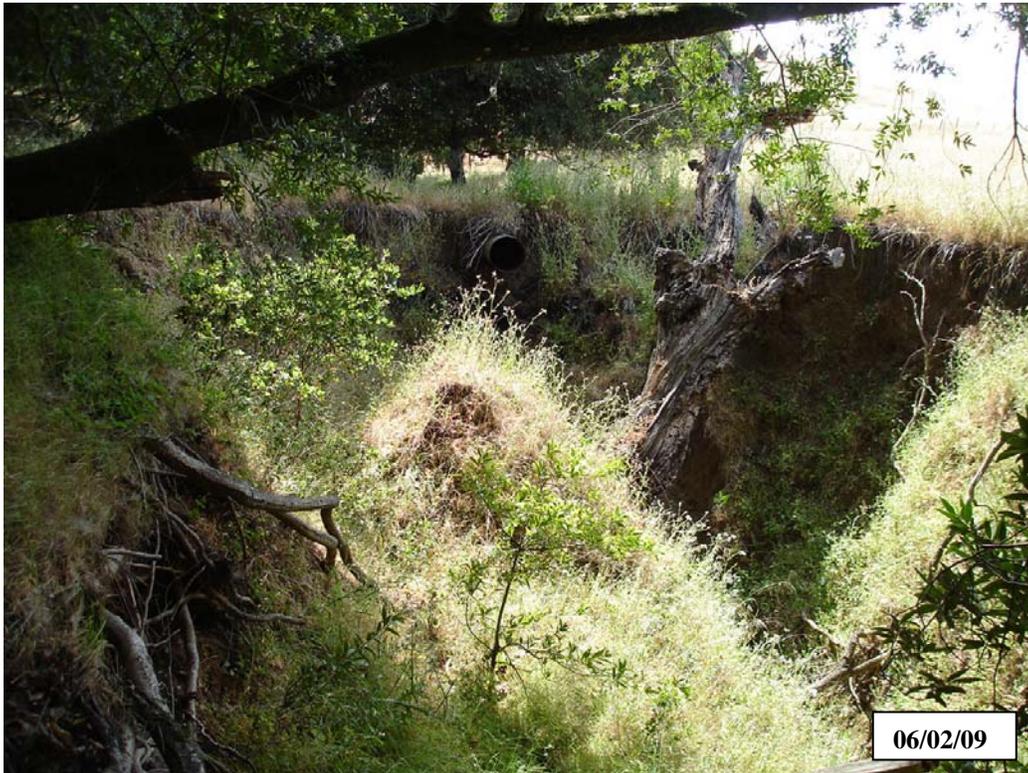
Photo 3a. Saintsbury property, stream crossing site #200, before decommissioning. View from the left bank, looking up-channel towards the outlet of the culvert and outboard road area.

0.129		XRD	A cross road drain was constructed.	
0.209	200		Previously a culverted stream crossing. 1. Crossing was excavated from TOP to BOT with an 8' wide channel width and down to base of fill for decommissioning. 2. Side slopes were lay back to natural channel slopes. 3. Spoil were stockpiled locally.

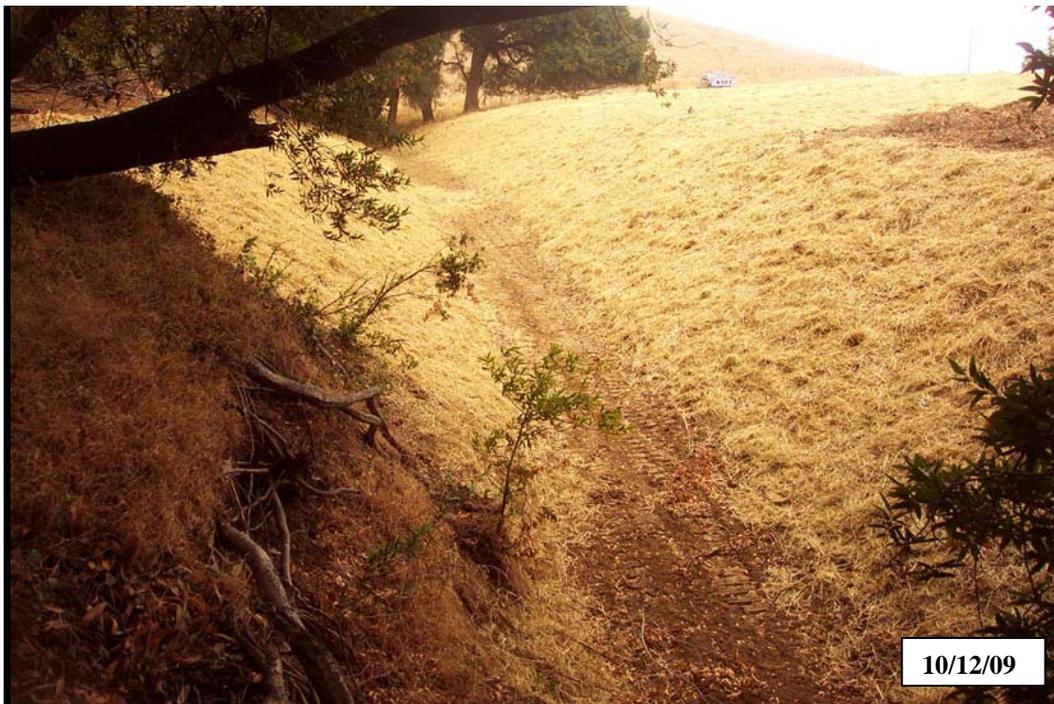
Photo 3b. Saintsbury property, site #200, same view as above, after implementation. The culvert has been removed, the channel excavated to natural grade, and channel banks sloped and mulched.

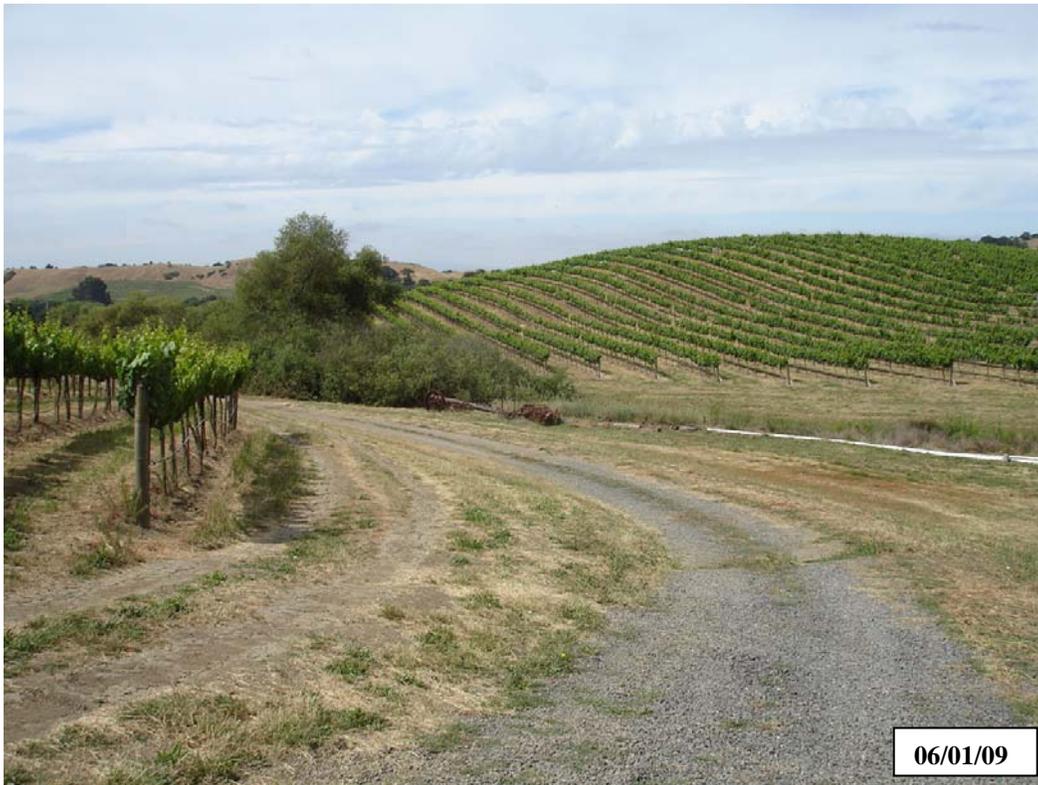
Photo 4a. Artesa property, site #217, before implementation. View from intersection with gravel road below dam, looking down road with creek flowing from right to left through center frame.

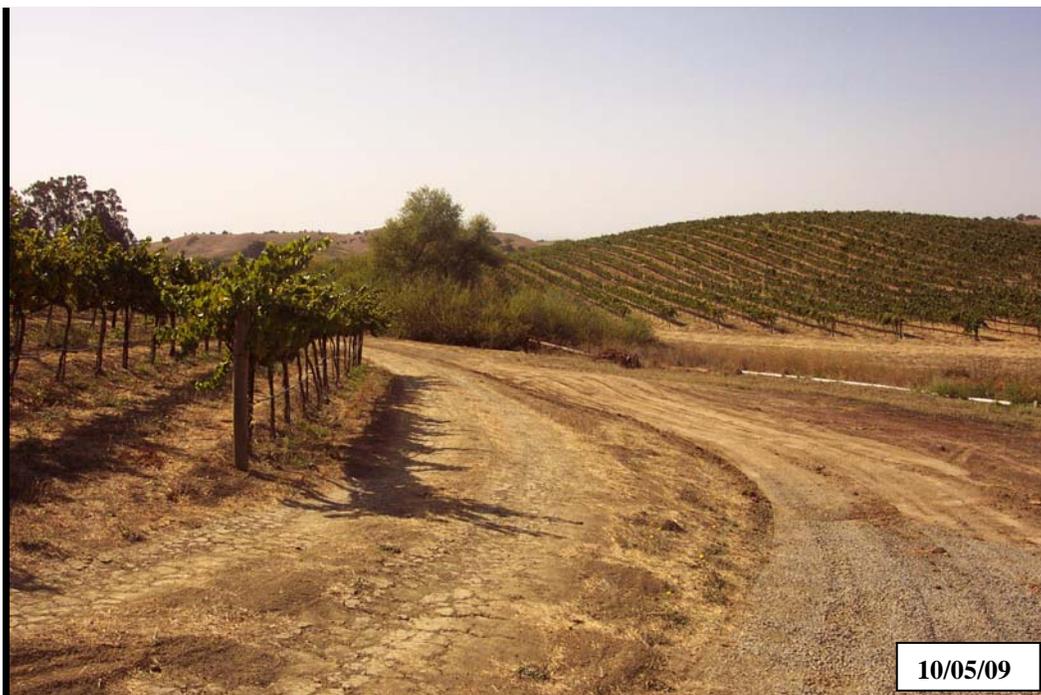
Photo 4b. Artesa property, site #217, same view as above, after implementation. A rolling dip has been constructed to disperse road drainage and reduce the amount of concentrated runoff reaching the stream.

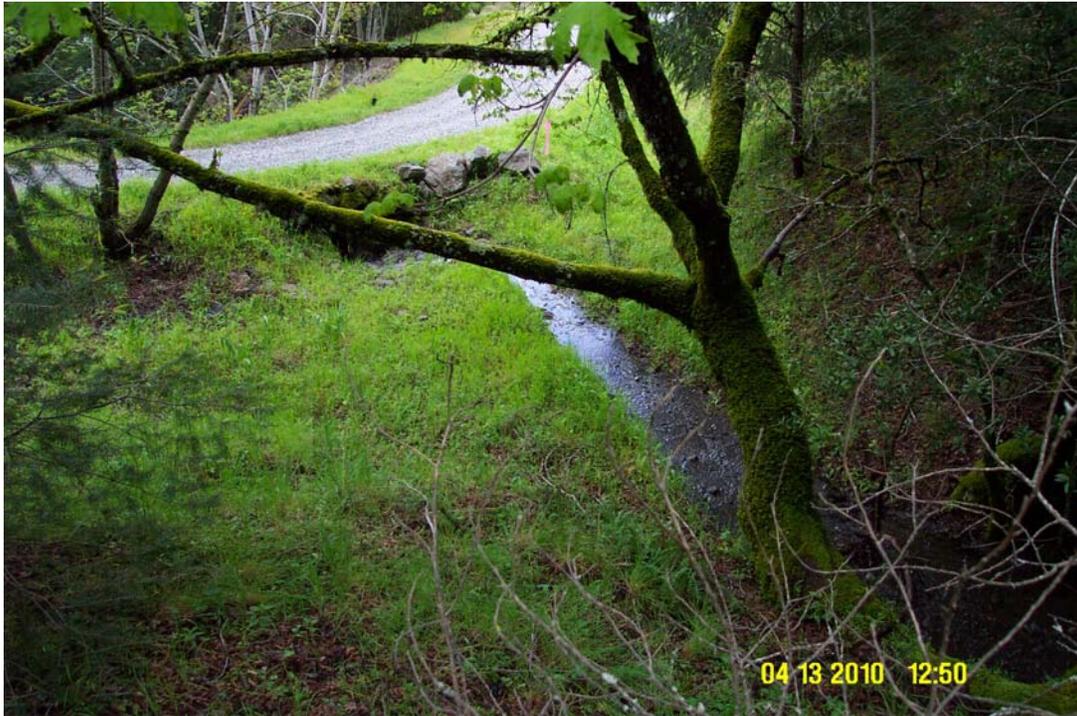
Photo 5a. Cain property, stream crossing site #54.1, before implementation. View from the left hillside, looking towards the culvert inlet and road surface.

0.880	54.1		Culverted stream crossing; Replaced with a 24" x 70' long CMP at base of fill in natural channel alignment, armored outboard fillslope with at least 25 yds ³ of 1'-2' riprap, and installed a trash rack above inlet. Road was re-rocked.	24" x 70' CMP, 3 couplers, 1 trash rack, 25 yd ³ 1'-2' riprap, 20 yd ³ 1.5" minus road rock

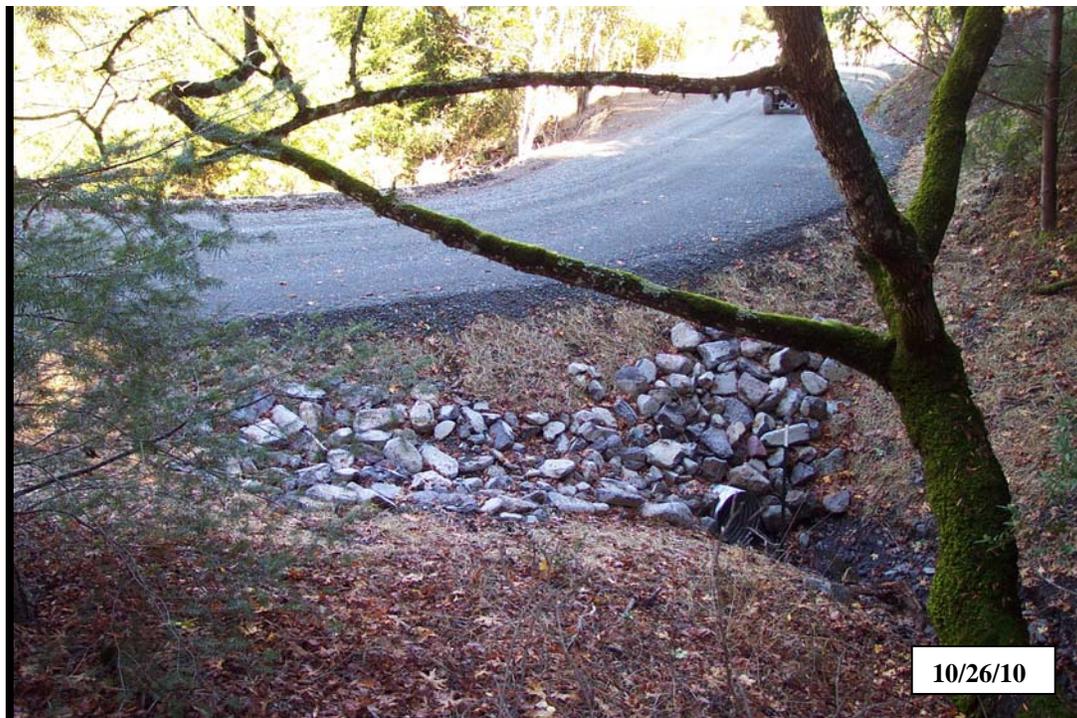
Photo 5b. Cain property, site #54.1, same view as above, after implementation. A new 24 in. x 70 ft culvert has been installed at the base of fill and a trash rack placed upstream from the inlet. Also the road surface has been re-rocked.

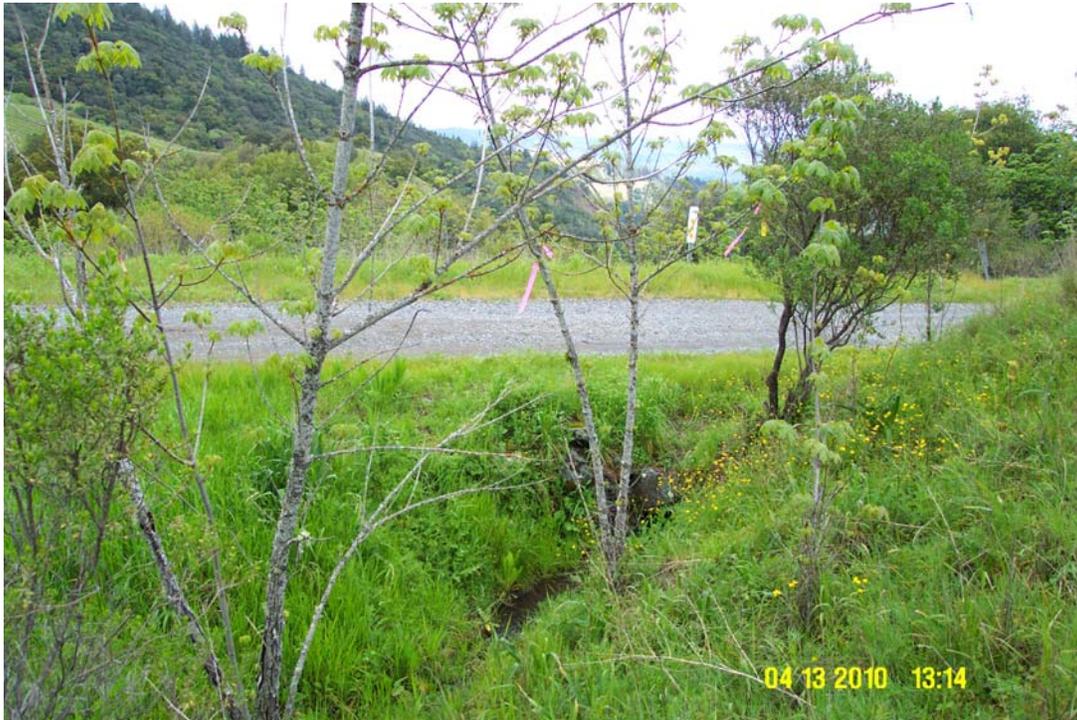
Photo 6a. Cain property, stream crossing site #55.1, before implementation. View from 35 ft above road, looking downstream at inlet area and road surface.

0.973	55.1	CD	Culverted stream crossing; Replaced with a 24" x 50' long CMP at base of fill in natural channel alignment with a trash rack installed above inlet and critical dip installed on right hinge of new crossing. Road was re-rocked.	24" x 50' CMP, 2 couplers, 1 trash rack, 5 yd ³ 1'-2' riprap, 20 yd ³ 1.5" minus road rock

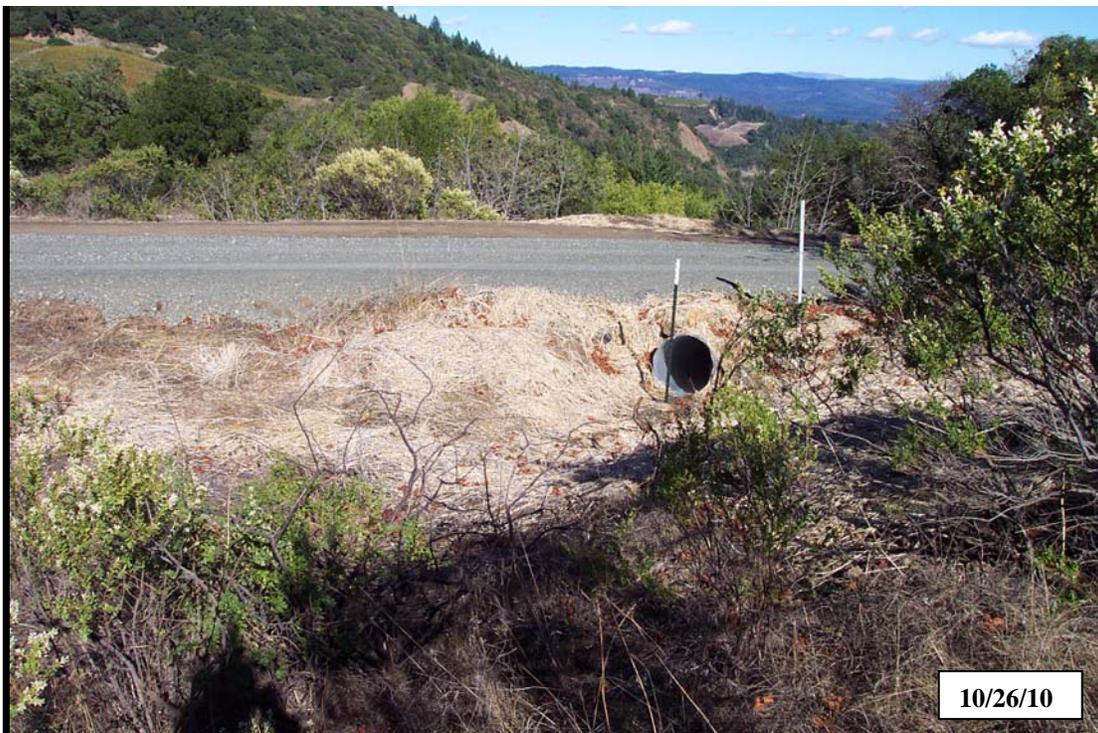
Photo 6b. Cain property, site #55.1, same view as above, after implementation. A new culvert and trash rack have been installed, and the road surface has been re-rocked.

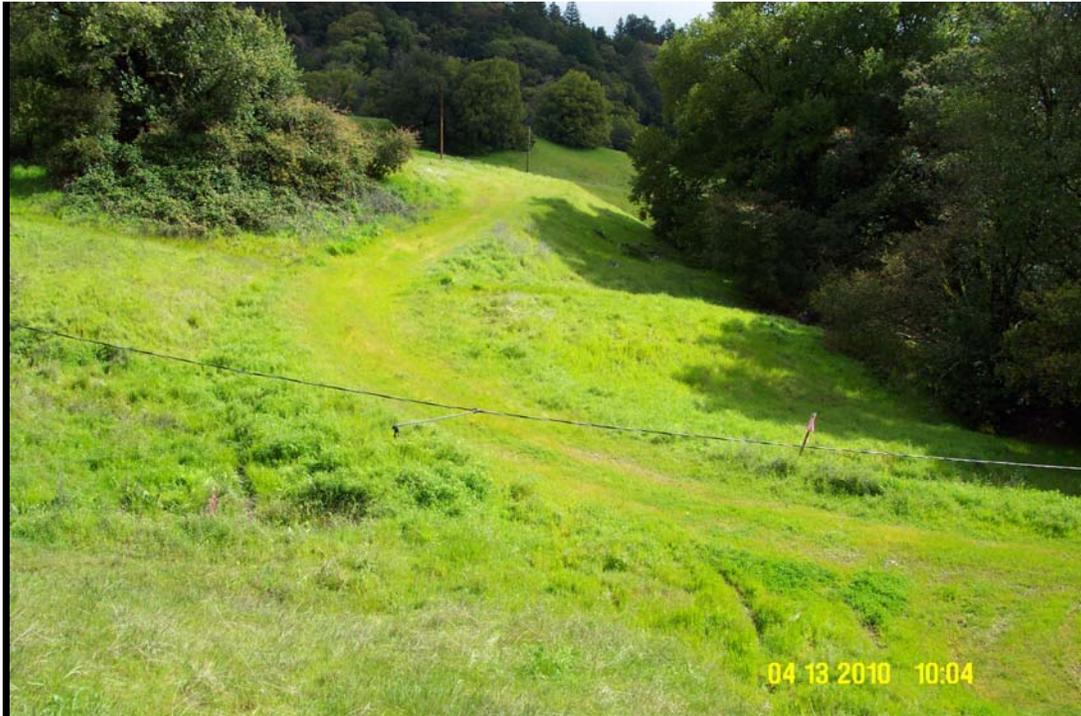
Photo 7a. Cain property, stream crossing site #99, before implementation. View from the hillslope above the crossing, looking downstream towards inlet area and the road surface.

0.121	99		Culverted stream crossing: Replaced with a 30" x 40' long CMP at base of fill in natural channel alignment with a flared inlet added and a trash rack installed above inlet. Road is re-rocked.	30" x 40' CMP; 1 coupler; 30" flared inlet, 1 trash rack, 15 yd ³ of 1.5' minus road rock

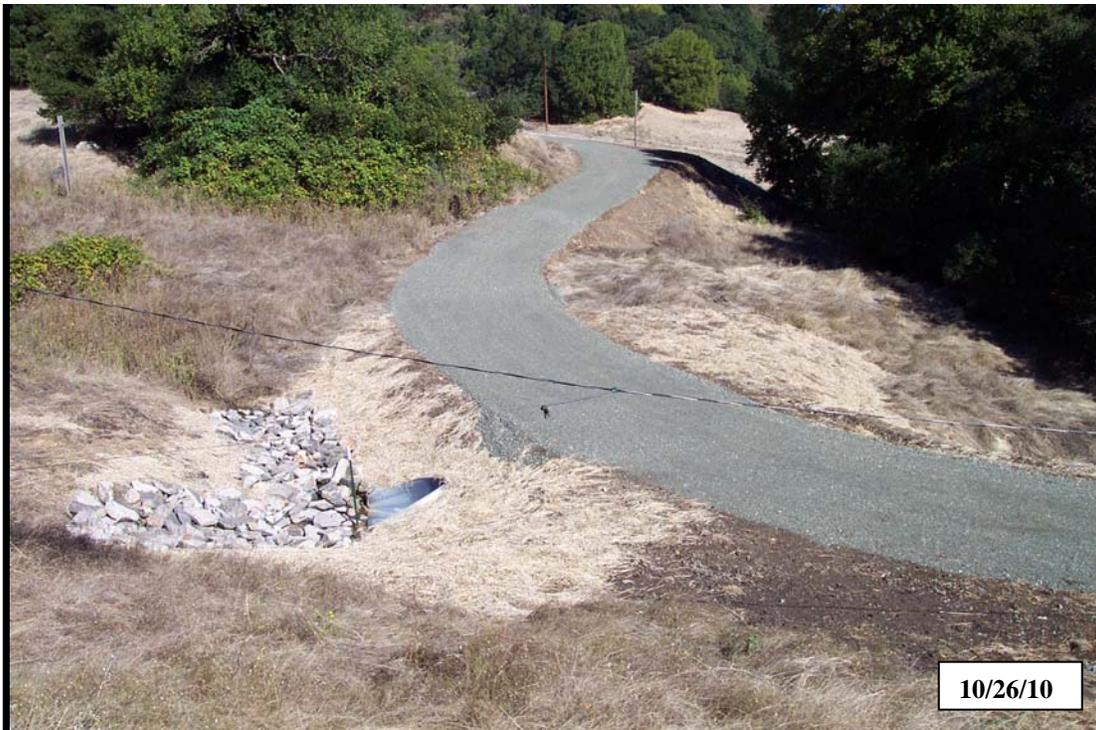
Photo 7b. Cain property, site #99, same view as above, after implementation. A new culvert with a flared inlet has been installed, as well as a trash rack. The inlet area has been armored with riprap, bare soil areas have been seeded and mulched, and the road has been re-rocked.

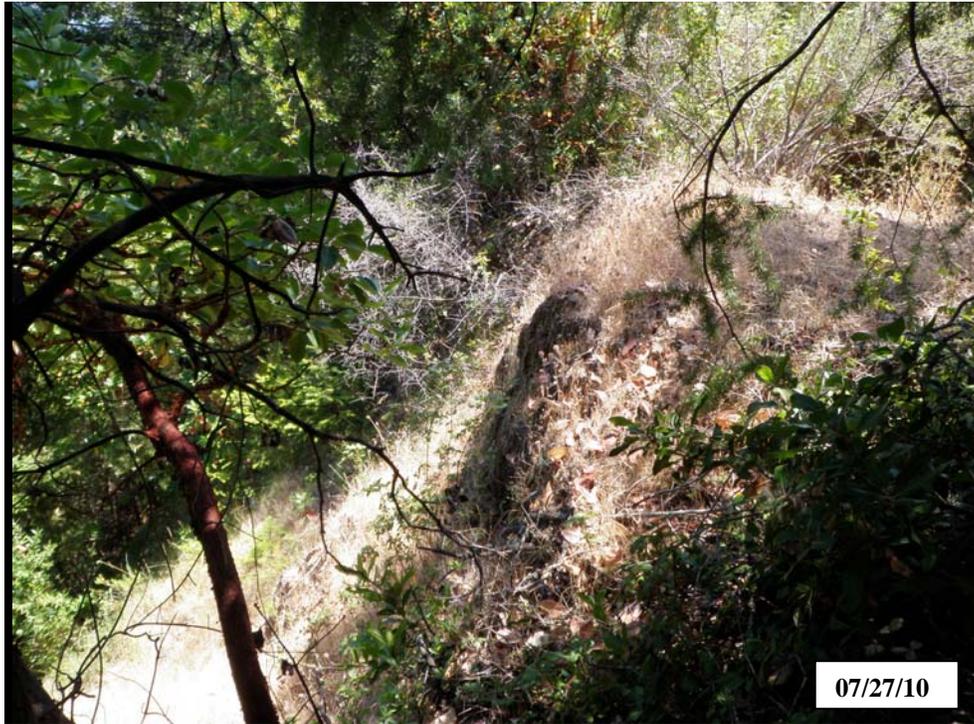
Photo 8a. Marston property, site #2001, before implementation. View from left, looking towards oversteepened and perched road fill material.

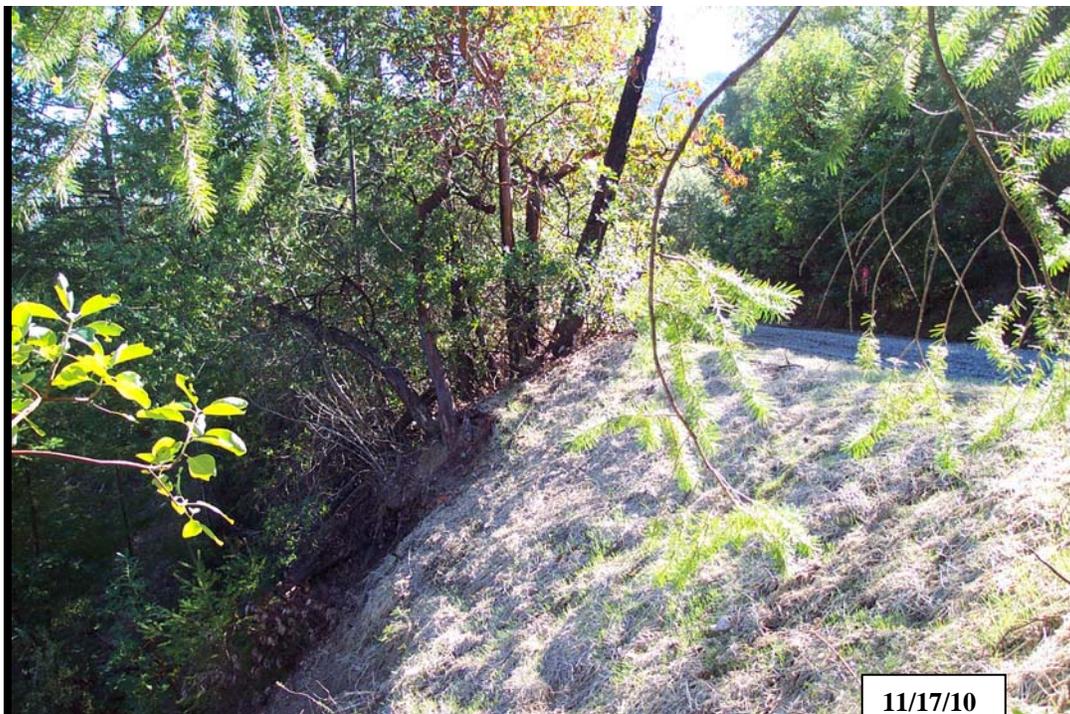
Photo 8b Marston property, site #2001, same view as above, after implementation. Oversteepened and perched material has been removed. Bare soils have been seeded and mulched with straw.

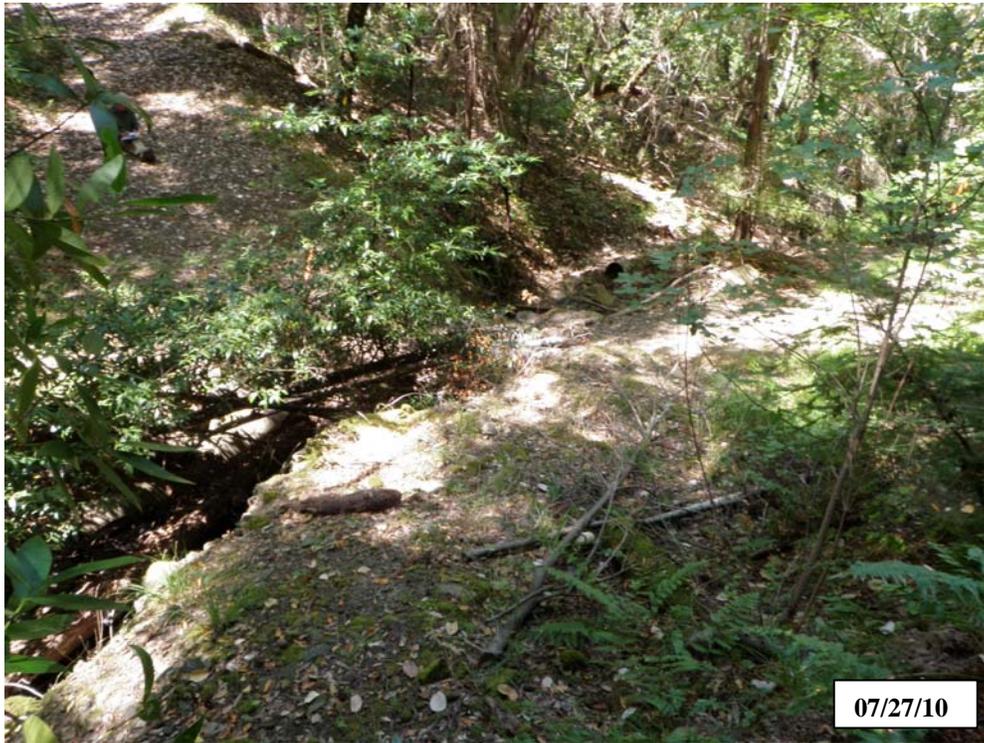
Photo 9a. Hoffman property, stream crossin site #133, before implementation. View from right cutbank, looking downstream towards road surface and stream crossing.

0.101	133	CD	Culverted stream crossing: The culvert is replaced with a new 42" x 29" x 50' long oval culvert and a critical dip installed on right hinge. Trash rack is installed above inlet and local riprap used to armor new fillslopes.	42" x 29" x 50' oval CMP, 2 couplers, 1 trash rack, local riprap

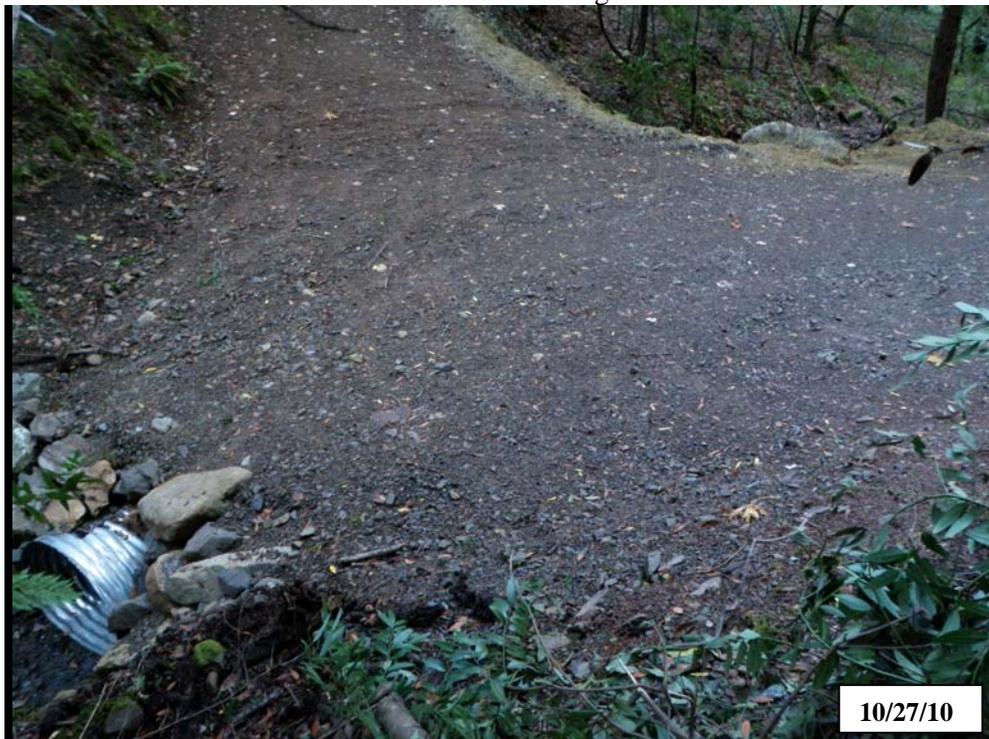
Photo 9b Hoffman property, site #133, same view as above, after implementation. A new, properly sized oval culvert has been installed at the base of fill in alignment with the natural channel. A trash rack was installed above the inlet.
