NAPA RIVER WATERSHED FISH BARRIER INVENTORY

SUMMARY

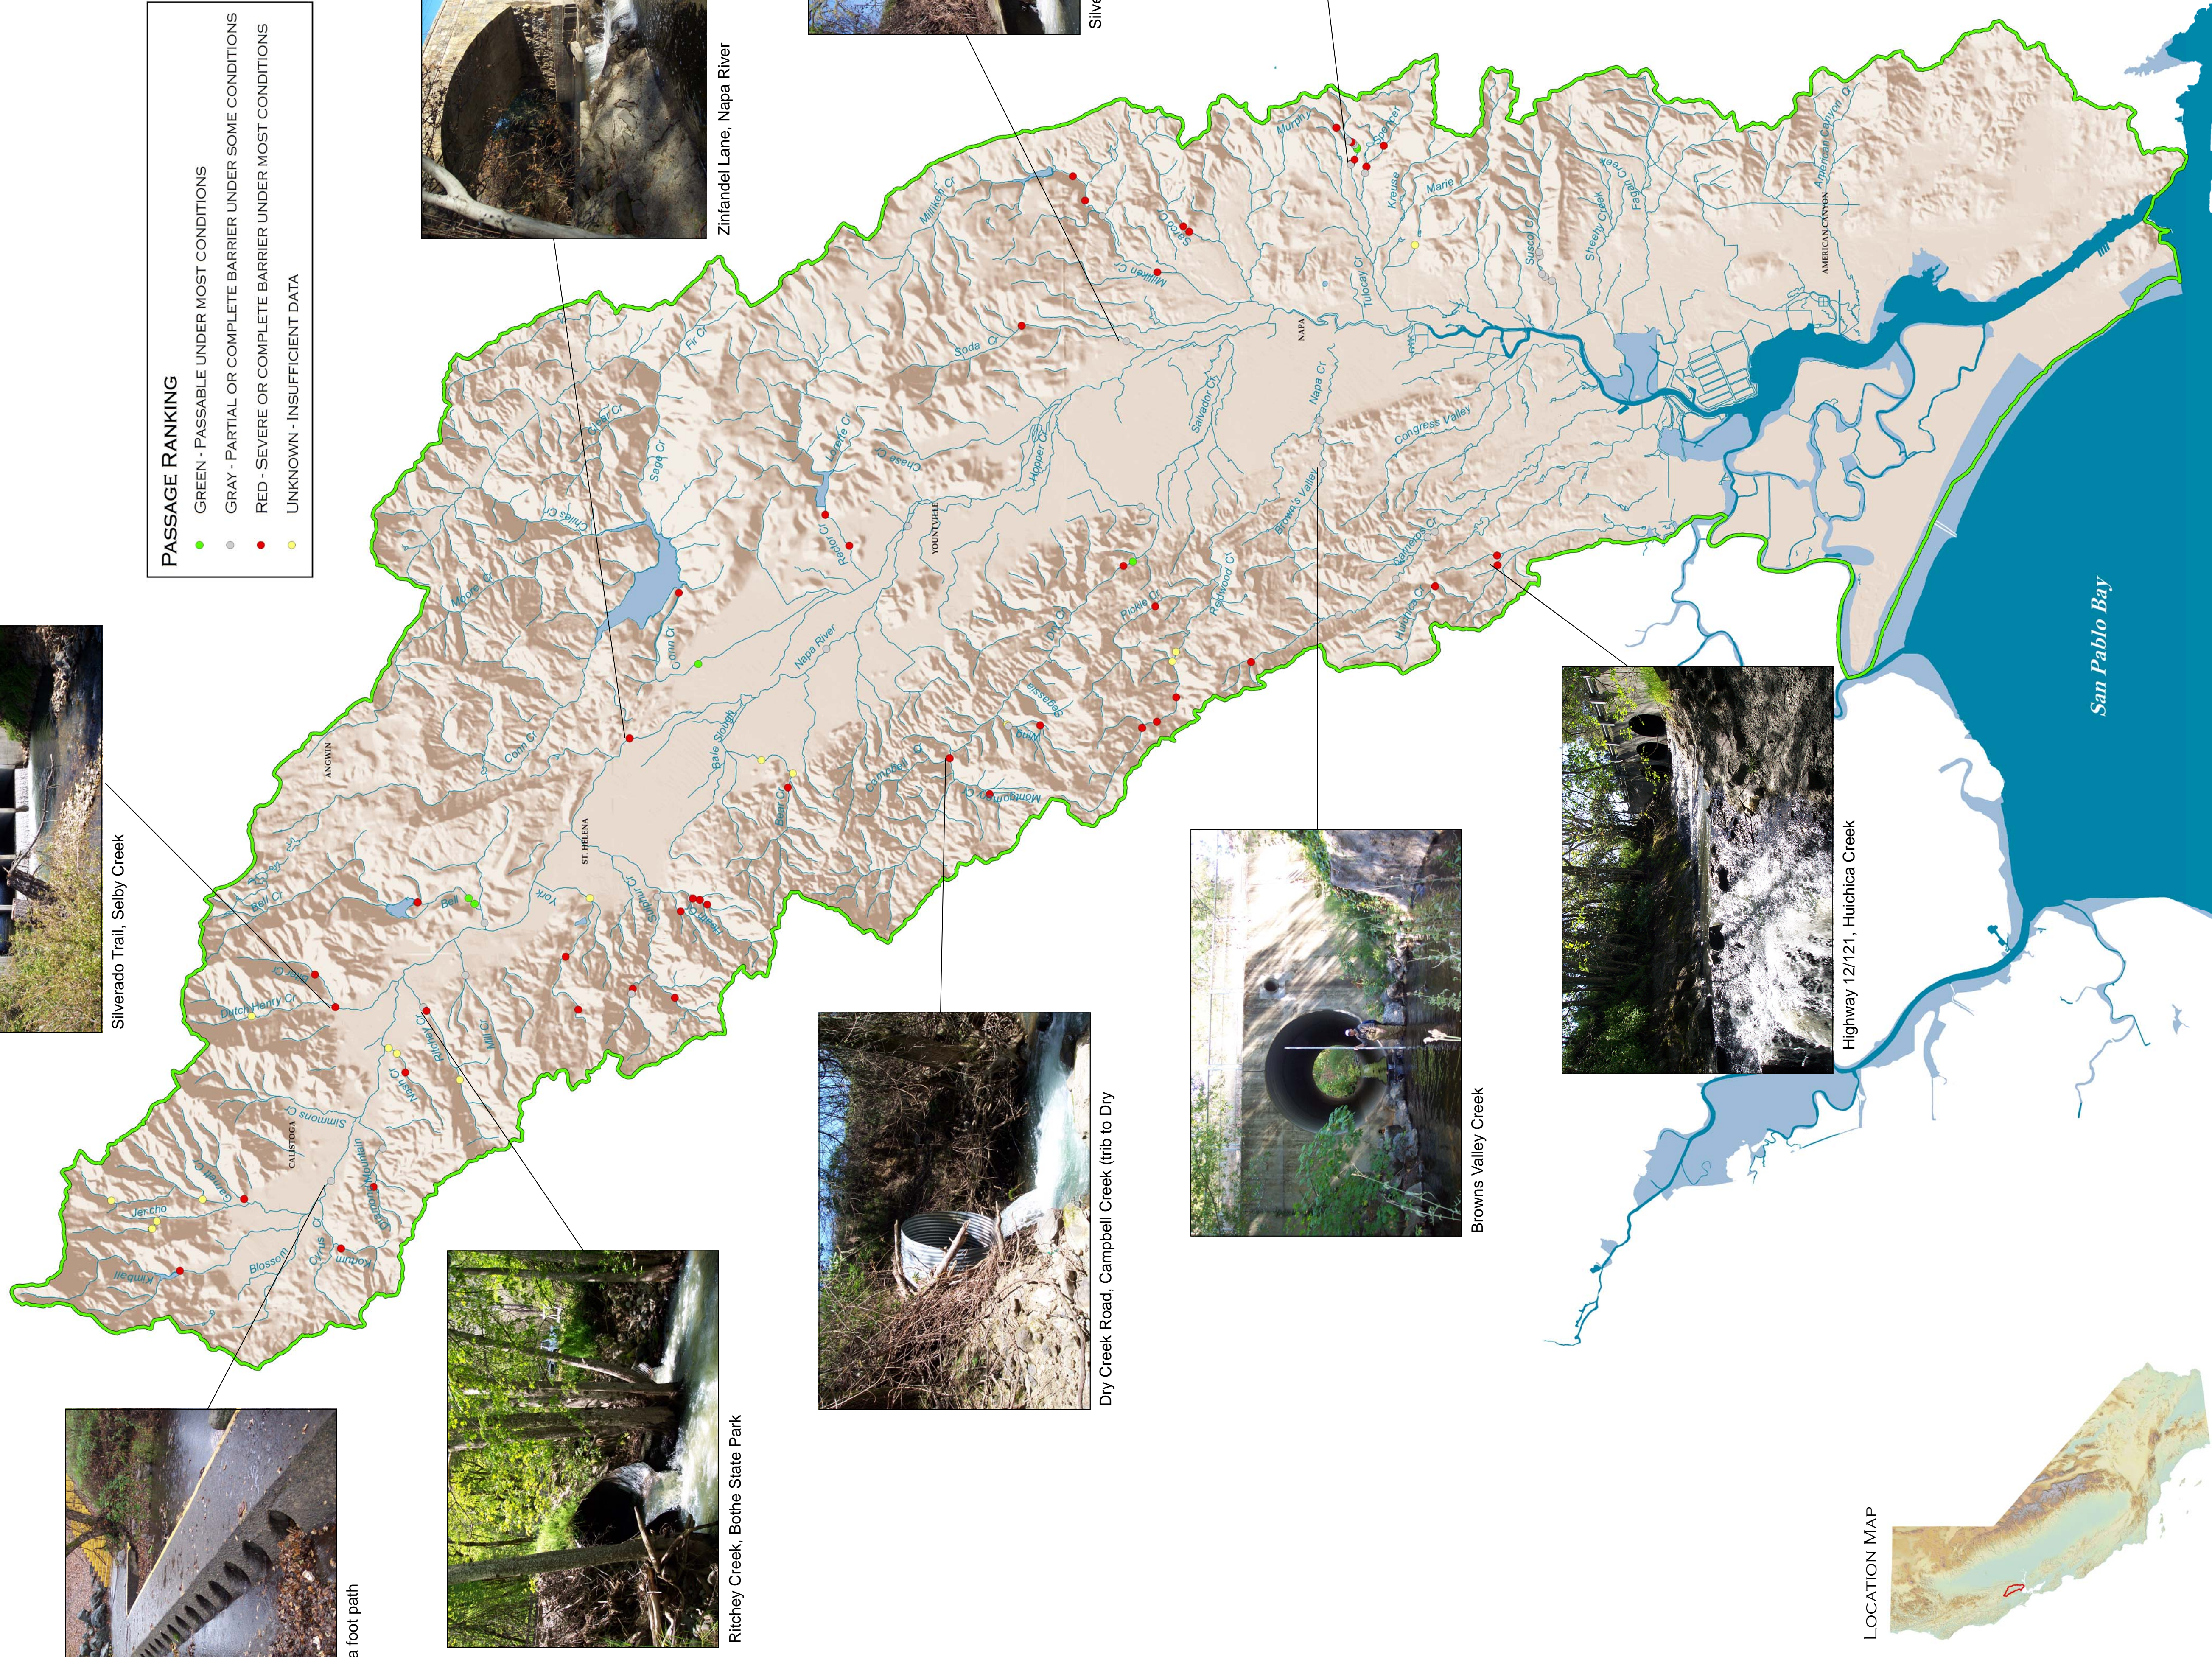
PASSAGE RANKING
 GREEN - PASSABLE UNDER MOST CONDITIONS
 GRAY - PARTIAL OR COMPLETE BARRIER UNDER SOME CONDITIONS
 RED - SEVERE OR COMPLETE BARRIER UNDER MOST CONDITIONS
 UNKNOWN - INSUFFICIENT DATA
