## 2007 – The Removal of a Fish Barrier

## 2008 – Restoring an Eroding Riparian Corridor

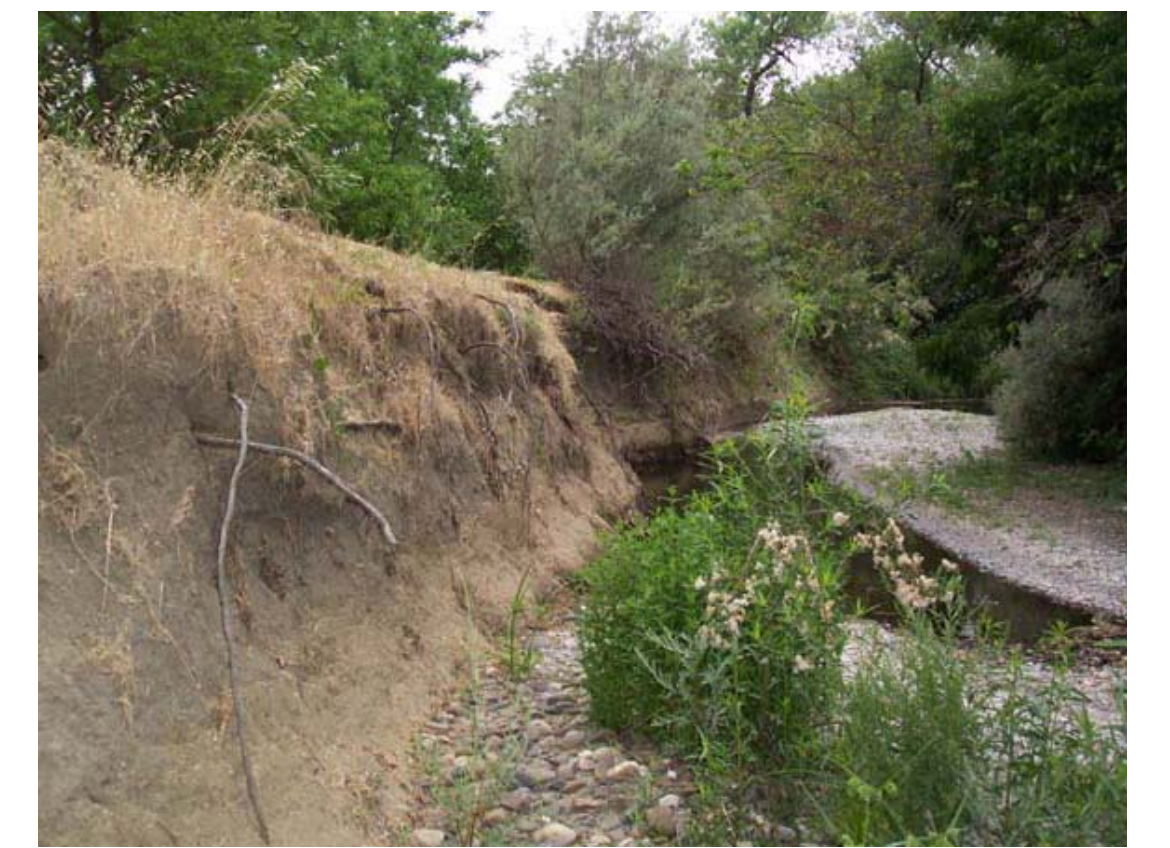
**May 23, 2008**  
 Before construction (all looking upstream): The creek bank was vertical, soil was sloughing into the channel during large storm events and there was very little vegetation on the streambank.

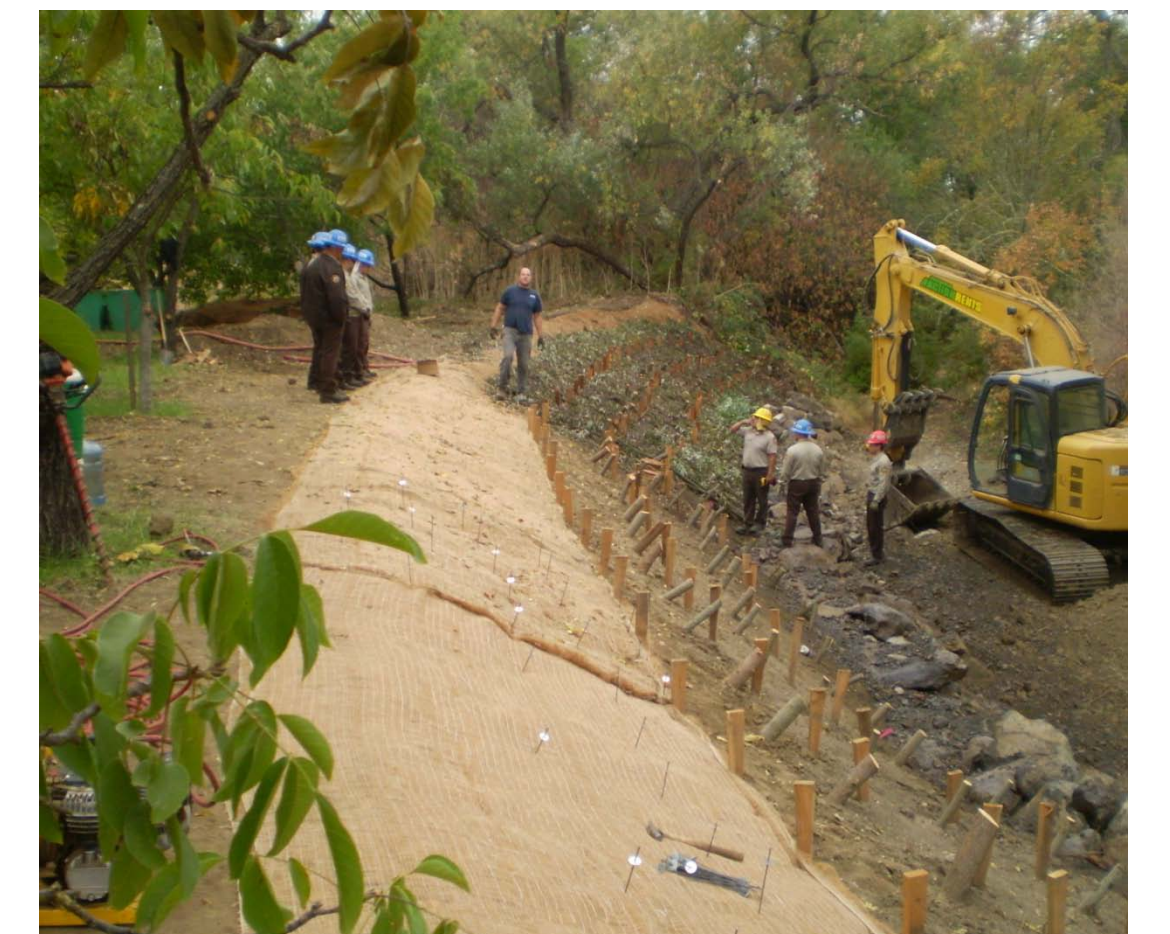
**September 29, 2008**  
 During construction: The bank has been graded back to open the channel. The bank toe has been reinforced with toe rock and rock stream barbs. The bank has been planted with willow posts.

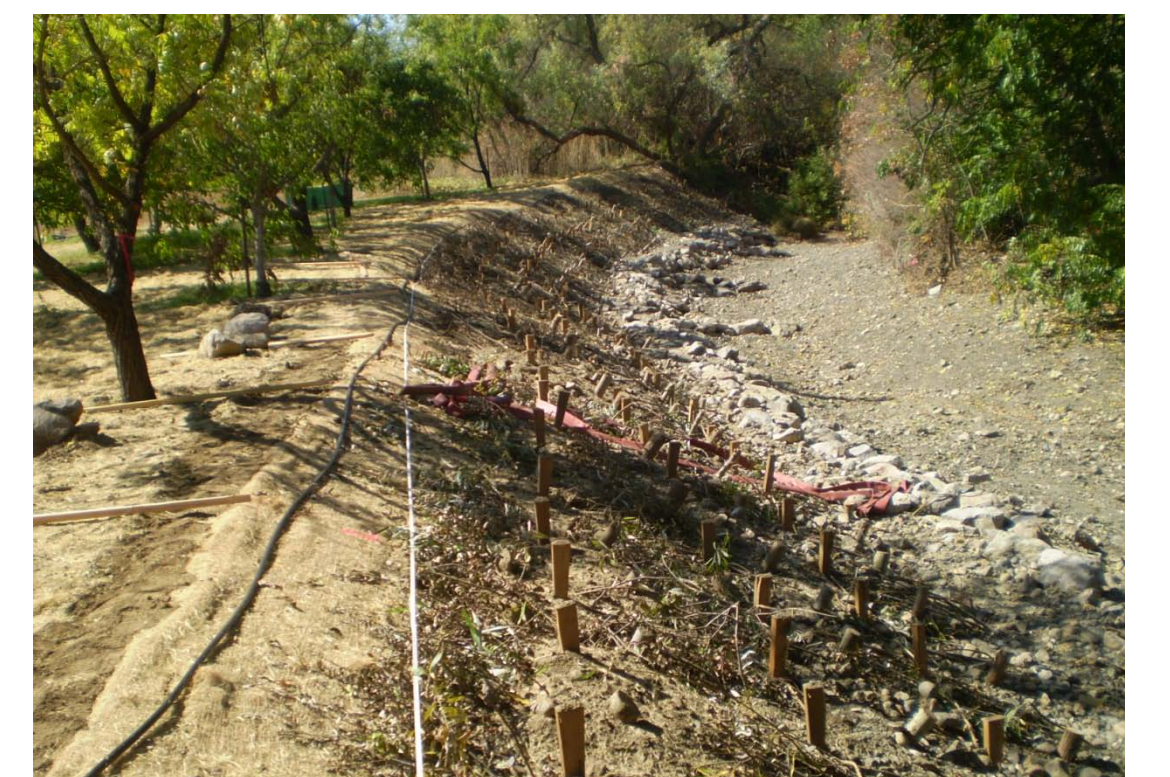
**October 6, 2008**  
 After construction: The willow brush mattress has been tied down. Irrigation uprights are at the channel top. The site is ready for late fall and winter rains.

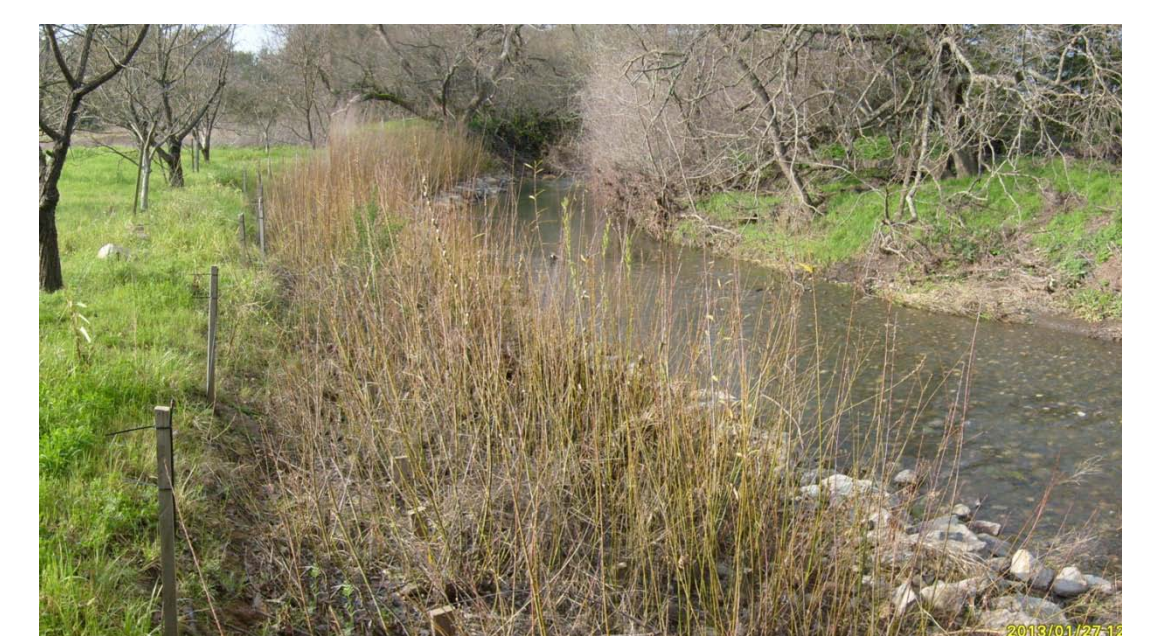
**February 2, 2010**  
 After the rains: The treatments have endured the '08-09 and '09-10 storm seasons, the willows are growing, and the dynamic stream is adjusting to a new equilibrium.
