**Napa River Rutherford Reach Restoration Project
Phase I, Reaches 1 and 2**

FINAL PROJECT REPORT

**Napa County, California
May 30, 2011**

State Revolving Fund Project No: C-06-6924-110
SWRCB Agreement No's: 08-348-550 and 06-282-552-01

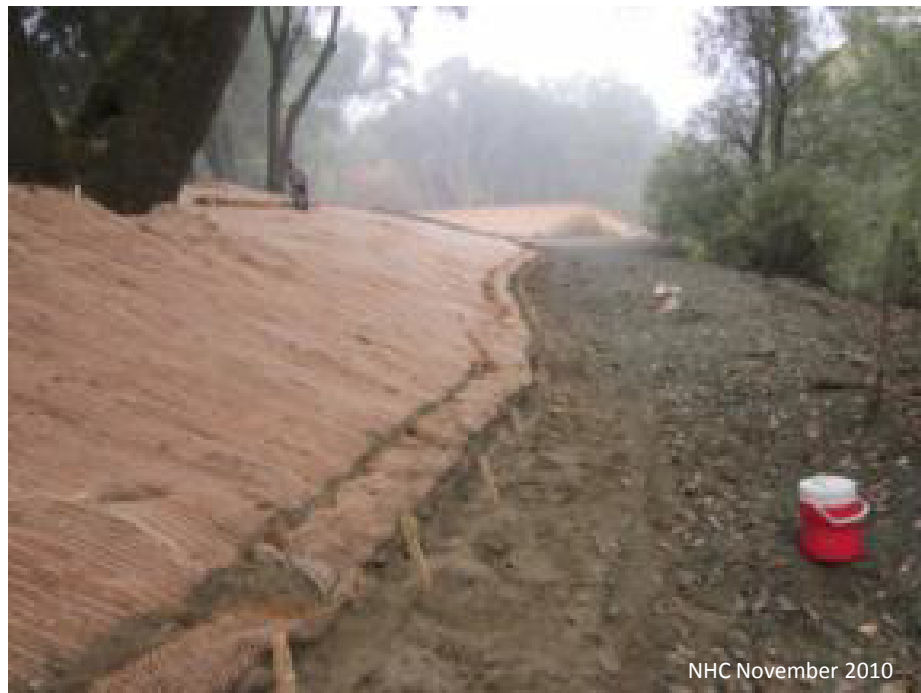
Looking Upstream from Station 21,750

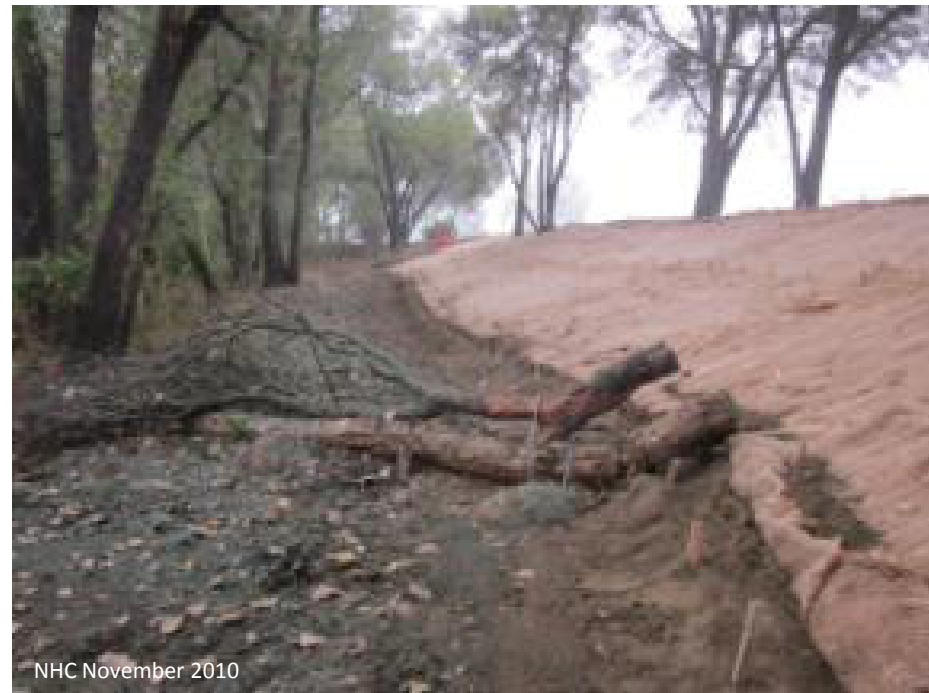
Looking Downstream from Station 21,750

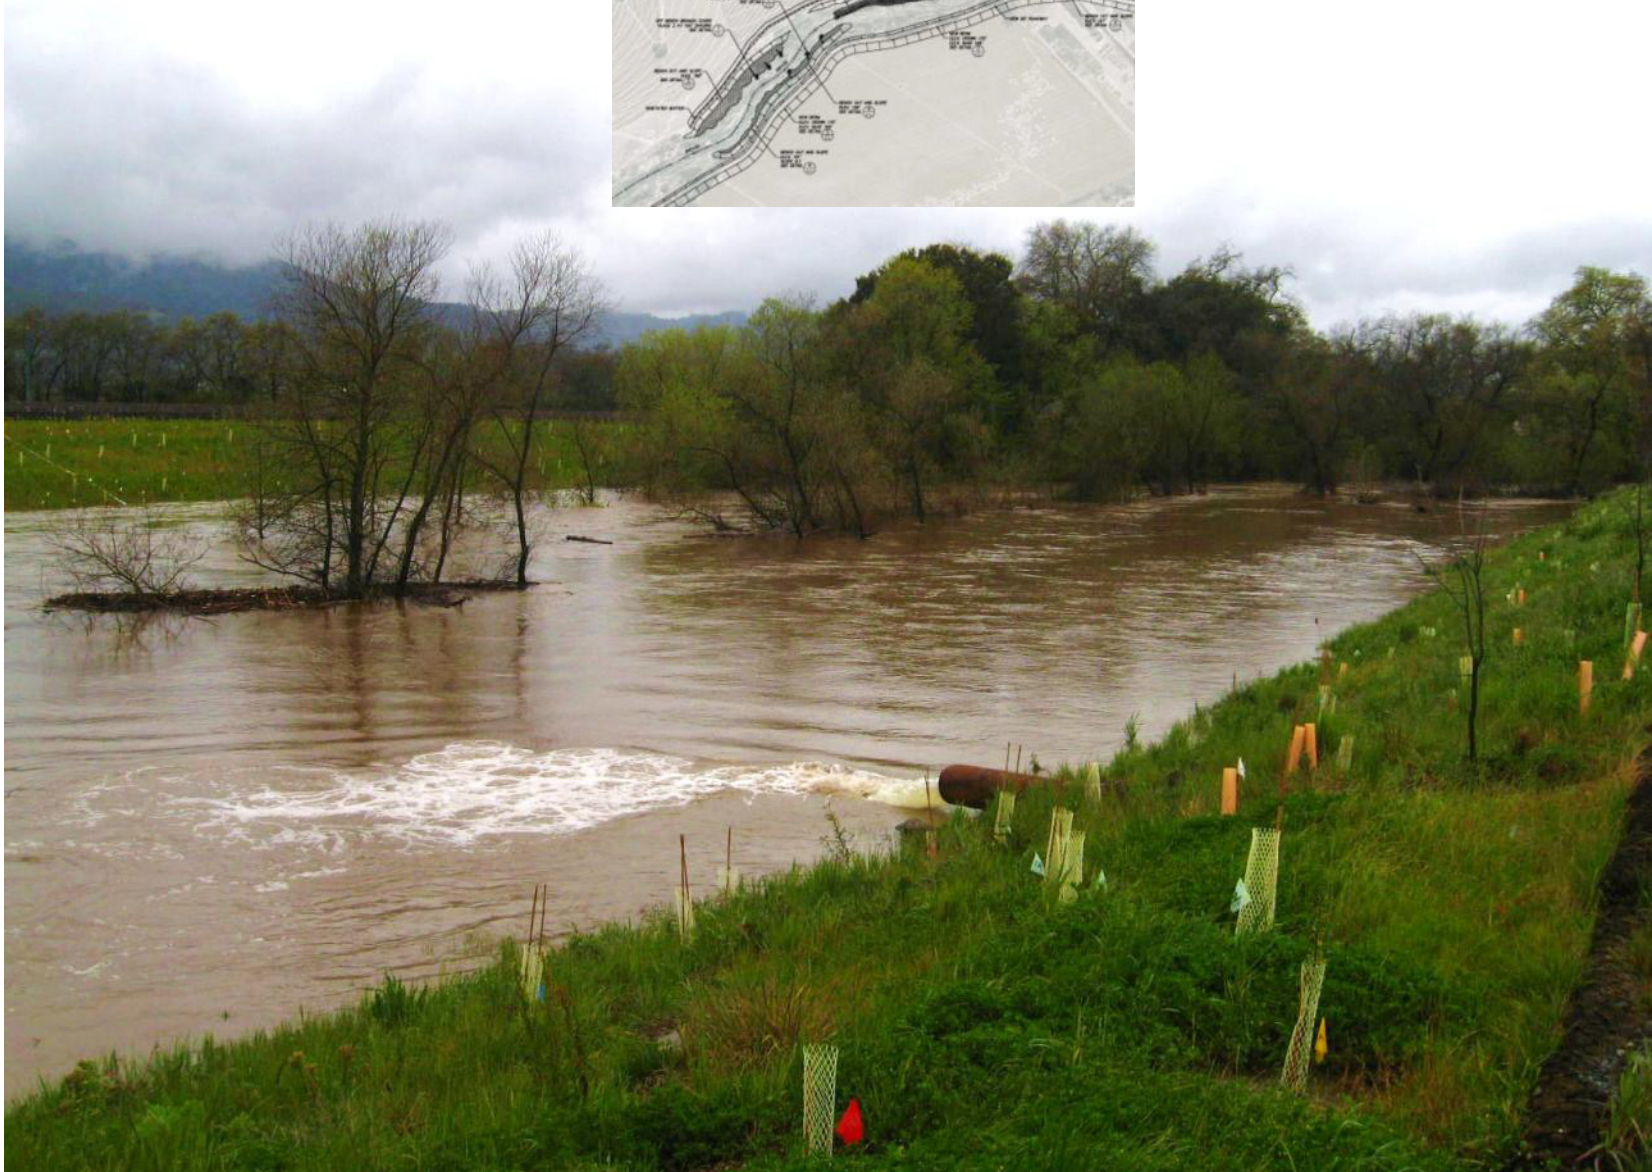
Station 19,800 From East Bank Bench to West Bank Bench March 2011

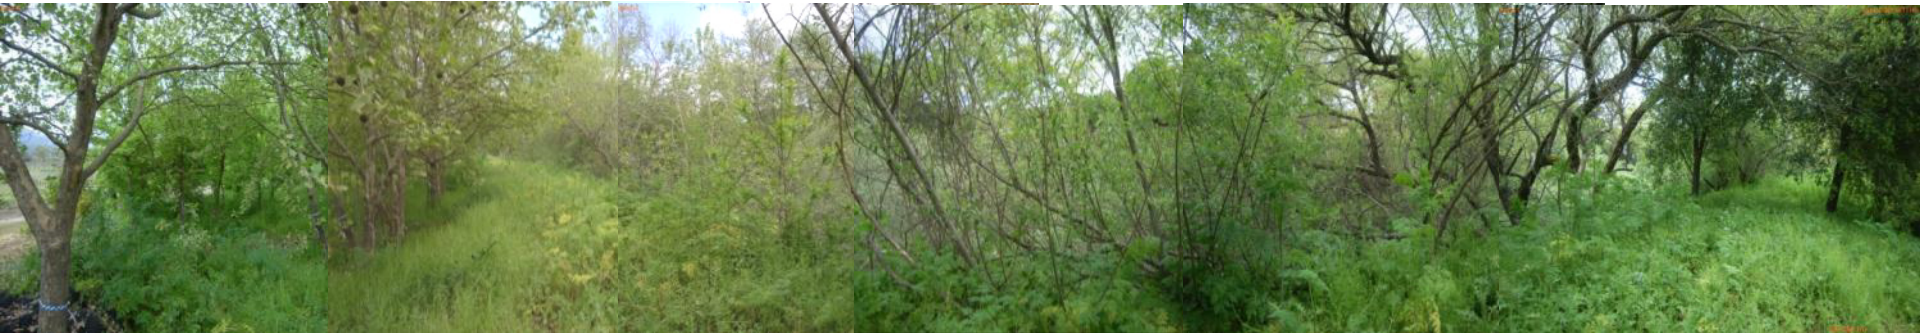
Looking Towards Channel From West Bank Station 18,400

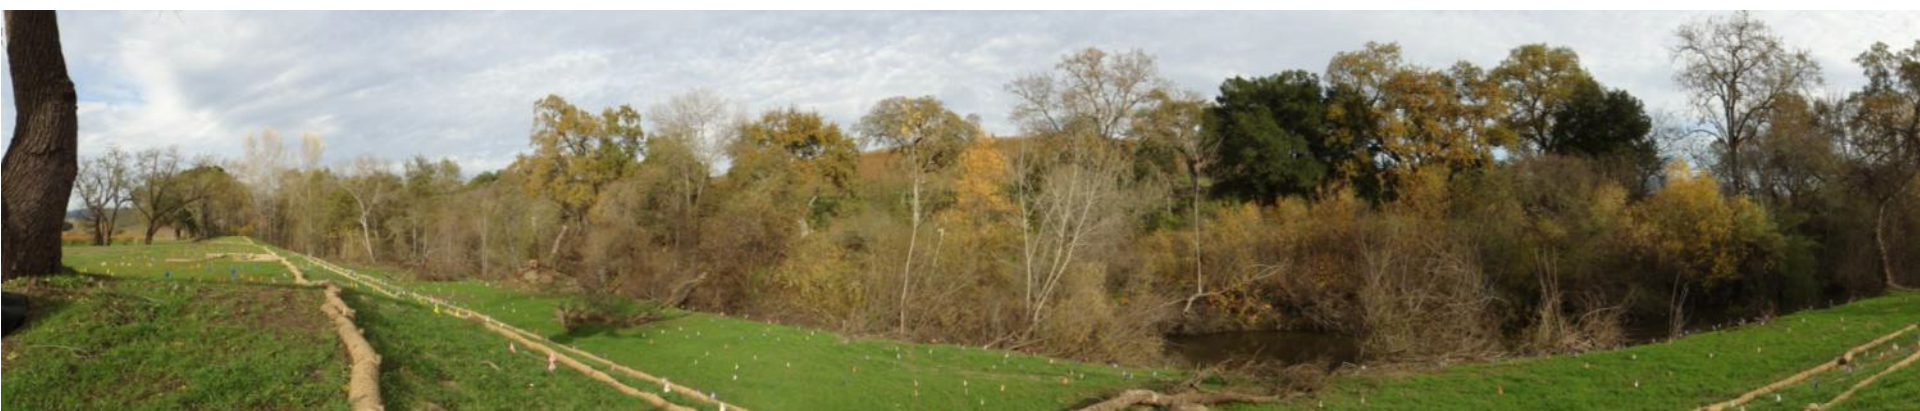
Looking Towards Channel From West Bank Station 18,200

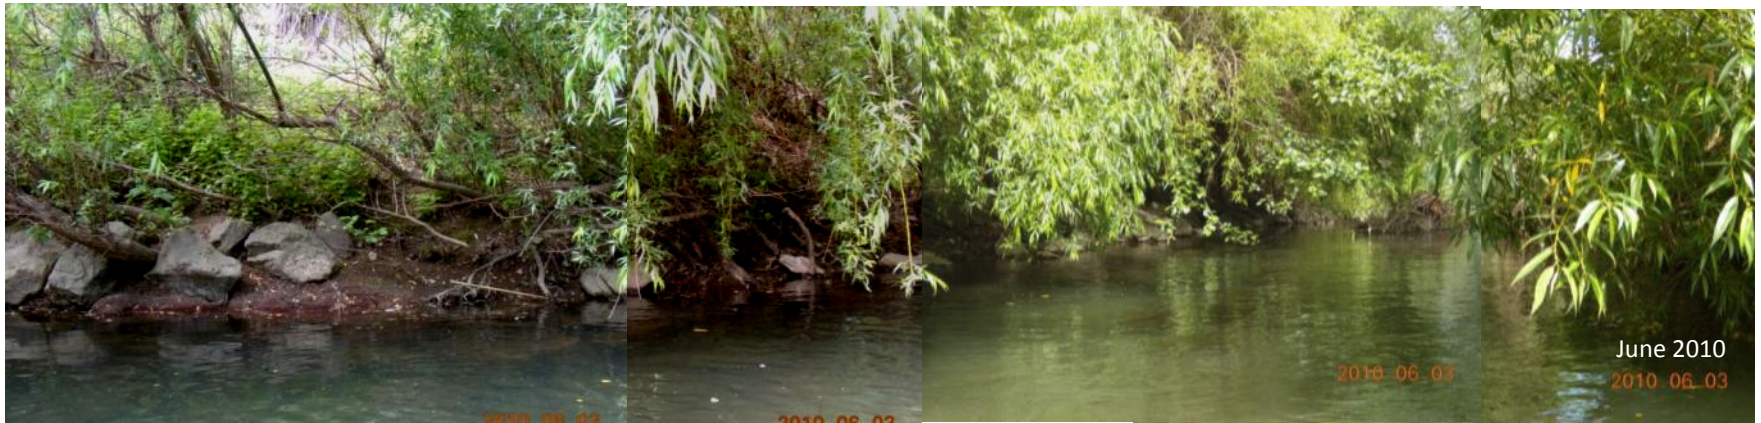
Looking Upstream From Station 19,420 to Station 19,450

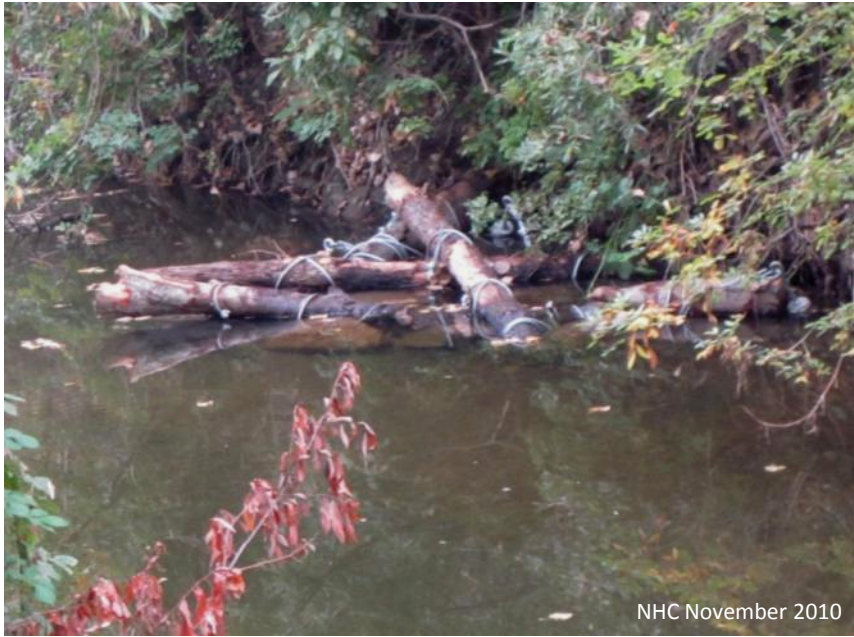
Looking Upstream From Station 21,870 to Station 21,900

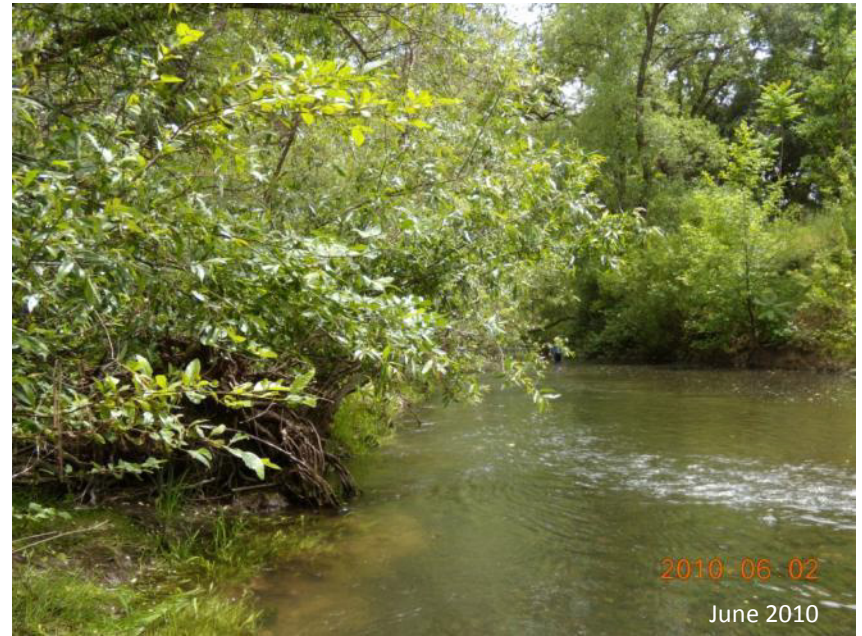
Looking Downstream From Station 21,940 to Station 21,900

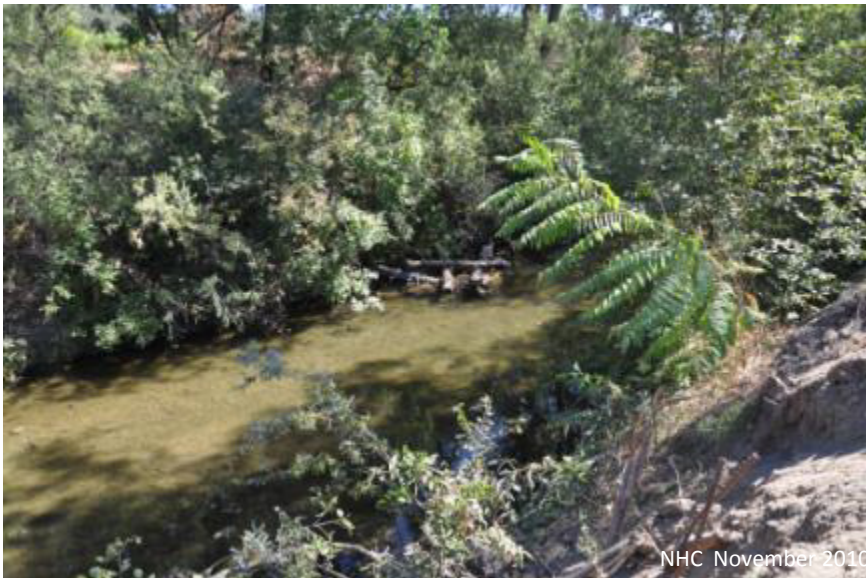
Looking Downstream From Station 21,940 West Bank to Station 21,900

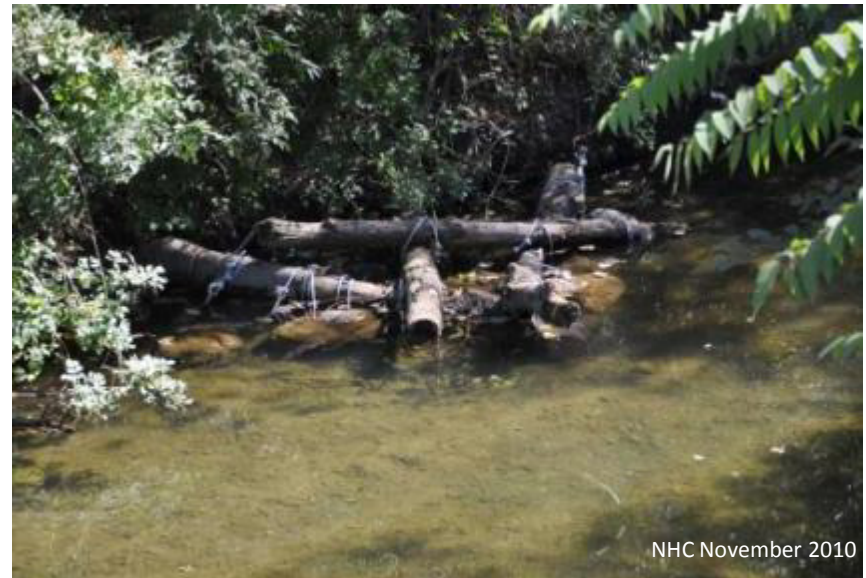
Looking Downstream From Station 21,920 West Bank to Station 21,900

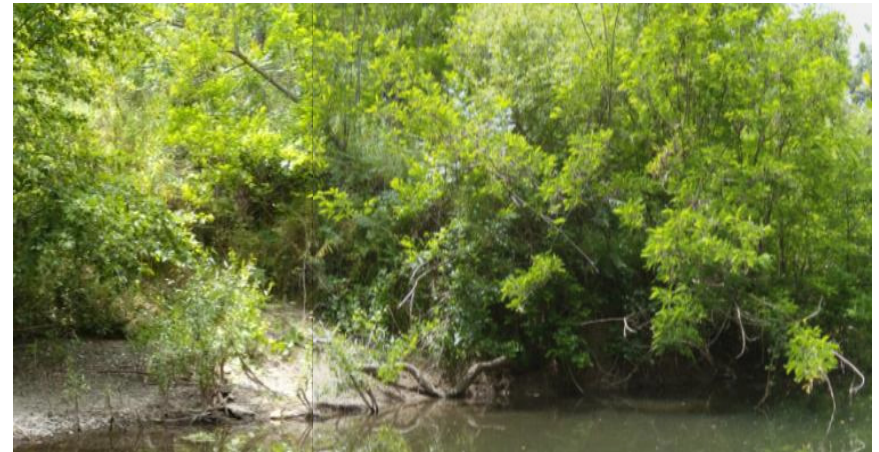
Looking Upstream From Station 22,050 to Station 21,100

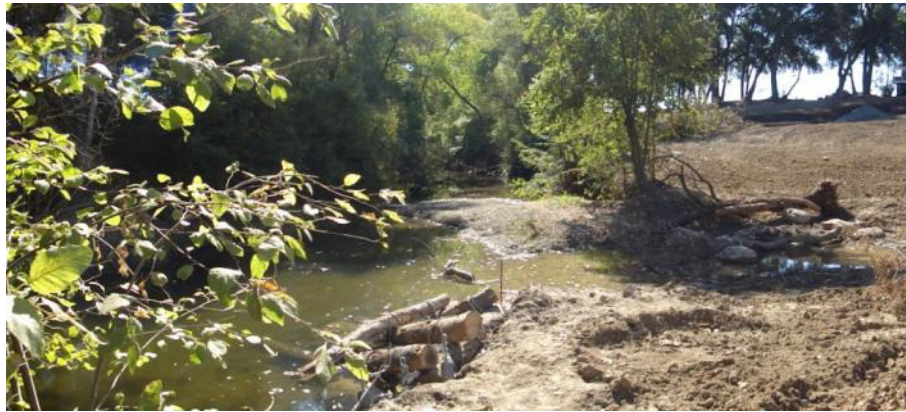
Looking Downstream From Station 22,200 to Station 21,100

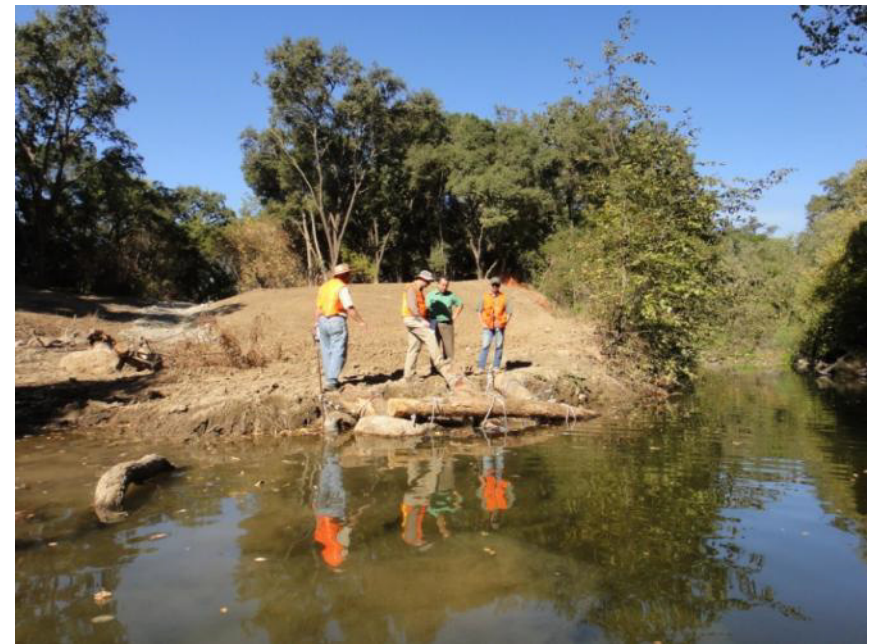
Looking Upstream From Station 22,050 to Station 21,100

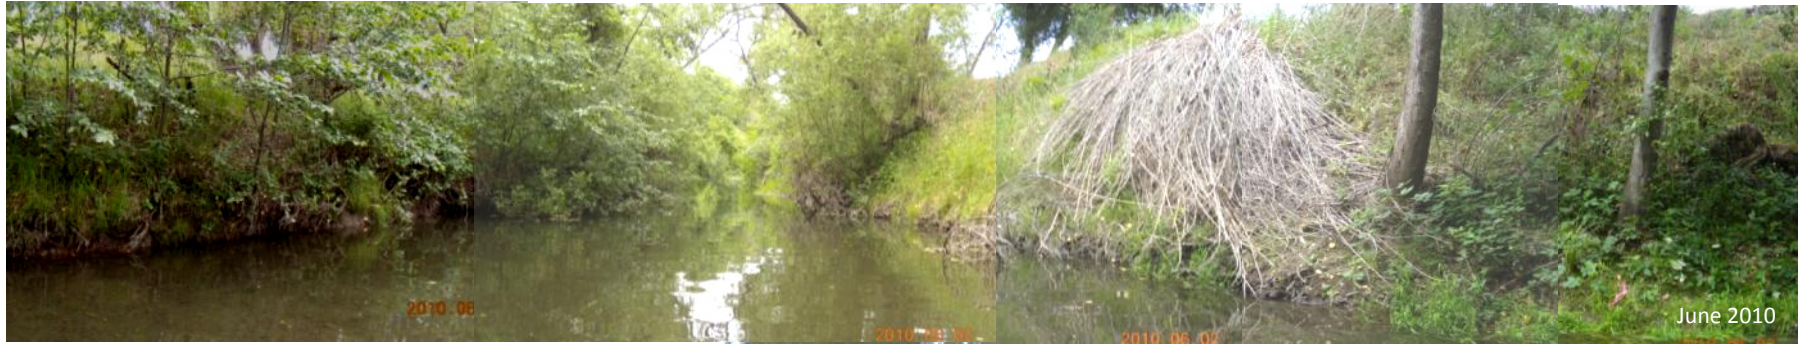
Looking Upstream From Station 21,690 to Station 21,700

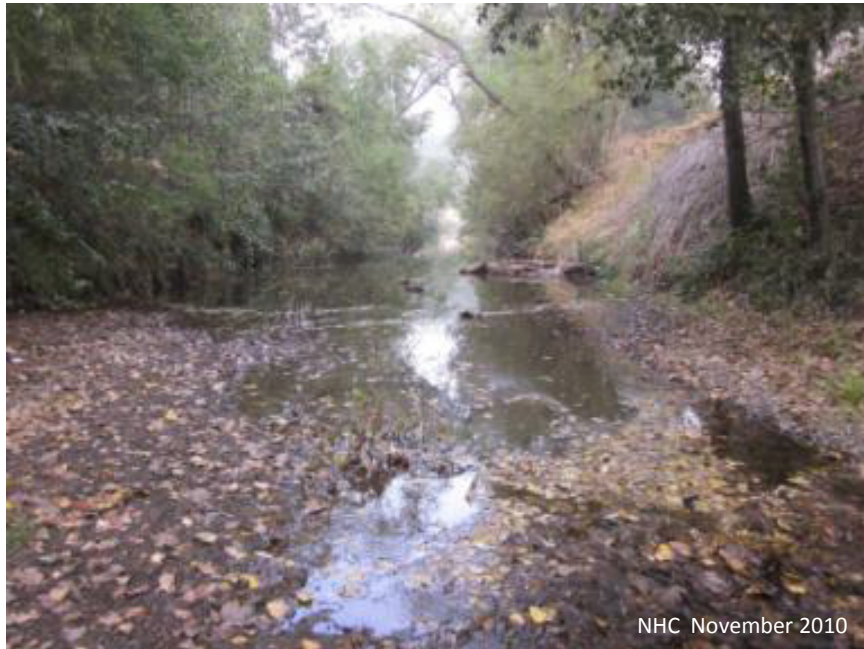
Looking Upstream From Station 21,690 to Station 21,700
November 2010
