Napa River Sediment TMDL Monitoring Program: Summary Report of Pilot Implementation

Stillwater Sciences. 2013. Napa River Sediment TMDL Monitoring Program: Summary Report of Pilot Implementation. Final Technical Memorandum. Prepared by Stillwater Sciences, Berkeley, California for the Napa County Resource Conservation District, Napa, California and State Water Resources Control Board, Oakland, California.

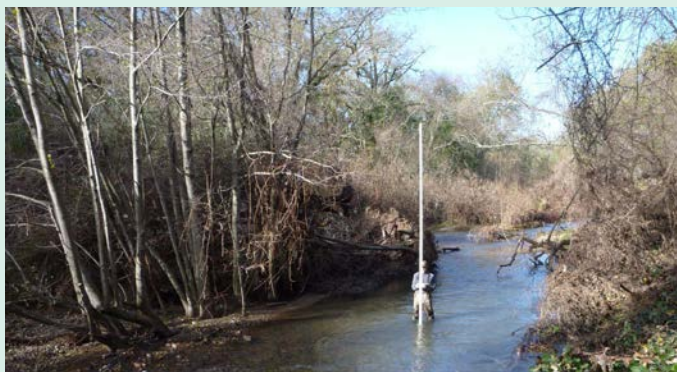
Upper right: Photographic view of high-water survey in reach M2 on the upper Napa River (photo taken December 14, 2012 by Napa County RCD)

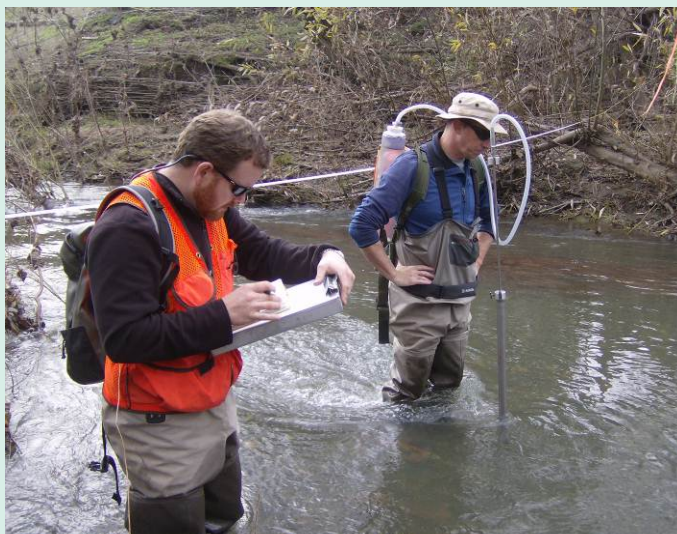
Bottom right: Photographic view of permeability measurements at site M5-1 on the middle Napa River (photo taken on December 12, 2012 by Stillwater Sciences)

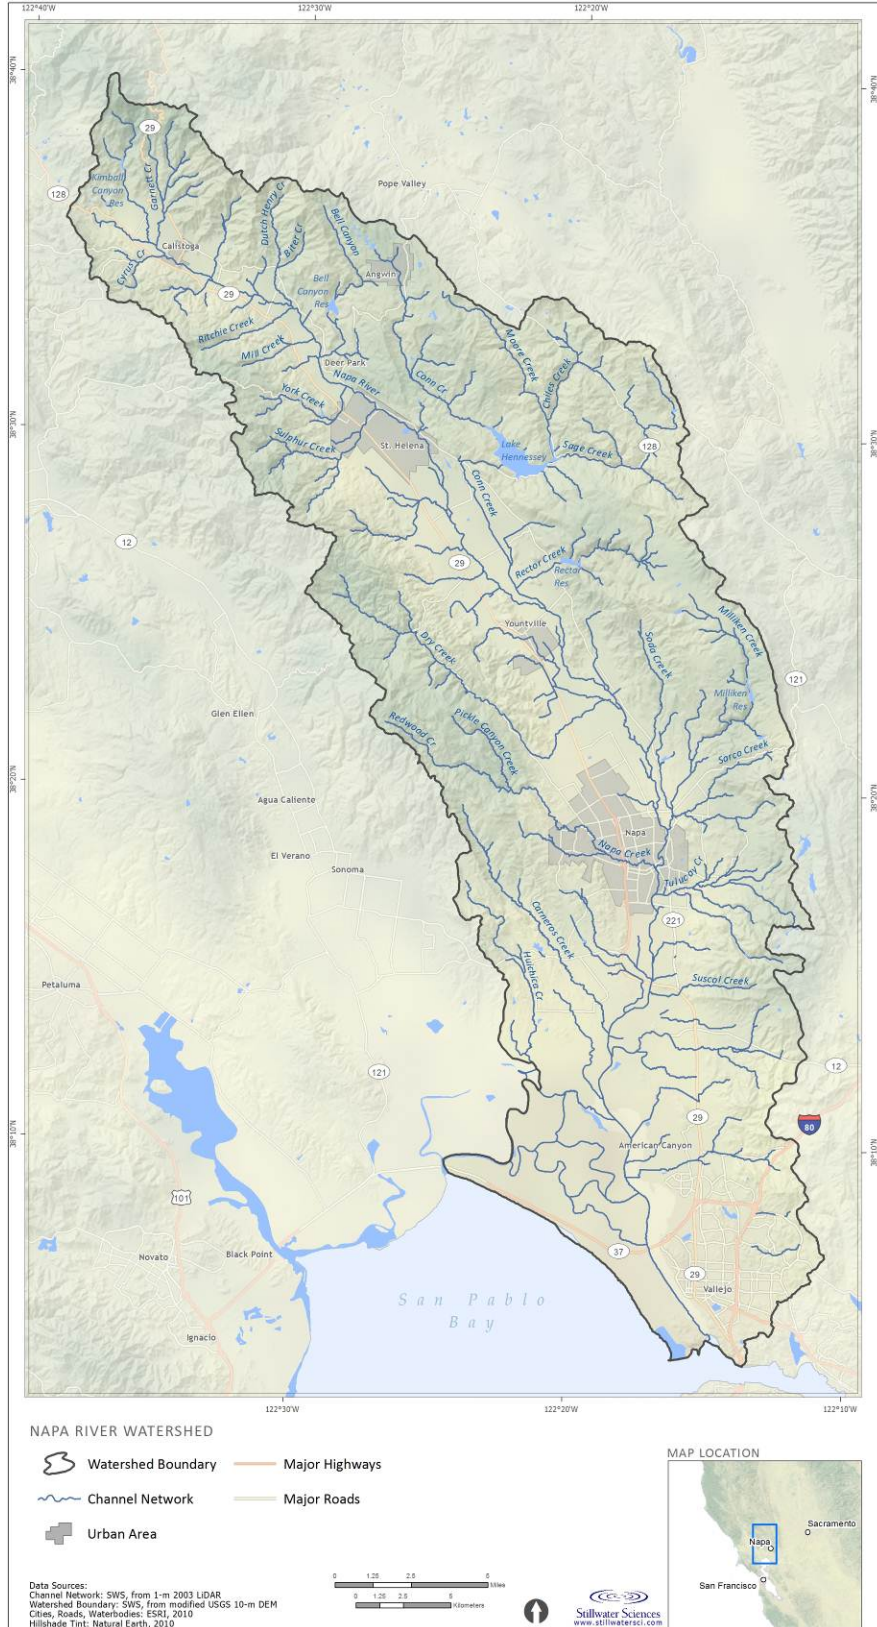
Figure 1. Hydrography map of the Napa River watershed.

The Napa River drains a 1,100-km² (420-mi²) watershed and flows through the cities of Calistoga, St. Helena, Yountville, Napa, American Canyon, and Vallejo before discharging into San Pablo Bay near the mouth of the Sacramento-San Joaquin estuary (Figure 1). The 90-km (60-mi) long river originates in steep, forested headwaters exceeding 1,300 m (4,300 ft) at Mount Saint Helena and then enters the depositional Napa Valley, whose floodplain is dominated presently by agriculture and developed areas. Historically, an array of both “connected” tributaries (i.e., tributaries with a discrete channel mouth that delivered water and sediment to the mainstem Napa River) and “disconnected” tributaries (i.e., tributaries without a discrete channel mouth that flowed directly onto the mainstem floodplain) flowed into the Napa Valley (Grossinger 2012). Over the past century, widespread channelization for urban and agricultural land uses has resulted in the direct connection of most tributaries to the Napa River. Currently,

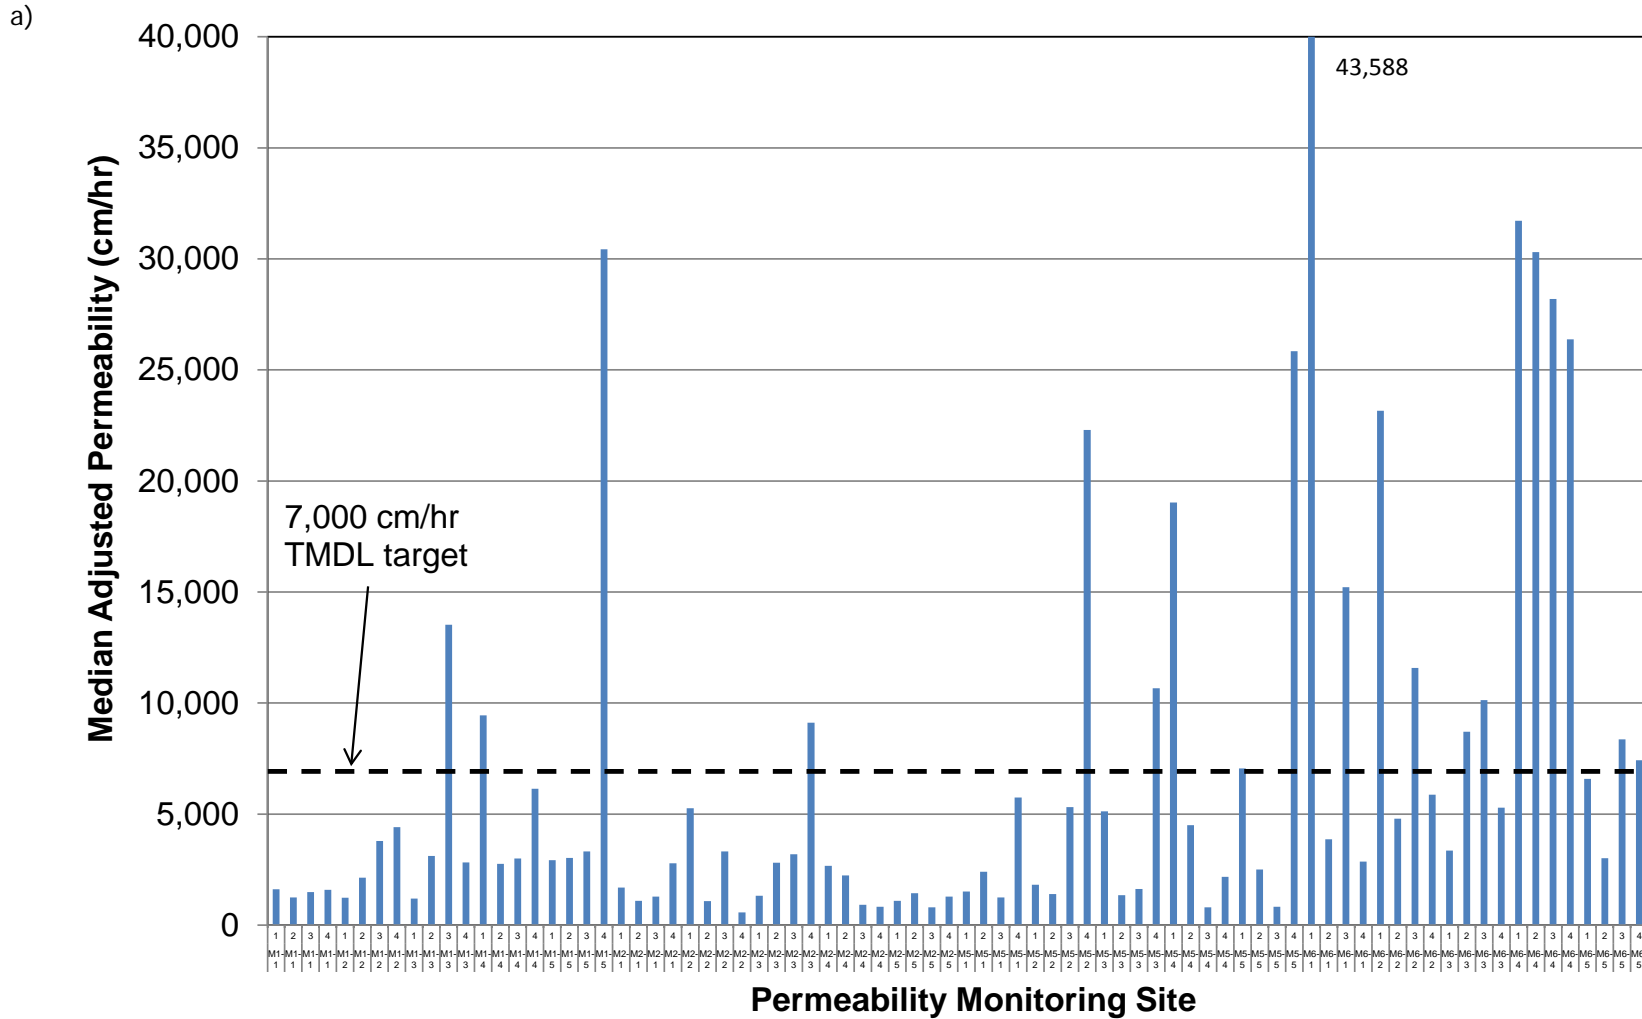
Figure 9. Permeability measurements from the mainstem (a) and tributary (b) monitoring sites. Shown in the plots are the median values of the five replicate measurements made at each artificial redd.

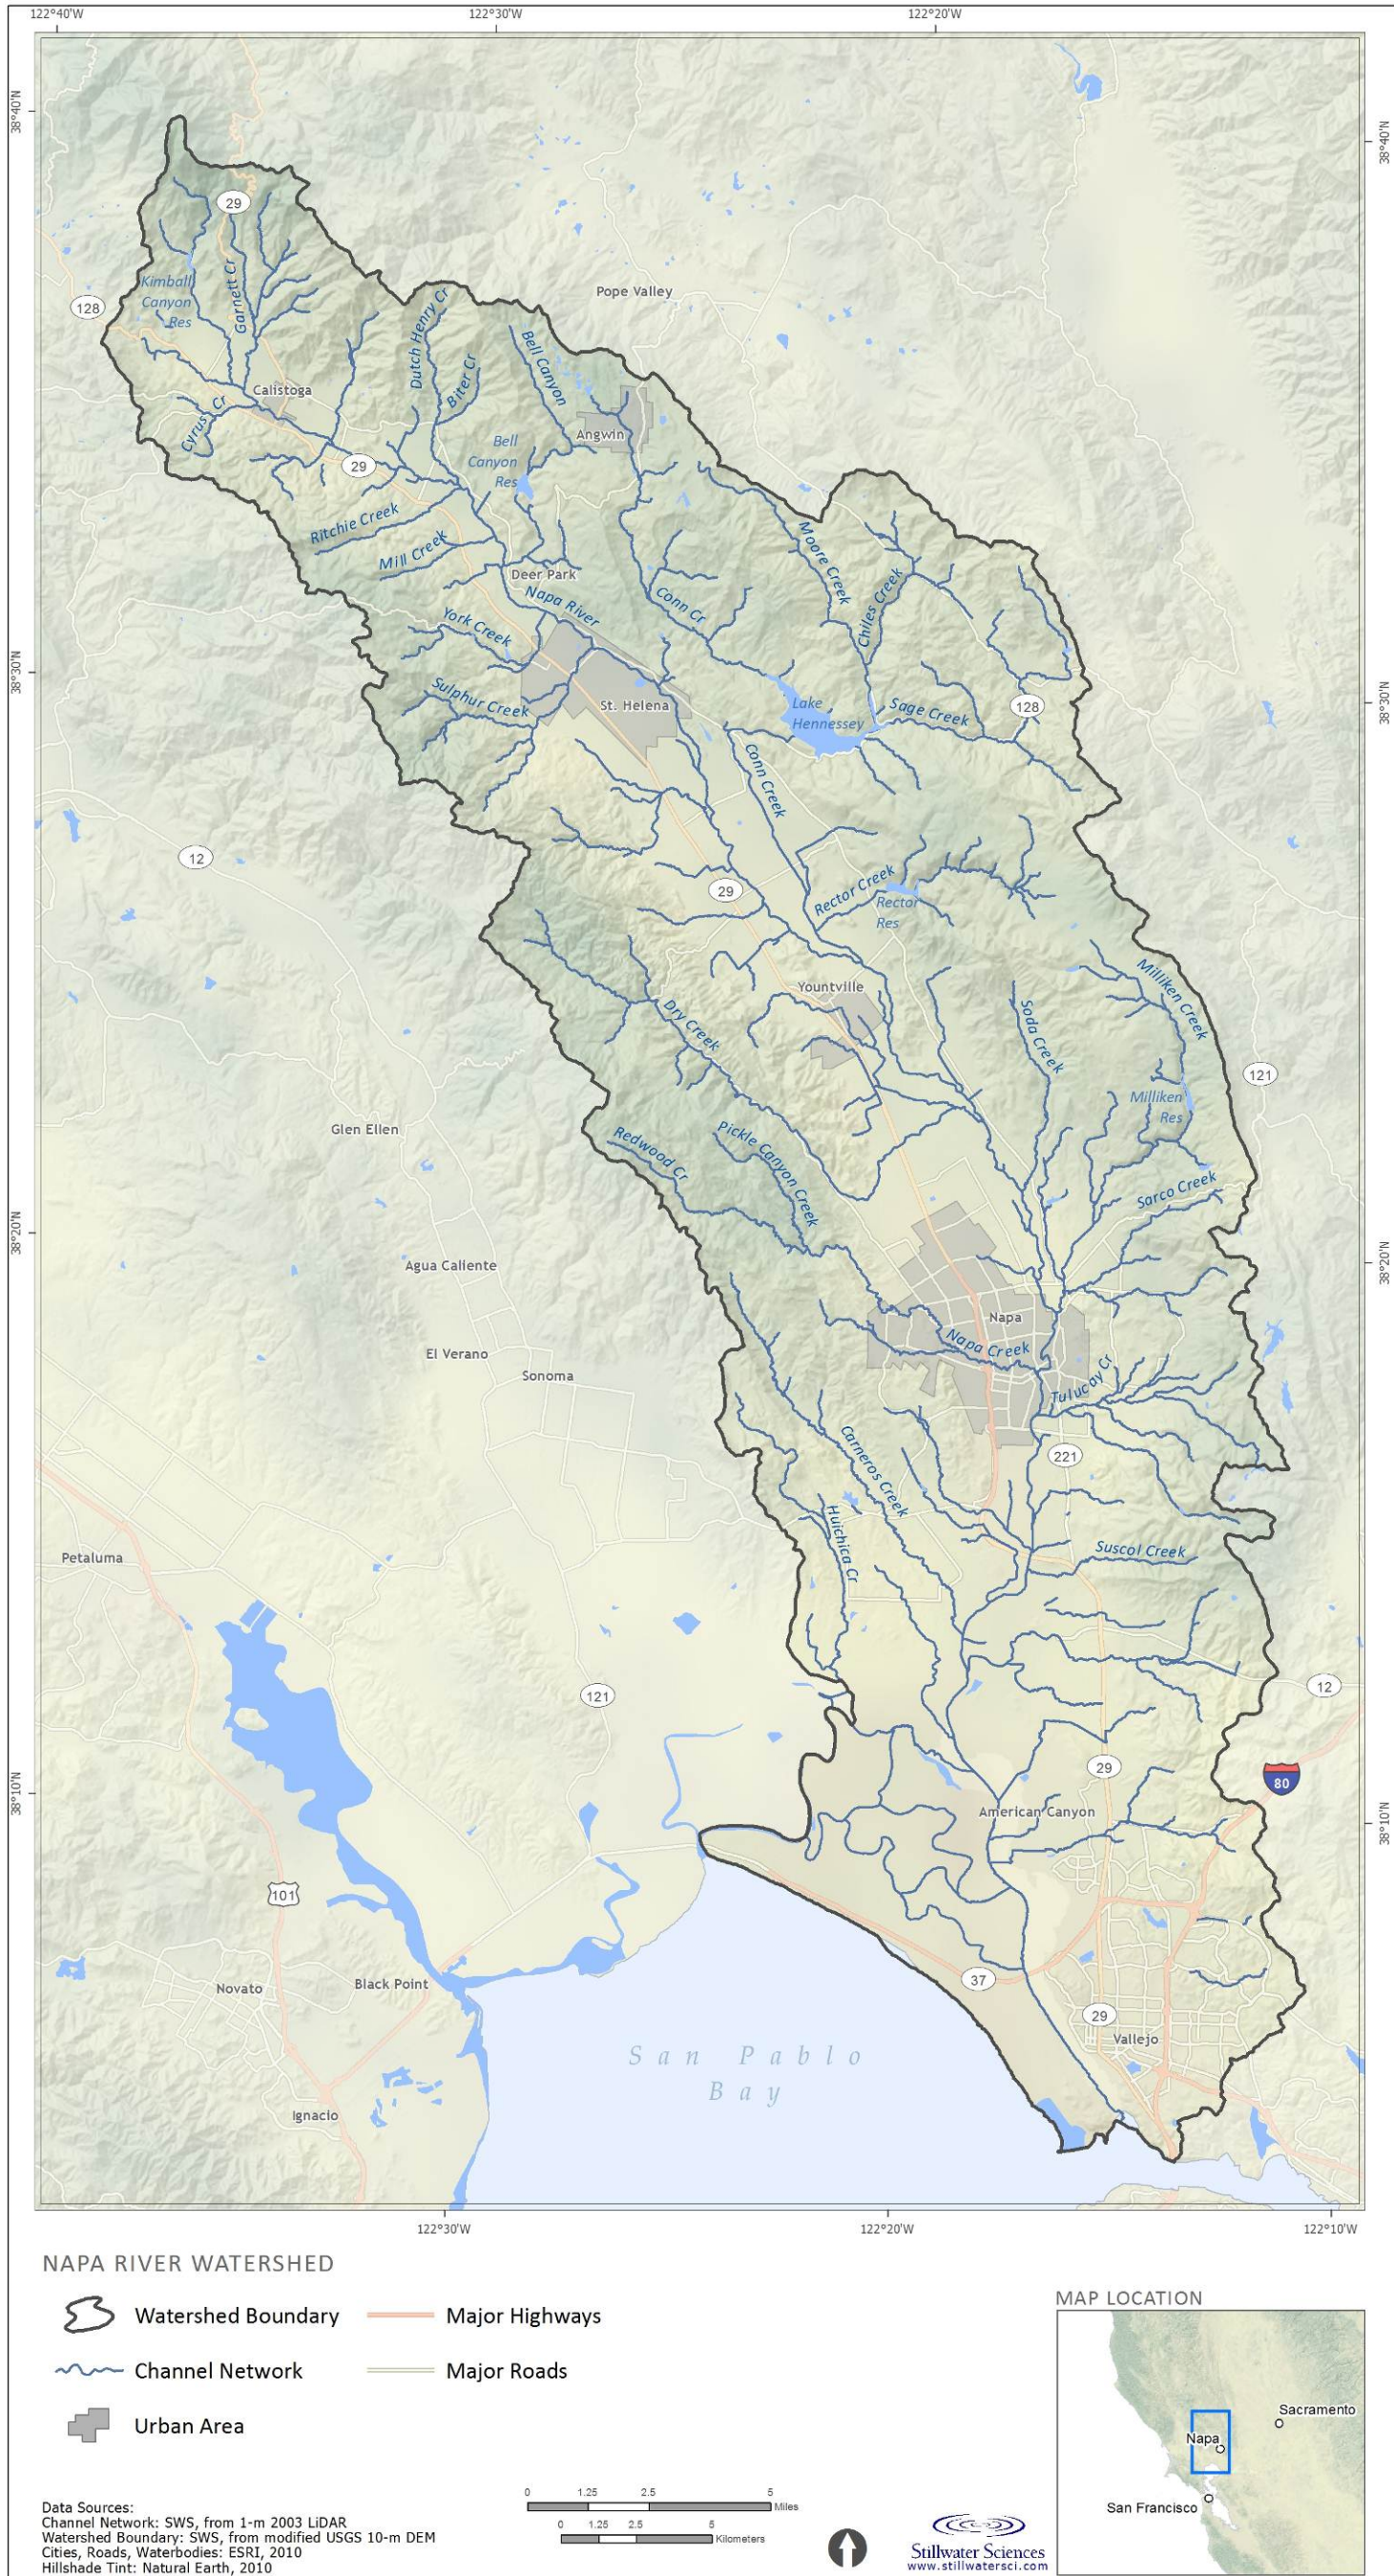
Figure 2-1. Napa River watershed.

The Napa River drains a 1,200 km² watershed and flows through the cities of Calistoga, St. Helena, Yountville, Napa, American Canyon, and Vallejo before discharging into San Pablo Bay near the mouth of the Sacramento-San Joaquin estuary (Figure 2-1). The river originates in steep, forested headwaters (elevation 1,200 m) and then enters the depositional Napa Valley, whose floodplain is dominated presently by agriculture and developed areas. Historically, an array of both ‘connected’ tributaries (i.e., tributaries with a discrete channel mouth that delivered water and sediment to the mainstem Napa River) and ‘disconnected’ tributaries (i.e., tributaries without a discrete channel mouth that flowed directly onto the mainstem floodplain) flowed into the Napa Valley (Grossinger 2012). Over the past century, widespread channelization for agricultural land establishment has resulted in the direct connection of most tributaries to the Napa River. Currently, delivery of both water and sediment from tributaries to the Napa River is regulated by the network of water supply dams installed over the past century. Most major dams (i.e., dams large enough to impound water and sediment) are located on the tributaries draining the eastern
