Napa River Rutherford Reach Restoration Project Annual Maintenance and Monitoring Survey

Assessing Instream Habitat Structure, Reach 6, Napa River Rutherford Reach, June 2016

Prepared by:
Napa County Flood Control and Water Conservation District
Napa County, California

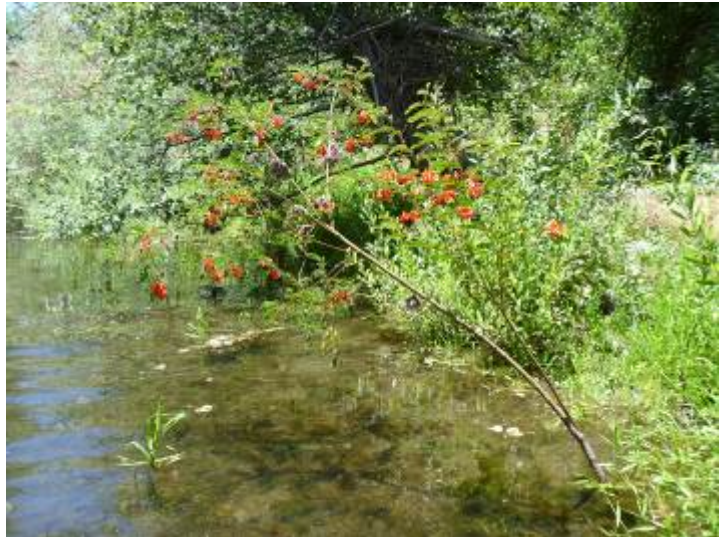
Picture 2: Red Sesbania Reach 4

Figure 3 at the end of the report shows the location of significant occurrences of invasive/Pierce host vegetation that was documented during the 2016 stream survey. Himalayan blackberry, native and hybridized grape, vinca and Mugwort were the dominant target plants identified; other target species documented include Arundo, tree-of heaven, red sesbania (**Picture 2**) and black locust but were limited in distribution. Invasive species such as poison hemlock, fennel, etc. were observed but not quantified during the survey as a result of land owner’s requests in previous meetings to focus on and use funds for treatment of only invasive plant species that are considered Pierce host’s species or priority invasive non-native species.

- Treat large accessible patches of invasive and Pierce host vegetation with mechanical and chemical (glyphosate) methods including Himalayan blackberry, mugwort, vinca, California grape and arundo; this task also includes appropriate re-vegetation planting/seeding and irrigation of treatment of sites where treatment has left significant gaps in the riparian under story canopy,

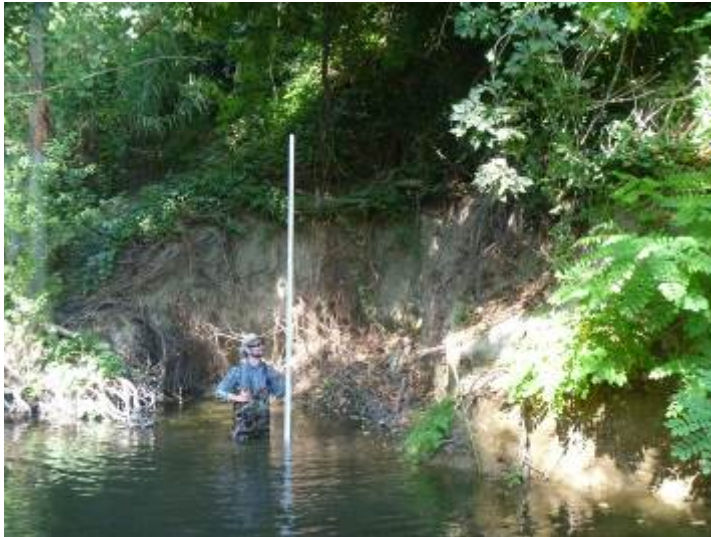
Picture 3: Erosion Site Reach 8

Two areas of localized bank erosion (**Picture 3**) were documented during the survey that the District intends to address/stabilize using a combination of bio-technical methods during the fall of 2016. See **Table 3** below for the location and details of the proposed bank stabilization work to be conducted at these sites.

River Station/Reach	Description	Proposed Work
57+00 (Reach 8)	Arundo treatment site, un-vegetated	Cover bare slope areas with erosion control fabric and jute net, broadcast erosion control seed mix and plant with live willow stakes in fall.
42+35 (Reach 8)	Localized erosion at outlet of floodplain bench	Plant slope with willow pole stakes and/or willow brush mat.

- Repair and stabilize exposed stream bank erosion areas as proposed in Table 3,
- Conducted annual summer mowing of non-native grasses/shrubs on constructed flood plain benches as needed.

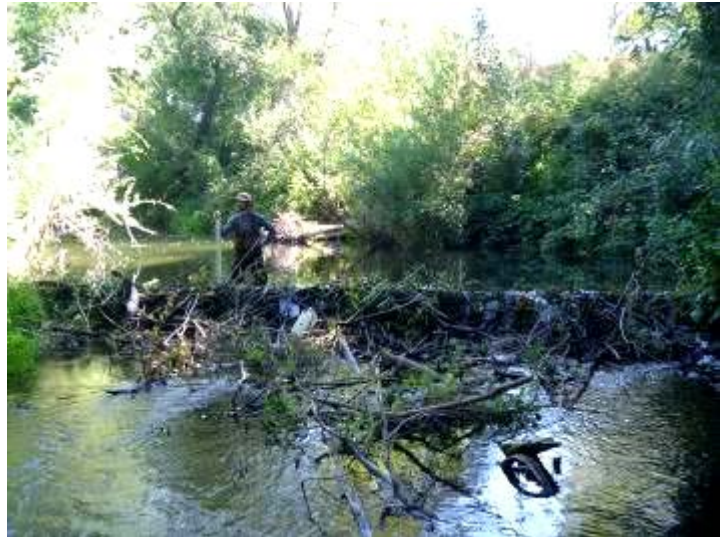
Picture 4: Beaver Dam Reach 9

As documented in previous surveys, a significant level of beaver activity (dam building, downing of trees) has been noted in the Project reach. District staff documented thirteen (13) beaver dams (**Picture 4**) in the Project reach. In general, the District does not consider beaver dams to be an issue that would cause bank erosion or localized flooding; the dams are small relative to the river channel and typically wash away during high winter flows. During the low flow season, the dams impound slow water, providing cool, pool habitat for aquatic wildlife. However, if a particular dam does appear to present a hazard the District will manage the area appropriately by thinning out the structural wood of the dam to allow for sufficient flow and debris conveyance.

- Monitor 2 LWD jams (<12-inches-in-diameter and/or <6-feet-long) adjacent to landowners property in Reaches 1 and 5, manage as needed,
- Continue to protect large riparian trees with hardware cloth in areas that are in close proximity of active beaver dams,
