# Rutherford to Oak Knoll: Napa River and Tributary Restoration

An overview of progress and plans,  
including restoration in Bear Creek/Bale Slough watersheds

**Michael Gordon**  
**Napa County Flood Control &  
Water Conservation District**

May 24, 2018

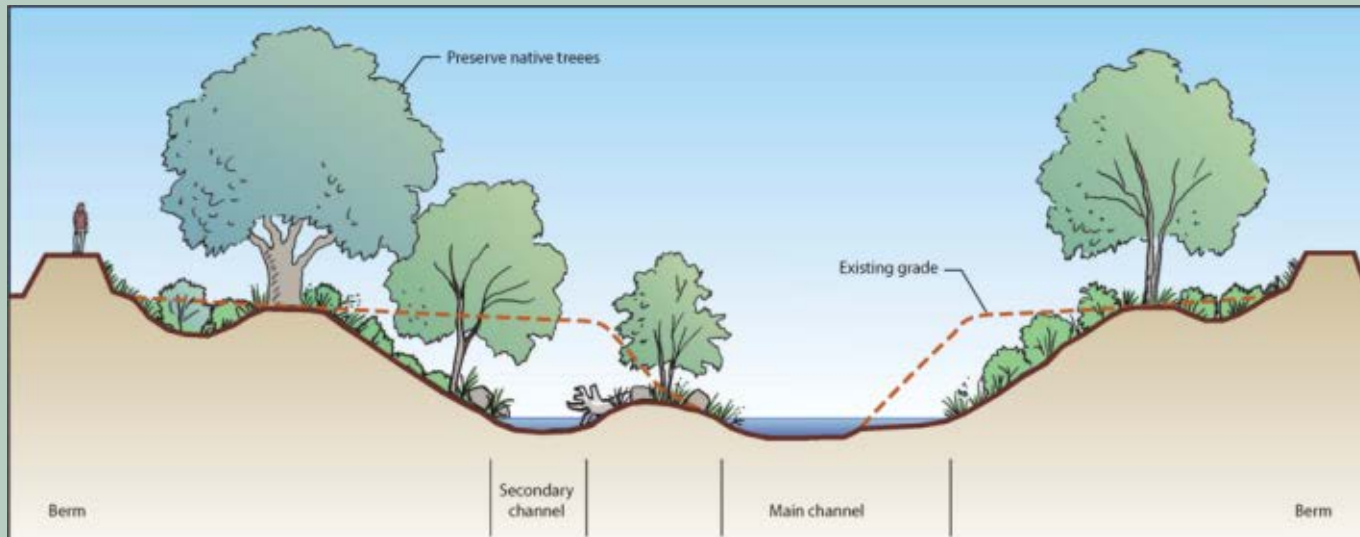
Instead of cutting continuous floodplain benches we have created a **series of expansion areas** separated by narrower sub-reaches. The expansions and contractions break up the existing long glides and force **riffle-pool formation**. Pools create summer **thermal refugia** while riffles create **spawning habitat**. Expansion areas also provide **high velocity refugia** for juvenile fish and a location for fine sediment to settle out.

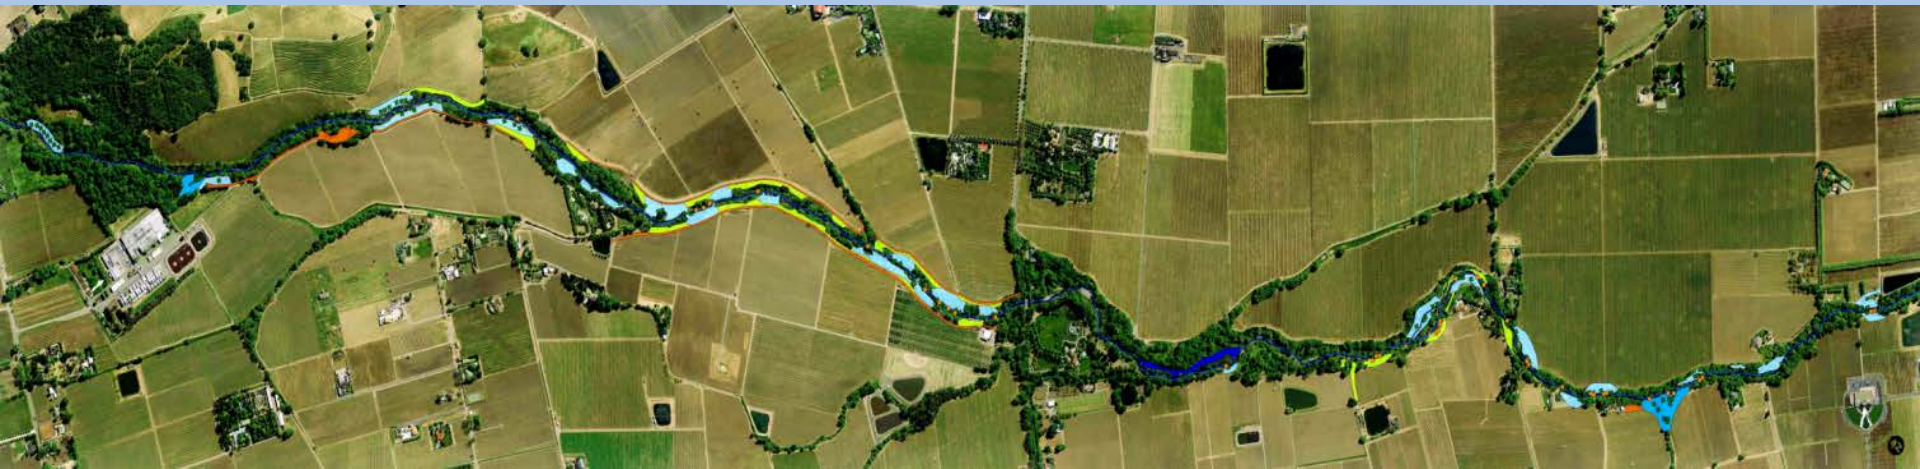
Expanded Riparian Corridor

Setback Berms

Floodplain Benches

Tributary Alcove

Instream Structures

3,054 Feet of Secondary Channels Created

31 Acres of Riparian Forest Enhanced

17 Acres of Slow Water Aquatic Habitat Created

2.5 Miles of Channel Widened

147 Instream Habitat Structures Installed

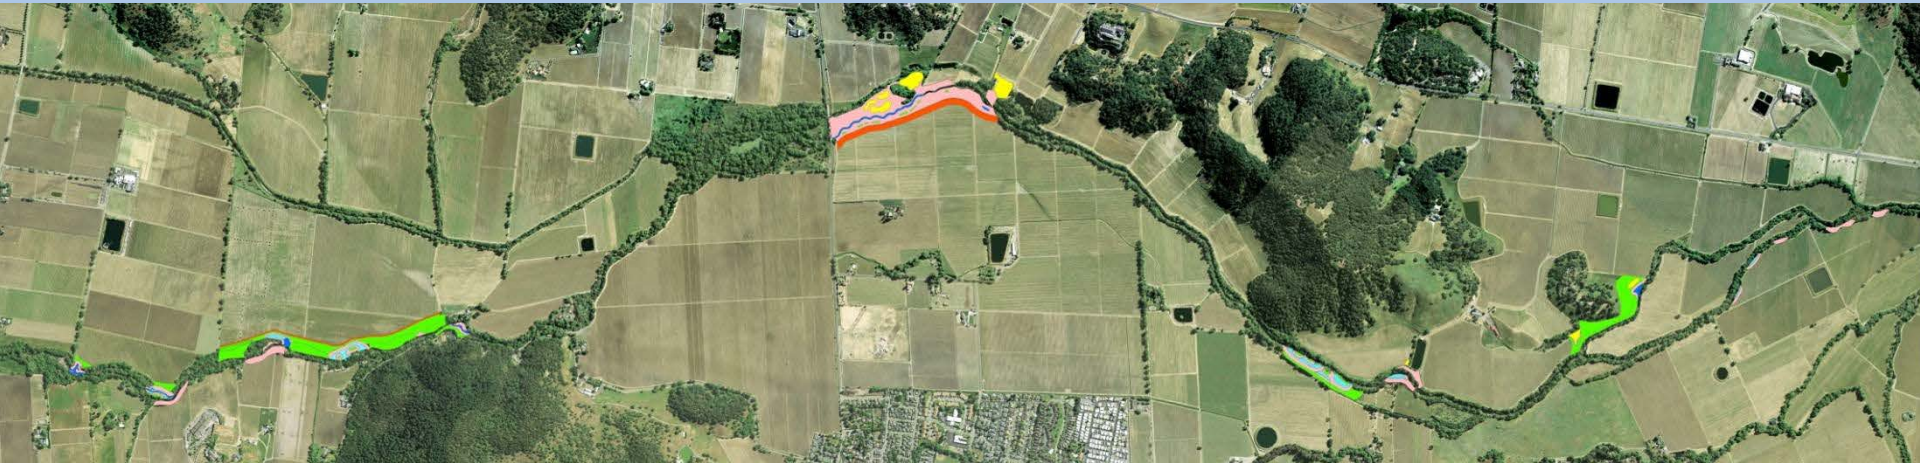
Expanded Riparian Corridor

Setback Berms

Floodplain Benches

Tributary Alcove

Instream Structures

1,000 Feet of Secondary Channels Created

56 Acres of Riparian Forest Enhanced

2.4 miles of Channel widening along the 9 miles  
OVOK Reach

200 Instream Habitat Structures Installed

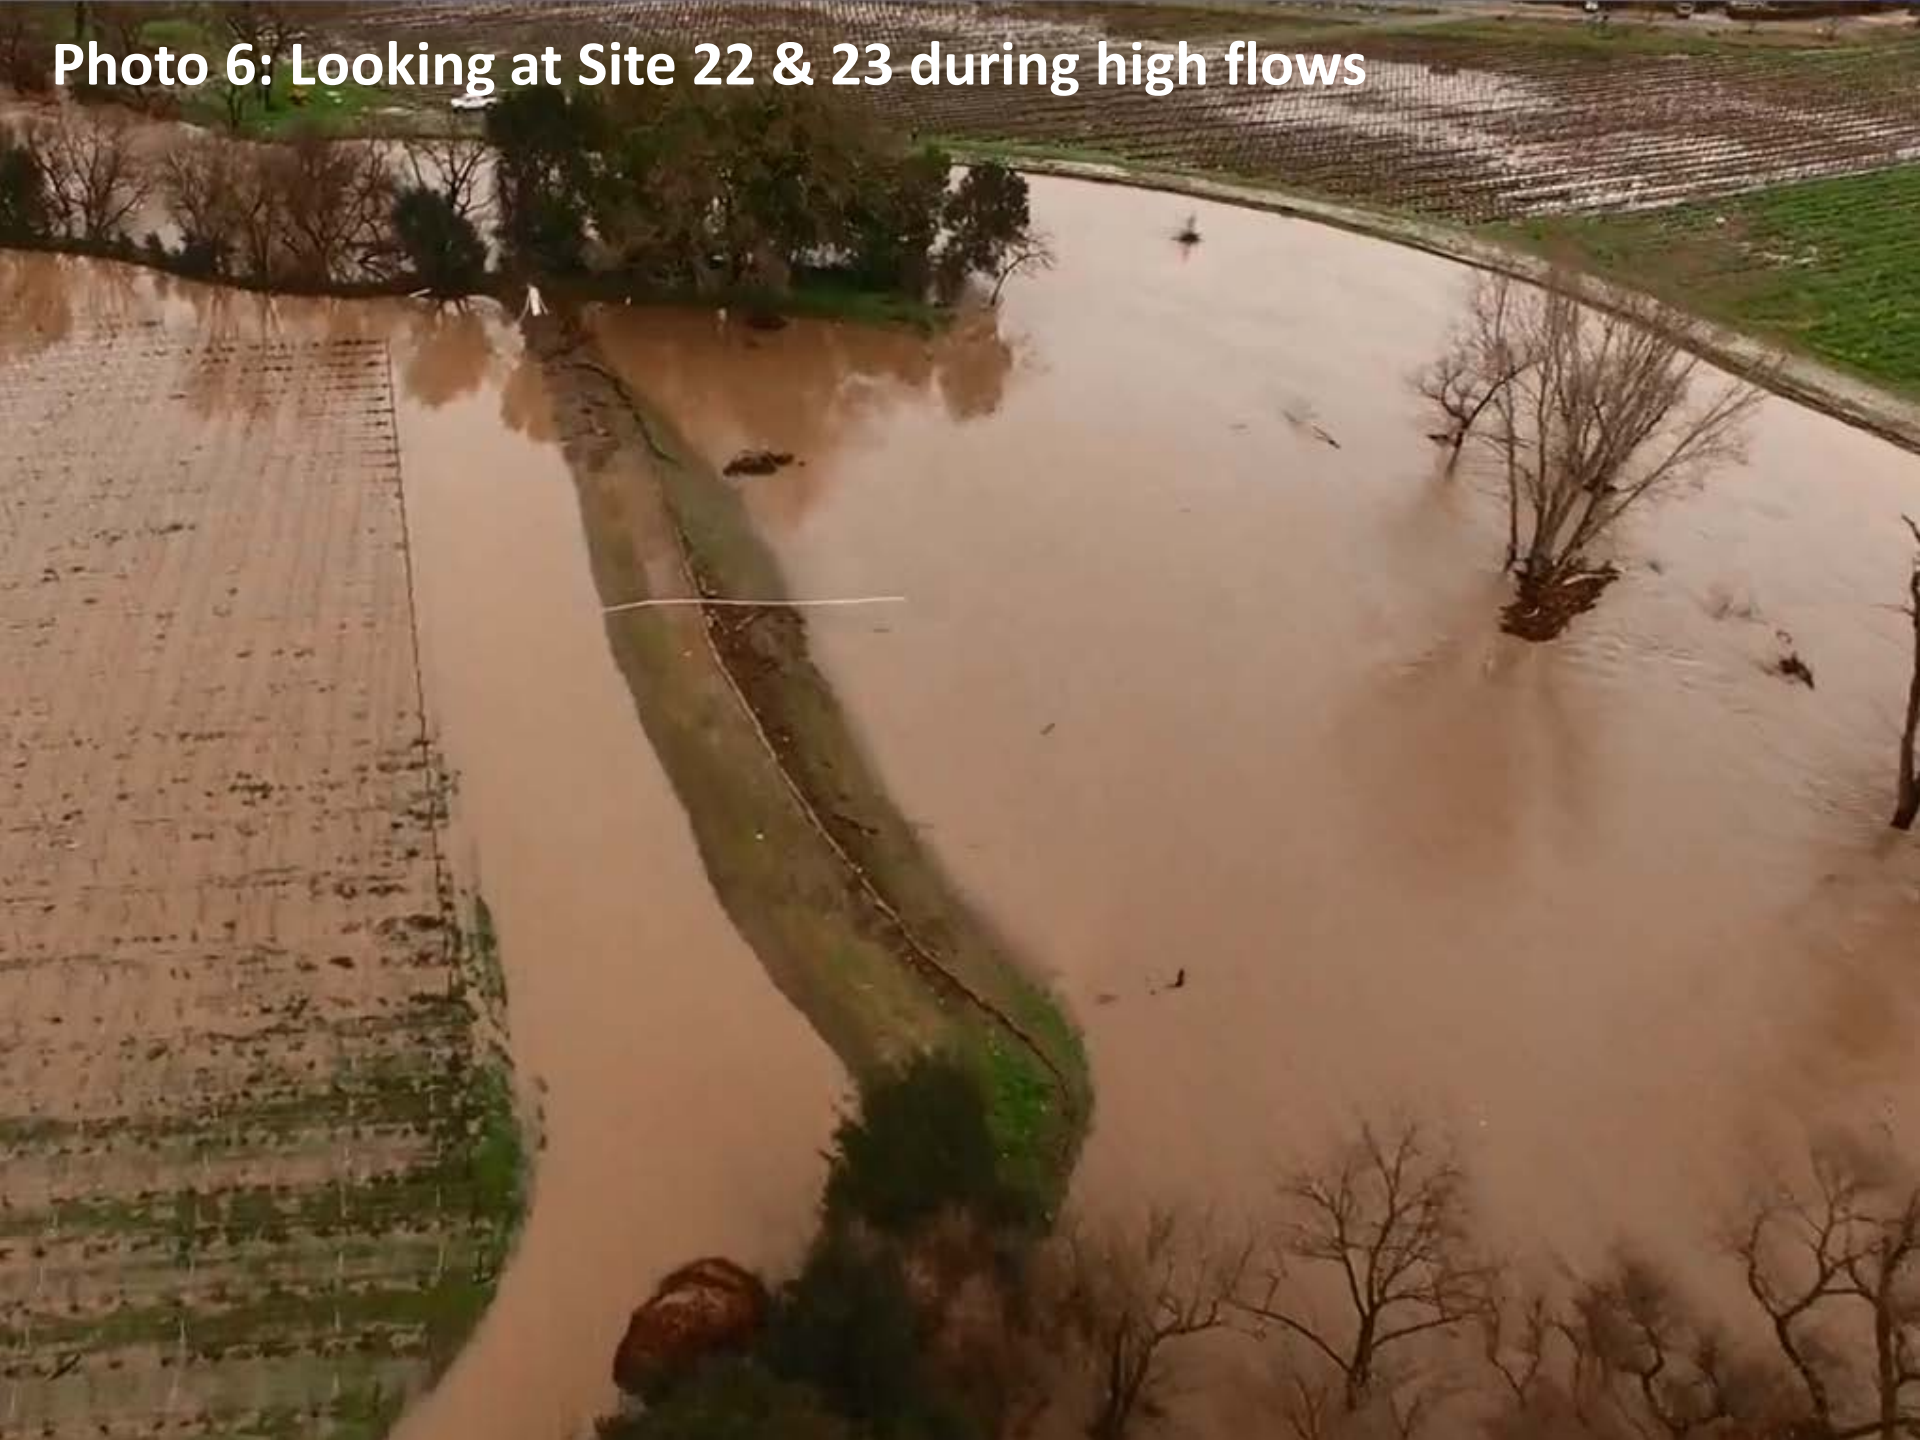
**Photo 6: Looking at Site 22 & 23 during high flows**

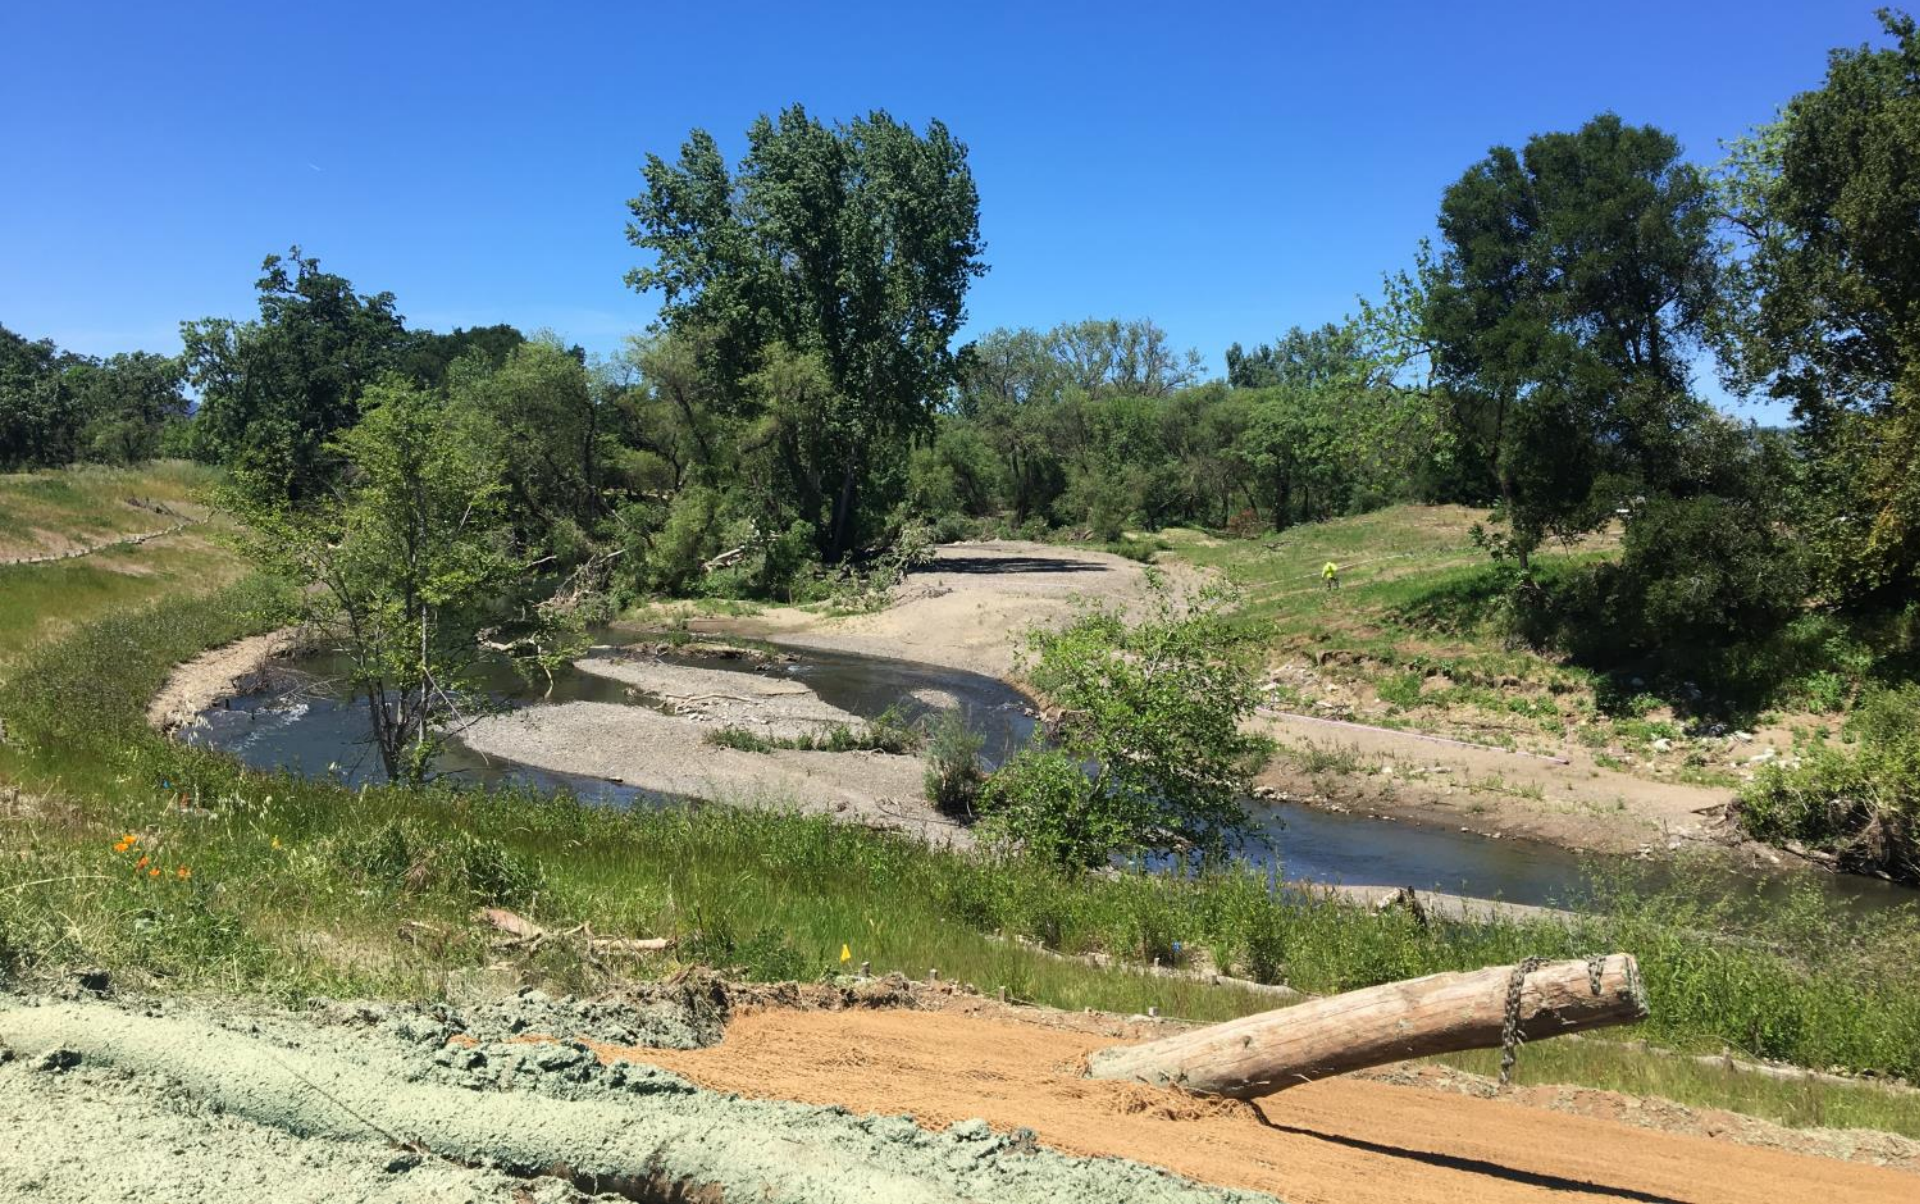
**Photo 5: Looking from Site 21 at 22 after winter flows**

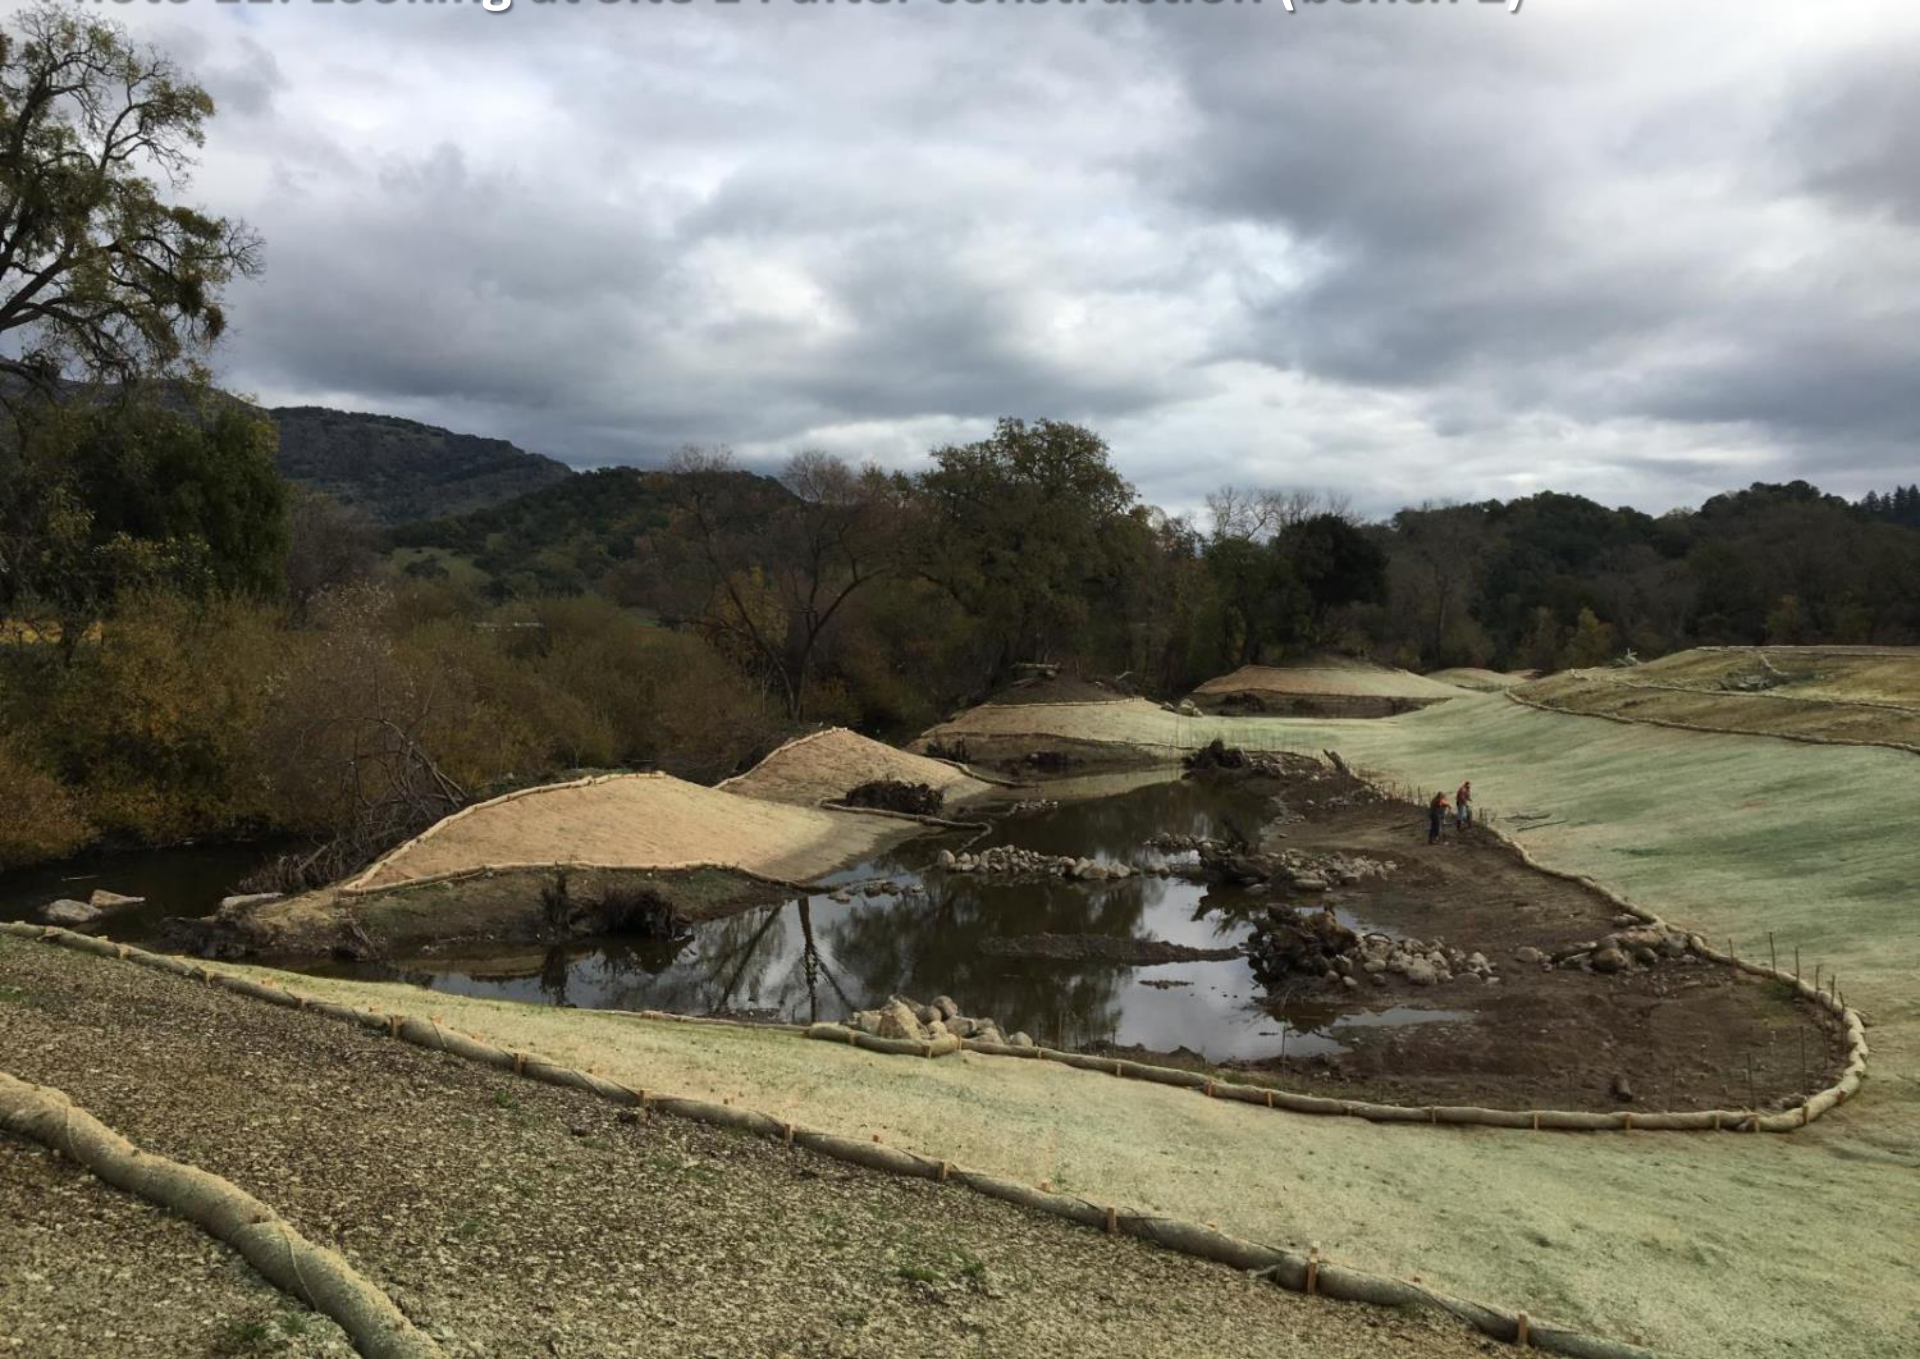
Photo 11: Looking at Site 14 after construction (bench 2)

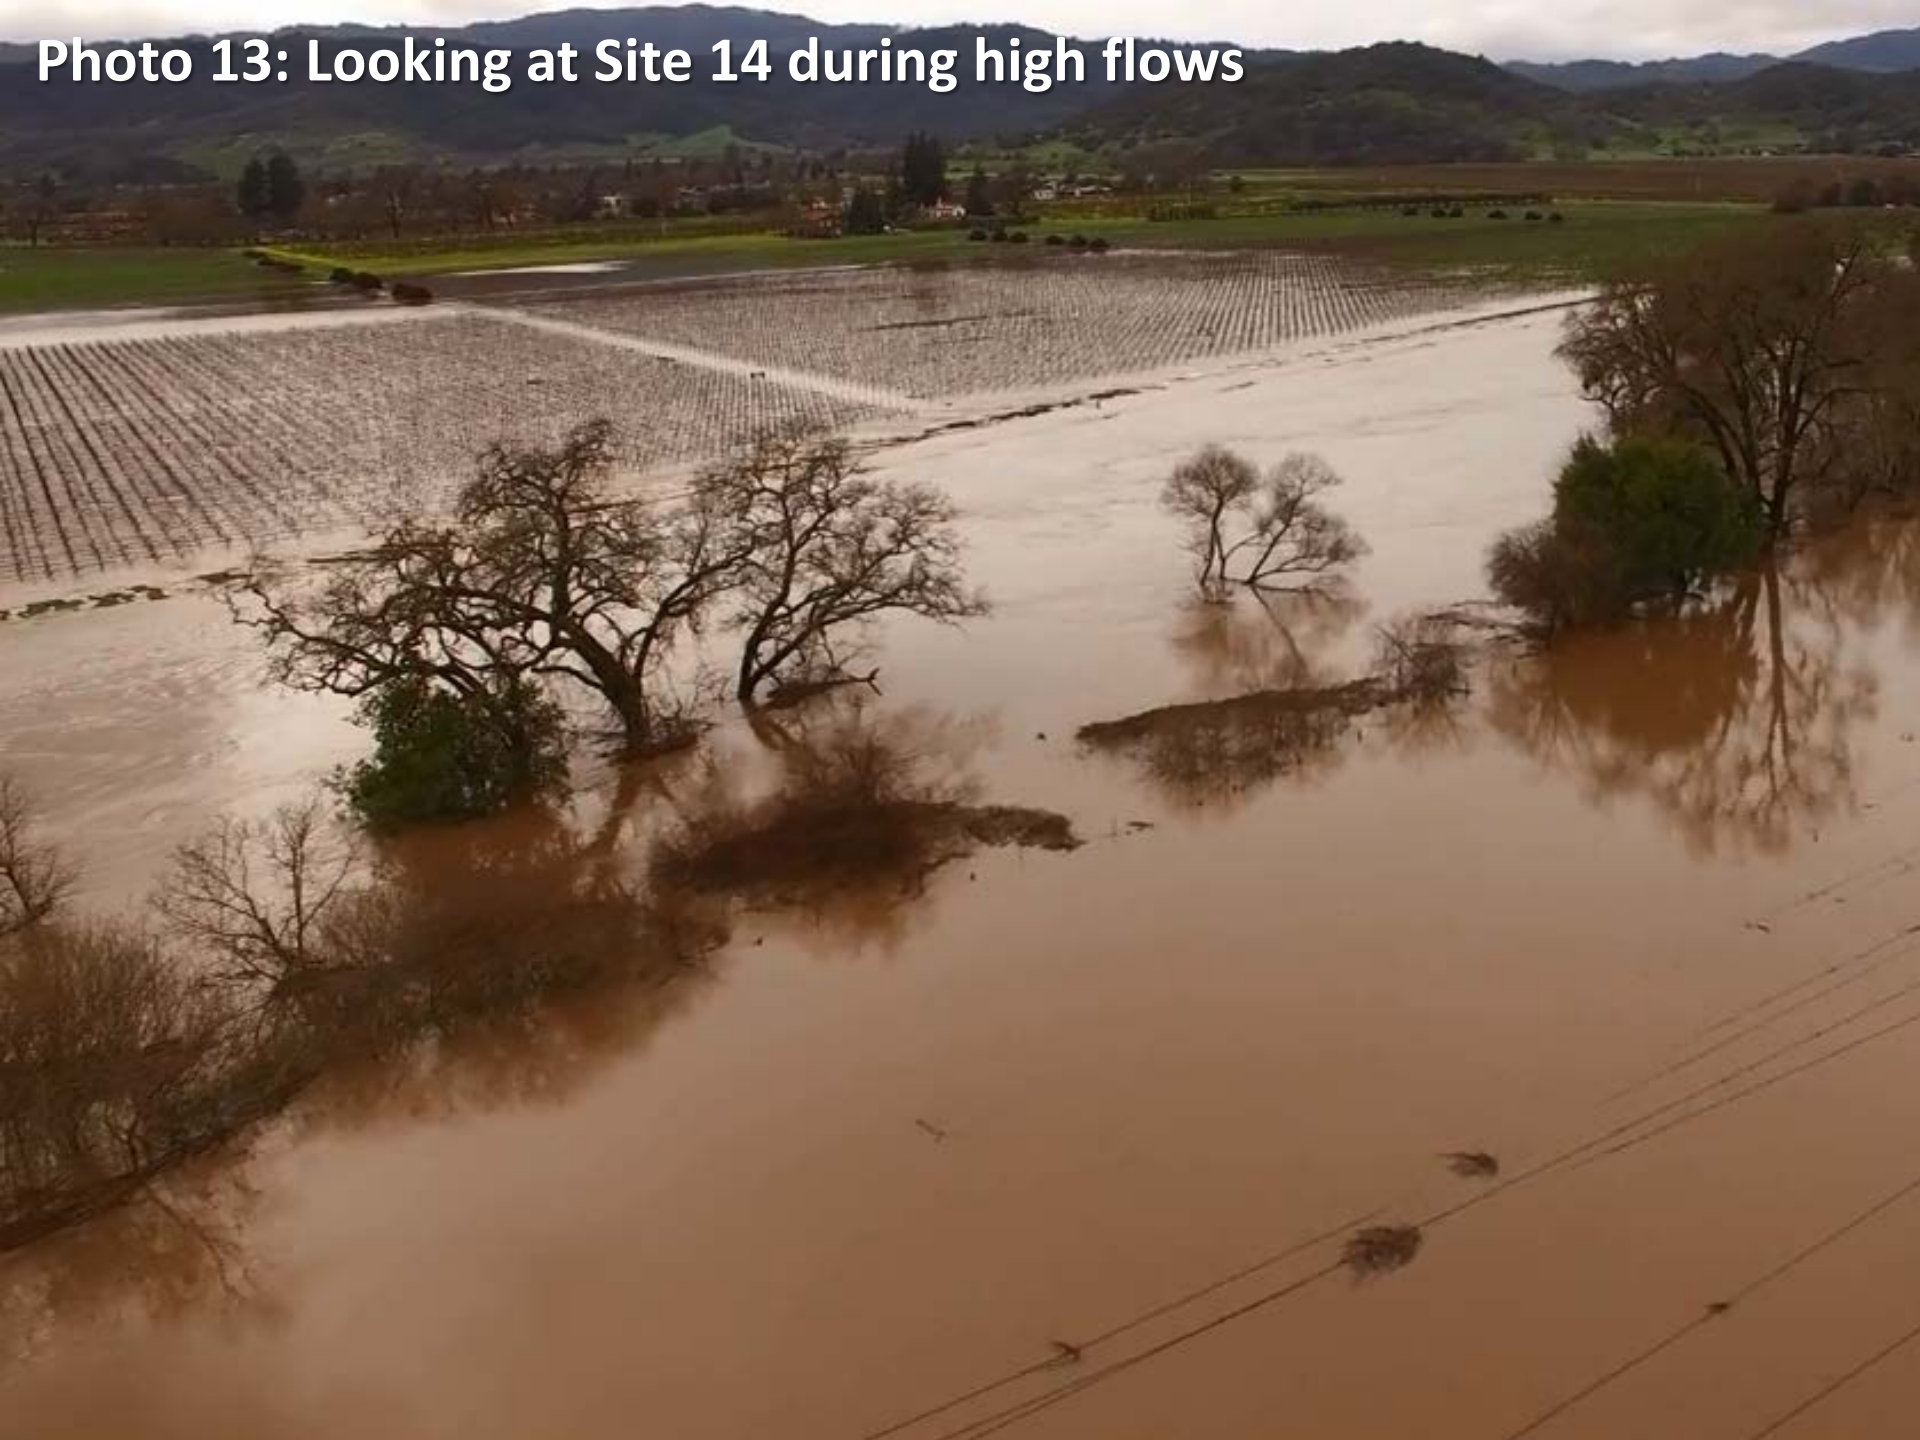
**Photo 13: Looking at Site 14 during high flows**

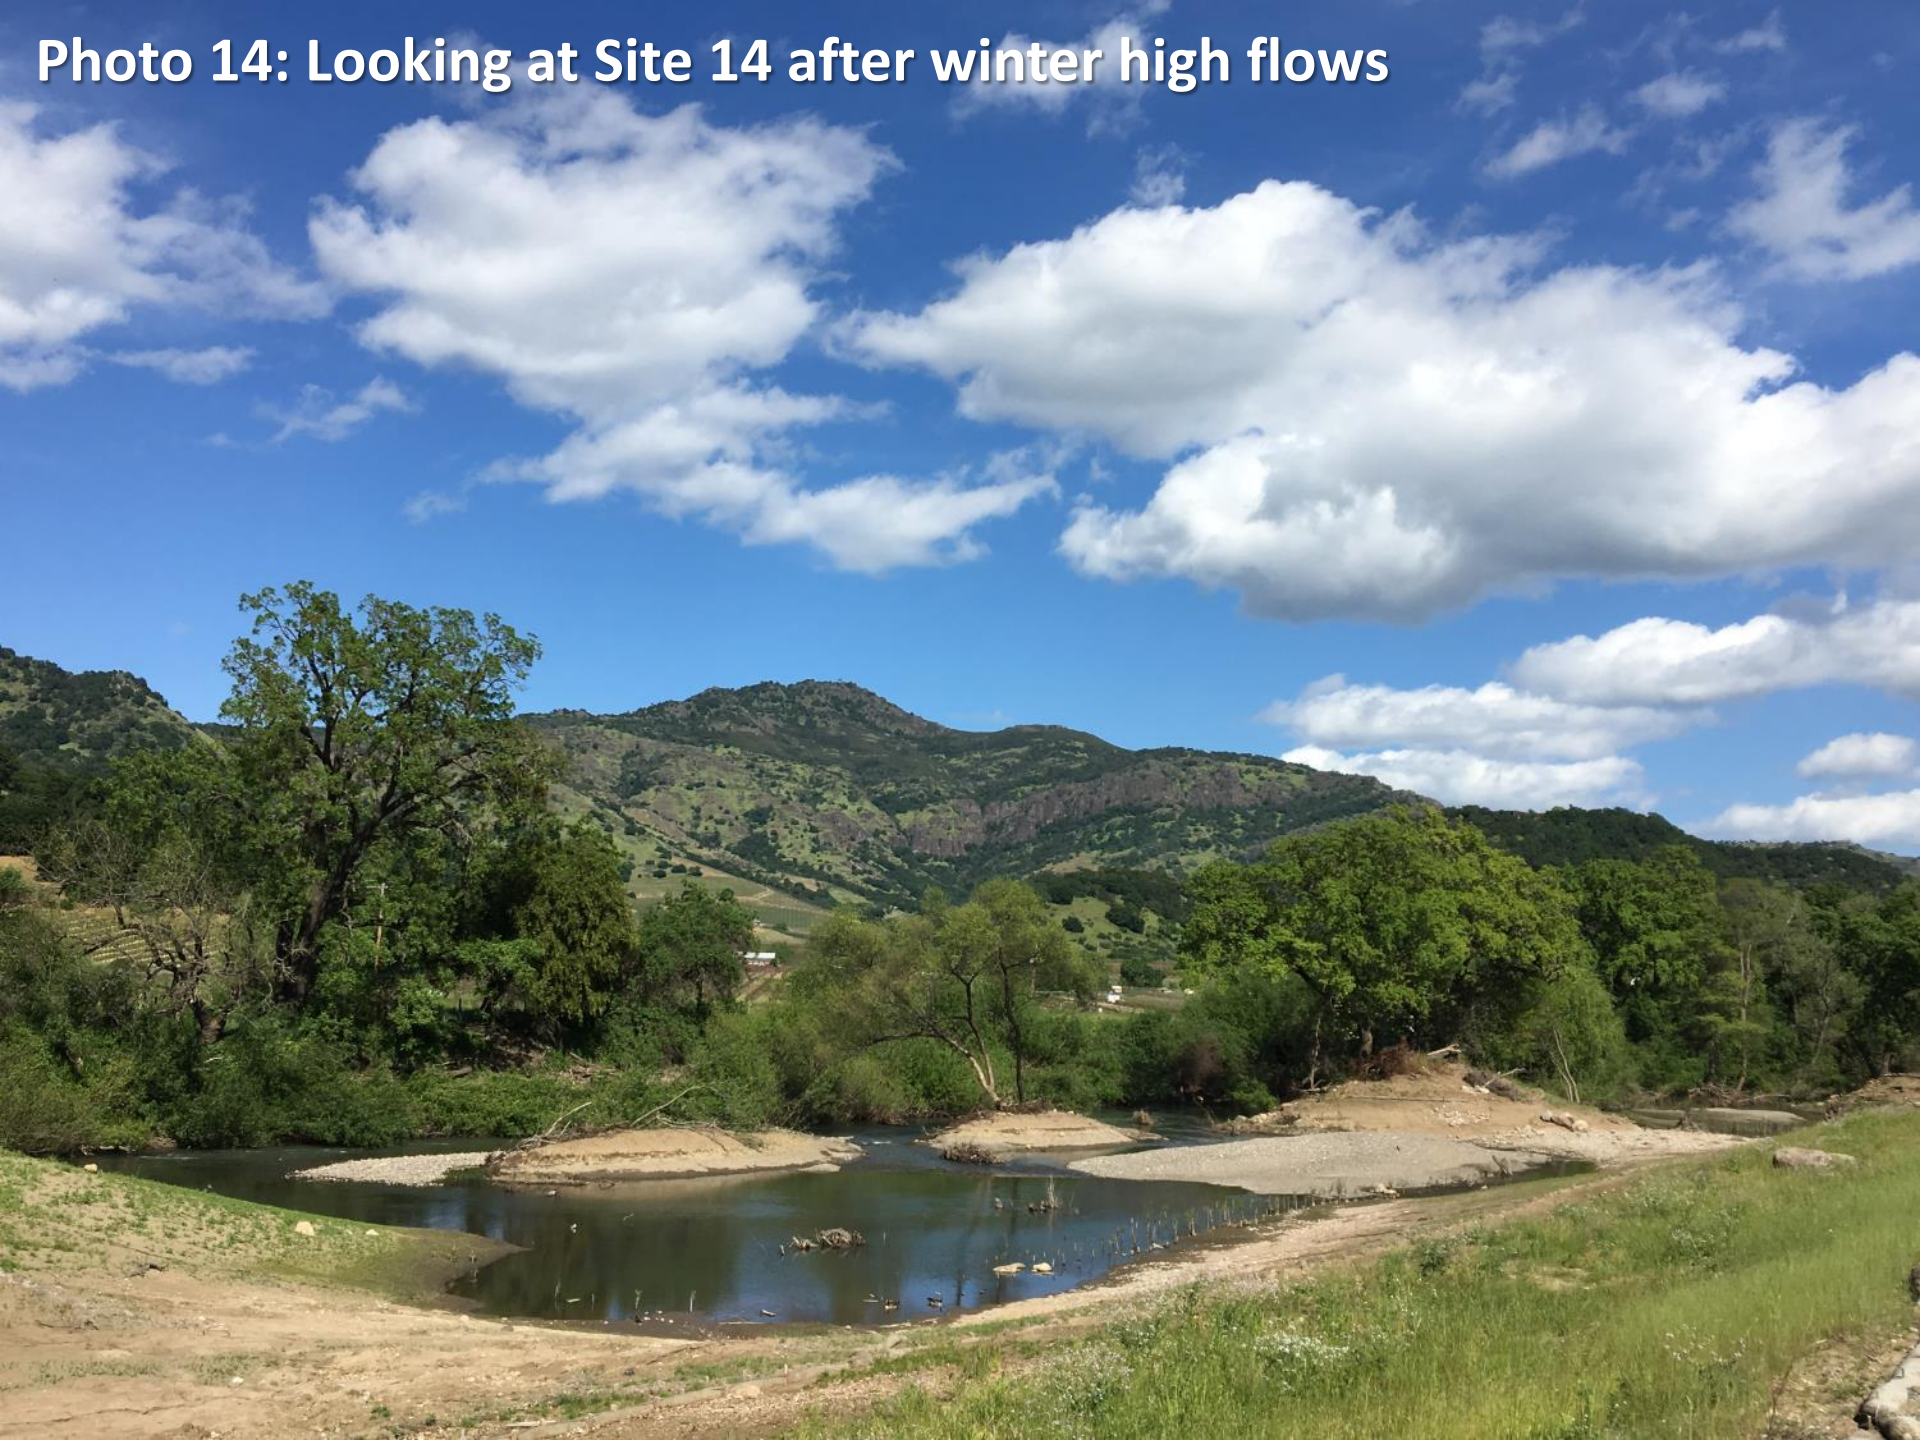
**Photo 14: Looking at Site 14 after winter high flows**

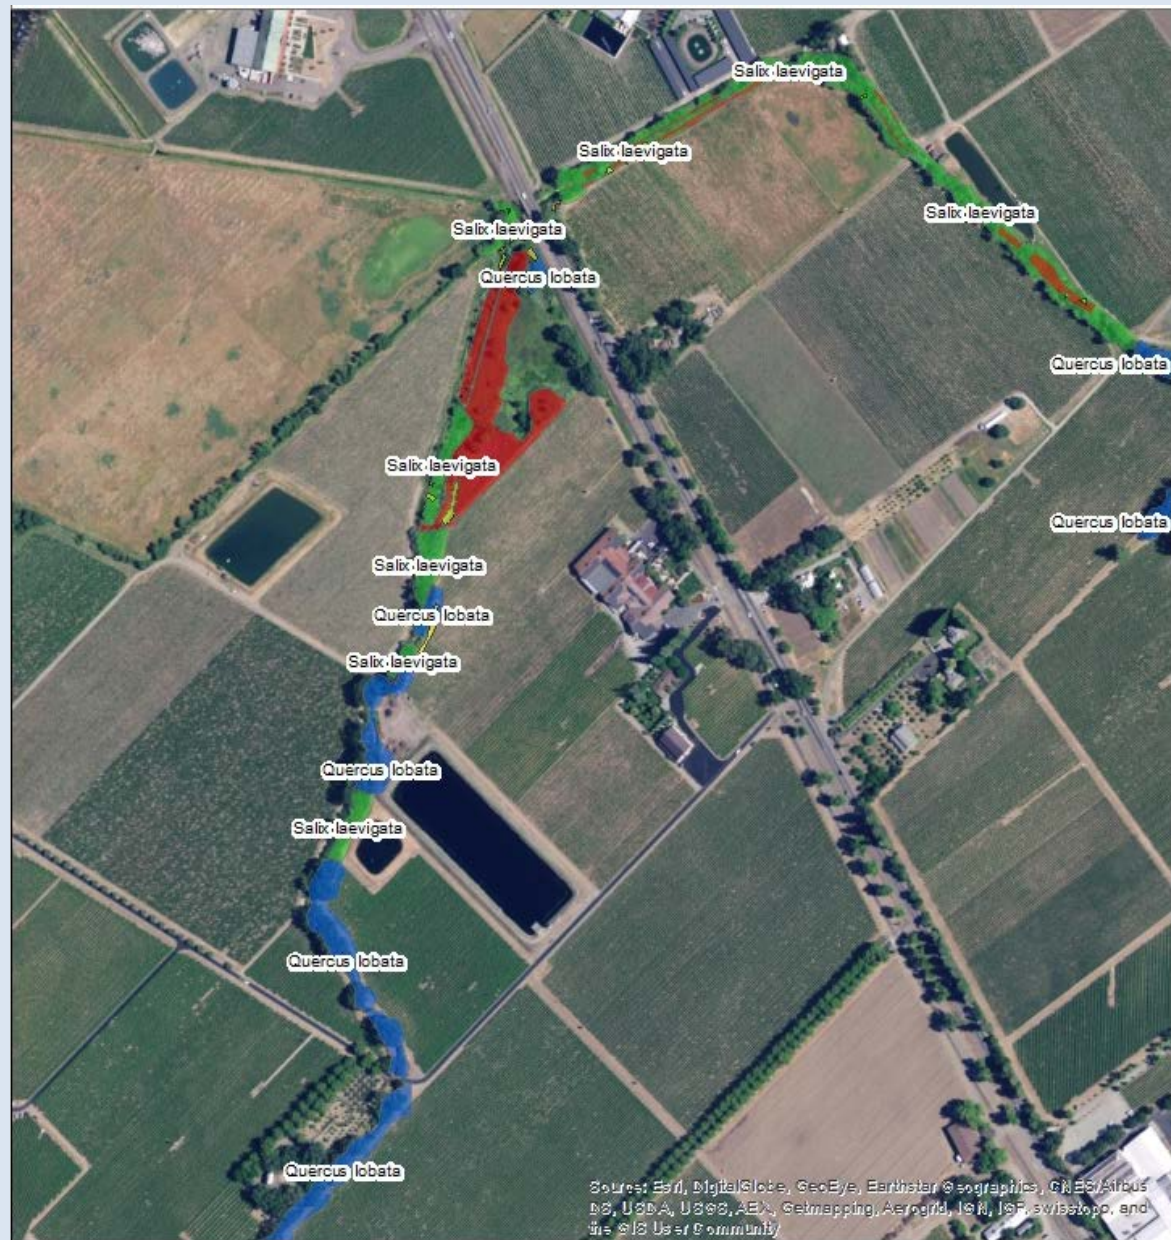
- Vegetation communities were mapped with finer detail to the “Alliance” level
- Targeted invasive plants (Arundo, Himalayan blackberry, Eucalyptus) were mapped at the patch level
- Distributions of vegetation types and invasive plant patches were considered in the development of potential restoration sites

Invasive Plants		Vegetation Type	
<span style="display:inline-block; width:15px; height:15px; background-color:yellow;"></span> Arundo	<span style="display:inline-block; width:15px; height:15px; background-color:blue;"></span> Quercus lobata	<span style="display:inline-block; width:15px; height:15px; background-color:lightblue;"></span> Acer macrophyllum	<span style="display:inline-block; width:15px; height:15px; background-color:tan;"></span> Eucalyptus globulus/camaldulensis
<span style="display:inline-block; width:15px; height:15px; background-color:red;"></span> Blackberry	<span style="display:inline-block; width:15px; height:15px; background-color:green;"></span> Salix laevigata	<span style="display:inline-block; width:15px; height:15px; background-color:purple;"></span> Ornamental	
	<span style="display:inline-block; width:15px; height:15px; background-color:brown;"></span> Quercus agrifolia

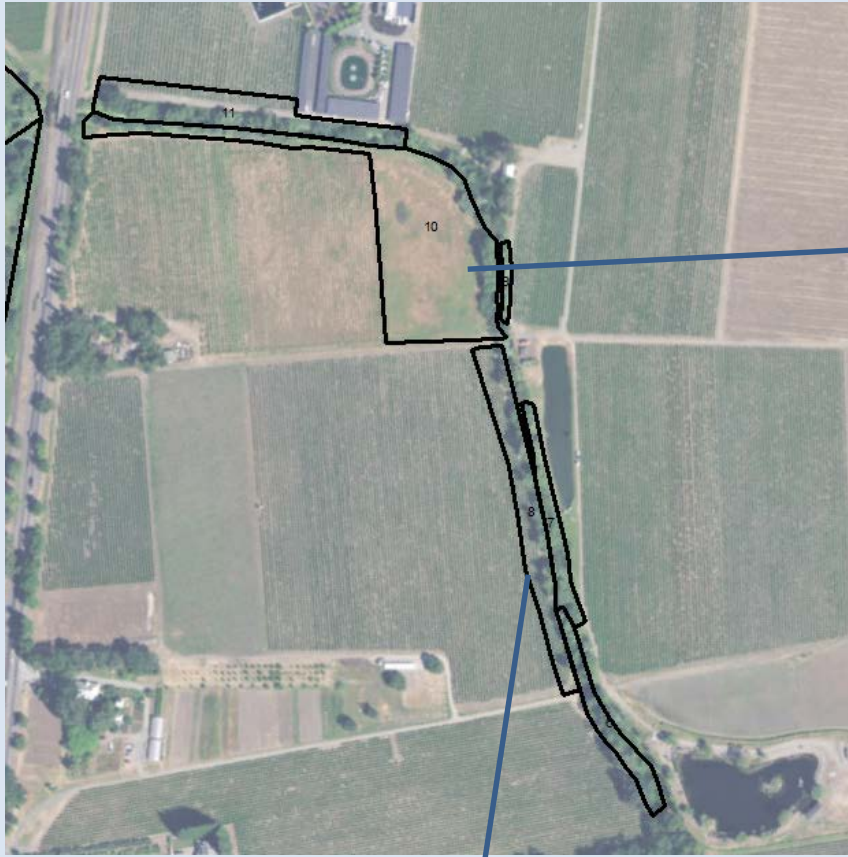
# Proposed Restoration Zone Example (Sites 8 & 10)

Site 10 – Reclaim  
Fallow Vineyard, Widen  
Channel, and Create  
Lowered Floodplain

Site 8 – Set Back  
Vineyard, Relocate  
Vineyard Avenue,  
Widen Channel and  
Riparian Corridor
