Napa County Watershed Symposium 2019

Update on Napa River Restoration Projects Continuing Restoration Post Measure A

Napa River Restoration-Rutherford to Oak Knoll

Napa River Restoration Rutherford Project 2009-2015

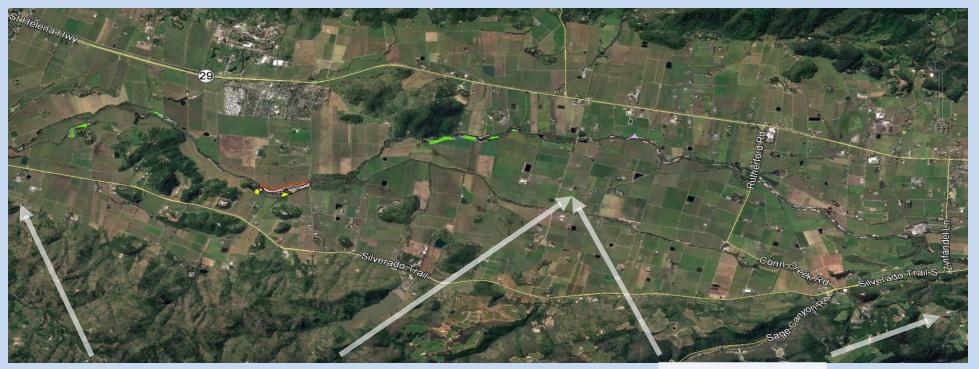
The Napa River has been impacted by a range of watershed changes including land drainage, urbanization, riparian encroachment, levee construction, and the elimination of secondary channels. The result has been channel incision, bank erosion and the degradation of both riparian and aquatic habitat. Despite this, the Napa River still has intact populations of steelhead trout and fall run Chinook salmon as well as an array of other wildlife that depends on the riparian forest.
