**Napa River Rutherford Reach Restoration Project  
Phase 2, Reach 3**

**FINAL PROJECT REPORT**

**Napa County, California  
July 1, 2011**

**SWRCB Agreement No:** 08-609-552-0

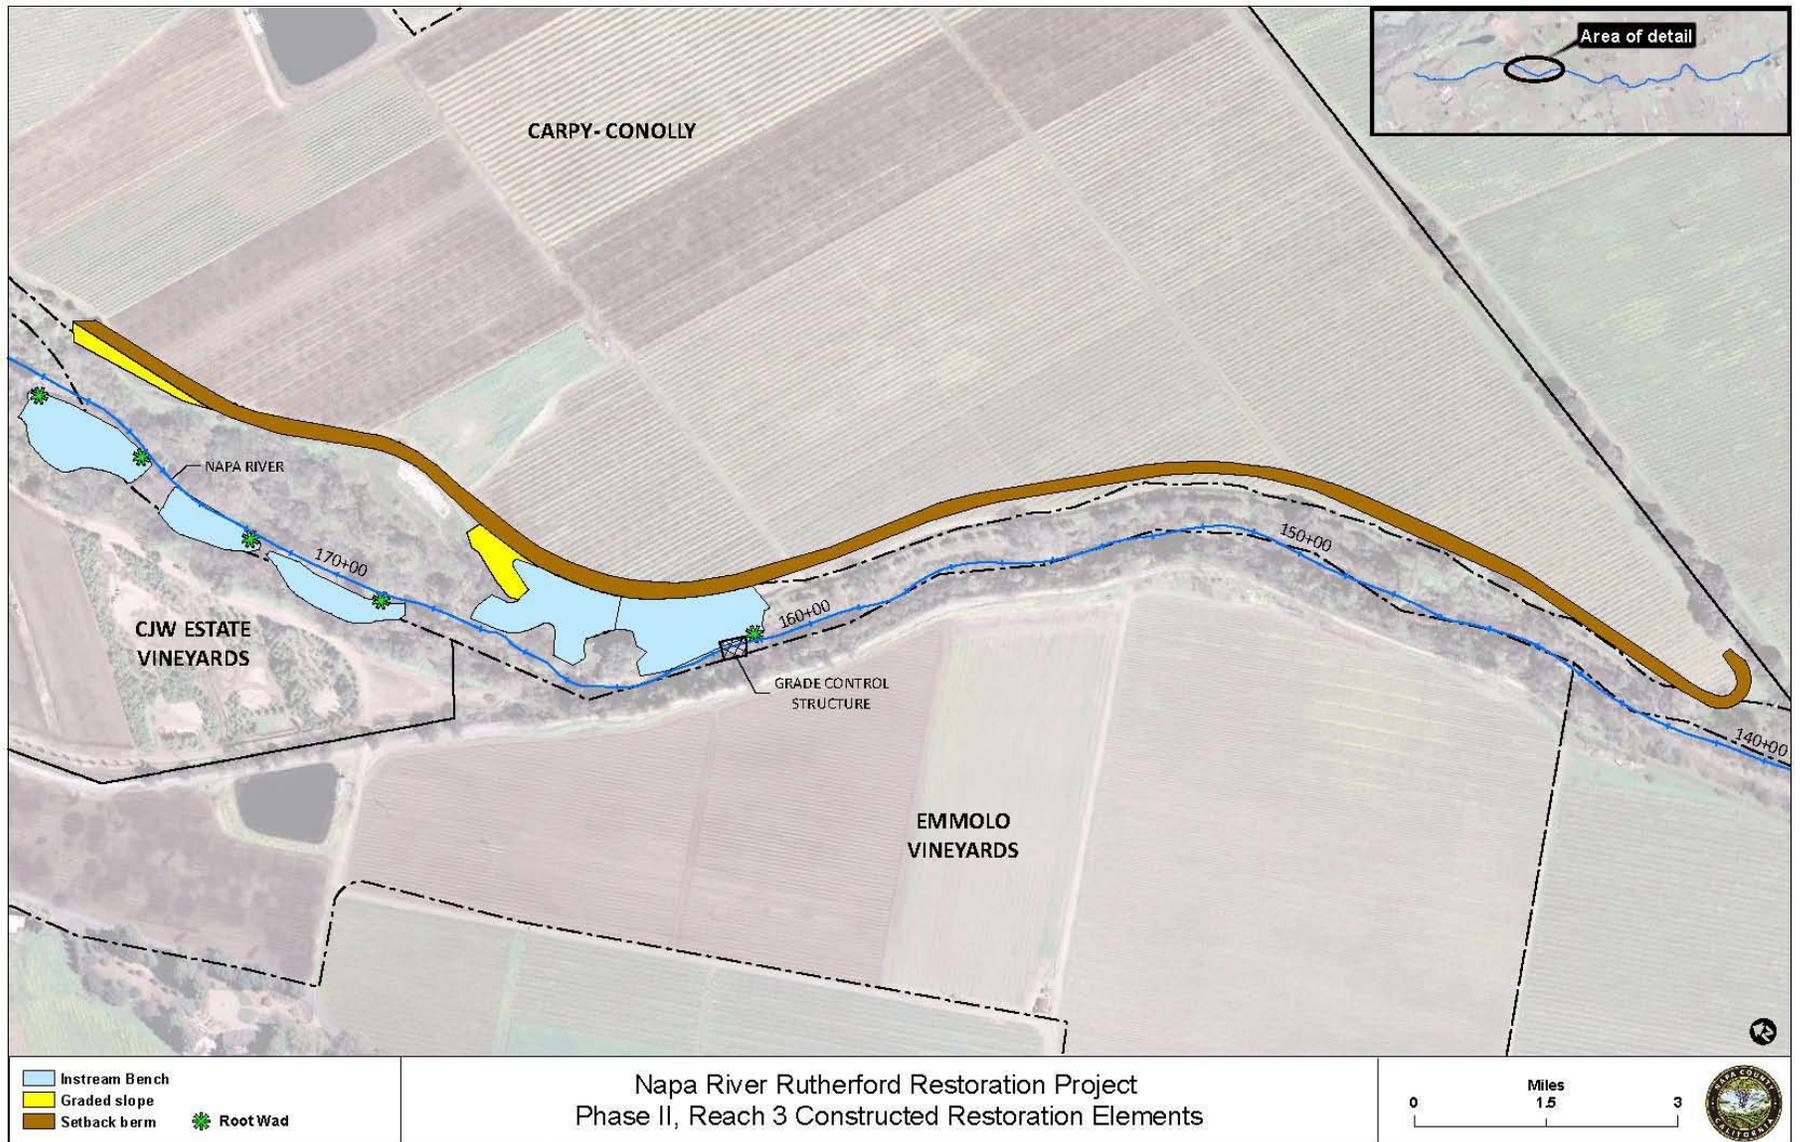
Figure 1. Phase 2, Reach 3 Constructed Restoration Elements

Phase 2 Reach 3 construction included wholesale setback of the levee along the left (east) bank of the river to stabilize and reduce sediment loads into the river and widen the riparian corridor; excavation of five (5) instream floodplain benches to widen the overall functional width of the river and create slow water habitat for salmonids; installation of five (5) instream Large Woody Debris (LWD) root wads trenched into constructed benches to provide additional refugia for native migrating fish; and installation of a buried grade control structure to prevent further incision of the river channel and protect installed restoration features upstream. The 5.04 acres of graded area on the benches were replanted with native riparian vegetation and erosion control seeding. An additional 8.7 acres of riparian outside the graded area were managed for invasive species and Pierce Disease host plants. See Figure 1 for an illustration of restoration elements installed in Phase 2, Reach 3, and Tables 3 and 4 for a summary of these features and their locations relative to the nine reaches of the Napa River Rutherford Reach Restoration Project.

Approximately 1,265 linear feet of stream bank were graded to create a series of inset floodplain benches along the project reach. The benches were graded at an elevation consistent with the 1.5-year flood event to reduce localized flow velocities and provide a surface suitable for the establishment of riparian vegetation. A 3:1 slope was graded between the floodplain bench and the top of bank to increase bank stability, and reduce erosion rates, and provide suitable surfaces for riparian revegetation.

Approximately 4,600 linear feet of existing levees were removed and/or breached, and new, set back, engineered levees were constructed to replace them along the left (east) bank of the river. The levees are approximately 5 feet high with a 15-foot crest, and were constructed with a 2:1 (river side) and 8:1 (land side) replantable side slopes. The levee was setback an average of 50

A 30-foot long grade control structure was installed in the low-flow channel between river stations 16,180 - 16,150 to protect the bed from scour and incision. The design specified a 50-foot long structure, but site constraints, including difficulty dewatering the channel for installation, necessitated reducing the length of the structure by 20 feet.

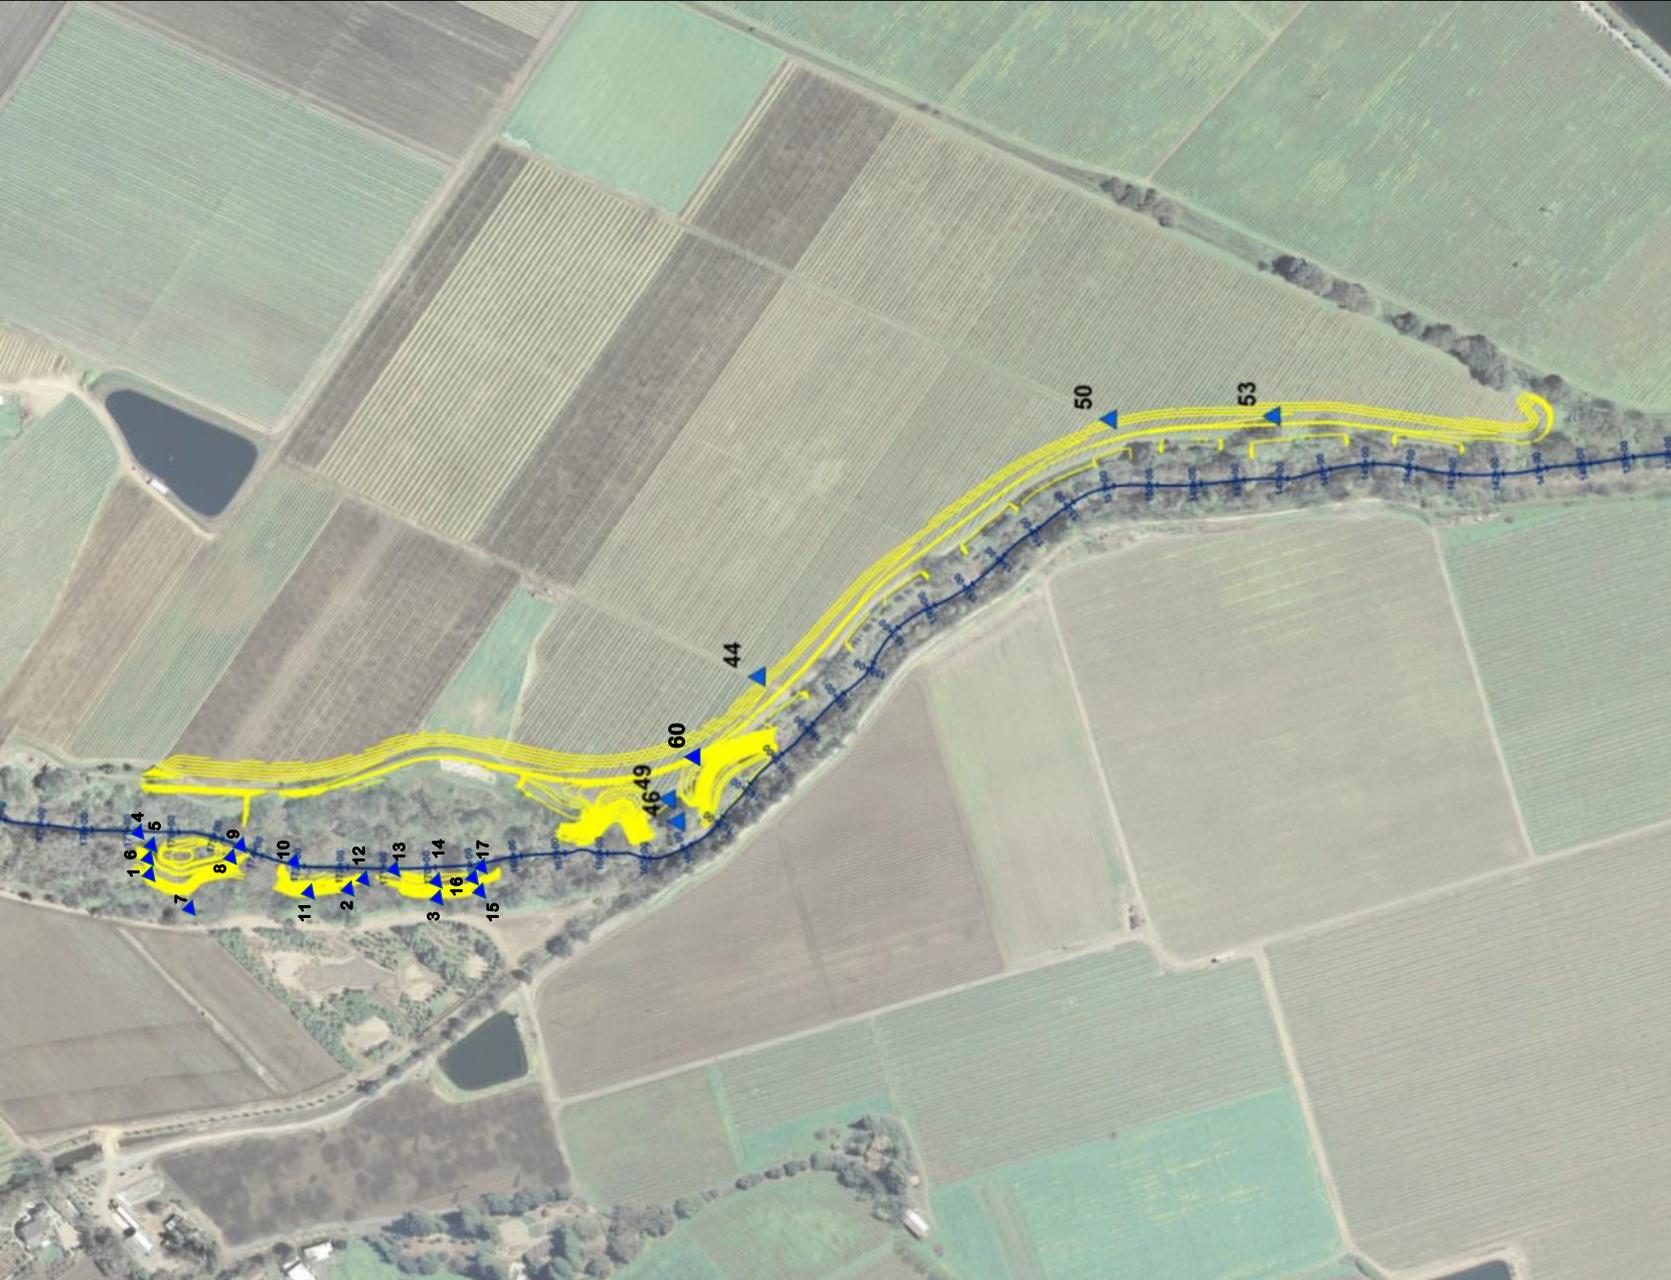
# Napa River Rutherford Reach Restoration Project Phase 2, Reach 3 Photopoints

- ▲ Photo Point
- River Station
- Topographic Lines of Constructed Features

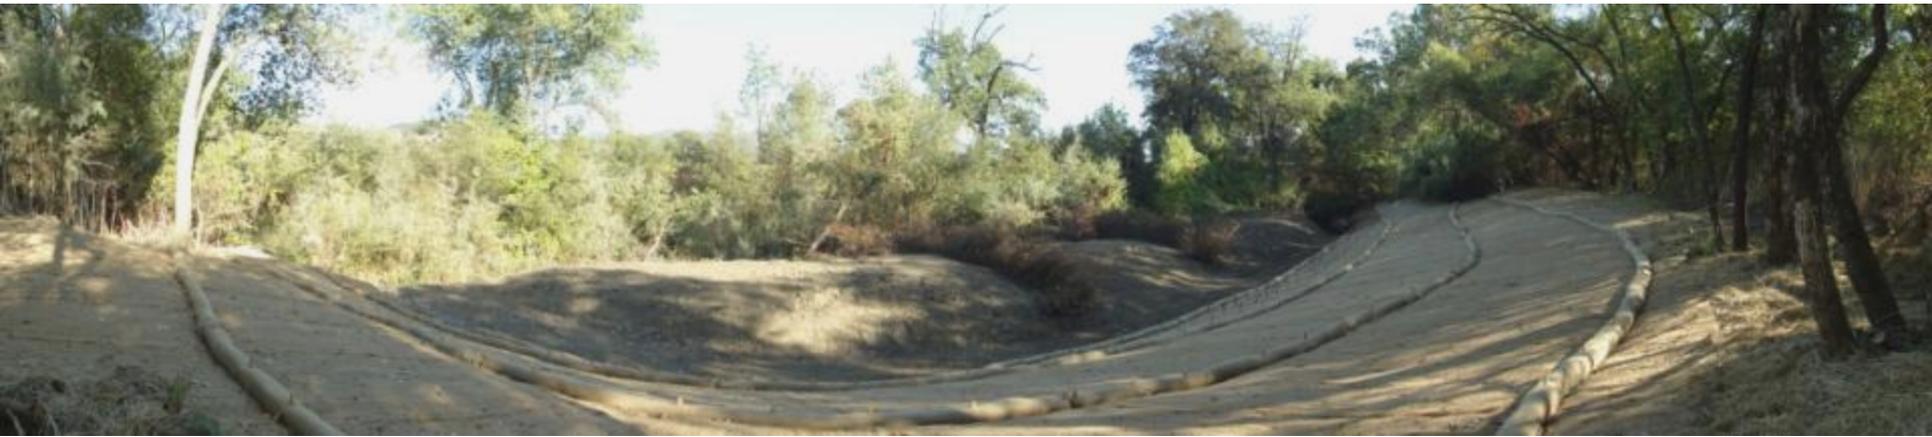
Bench 1 with Secondary Channel: Reach 3: River Stations 17,425-17,700: Photo Point 1

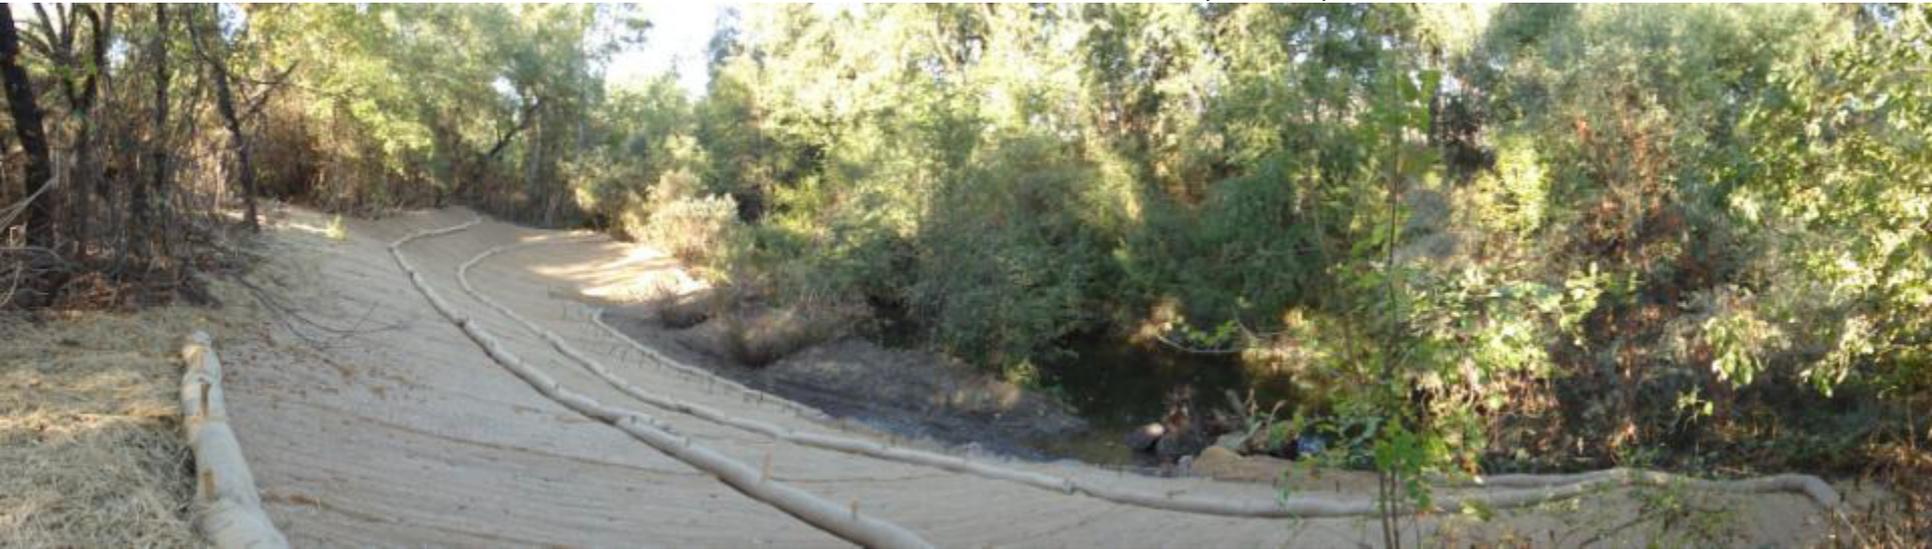
Bench 2 with Backwater Alcove: Reach 3: River Stations 17,160-17,350: Photo Point 2

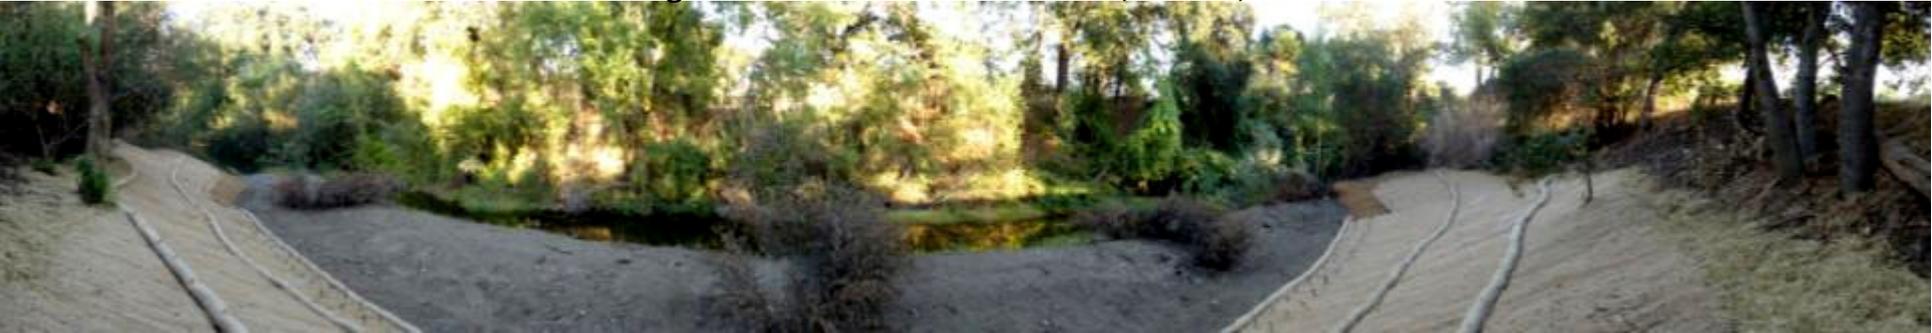
Bench 3 Refugia: Reach 3: River Stations 16,850-17,150: Photo Point 3

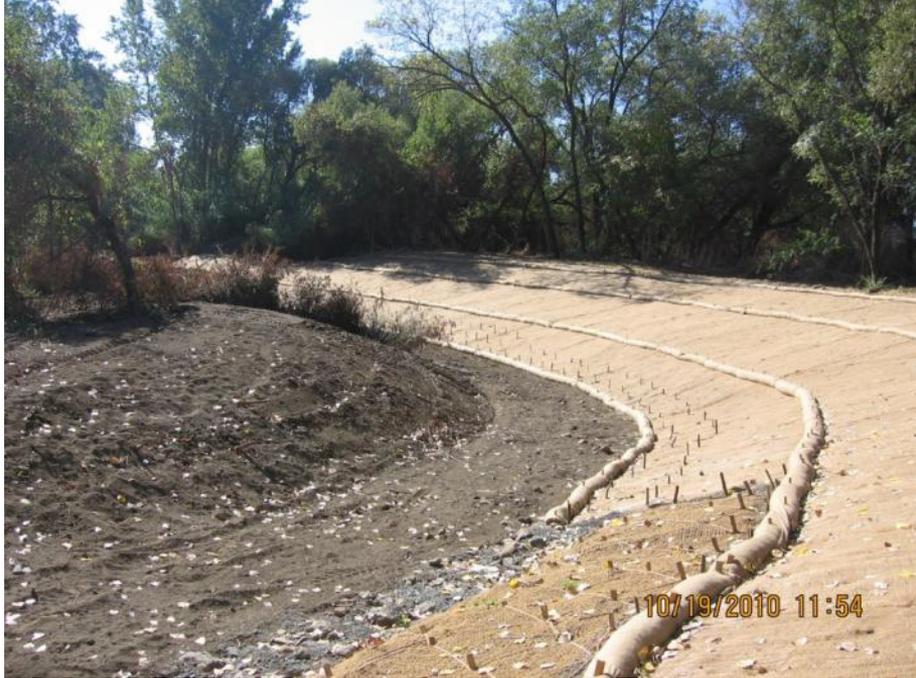
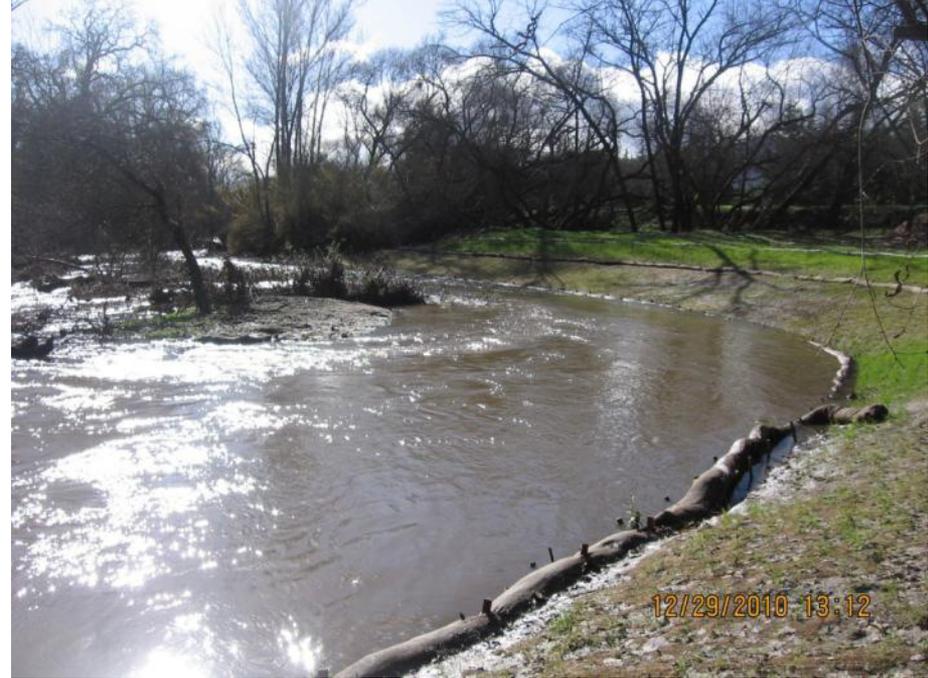
## Caymus Bench 1

Right (West)Bank to Downstream: Photo Point 6

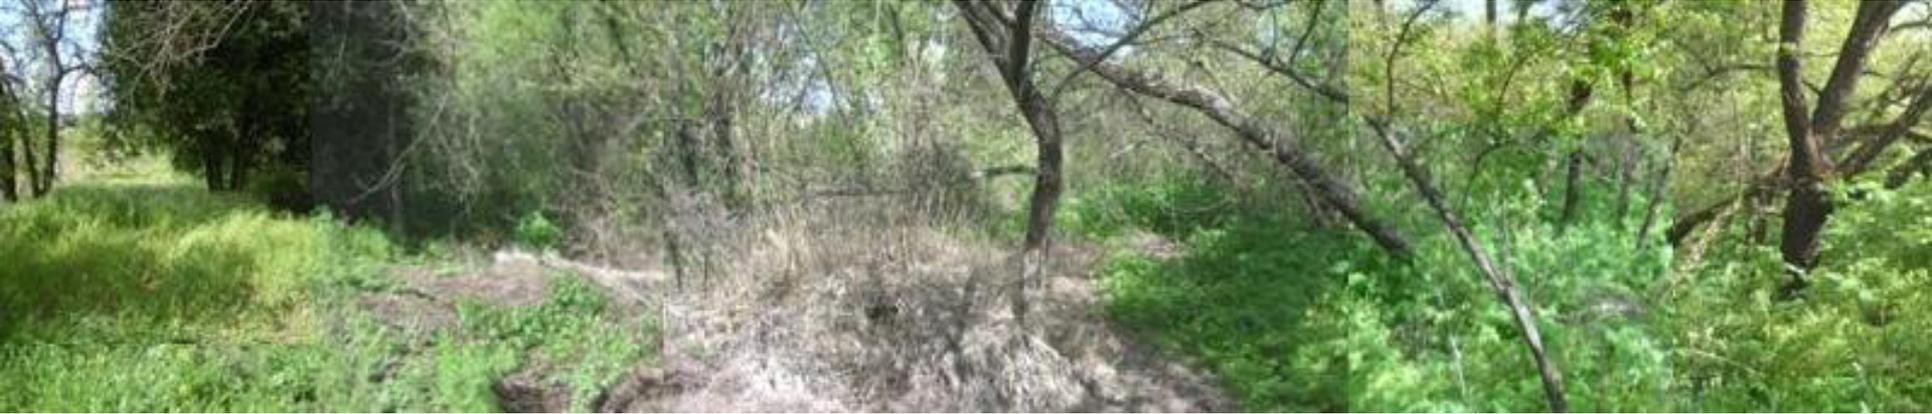
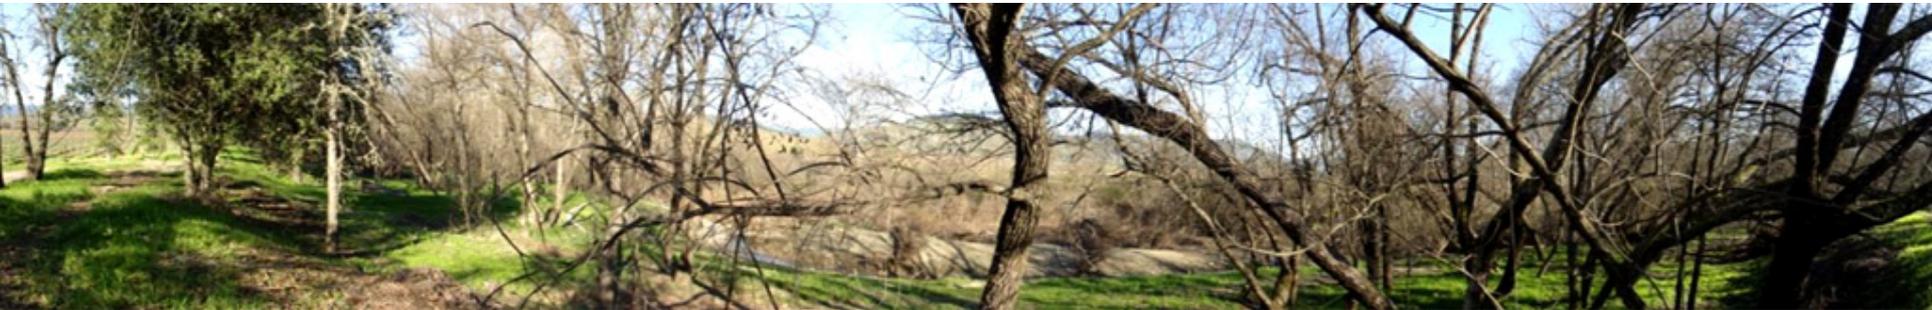
## Caymus Bench 1

Right (West) Bank Existing Berm to Channel: Photo Point 7

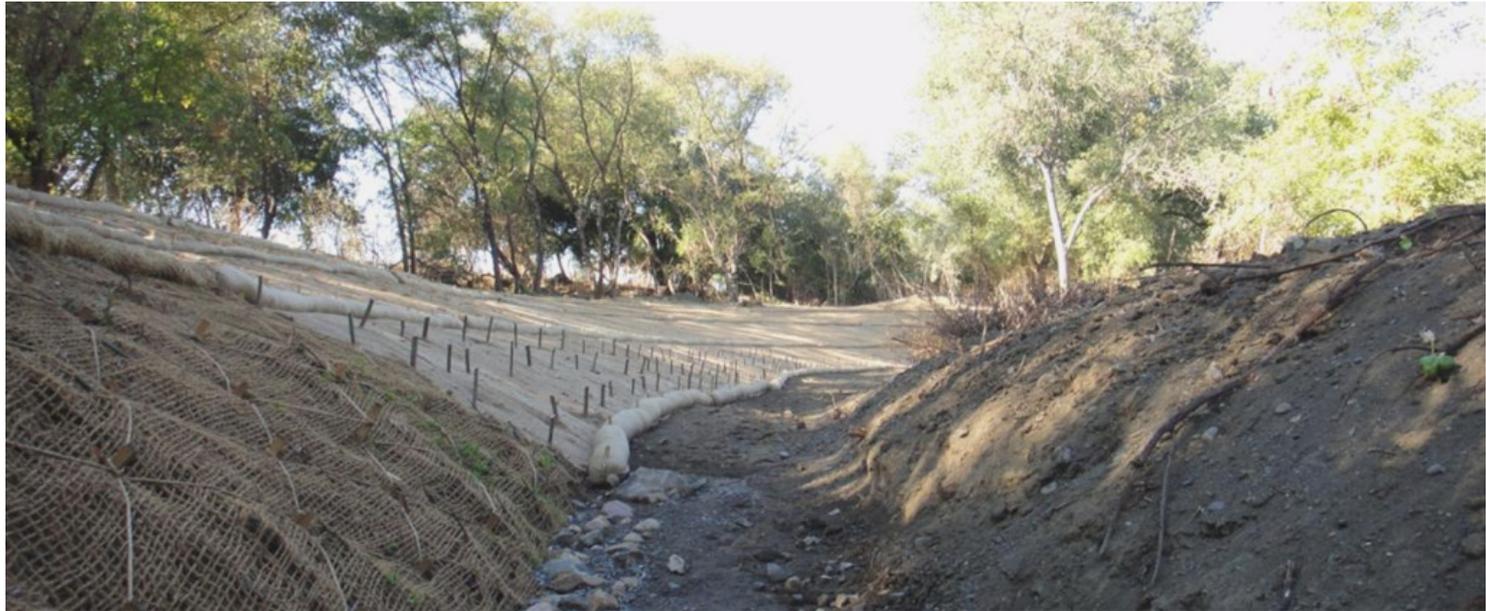
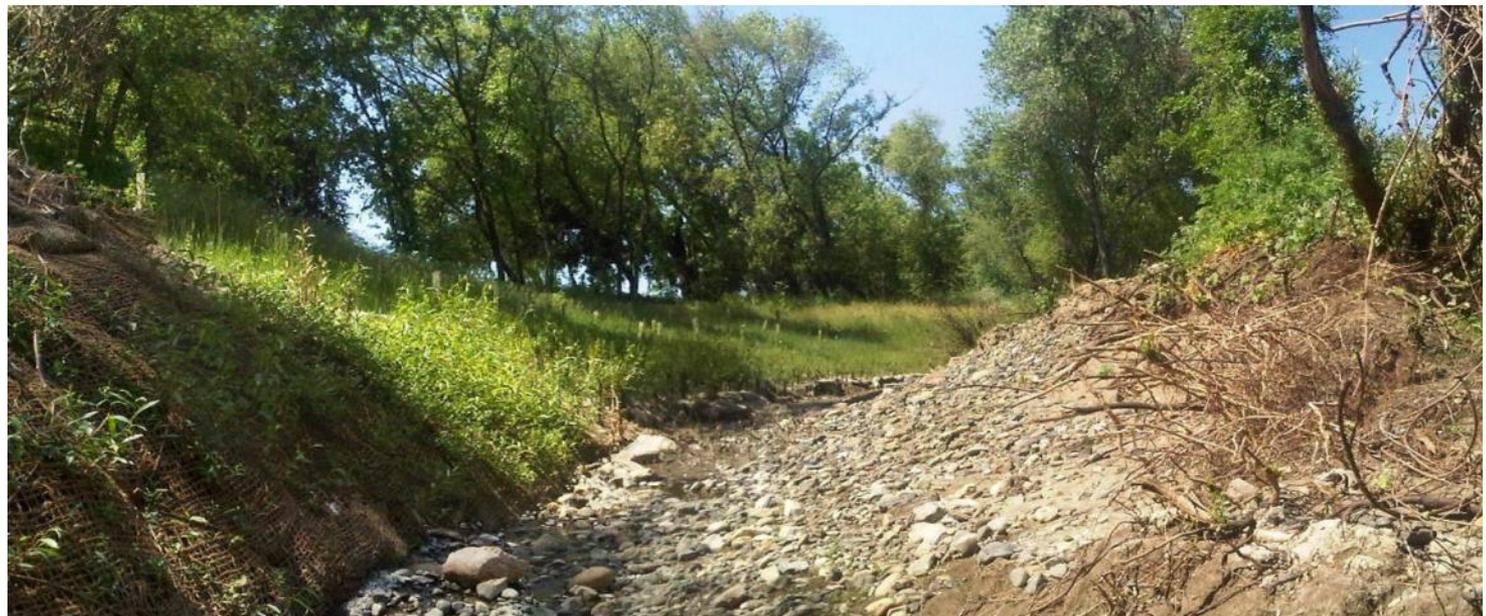
## Caymus Bench 1

Right (West) Bank Secondary Channel to Upstream: Photo Point 8

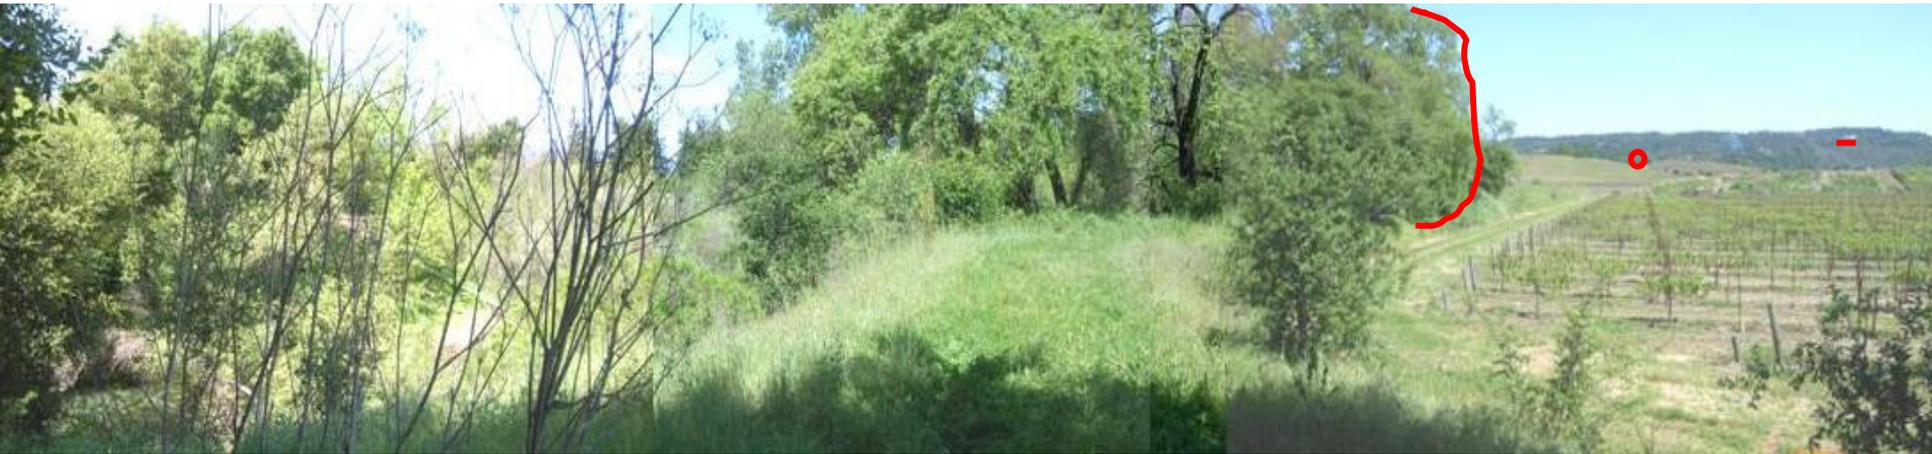
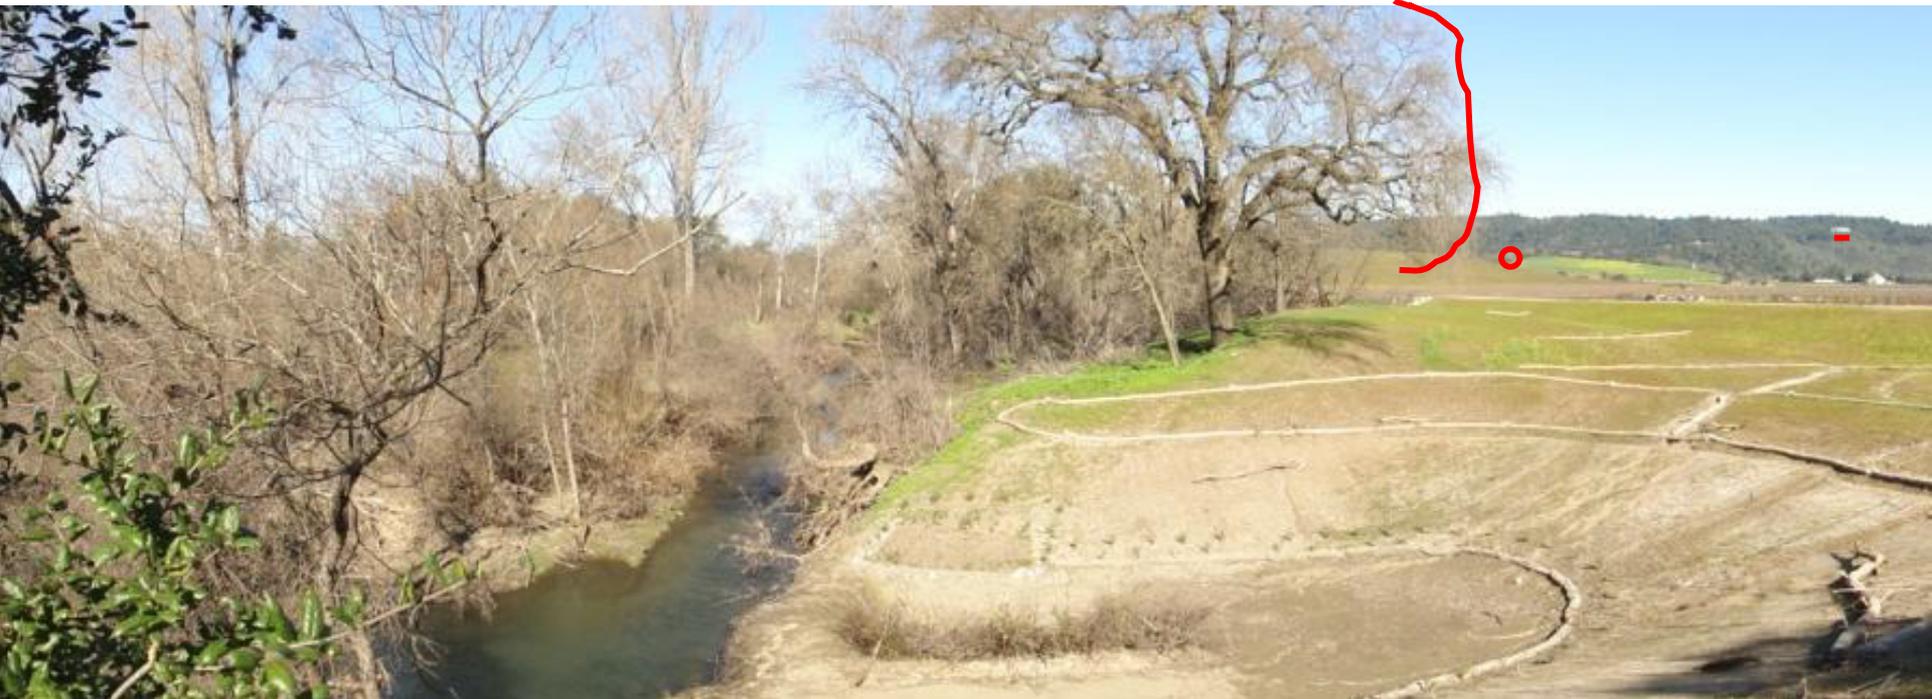
# River Station 16,420

Left (East) Bank Top of Old Berm Looking Upstream: Photo Point 46  
Carpy-Conolly Bench 4, Setback Berm

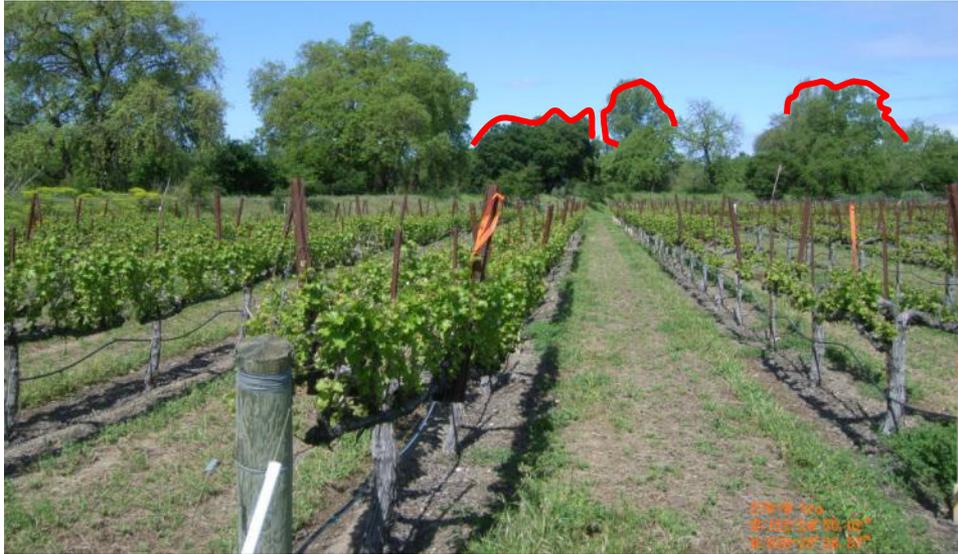
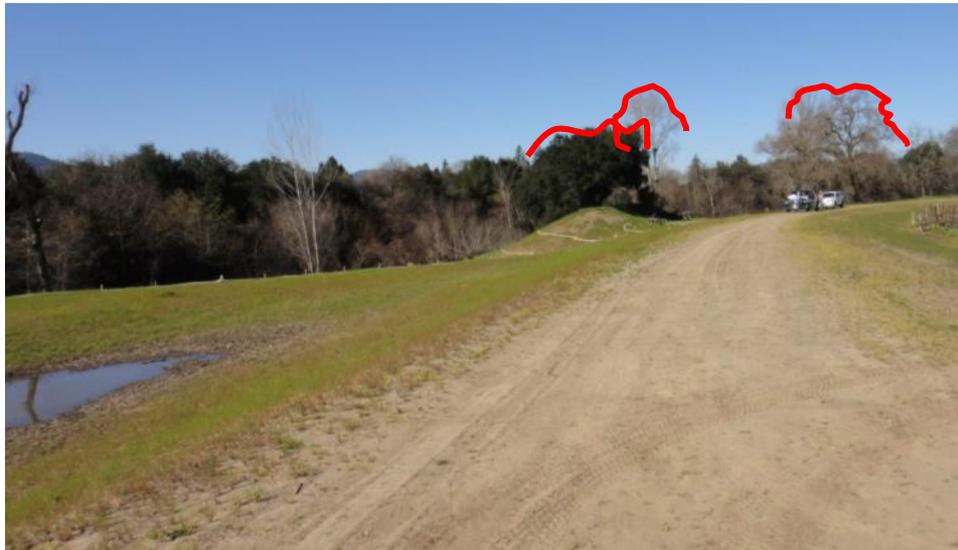
# River Station 15,950

Left (East) Bank Top of New Berm Looking Upstream: Photo Point 44

## Carpy-Conolly Benches 5 and 4, Heritage Oak Tree Island, Setback Berm

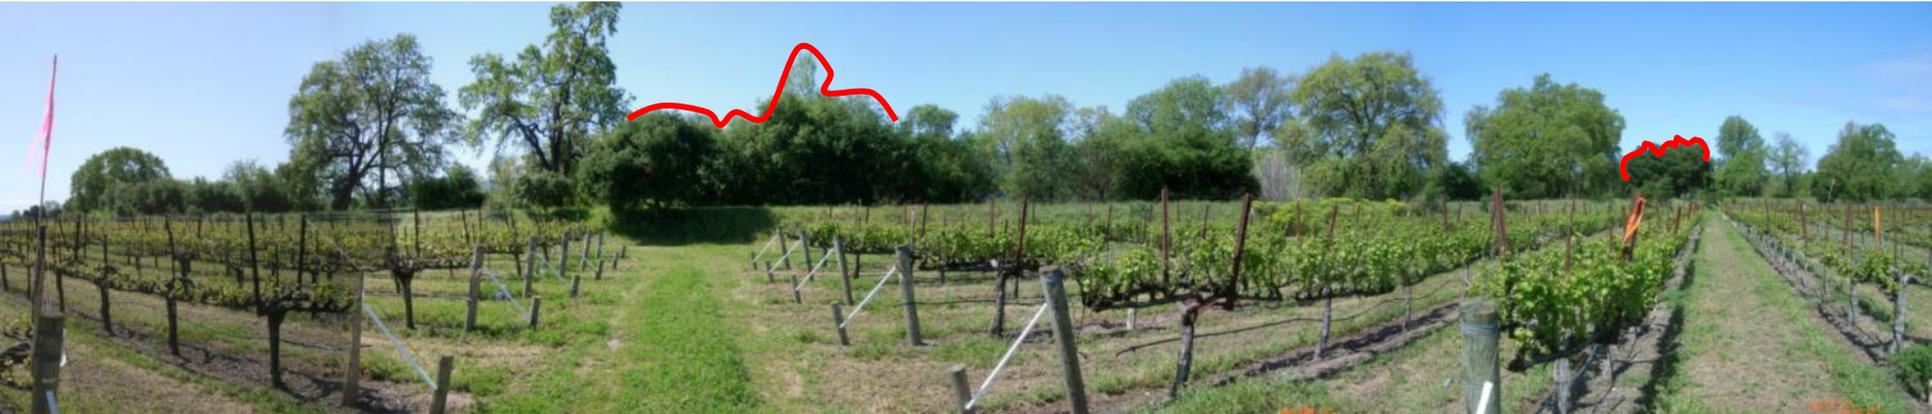
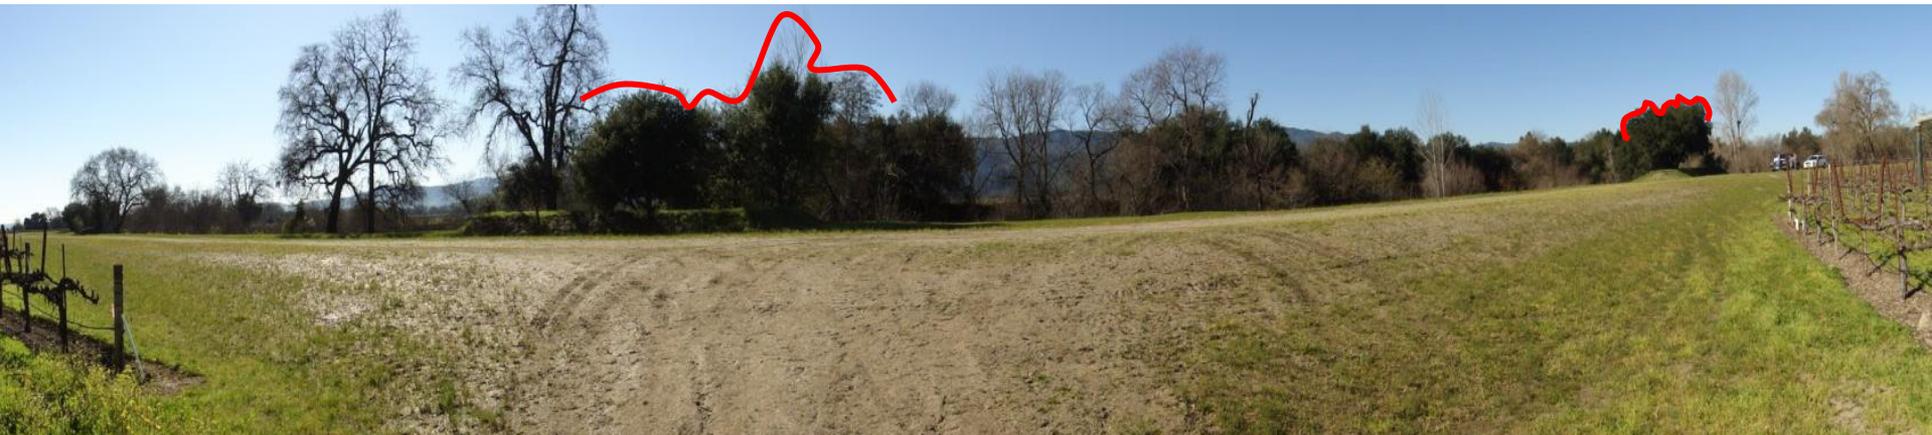
# River Station 15,950

Left (East) Bank Base of New Berm Looking Towards Channel: Photo Point 44  
Setback Berm, Carpy-Conolly Bench 5, Heritage Oak Tree Island

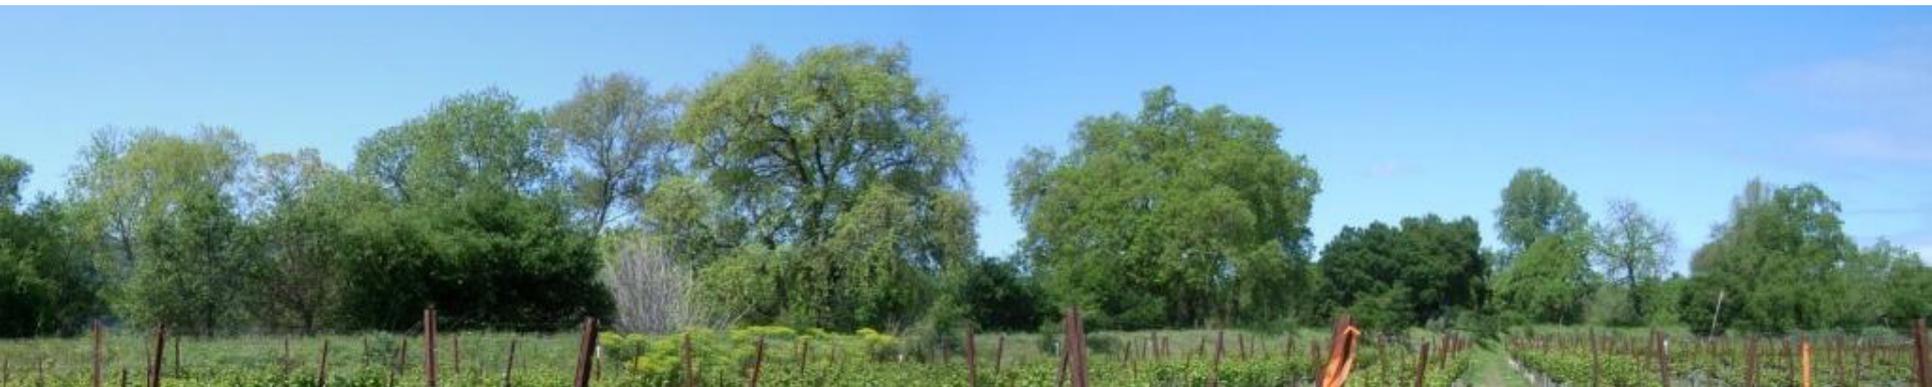
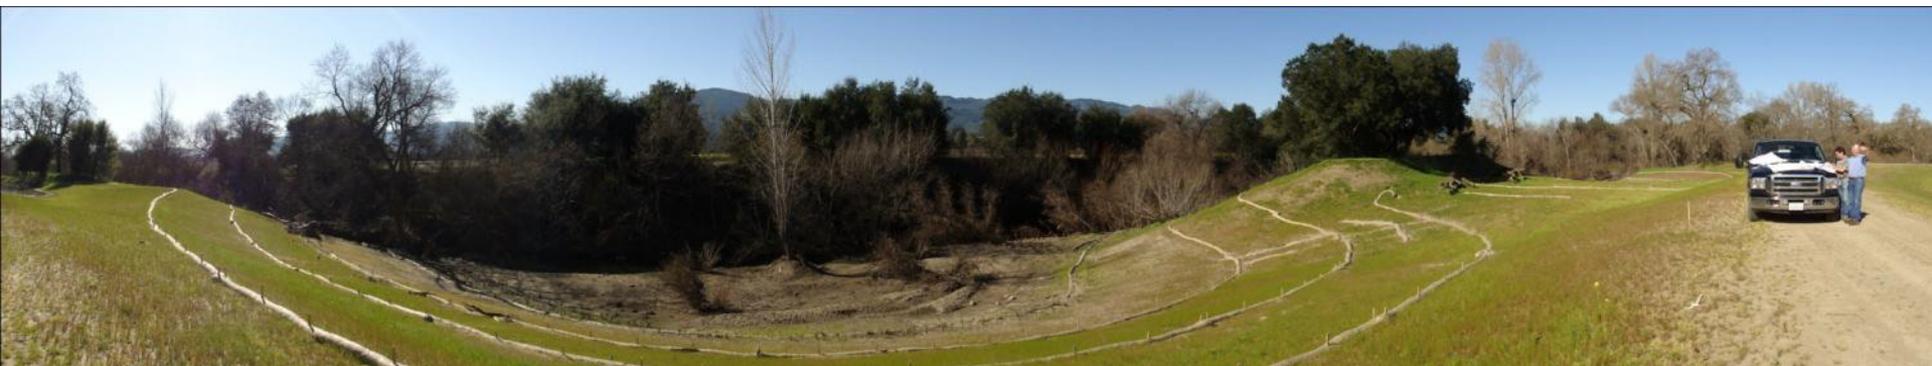
## River Station 16,250

Left (East) Bank Top of New Berm Looking Towards Channel: (300 feet Upstream of Photo Point 44) Photo Point 60  
Setback Berm, Carpy-Conolly Bench 5, Heritage Oak Tree Island

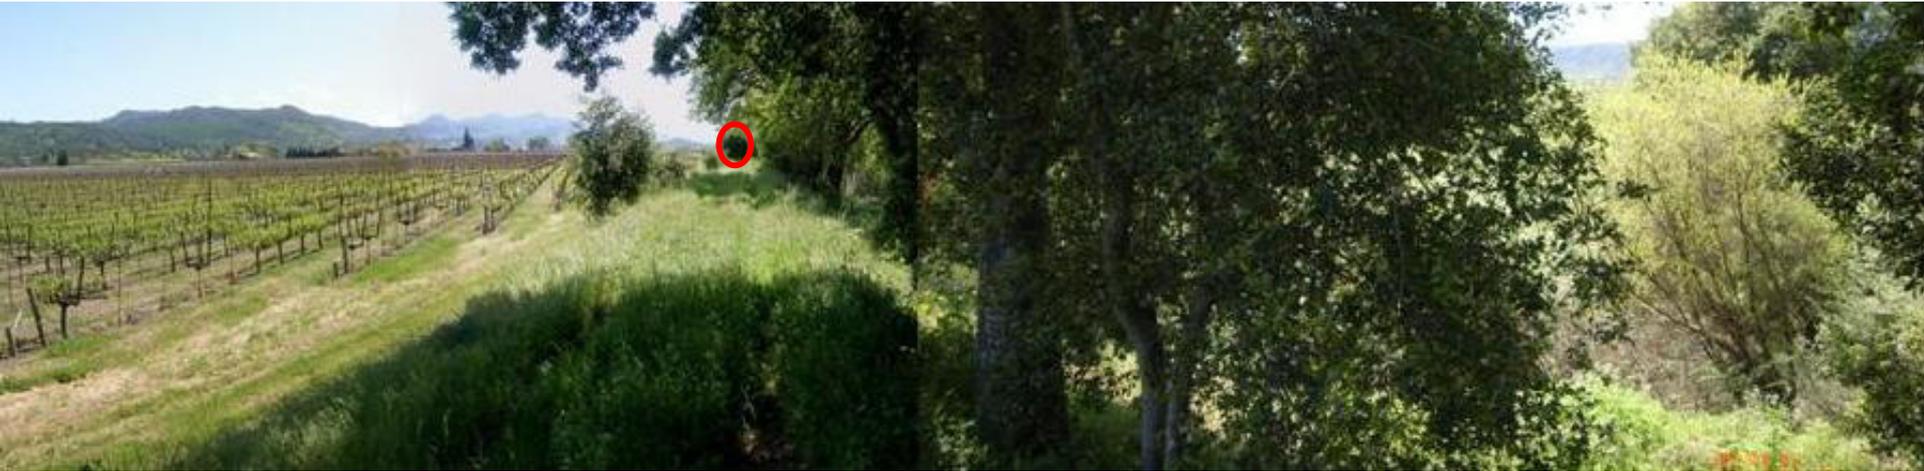
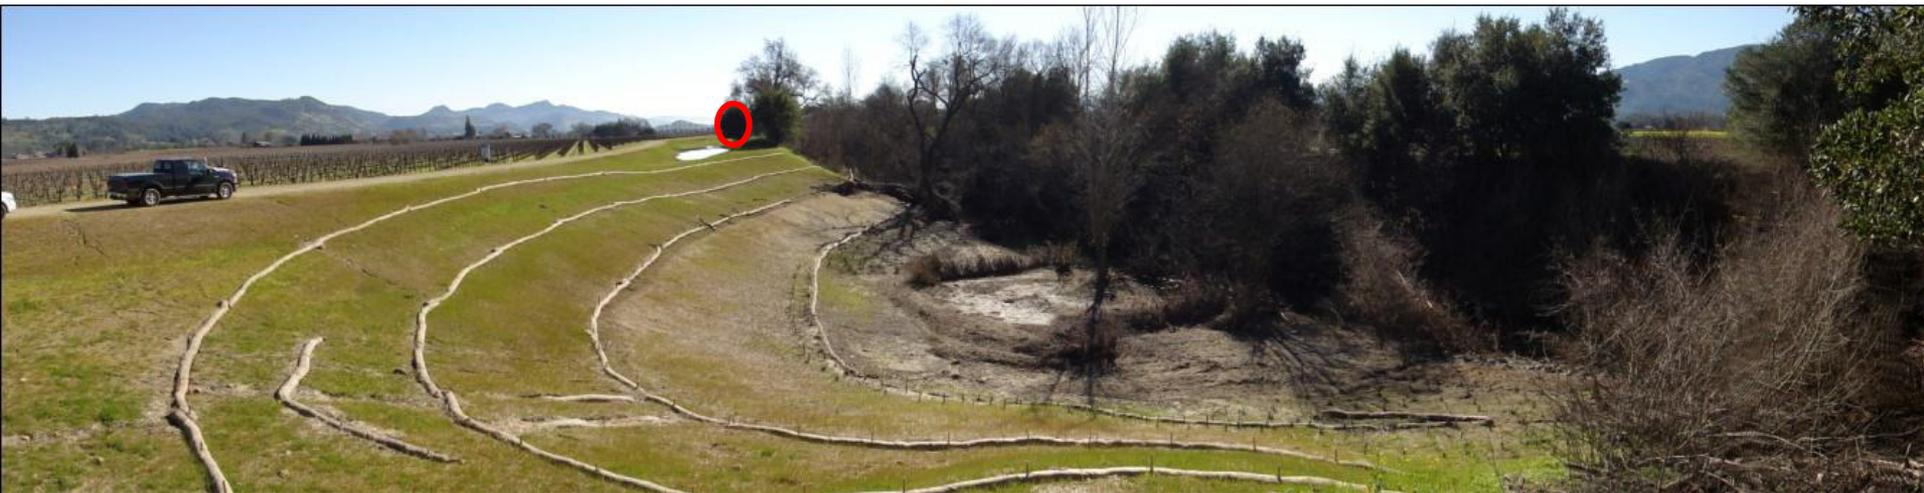
# River Station 16,381

Left (East) Bank Top of Old Berm on Heritage Oak Tree Island Looking Downstream: Photo Point 49  
Carpy-Conolly Bench 5, Setback Berm

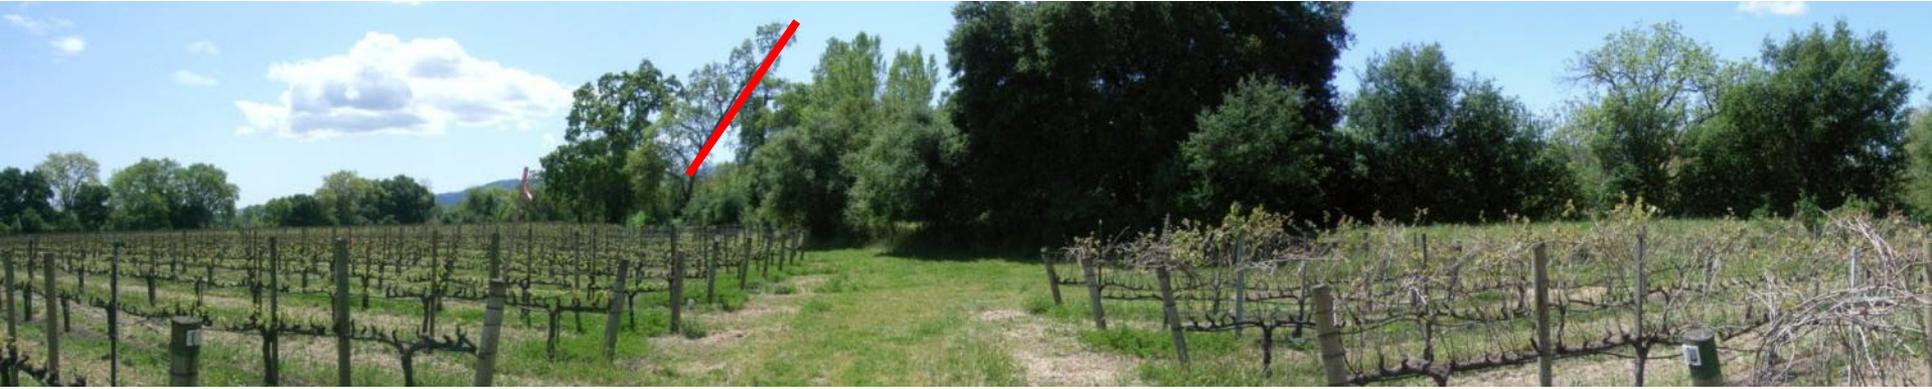
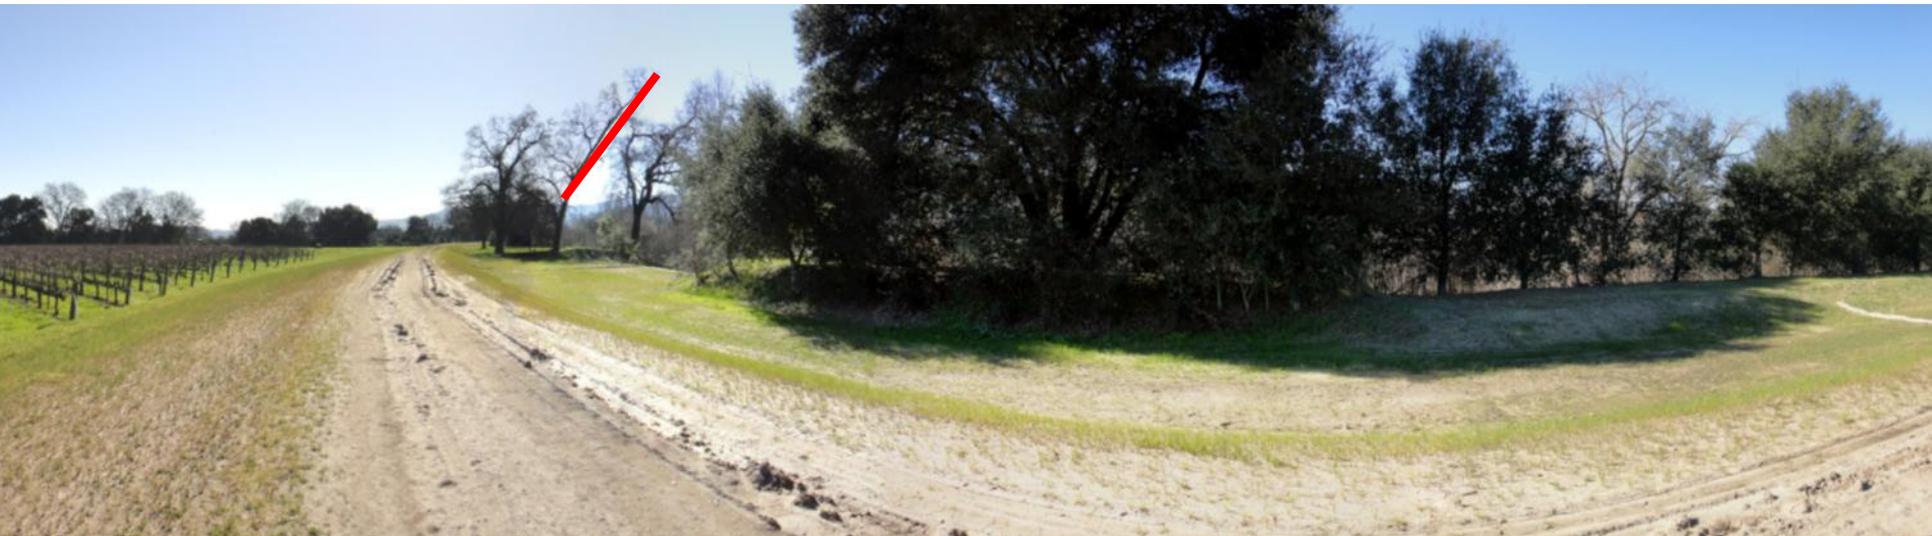
# River Station 15,100

Left (East) Bank Top of New Berm Looking Towards Channel: Photo Point 50  
Setback Berm
