**Napa River Rutherford Reach Restoration Project  
Phase 2, Reach 3**

**FINAL PROJECT REPORT**

**Napa County, California  
July 1, 2011**

**SWRCB Agreement No:** 08-609-552-0

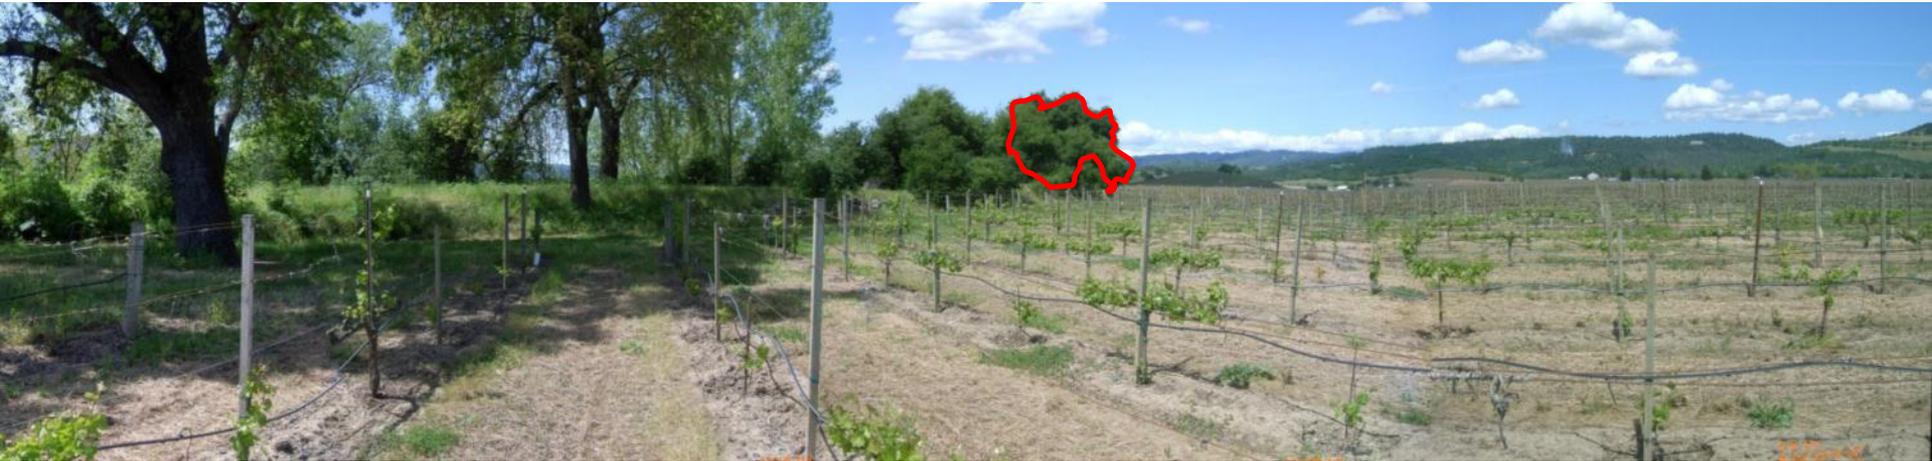
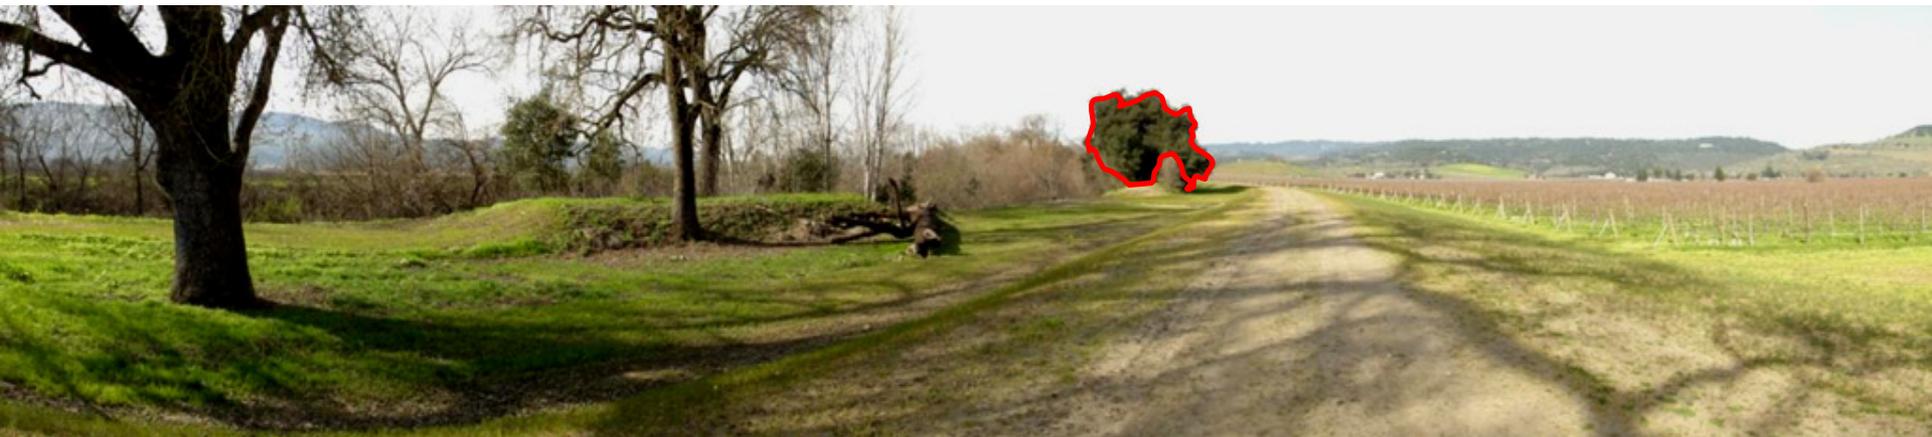
# River Station 14,700

Left (East) Bank Top of New Berm Looking Upstream: Photo Point 53  
Setback Berm, Expanded Riparian Buffer
