Napa River Rutherford Reach Restoration Project Annual Maintenance Survey

August 2009

*Napa County Flood Control and
Water Conservation District
Napa County, California*

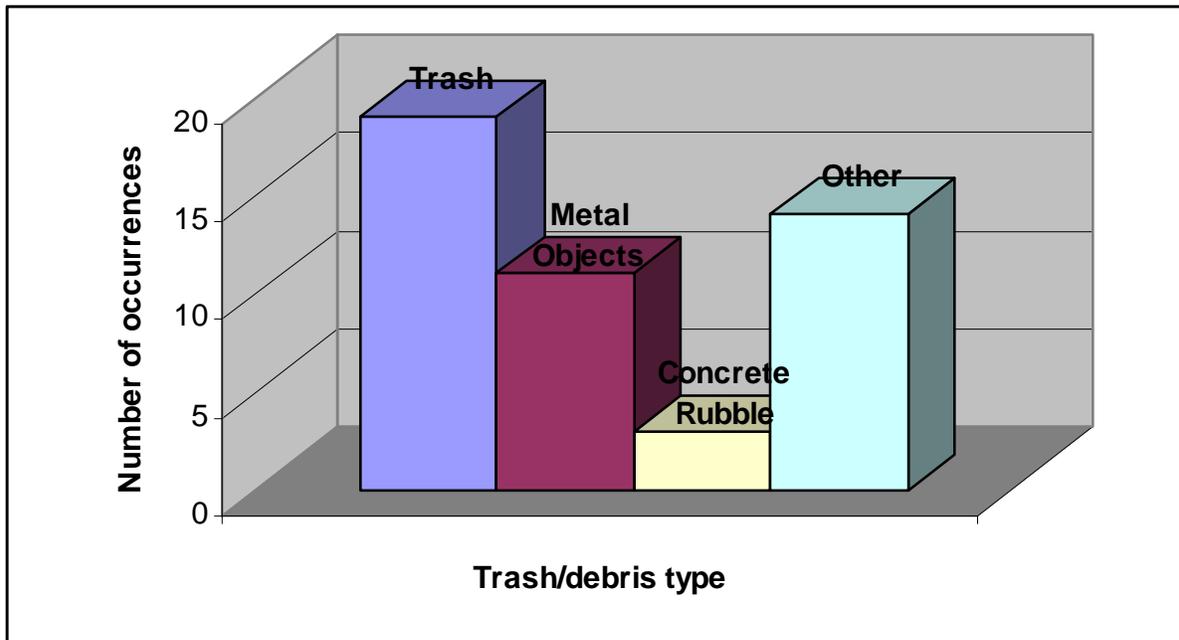
Chart 1: Trash and Debris

A total of 47 occurrences of trash and debris were documented in the Project area with the dominant trash and debris type being tires (19) and the remaining 28 occurrences of trash and debris were objects such as irrigation drip lines, tarps, metal objects (storage drums, appliances, lawn mowers, etc.), a TV set, kiddy pool, car batteries, concrete rubble and a 1947 Buick automobile. Figure 2 shows the location of the trash and debris documented while Chart 1 below represents the amount of trash types documented during the stream survey.
