Napa River Rutherford Reach Restoration Project

Annual Maintenance and Monitoring Survey

July 2015

***Napa County Flood Control and Water Conservation District
Napa County, California***

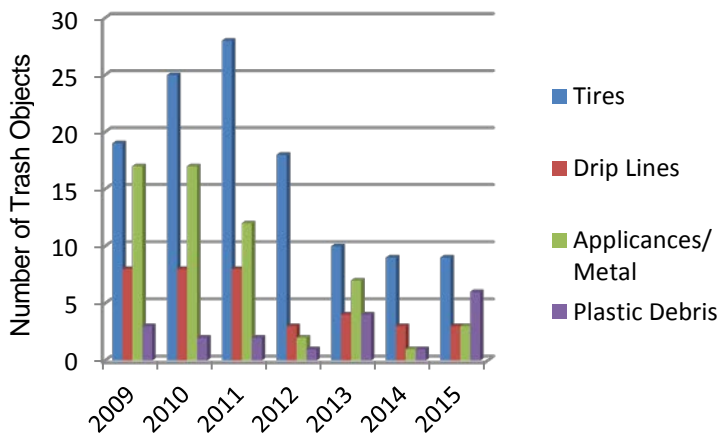
Graph 1: Trash and Debris (2009-2015)

A total of 22 occurrences of trash and debris were documented in the Project area. **Graph 1** illustrates the number and types of trash documented during the stream survey, including tires, drip lines, appliances and metal debris, and plastic. Since surveys began in 2009, tires have consistently been the dominant debris documented in the channel. This year 9 of the 22 occurrences were tires. The remaining four (13) occurrences of trash and debris were drip lines, a plastic tarp, a lawn mower, and an oven (**Picture 1**). **Figure 2** shows the locations of the surveyed trash and debris. While overall occurrences of trash and debris are less when compared to the peak number (48) documented in 2011, more were documented this year (22) than last year (13).

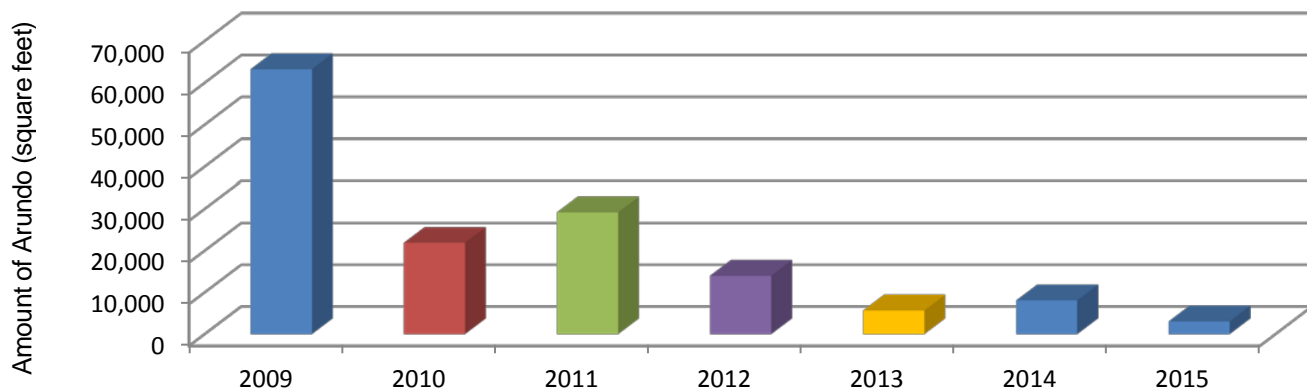
Graph 2: Arundo mapped and treated (2009-2015)

Previous and ongoing efforts to manage and remove giant reed (*Arundo sp.*) have been successful in significantly reducing the amount of giant reed in the entire Project area. **Graph 2** below depicts the general decline of *Arundo* throughout the Project area. The area of *Arundo* documented this year was approximately equal to that detected last year; this is due to the occurrence of re-sprouting patches and/or patch that were not found previously that will require re-treatment under the Maintenance Assessment District.
