Napa River Rutherford Reach Restoration Project Annual Maintenance and Monitoring Survey

Napa River June 2012

July 2012

*Napa County Flood Control and
Water Conservation District
Napa County, California*

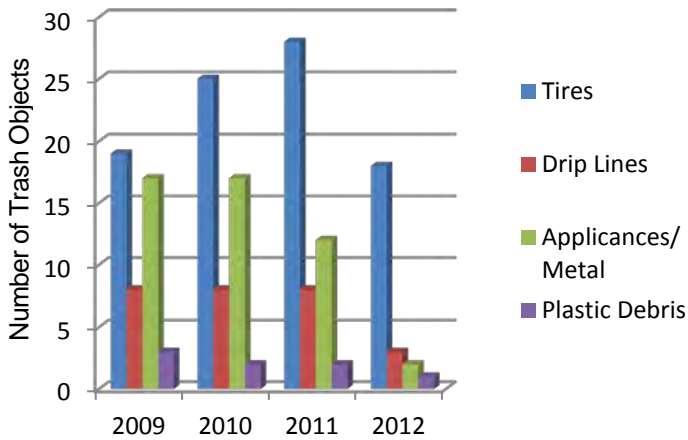
Graph 1: Trash and Debris

A total of 24 occurrences of trash and debris (Picture 1) were documented in the Project area with the dominant trash and debris type being tires (18) and the remaining (6) occurrences of trash and debris being various objects including irrigation drip lines, agricultural containers and large residential electronic appliances. This represents a significant decrease in the amount of trash and debris documented and removed from the three prior maintenance surveys. Figure 2 shows the location of the trash and debris documented; accumulation of trash was fairly consistent throughout the Project reach with the exception of Reach 9 having a fairly low amount of trash documented. Graph 1 below represents the amount and types of trash documented during the stream survey.

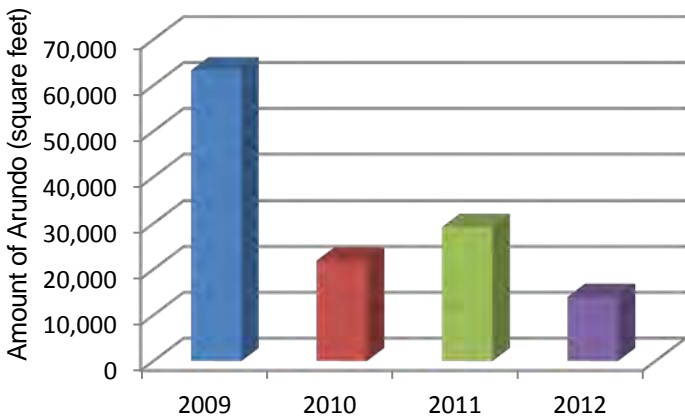
Graph 2: Arundo mapped and treated (2009-2012)

A total of 44 occurrences of invasive non-native plants and non-native Pierce host plants were identified and will be targeted for treatment within the Project area (Figure 3). As identified in previous surveys, Giant reed, Himalaya blackberry, periwinkle (*Vinca sp.*), poison hemlock and native and hybridized grape species were the dominant target plants identified; other target species documented include tree-of heaven and red sesbania but were limited. The two sesbania occurrences detected during the survey were removed at the time of the survey. Species such as poison hemlock, fennel, etc. were observed but not quantified during the survey as a result of land owner’s requests in previous meetings to focus on and use funds for treatment of only invasive plant species that are considered Pierce host’s species as well. A total of 60, 112 square feet (sqft) of non-native invasive and Pierce host plants were documented including 13,982 sqft of giant reed, 36, 241 sqft of Himalaya blackberry and the remaining 9,889 sqft being a combination of native/non-native grape and periwinkle. However, it is important to note that there is significantly more grape, periwinkle and other Pierce host plants present beyond the river’s top of bank; in general the extent of these plants that can be documented from the perspective of the river channel and treated under the maintenance program extends to the top of bank of the riparian zone. For this reason landowners are encouraged to contact the maintenance lead with requests for management of invasive and Pierce host plants in the riparian zone beyond the top of bank. Additionally, to a large extent Himalayan blackberry and grape occur in a near continuous band of various width(s) throughout the entire 4.5 mile Project reach on both the east and west river banks. In general, previous and ongoing efforts to manage and remove giant reed (*arundo*) has been successful in significantly reducing the amount of giant reed in the Project area (Graph 2), therefore only small or re-sprouting patches will require minor treatment in 2012. However, it was noted that several areas where giant reed was treated previously have become unstable stream banks (Picture 2) and will require significant bank stabilization and re-vegetation work before the onset of winter rains and high stream flows.
