Napa River Sediment Reduction and Habitat Enhancement Plan: Oakville to Oak Knoll

April 2011

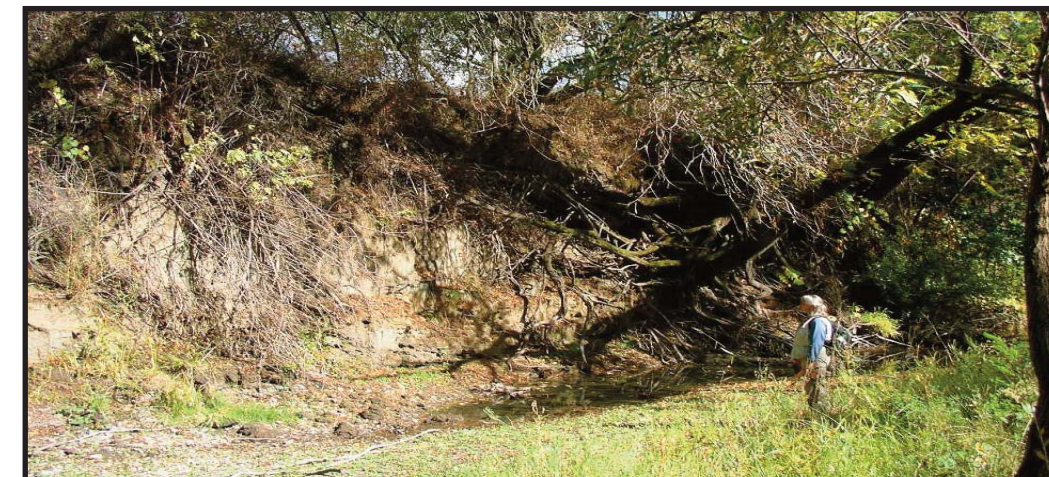
BANK EROSION IN REACH 9

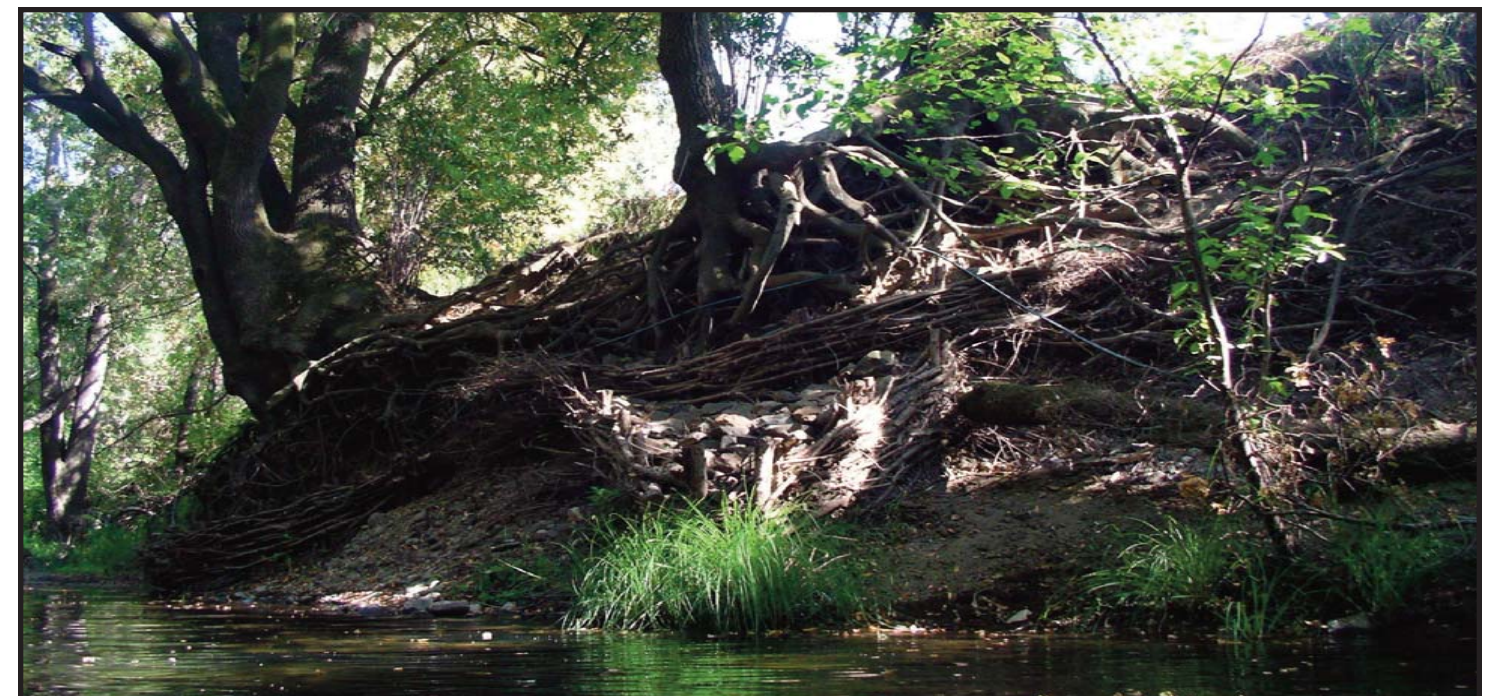
REACH 8 HAS NUMEROUS LARGE OLD GROWTH TREES. MANY OF THESE TREES ARE BEING UNDERCUT BY BANK EROSION. A WILLOW REVETMENT WAS CONSTRUCTED AROUND THE TREES IN THE PHOTO TO REDUCE EROSION BUT NEVER GREW.

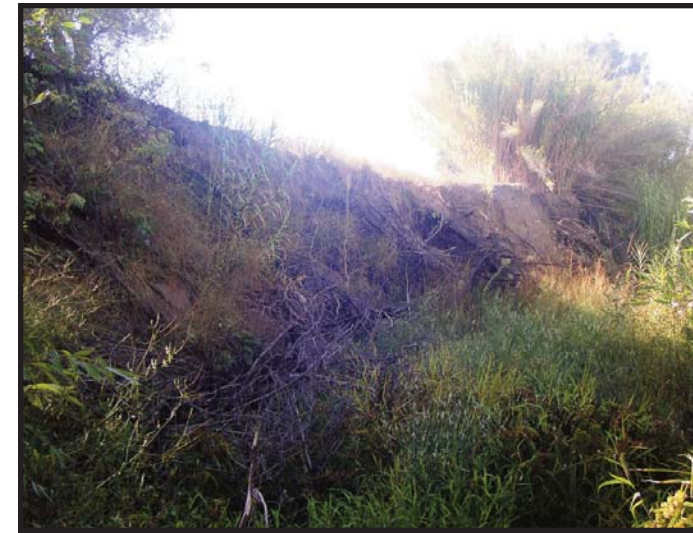
Reach 5 has several areas of vertical, eroding banks with riprap.

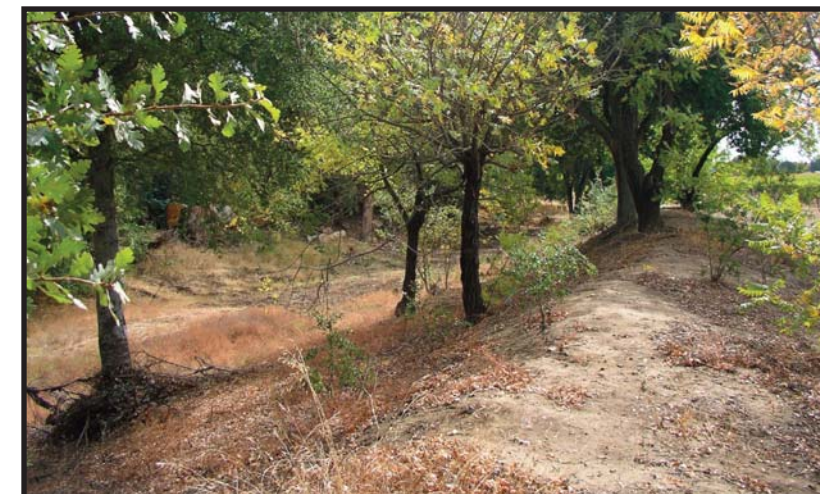
THE FLOOD CONTROL BERM IS ON THE RIGHT AND THE OVERFLOW AREA ON THE LEFT IN THIS PHOTO WITH THE RIVER CHANNEL TO THE FAR LEFT.

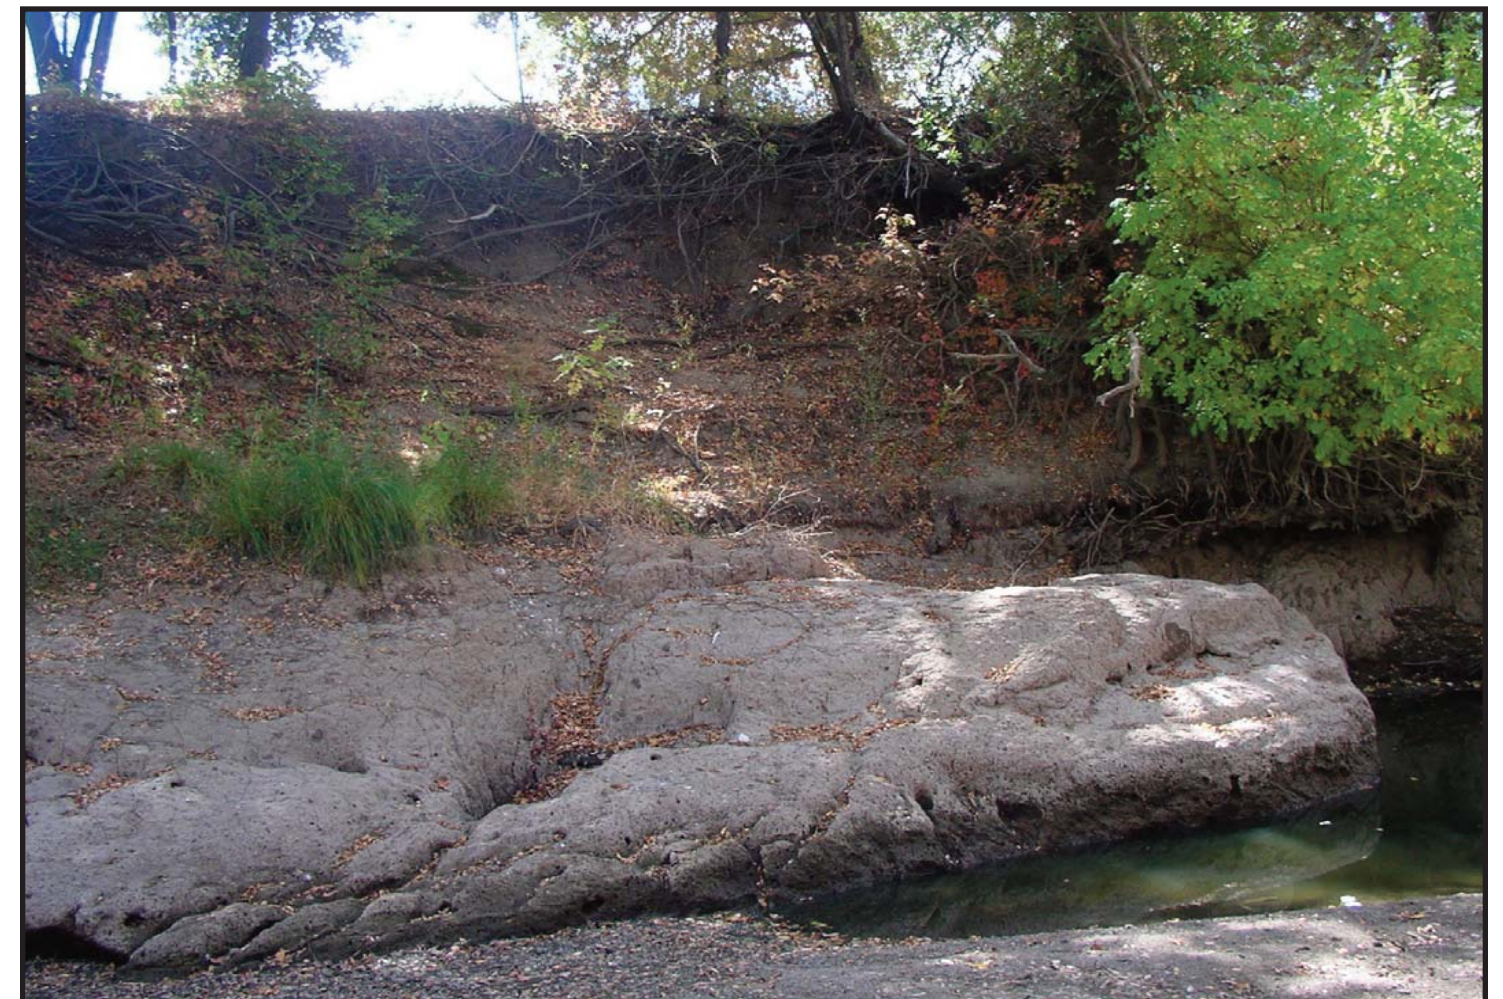
Ecological Trends: Reach 5 has a simplified morphology with minimal vegetation and little to no re-generation. Neither the left nor right bank has many C1 or C4 trees; both banks have low density vegetation. A resistant clay layer dominates the channel area which is nearly unvegetated. The berms also have few naturally occurring seedlings and few C4 trees. The large trees remaining in Reach 5 are being undercut and eroded out. Overall tree density is low to very low in comparison to other reaches.

A RESISTANT CLAY LAYER IN THE CHANNEL OF REACH 5 DOES NOT SUPPORT VEGETATIVE GROWTH. 59

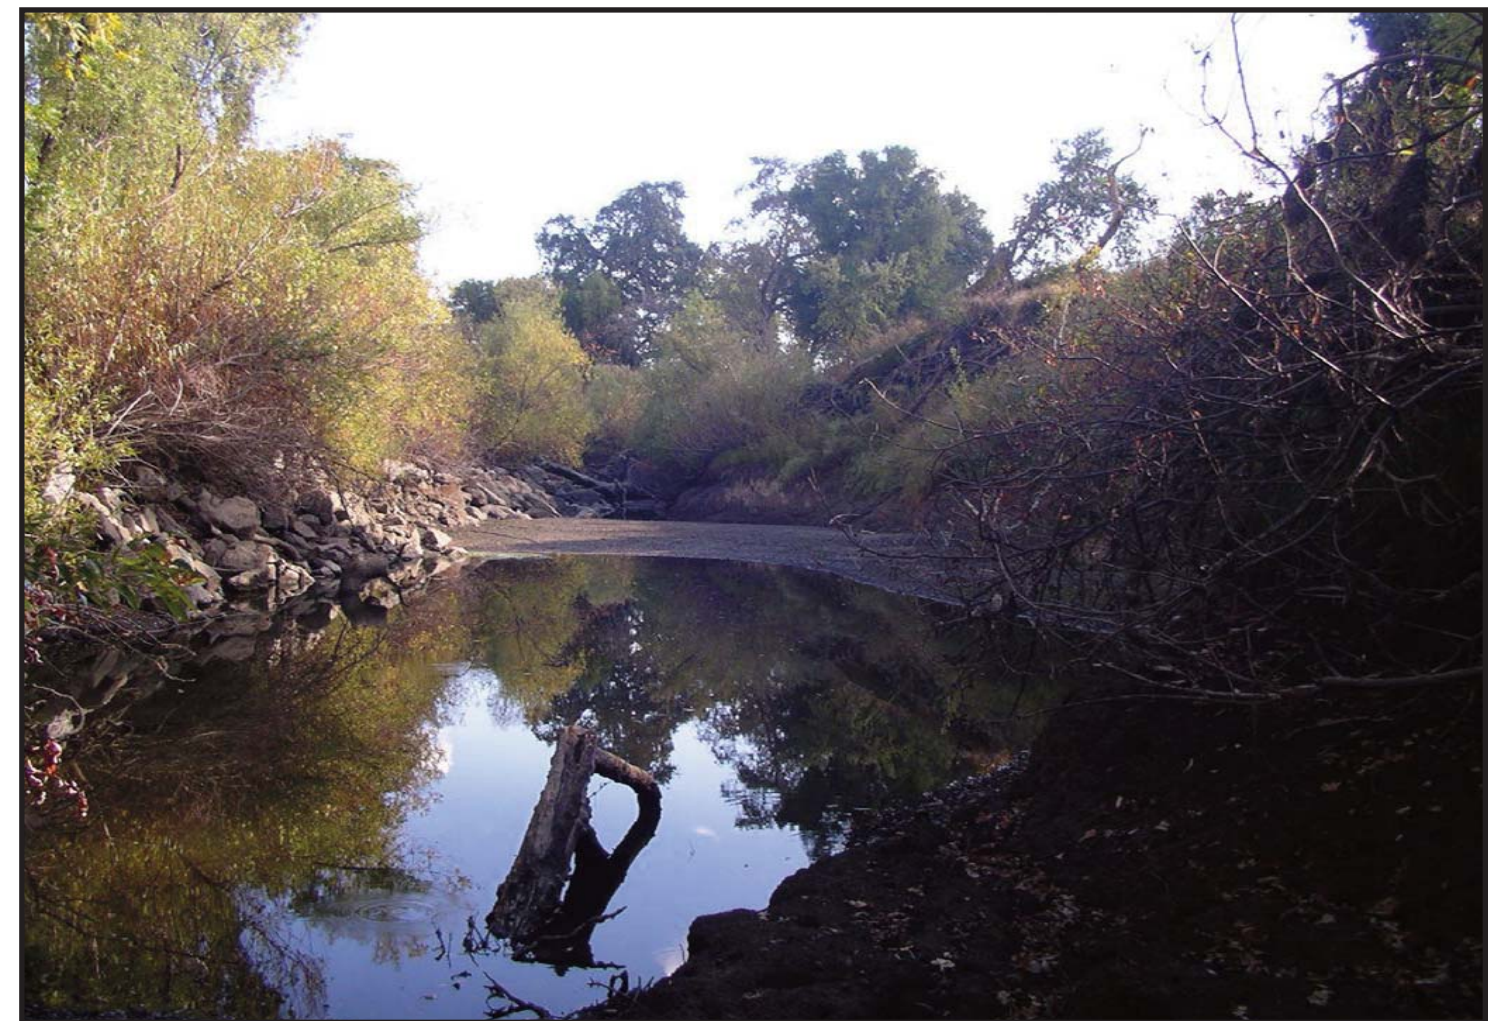
REACH 4 HAS FEW SEEDLINGS IN THE CHANNEL AND LITTLE REGENERATION. RIPRAP IS COMMON ON THE BANKS AS ARE UNDERCUT LARGE TREES.

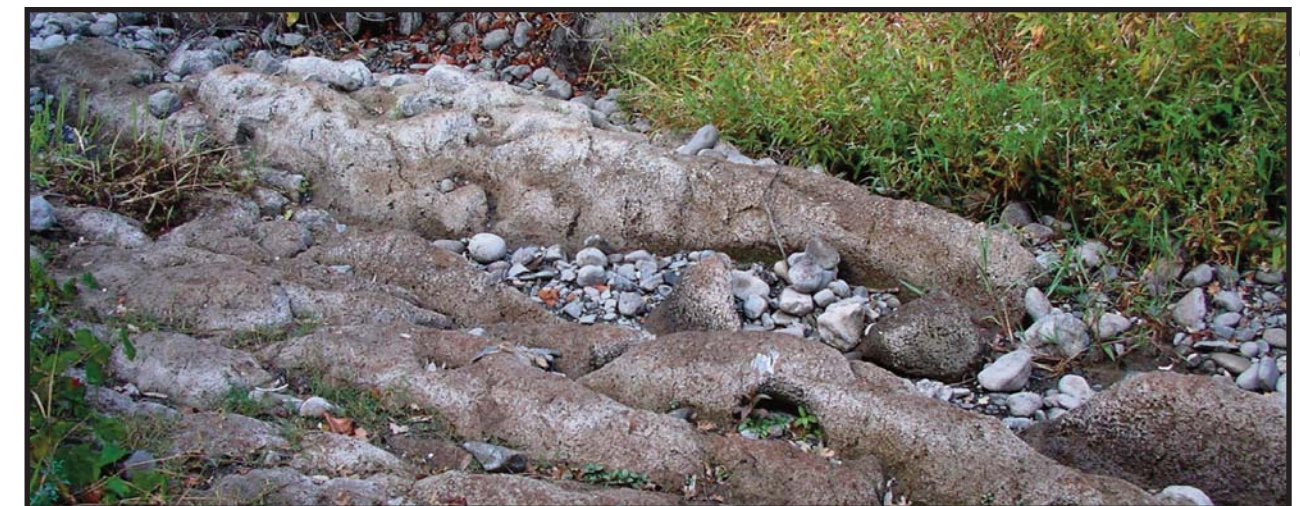
Reach 1 is dominated by resistant channel bed materials of cohesive clays and indurated sediments. This resistant clay layer forms a poor substrate for both channel processes such as riffle and pool formation and biological processes such as spawning gravels and rearing pools, and riparian vegetation. The reach is dominated by long pools and flatwater, with no side channels or backwater areas and few terraces to provide high flow refugia for fish.

RESISTANT CLAY LAYER IN THE CHANNEL OF REACH 1

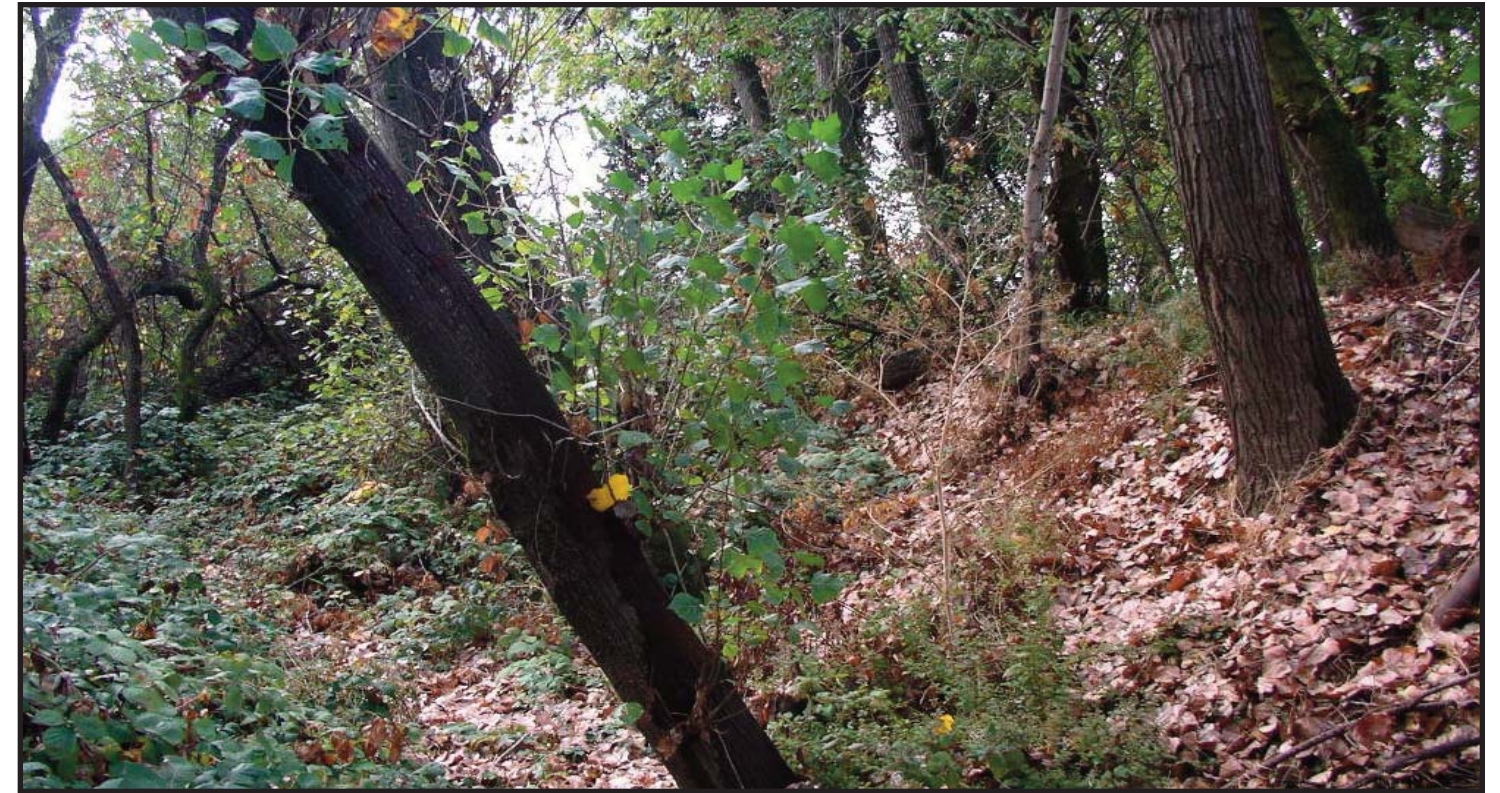
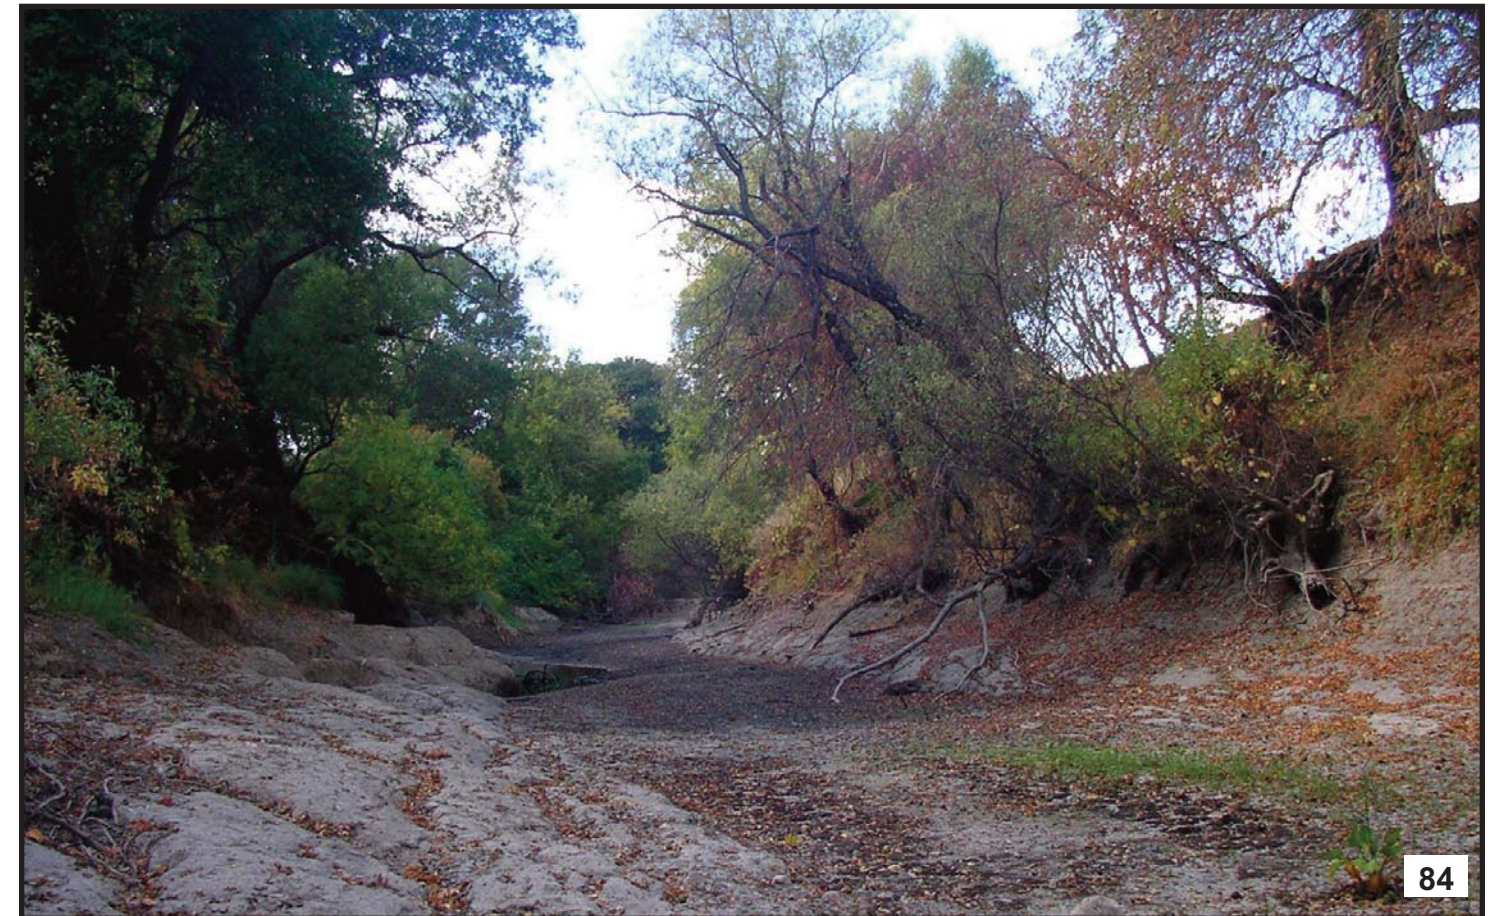
THE WIDEST REACHES IN THE PROJECT AREA ARE 10, 5 AND 1. ABOVE: REACH 10 HAS SEVERAL FLOODPLAIN AREAS AND SECONDARY CHANNELS AND IS THE WIDEST REACH OF THE PROJECT AREA.

BELOW: REACH 5 HAS LOW DENSITY VEGETATION IN ALL ITS MORPHOLOGICAL AREAS AND NO REGENERATION IN THE CHANNEL AREA DESPITE BEING ONE OF THE WIDER REACHES.

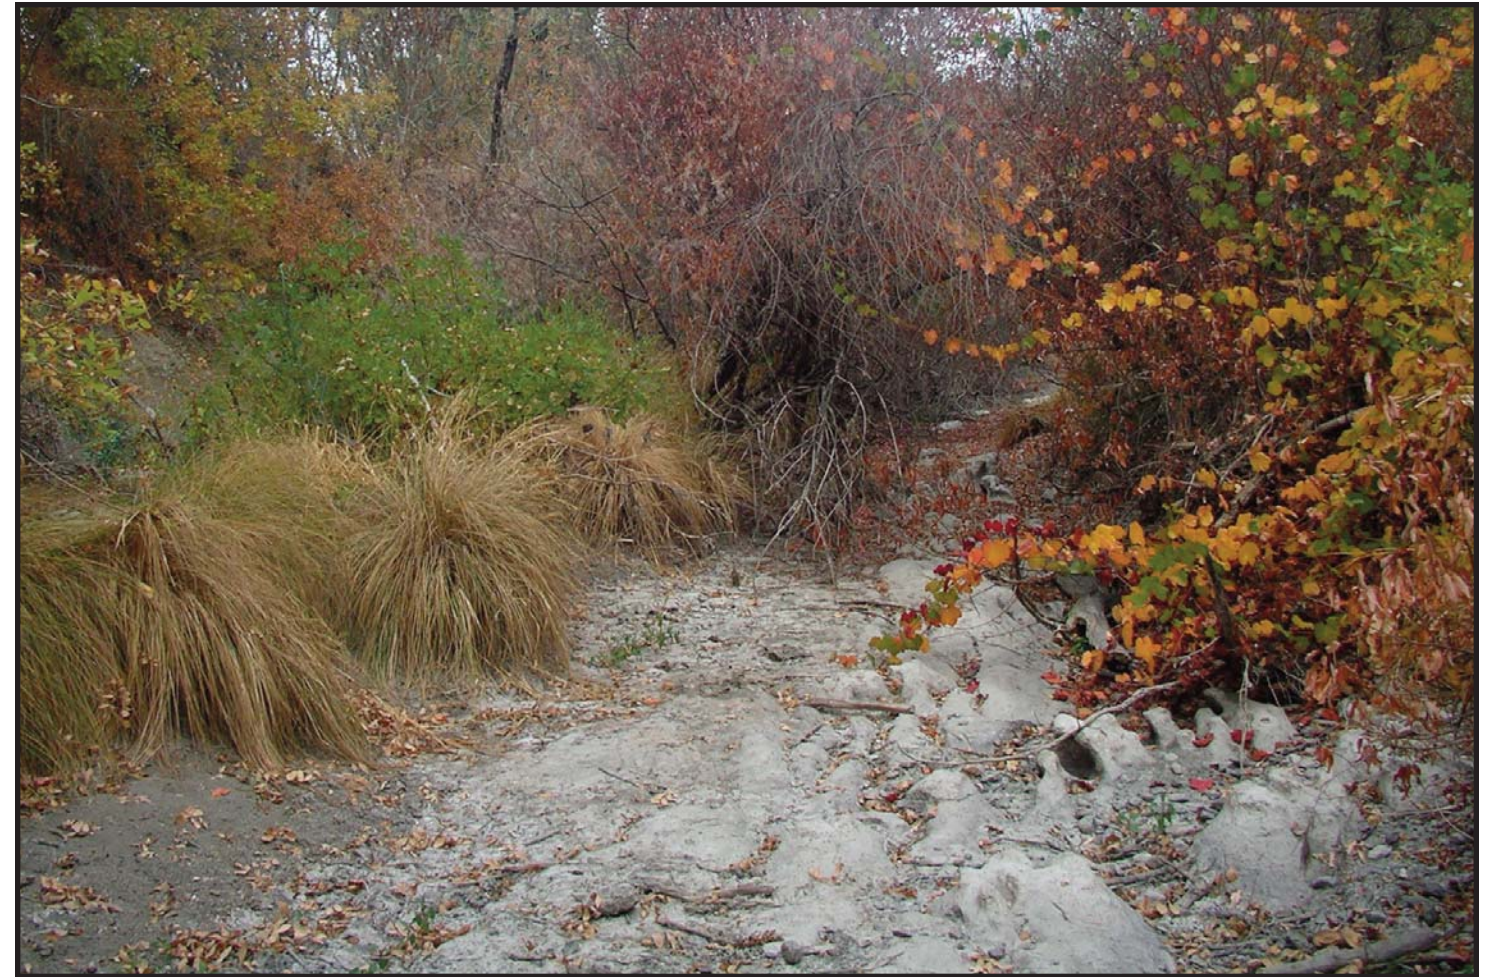
THE NARROWEST REACHES ARE 4, 6 AND 7.

REACH 4 (LEFT AND RIGHT) HAS NO TREE REGENERATION AND MOST OF THE TREES ON THE BANKS ARE BEING ERODED OUT.

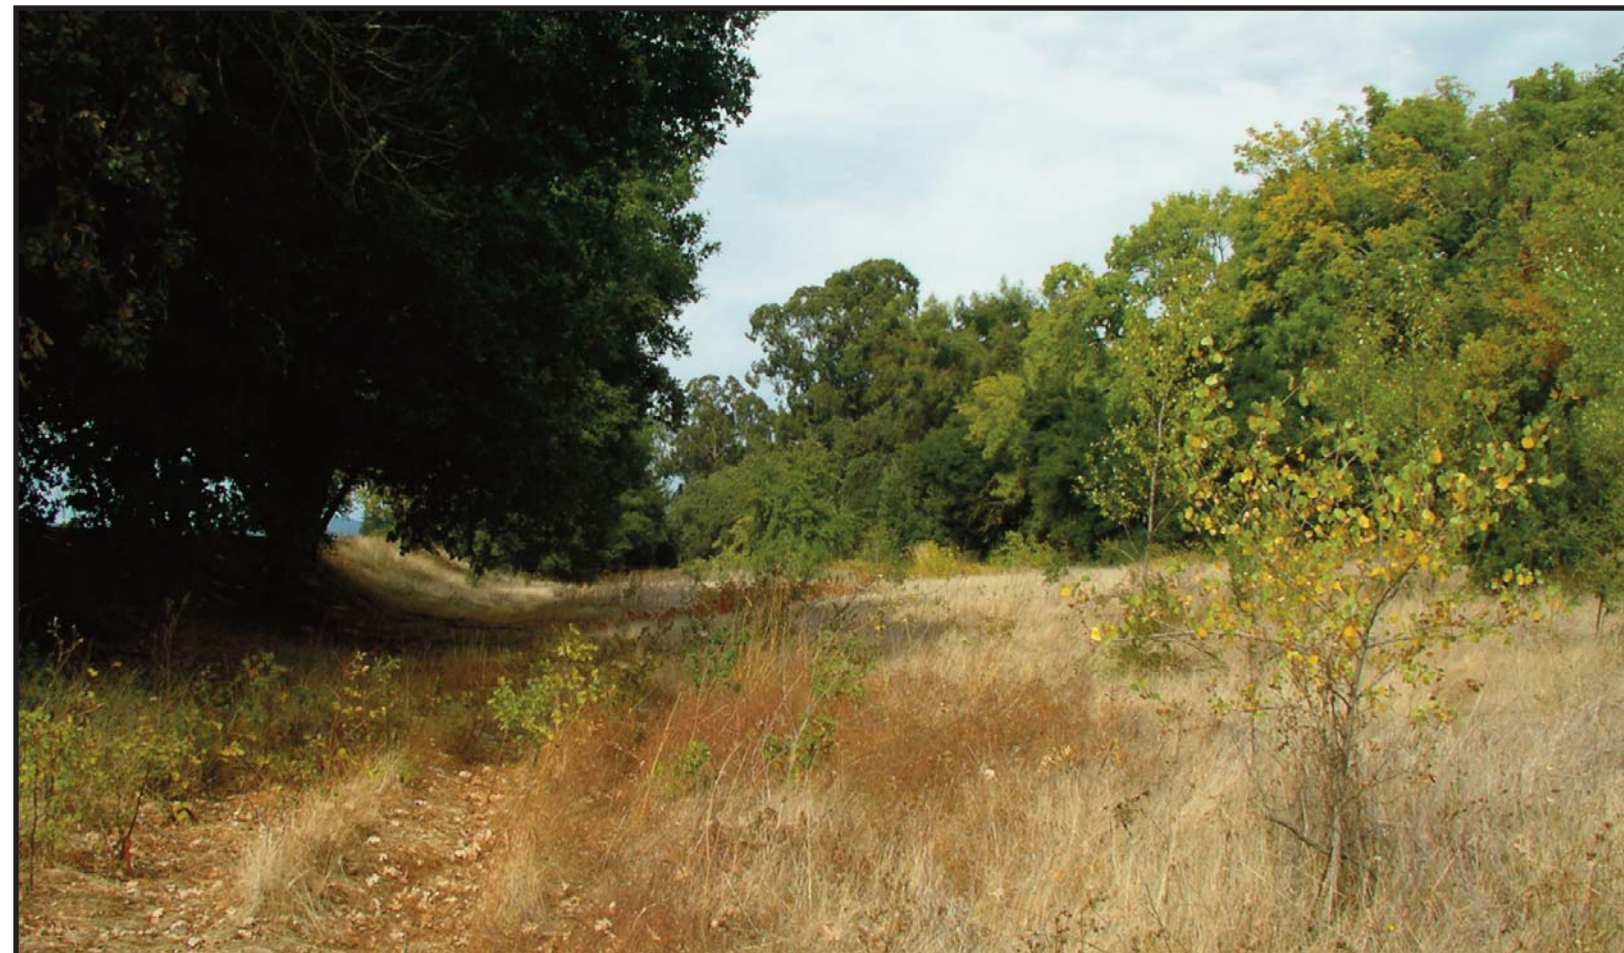
Existing Condition: Area 13 is a flood overflow channel which was created in the 1960's. The western edge of the area is bermed and live oaks cover portions of the berm. The area between the berm and the river riparian corridor is mostly grass with seedling trees.

VIEW LOOKING UPSTREAM AT OVERFLOW CHANNEL IN AREA 13. BERM IS ON LEFT AND RIVER CHANNEL IS ON RIGHT.

Proposed Condition: Area 13a would use the entire Area 13. A secondary channel and adjoining floodplain would be graded to the 2-year flood elevation adjacent to the river channel. The berm would be fortified to protect adjacent vineyards. Area 13b would create the same features only confine the changes to the northern parcel.

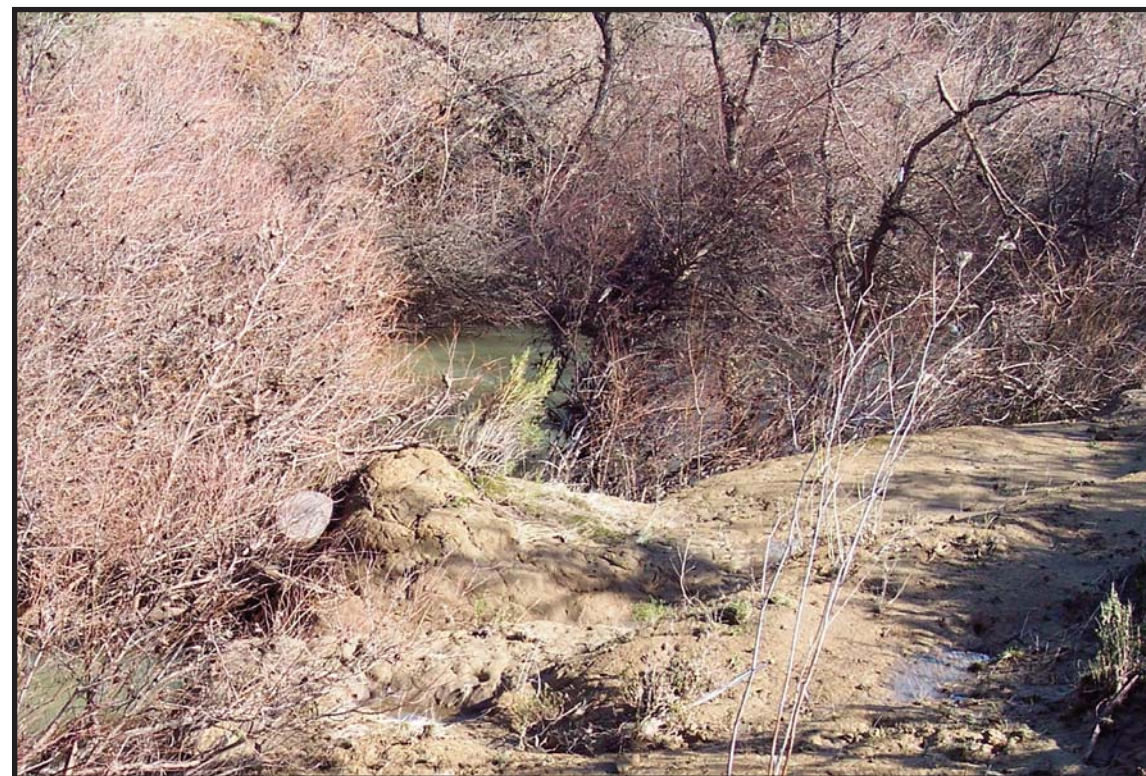
LEFT: CLAY LAYER AT CONFLUENCE OF DRY CREEK AND THE NAPA RIVER
