NAPA RIVER RUTHERFORD REACH RESTORATION PROJECT 2013 MONITORING REPORT

April 2014

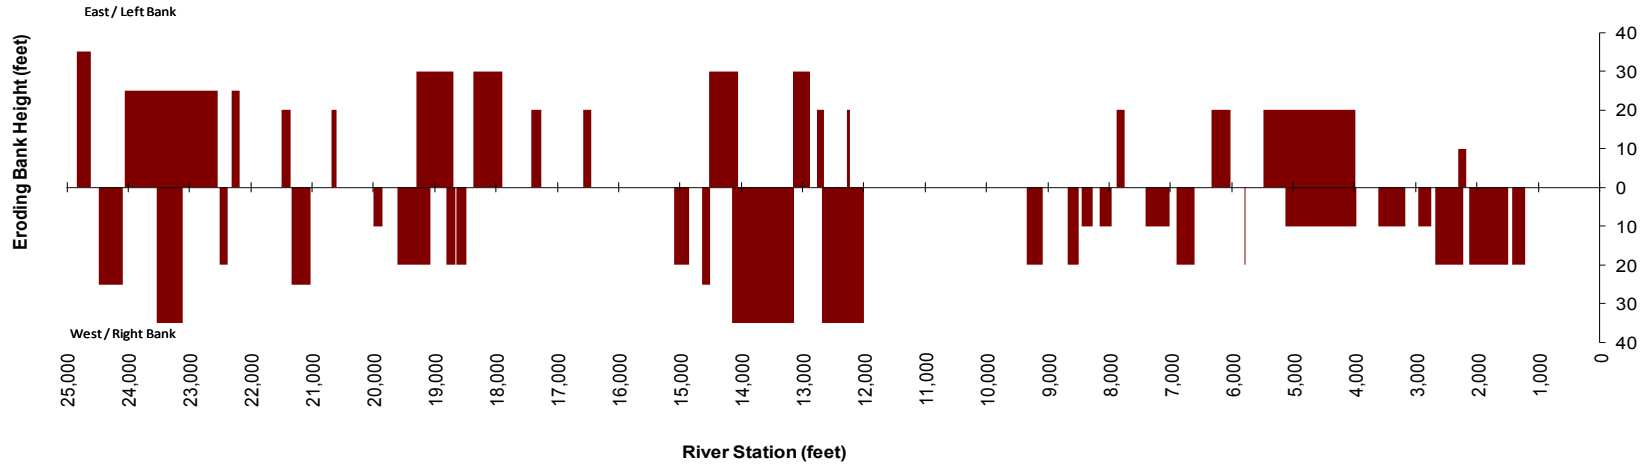
2009
 Napa River Rutherford Reach
Eroding or Unstable Banks
14,700 Feet: 60%

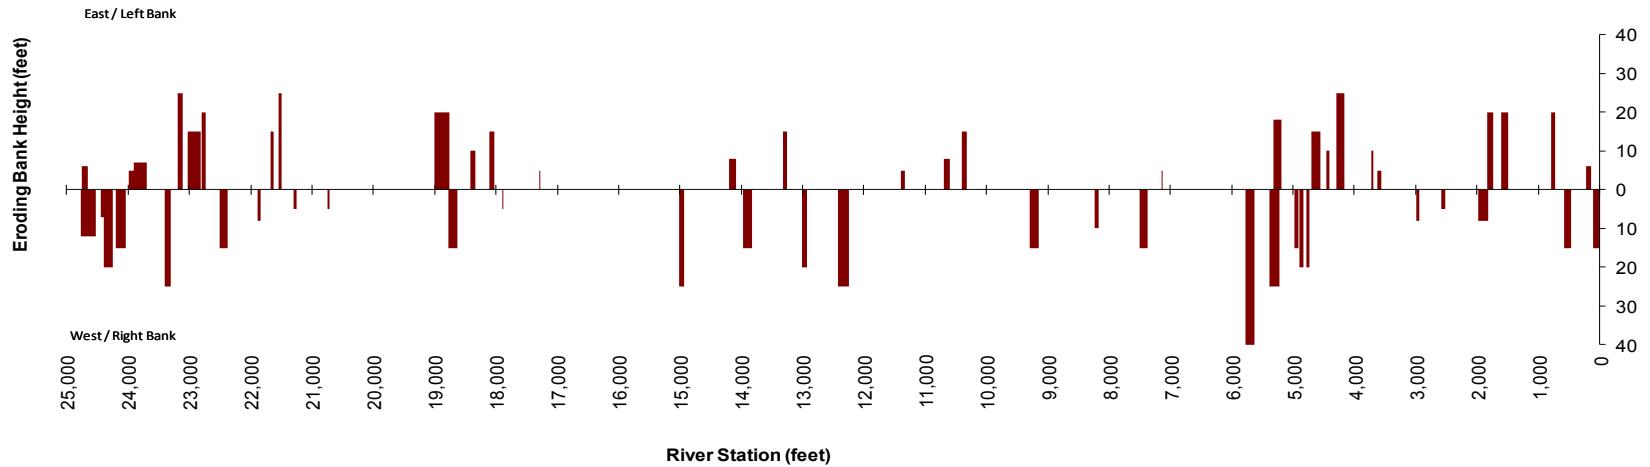
2013
 Napa River Rutherford Reach
 Eroding or Unstable Banks
 5,200 Feet: 18%

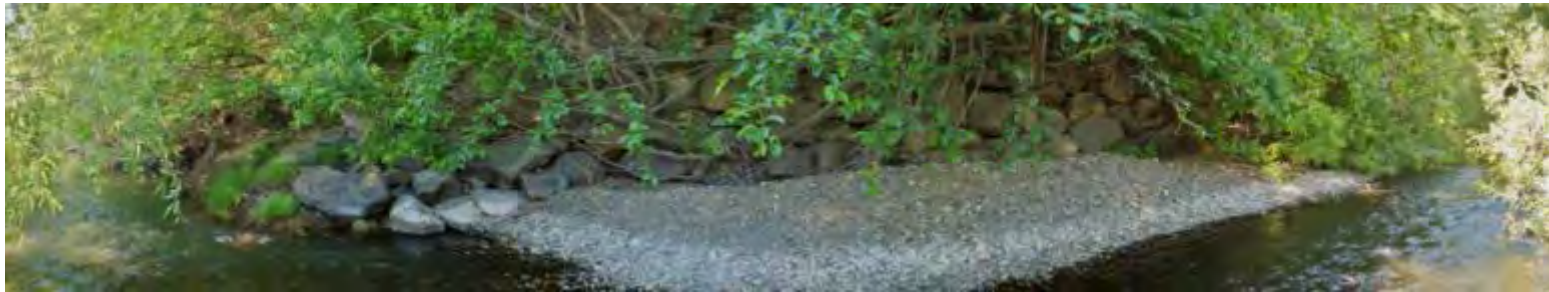
16,200-16,300 New Gravel Bar 2011

The widening of the channel at restoration sites also appears to be a contributing factor to the formation of new gravel bars, creating greater complexity in the channel. Comparison of pebble counts taken at monitoring cross sections in 2009 and 2011 pre- and post- construction of Phase 2: Reach 3 in 2010 demonstrate that a new gravel bar formed at river station 16,300 on the east bank opposite Carpy-Conolly Bench 5. The gravel bar that was sampled in 2009 at station 16,422 prior to construction of Carpy-Conolly Bench 4, constructed from east bank river stations 16,725-16,475, and Carpy-Conolly Bench 5, constructed from east bank river stations 16,350-16,100, no longer existed in 2011. It is likely that the widening of the channel at Bench 5 slowed velocities sufficiently to cause the gravel that was mobilized from the bar between the two benches 122 feet upstream, where the channel width was unchanged, to deposit as a new bar.

Sampling of the new downstream bar in 2011, which set up on the opposite west bank, shows that the median grain size increased from $D_{50}=16\text{mm}$ to $D_{50}=32\text{mm}$, and the D_{84} increased from 32mm to 45mm following the 2011 peak flow event of 7,330 cfs. Significantly, not only did the gravel bed coarsen from 2009, but the percentage of fines in the new bar decreased from 17% to 1% of the sample. The reduction of fines in the gravel might be attributed to the fact that sand and finer sediments can now escape the incised low flow channel and deposit on the restored benches at relatively low flows (less than a 10 year recurrence interval). The sandbar, which accumulated on the new east bank Carpy-Conolly Bench 5, provides further evidence of this hypothesis that instream bench creation in serving to reduce the percent of fines in spawning gravel.

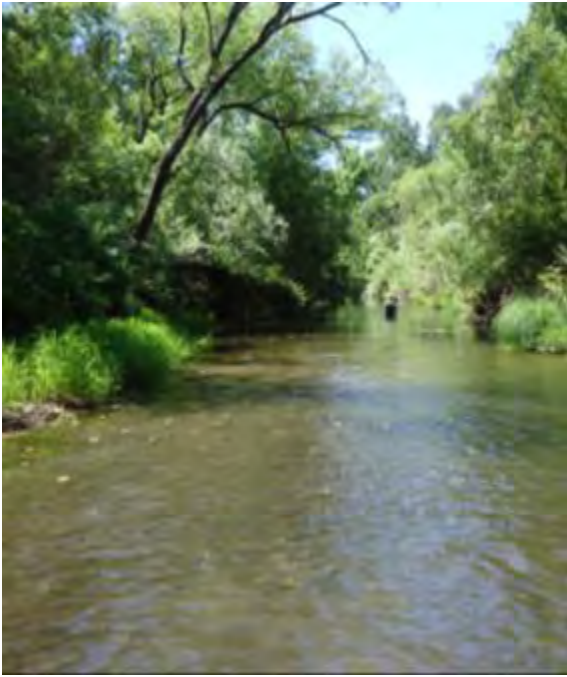
13,050 Glide Pre-Restoration 2011

A new gravel bar also formed at station 13,050 on the east bank in 2012 following construction of Phase 3: Reach 4 East Bank Honig Bench 13 between stations 13,150-12,725 in 2011. The gravel in the bar was coarser and contained a lower percentage of fines than the gravel which existed previously in the glide that existed in the reach prior to restoration of the bench. Following the peak flow event of 7,330 in 2011, comparison of pebble counts from 2010 and 2011 show a coarsening of the bar at station 13,050, with an increase in the D_{50} from 11mm to 22mm , and an increase in the D_{84} from 32mm to 45mm . The percentage of fines in gravel on the bar decreased markedly from 30% to 2%. Like Bench 5 upstream, the new Honig Bench 13 on the east bank had also accumulated sand.

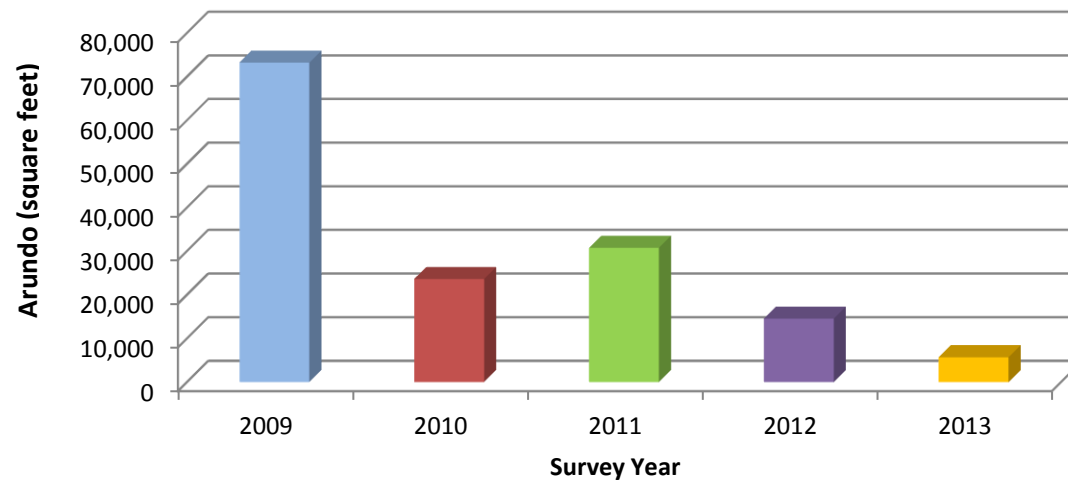
Chart 1: Arundo mapped and treated (2009-2013)

Previous and ongoing efforts related to the Project designed to manage and remove giant reed (*Arundo*) have been successful in significantly reducing the amount of giant reed in the entire Project area. Chart 1 below depicts the general decline of *Arundo* throughout the Project area. Currently, only small or re-sprouting patches of giant reed require treatment under the Maintenance Assessment District (MAD).

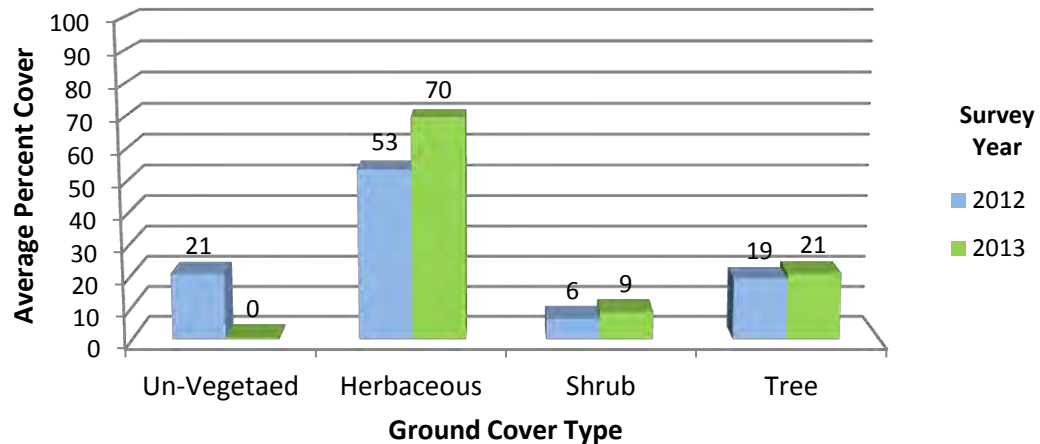
Chart 2: Average percent cover by ground cover type for line transect surveys (2012-2013)

Line intercept transects were established at 5 locations in Reaches 1 and 2 in 2012 and 7 additional transects were established in Reaches 3 and 4 in 2013. Representative photos of each established transect line can be seen in Figure 5. The transect lines established thus far range between 42 to 111 feet in length. Figure 1 shows the name and location, by river station, of each transect line surveyed. Chart 2 below presents the average relative percent cover, by ground cover type, for all transect lines in Reaches 1 through 4 for survey years 2012 and 2013. As one can see from chart 2 whereas approximately 21% of the ground cover surveyed within the transects were classified as un-vegetated in 2012, in 2013 0% of the ground cover was un-vegetated. In 2012 approximately 53% cover was herbaceous, 6% shrub and 19% was classified as tree cover; the same transects measured in 2013 all showed an increase in respective vegetation cover type. This positive trend is to be expected as the installed vegetation establishes at each respective site and relative cover types increase.

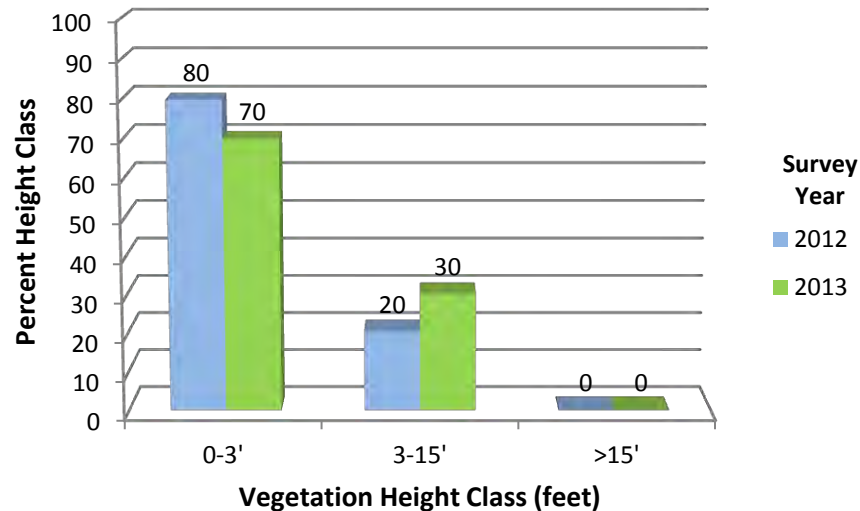
Chart 3: Average height class herbaceous and woody vegetation for line transect surveys (2012-2013)

Chart 3 presents the average percent of cover of herbaceous and woody vegetation, by vegetation height class, for each transect line surveyed in 2012 and again in 2013. Approximately 70% of the vegetation measured in 2013 at a given transect is between 0 and 3 feet tall while approximately 30% of the vegetation measured in 2013 ranges between 3 and 15 feet height. This represents a significant increase in average vegetation height measured from survey year 2012, approximately 10% respectively. Representative photos of the transect sites are shown in Figures 2-5.

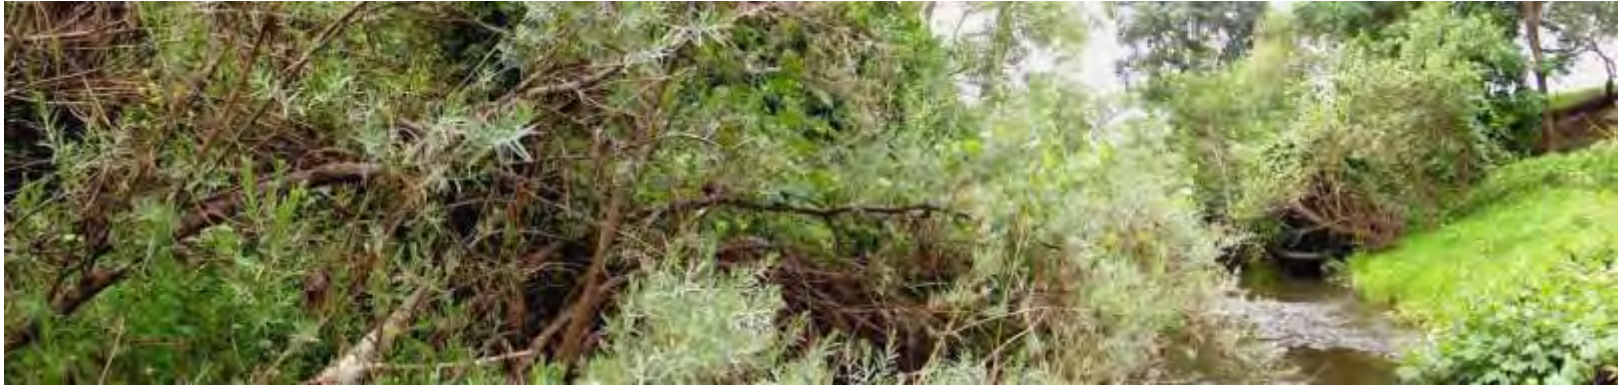
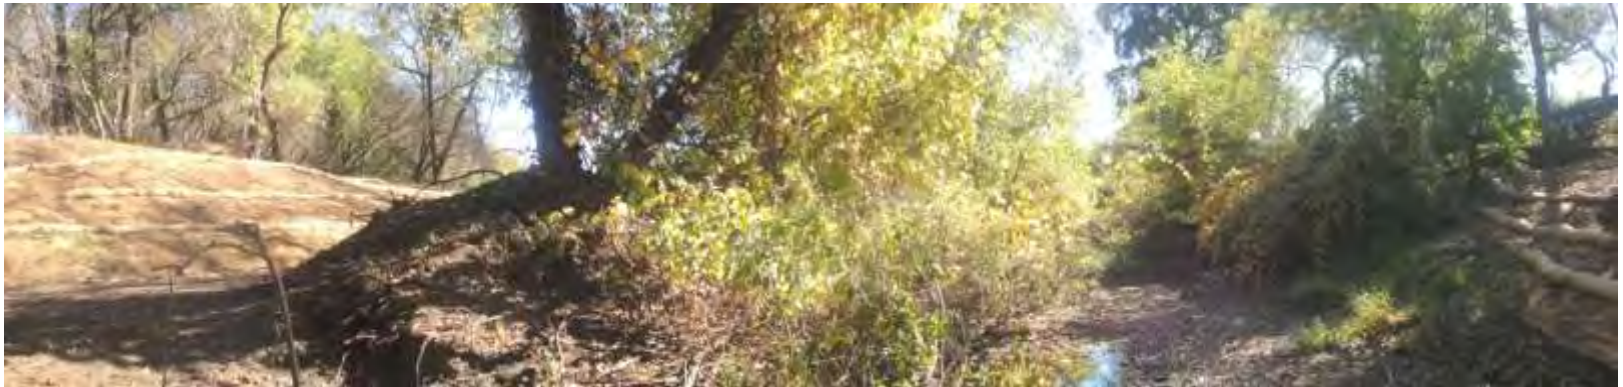
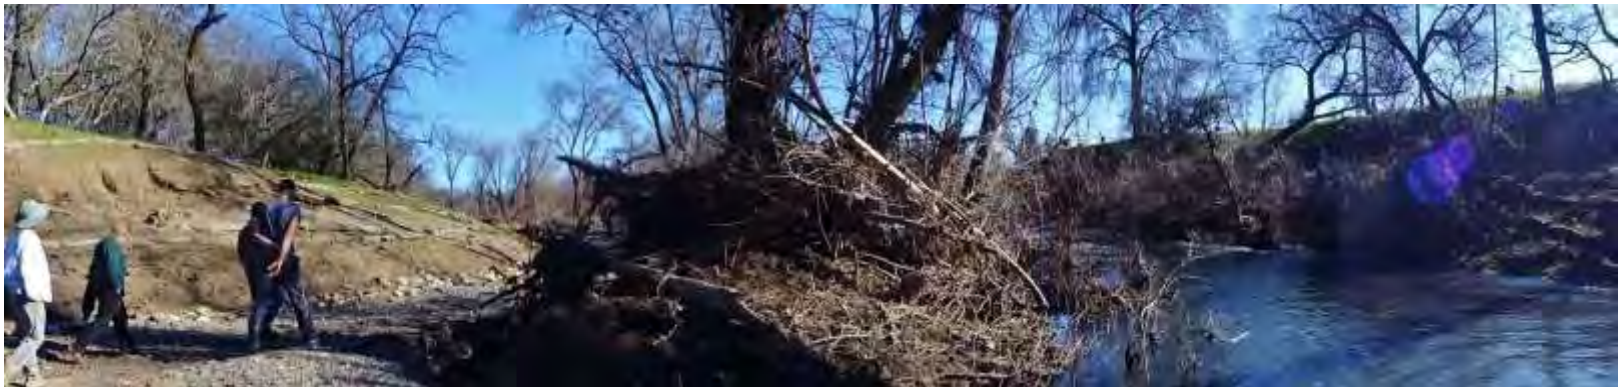
River Station 7,100
Bench 1 Secondary Channel Inlet: Wilsey
Channel to Downstream

Following a series of significant high flow events (5-10 year flows) in December of 2012, bio-engineered elements (vegetated soil lifts, pole planting etc.) along the secondary channel were damaged by storm flows that caused localized erosion and slumping. County staff surveyed the channel with design contractors after these events and developed a series of slope repair recommendations. The contractors repaired the slope by constructing vegetated soils lifts, installing an additional willow brush mattress and willow pole plantings, and re-hydroseeding the area. All repairs were successfully completed in April of 2013. As illustrated in the photomonitoring pairs, the slope repairs remained intact, and the slope remained stable during high flow events in February and March of 2014.
