NAPA RIVER RUTHERFORD REACH RESTORATION PROJECT ANNUAL MONITORING REPORT- 2016

Napa County Flood Control and Water Conservation District
804 First Street
Napa, California, 94559
Contact: Jeremy Sarrow
(707) 259-8204

Napa County Resource Conservation District
1303 Jefferson Street, Suite 500 B
Napa, California, 94558
Contact: Paul Blank/Jonathan Koehler
(707) 252-4188

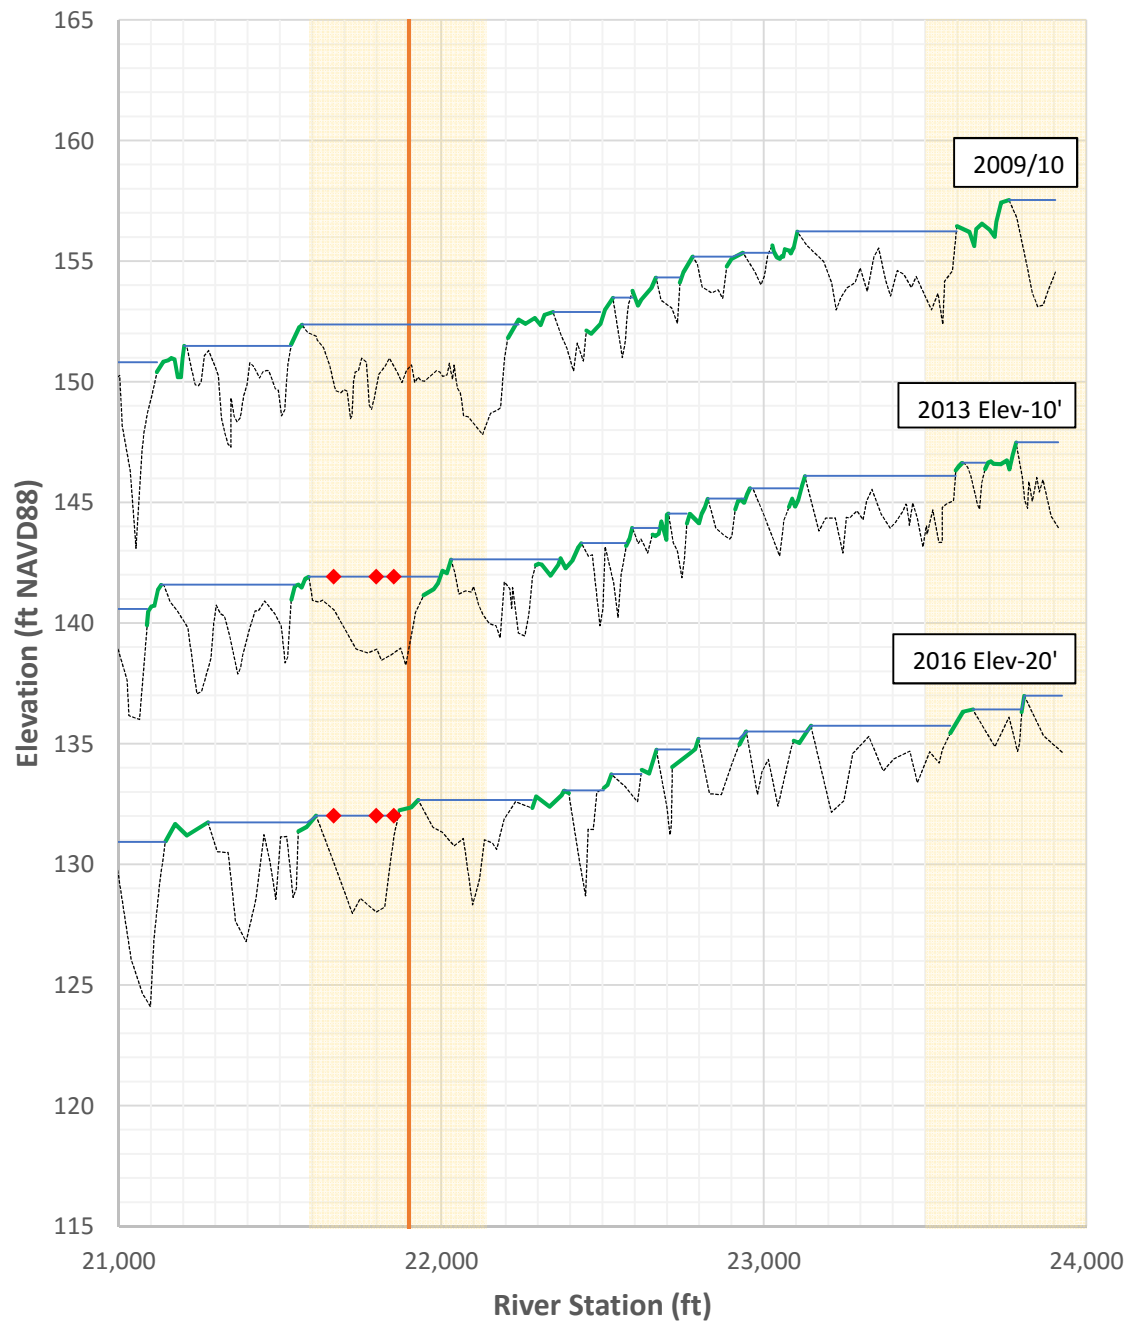
Subreach 1

The largest decreases in riffle length were observed in Subreaches 1 and 2. In Subreach 1, an especially long riffle at RS 23700 broke up into 2 smaller riffles resulting in a loss of 84 feet of riffle length. In this case, although riffle length was lost, streambed complexity in the form of a new riffle-pool unit was gained. With time, continued deposition may restore the lengths of these riffles. Other losses of riffle length in Subreaches 1 and 2 appear to have multiple causes, including the drowning out effect from aggradation in restored areas
