CITY OF ST. HELENA UPPER YORK CREEK ECOSYSTEM RESTORATION AND AQUATIC HABITAT ENHANCEMENT PROJECT

Presentation to the Napa County Watershed Information & Conservation Council (WICC) by

28 January 2021

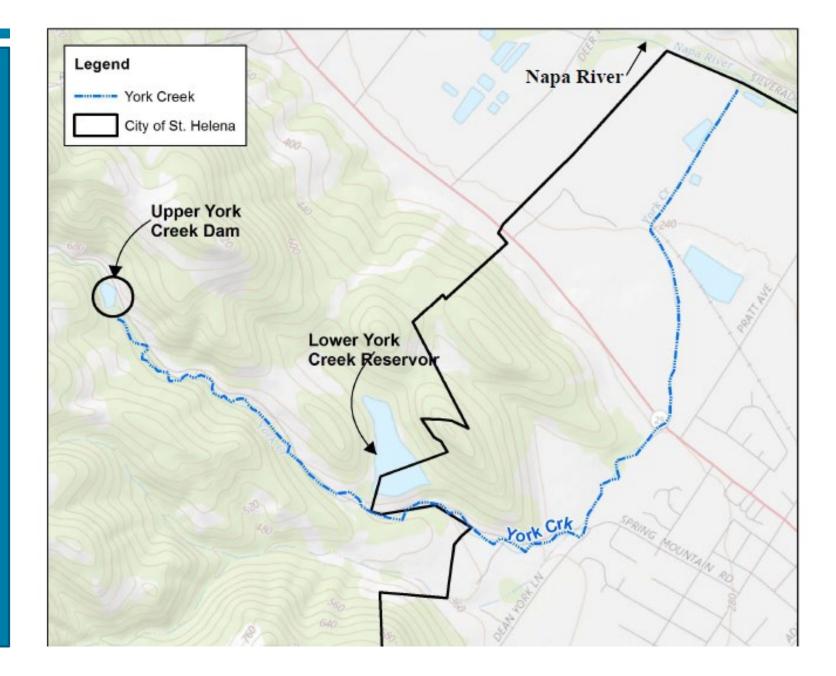
UPPER YORK CREEK DAM

- Constructed in 1900
- Downstream diversion dam removed in 1990s
- Sediment accumulated behind the dam, rending the reservoir unusable without frequent dredging
- 1992 accidental release of sediment
- Downstream habitat degraded due to lack of sediment

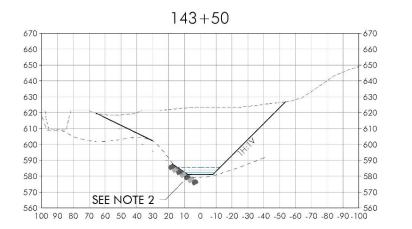
Typical dam section

Typical channel section

- Remove most of the dam
- Remove about half of the sediment, leaving sediment behind to restore sediment-starved areas downstream
- Match slope of creek up and downstream
- Pilot channel in the sediment, allowing nature to sculpt the channel ("process-based design")
- 36 new log structures
- Natural revegetation

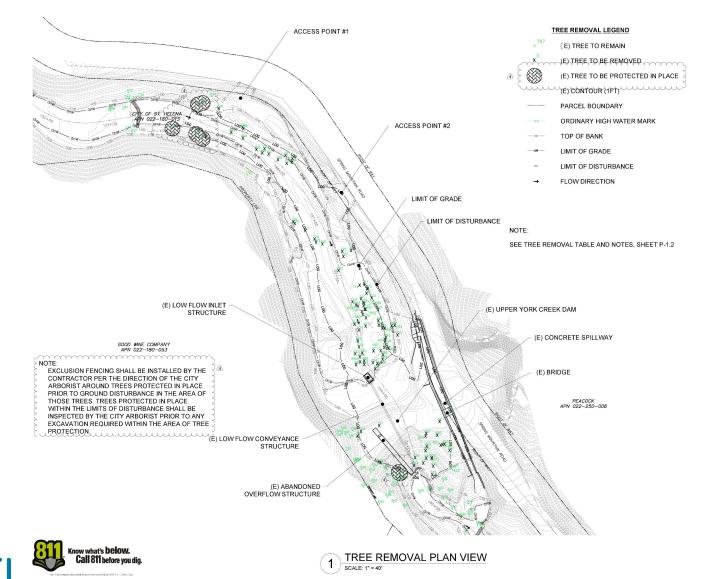
VEGETATION REMOVAL

- Detailed tree inventory
- Save selected trees for reuse in log structures
- Slash saved for reuse in Slash Trenches and Log Structures
- Initial clearing required continuous biologist monitoring

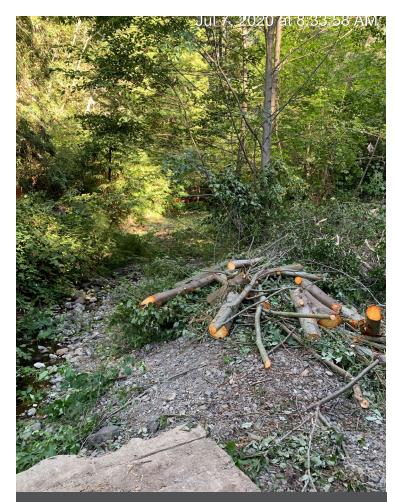
Cut down trees to grade

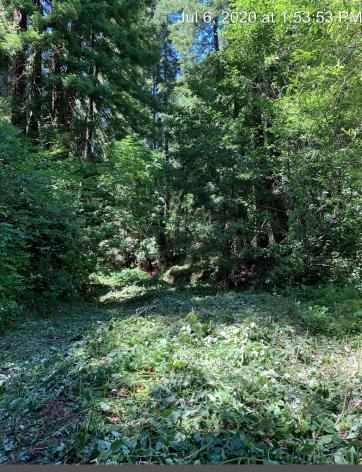
Cut down shrubs and plants to 8" height

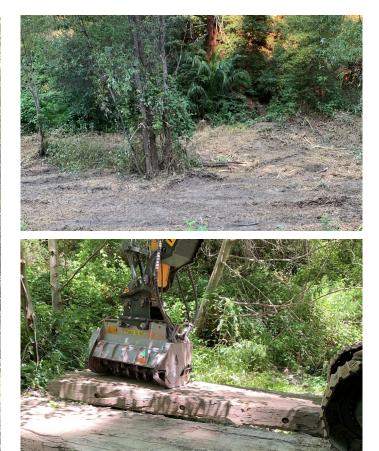
Remove all plants and roots with a masticator under the watchful eye of a biological monitor

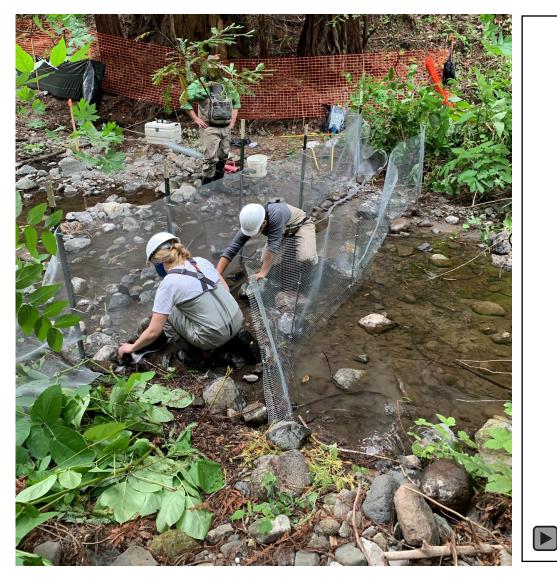
CREEK BYPASS DURING EXCAVATION WORK

- Fish removal performed in advance of installation
- Sheet piles selected to capture below grade creek flow
- Optional bid item to remove bypass in case of an unexpected storm

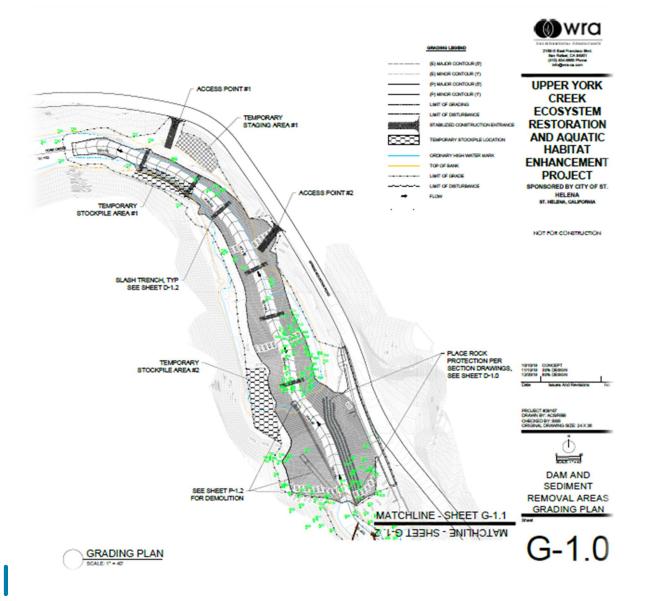
DAM AND SEDIMENT REMOVAL

- Haul 22,000 cubic yards (CY) offsite
- 6 Slash Trenches
- Riprap along steep slope to protect road

Slash trench detail

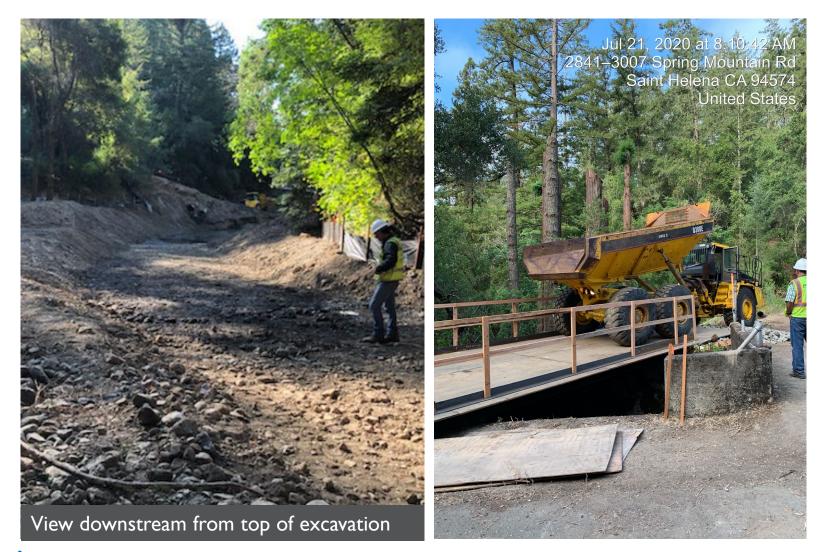
DAM AND SEDIMENT REMOVAL - CHALLENGES

- Narrow work window: Contractor worked 12-hour days; 1,933 truck loads were hauled offsite over 6 weeks
- Naturally-occurring asbestos: required special air monitoring at 3 locations, plan and BAAQMD permit
- Site access: only possible at spillway; special bridge built
- Traffic control: one lane closed for a couple months on Spring Mountain Rd.

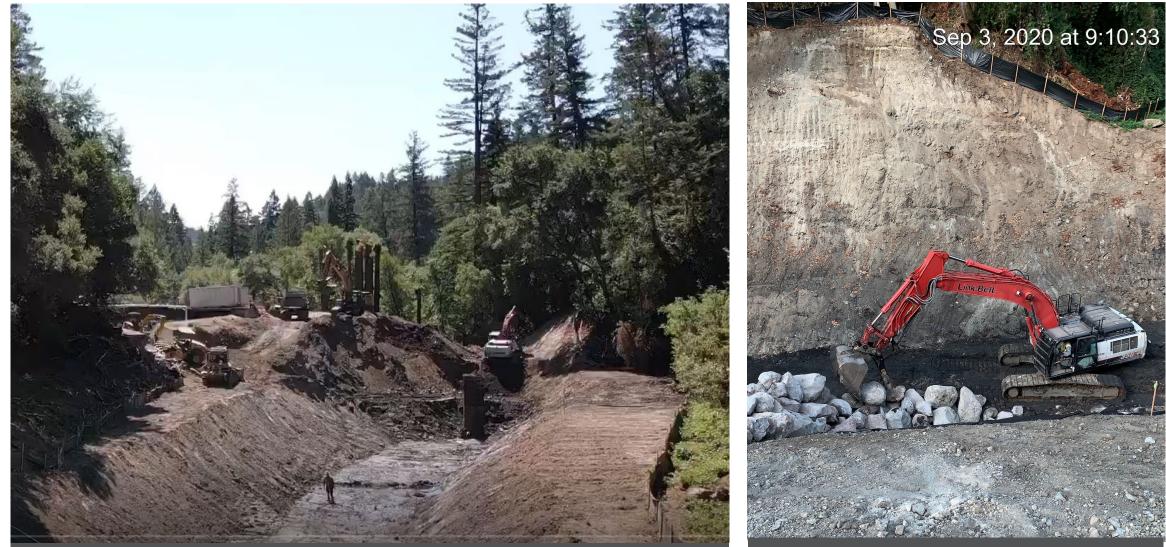
DAM AND SEDIMENT REMOVAL

View from center of excavation towards dam

Placing riprap in the dam notch

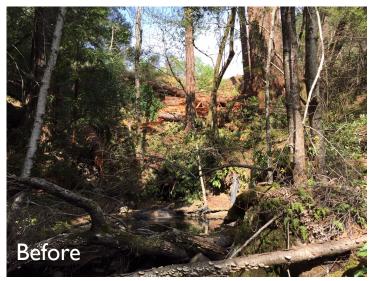
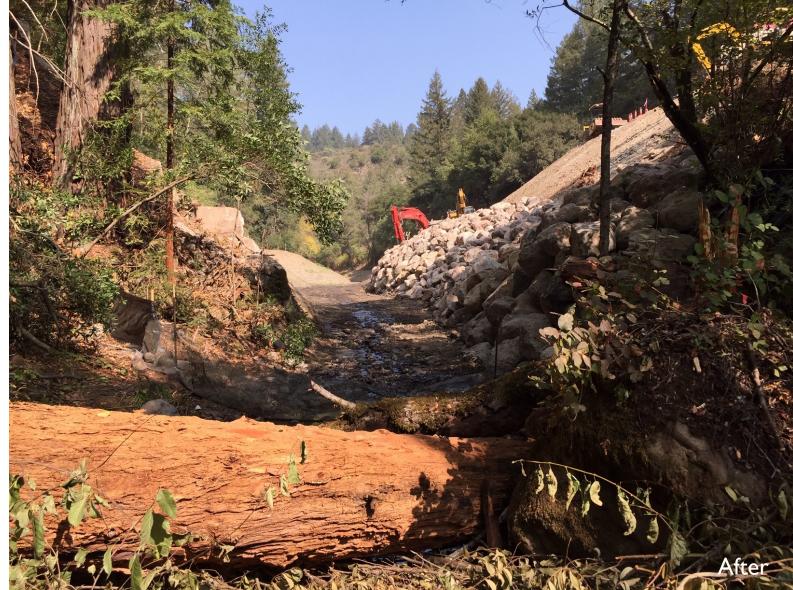
DAM AND SEDIMENT REMOVAL

View upstream from base of dam

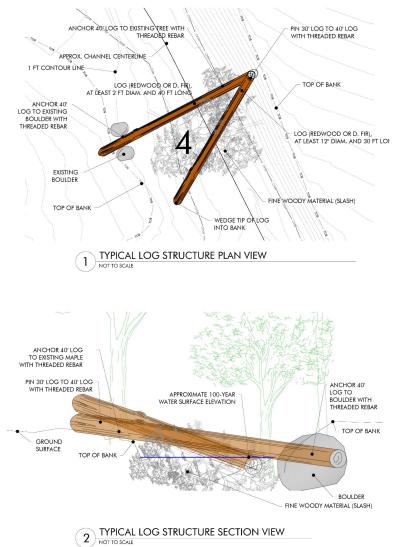
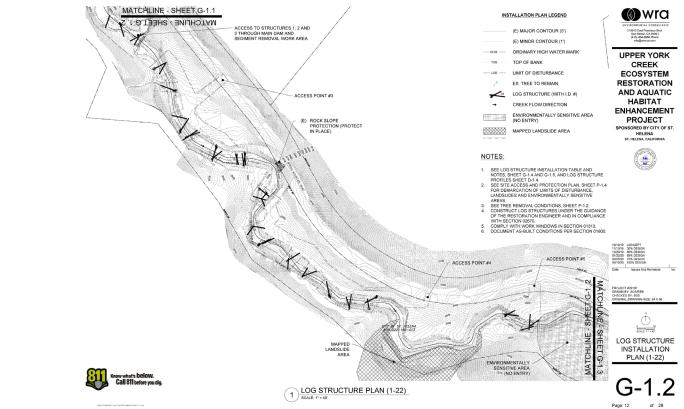
36 LOG STRUCTURES

- Trap sediment and create habitat
- Logs donated by Spring Mountain Vineyard
- Anchored to trees

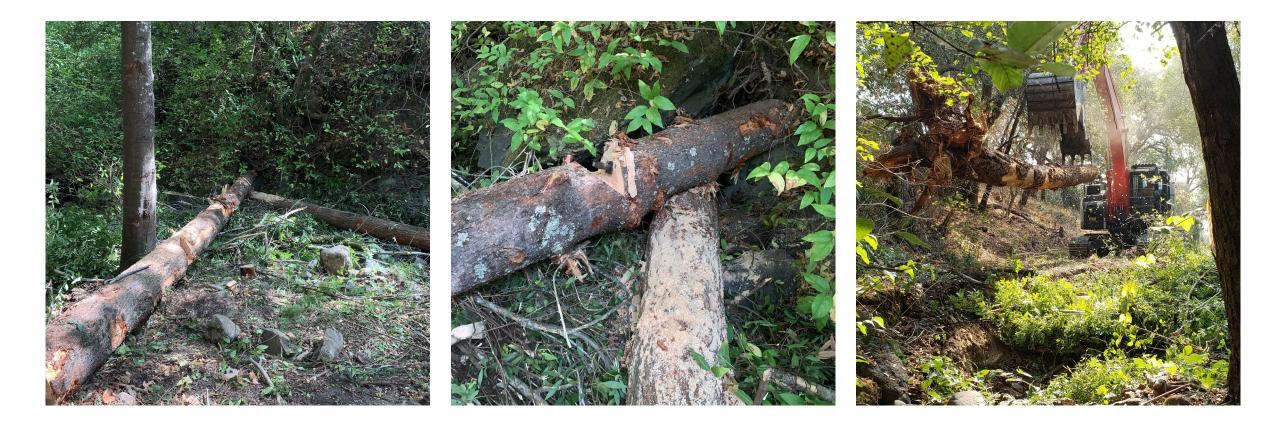
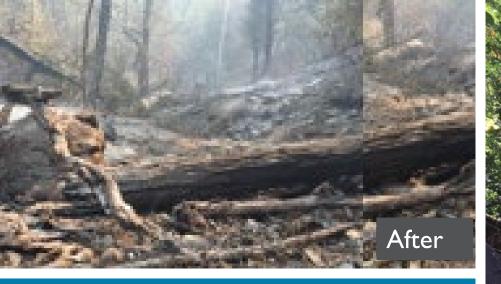
36 LOG STRUCTURES

Challenges: Protect or avoid historic tribal artifacts; anchor logs so they do not float downstream

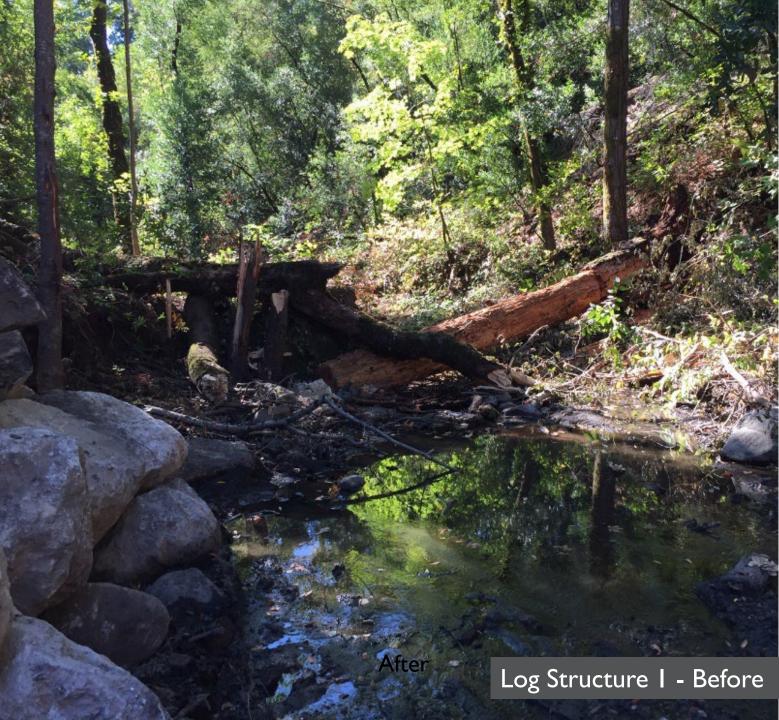
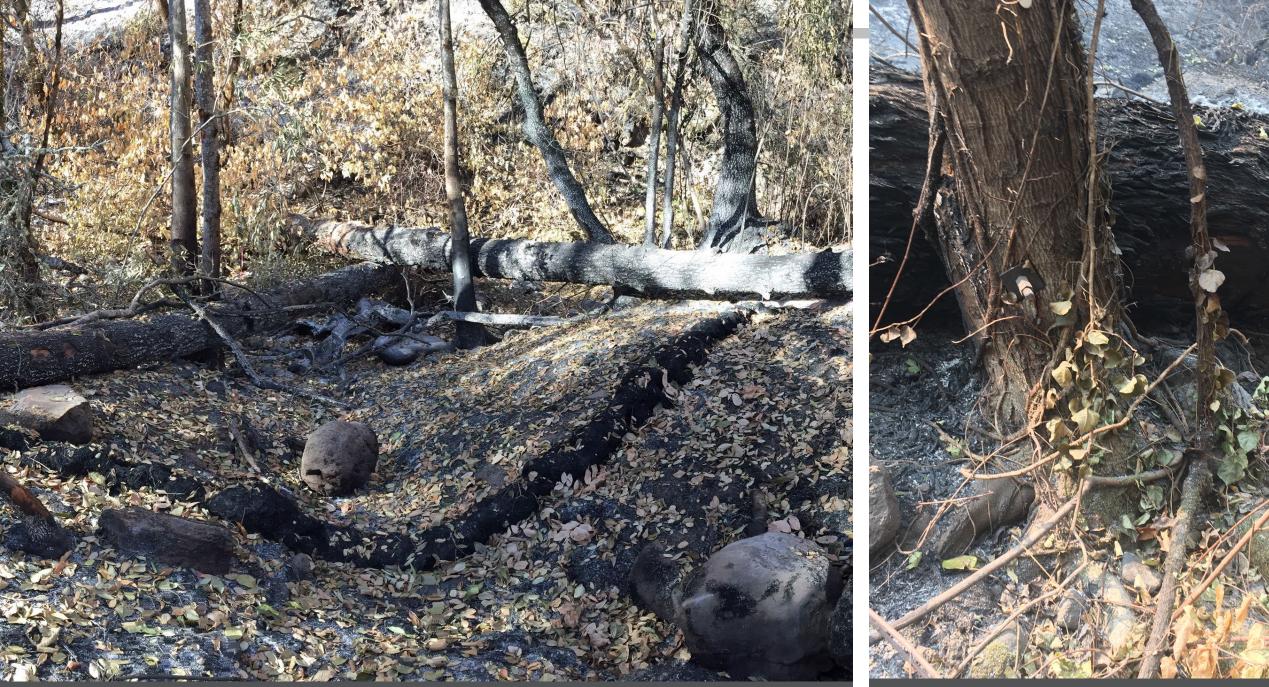
GLASS FIRE PROJECT IMPACTS

- 6 Log structures and most of the slash burnt requiring repair
- Understory gone and most invasive species with it
- Increased concern regarding erosion, turbidity, debris

Log structure 34 post-fire

Log structure bolted to a tree

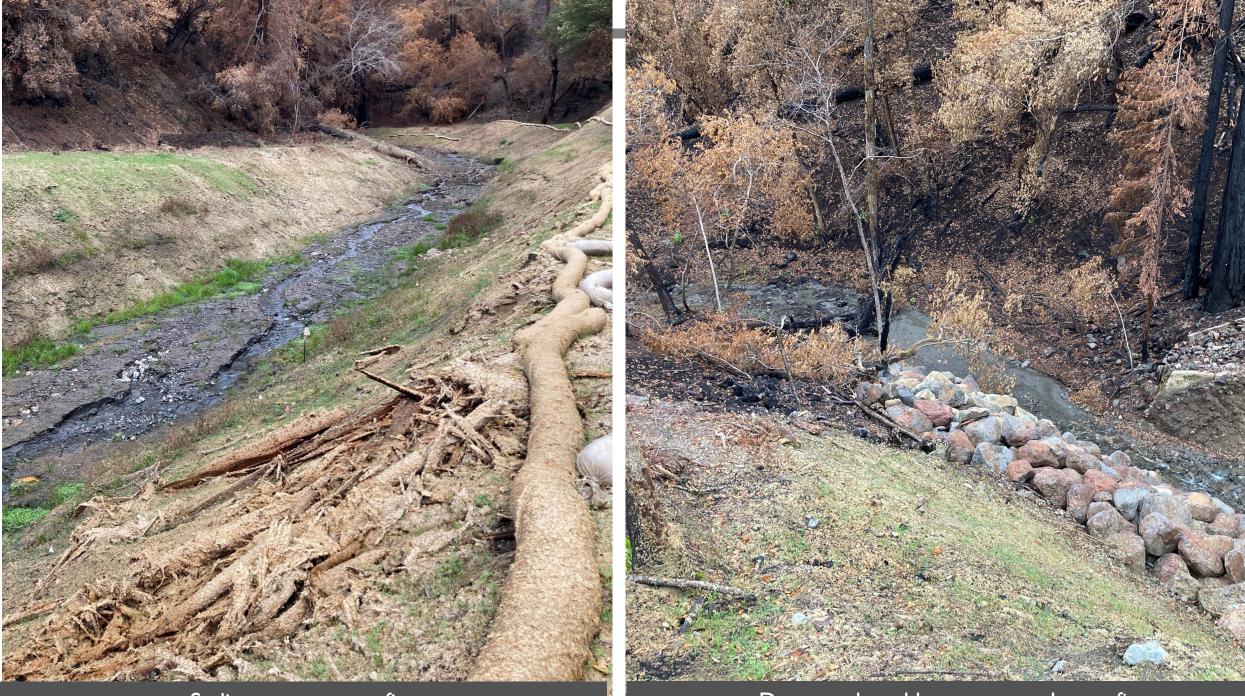
Sediment area post-fire

Dam notch and log structure I post-fire
