### 5.2.2 Reach Descriptions and Restoration Strategies for Reaches of the Napa River

Napa River Rutherford Reach Restoration Conceptual Design

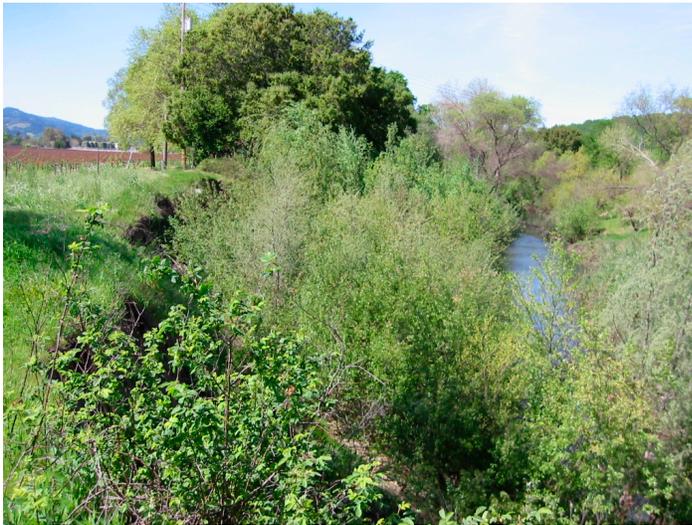
**Figure 12.** Typical existing conditions and conceptual design for Reach 2

Typical cross section (distances in meters)

**STAGE 4** WIDENING CHANNEL  
**ALTERNATIVE C** - IN BANK TOP APPROACH

**STAGE 5** WIDENING CHANNEL  
**ALTERNATIVE C** - IN BANK TOP APPROACH

We recommend a combination of biotechnical stabilization of local areas of high erosion, use of biotechnical structures such as weirs to increase channel diversity, and limited bank regrading and the creation of embayments (local small scale terraces with setbacks) where constraints allow, with the objective of reducing overall erosive forces in the reach and increasing channel habitat potential. All work should be accompanied by revegetation using appropriate native species. The recommended restoration conceptual alternative is 4C and 5C (page 39 and page 40) and 4D and 5D. This reach has a length of 4,100 feet. The proposed alternative would restore more natural function to the river while working within the constraints of preserving the mature riparian canopy. This reach has potential for even further improvement if west side tributary and back channels that existed historically can be restored, and we recommend that an analysis of historic and current tributary channel conditions, and a conceptual plan for their restoration, be carried out.

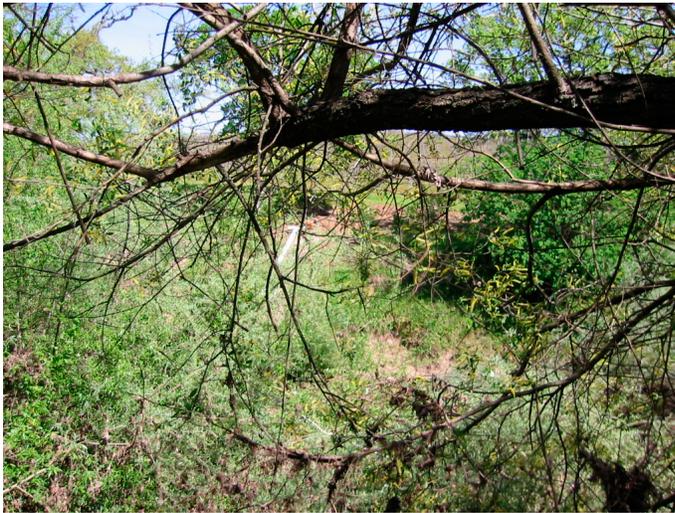
Figure 13. Typical existing conditions and conceptual design for Reach 3

Typical cross section (distances in meters)

This is a suitable reach for natural recovery, with some assistance in the form of Arundo removal, and native planting in places. The recommended restoration alternative is 5E (6.5.5, page 40).
