Napa River Rutherford Reach Restoration Project Final Memorandum Report for Annual Maintenance Activities 2014 Field Season

Prepared by: Napa County Flood Control and Water Conservation District

March 2015

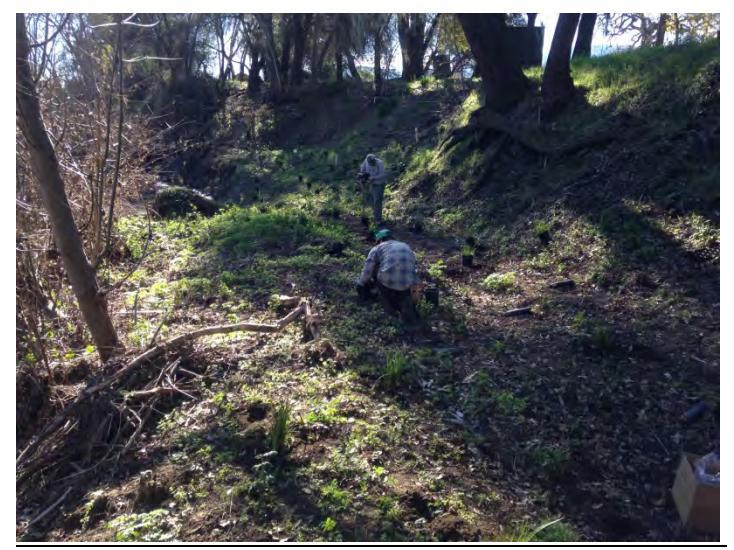
Photo 1: Revegetation Work, Reach 5 Bale Slough

A total of 410,581 square feet (9.4 acres) of invasive and Pierce host's plants (arundo, vinca, grape, Himalayan blackberry and mugwart) were ultimately treated by District staff and contractors during the summer and fall of 2014; the largest amount treated to date. Species such as fennel, poison hemlock, etc. were observed during the June survey but not treated as a result of land owners requests to prioritize the maintenance funds use for only treatment of invasive plants that are considered Pierce host's species as well giant reed which is not a Pierce host. **Table 2** and **figure 1** shows the total area and general location of invasive and Pierce host plants that were treated in 2014 that had the potential to cause streambank erosion were replanted with willow stakes and broad cast seeded with native species during the winter and spring of 2014 and 2015; Photo 1 below.

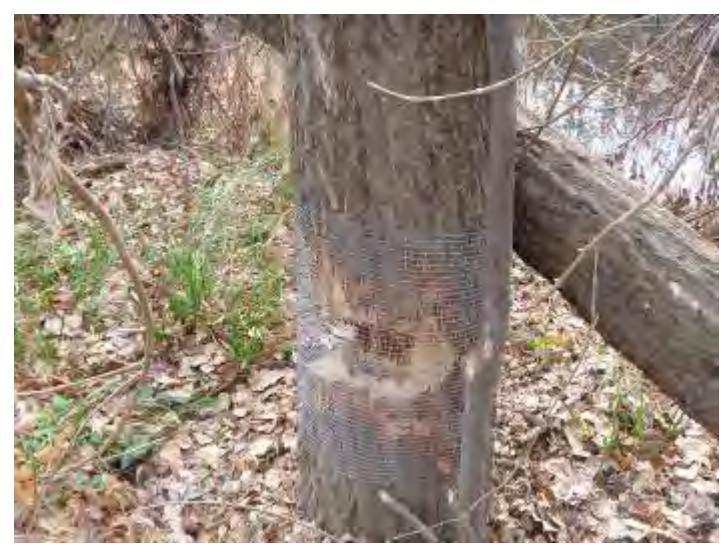
Photo 2: Damaged Cottonwoods Related to Beaver Activity, Reach 9

As, noted in previous reports, increasing amounts of beaver activity (dam building, downing of large significant native trees) necessitated management measures to protect large cottonwood trees. Similar to 2013, the District wrapped several cottonwood tree trunks in Reach 9 with wire mesh in an effort to protect them from further beaver related damage and to maintain sufficient riparian canopy and bank stability; Photo 2 below. It should be noted that District staff documents several beaver dams in the Project reach annually but generally does not view these as a significant issue. Generally, the beaver dams are small and wash away during high winter flows. During low flow, the dams impound slow water, providing cool pool habitat. However, should a beaver dam become a significant problem the District will manage the dam appropriately.
