Napa River Rutherford Reach Restoration Project Final Memorandum Report for Annual Maintenance Activities 2012 Field Season

Prepared by: Napa County Flood Control and Water Conservation District

April 2013

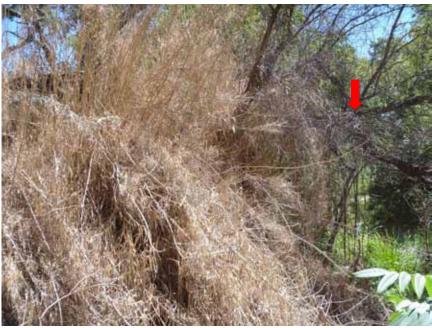
Figure 1: Arundo treatment site (before)

A total of 3 landowner requests forms were received by the District for maintenance activities during the 2012 field season. Landowners requested specific maintenance actions including removal of specific patches of invasive plants

(*Arundo*) and realignment and/or removal of large woody debris jams. All 3 landowner's maintenance requests were addressed during the 2012 maintenance season (Figures 1-4).

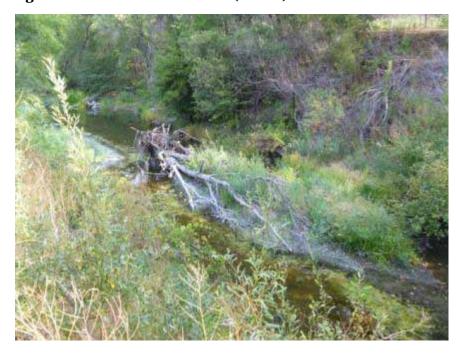
Figure 3: LWD management site (before)

A total of 5 large woody debris (LWD) accumulations were documented during the 2012 survey that ranked as potential maintenances issues in the river channel. The Report recommended thinning out and/or realigning all 5 LWD occurrences. However, after several additional site inspections under low and high flow conditions, District staff concluded that only 4 LWD accumulations required treatment including 1 requested by a landowner. All LWD maintenance issues were addressed between October 1st and October 15th, 2012 respectively (Figures 3 and 4). Table 3 represents the number of LWD accumulations treated over the life of the Project thus far.

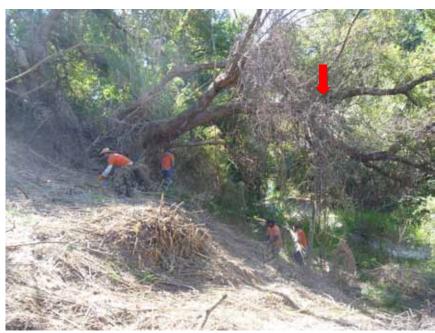
Figure 2: Arundo treatment site (after)

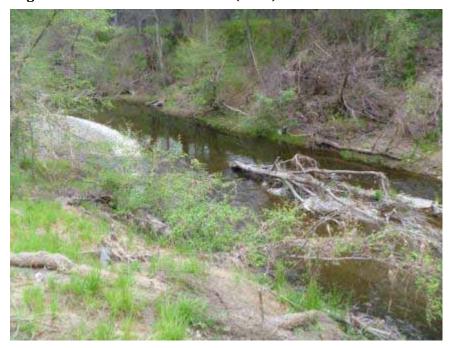
Figure 4: LWD management site (after)

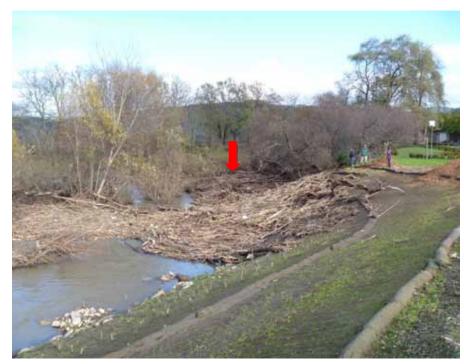
Figure 5: Large LWD jam December 2012 (before thinning)

As mentioned above in the Trash and Debris section, following high flow events on November 30th and December 23rd, two large wood debris jams were thinned out (twice) that required considerable time and in the form of consecutive days utilizing hand labor crews (CA Conservation Corps) and small equipment (Figures 5 and 6).

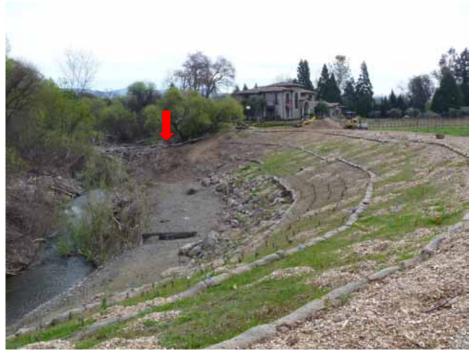
Figure 6: Large LWD jam January 2013 (after thinning)
