**CHANNEL GEOMORPHOLOGY ASSESSMENT:
A COMPONENT OF THE WATERSHED
MANAGEMENT PLAN FOR THE SULPHUR
CREEK WATERSHED, NAPA COUNTY,
CALIFORNIA:**

**PREPARED FOR
STEWARDSHIP SUPPORT AND WATERSHED ASSESSMENT IN
THE NAPA RIVER WATERSHED: A CALFED PROJECT**

**CALFED CONTRACT NO. 4600001703
NAPA COUNTY RESOURCE CONSERVATION DISTRICT**

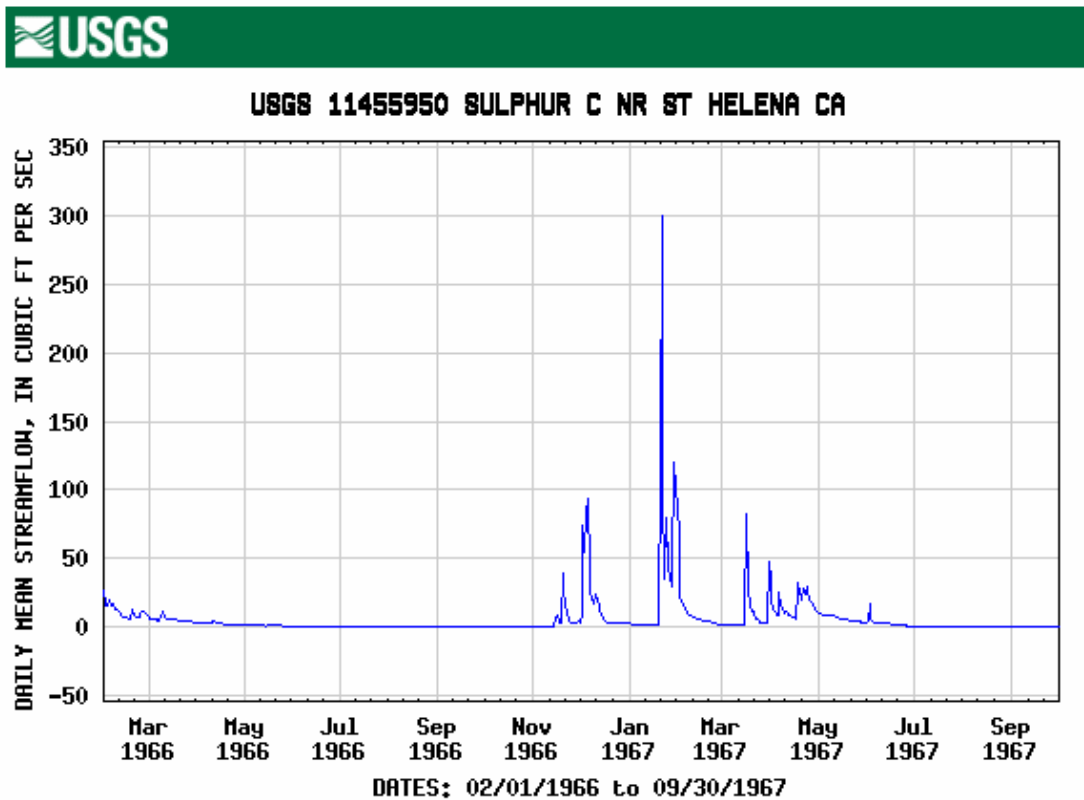
Figure 2. USGS gage data for Sulphur Creek near St. Helena (gage number 11455950). The data is from February 1966 to September 1967.

The USGS maintained a gage site on the main stem of Sulphur Creek, just upstream from the confluence with Heath Canyon that recorded daily discharge from February 1, 1966 to September 30, 1967 (Figure 2). During this time, the average discharge was $0.17 \text{ m}^3/\text{s}$ ($6.0 \text{ ft}^3/\text{s}$), and the peak discharge was $8.50 \text{ m}^3/\text{s}$ ($300 \text{ ft}^3/\text{s}$) for this 11.65 km^2 (4.5 mi^2) drainage sub-basin. Katzel and Larsen (1999) report that bankfull discharge (recurrence interval of 1.5 years) is $14.2 \text{ m}^3/\text{s}$ ($500 \text{ ft}^3/\text{s}$) for this sub-basin. Peak discharges were recorded for the period between 1956 and 1973, with a maximum discharge of $27.8 \text{ m}^3/\text{s}$ ($980 \text{ ft}^3/\text{s}$) in December of 1964.

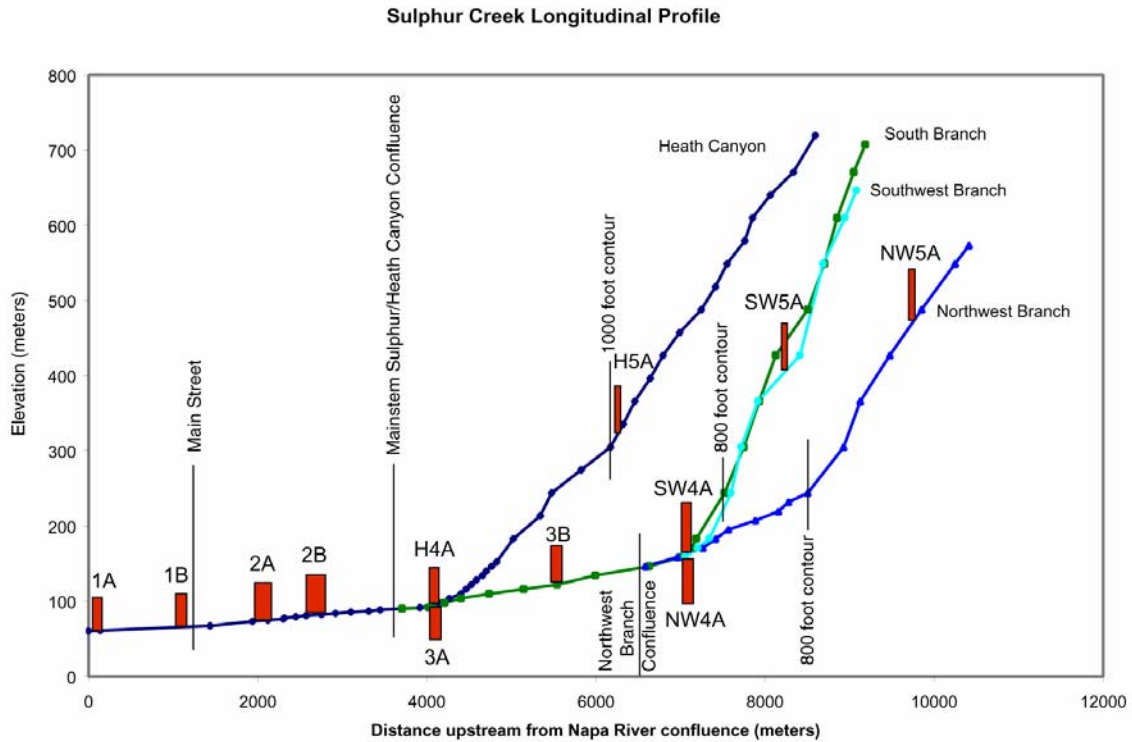
Figure 3. Longitudinal profile of Sulphur Creek. Red rectangles represent sample reach locations, while vertical thin lines represent Strata boundaries.

Five segments, or strata, each identified by a characteristic slope were revealed by a visual inspection of the longitudinal profile. Because channel slope is a good predictor of channel morphology (e.g. Montgomery and Buffington, 1997), these five strata were used to organize the sampling strategy in Sulphur Creek. The sample strata were numbered I through V, with Stratum I being the furthest downstream near the confluence with the Napa River, and Stratum V being the furthest upstream in the headwaters of

Sulphur Creek. Two sample reaches in Stratum I, II and III were characterized in the field (e.g. sample reach 1A, sample reach 1B, sample reach 2A, sample reach 2B, and so on). One sample reach in Stratum IV and V was sampled for each sub-basin: Heath Canyon, Southwest Branch and the Northwest Branch. The South Branch was not sampled due to the similar slope to the Southwest Branch, and also for logistical issues. Data was collected from a total of 12 sample reaches to characterize Sulphur Creek (Figure 3).

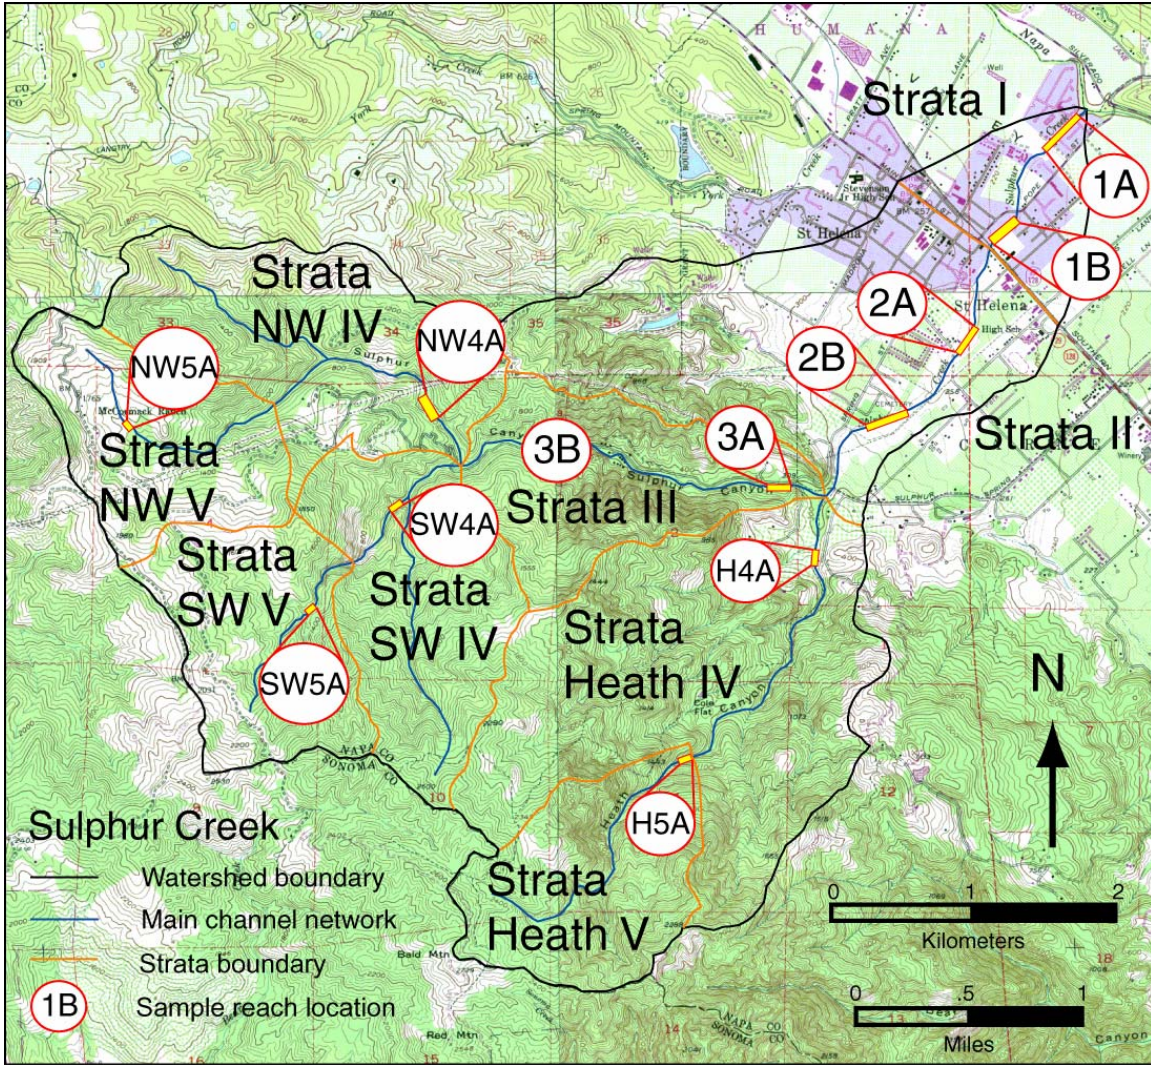
Figure 4. Map of the Sulphur Creek watershed, sample Strata, and sample reach locations.

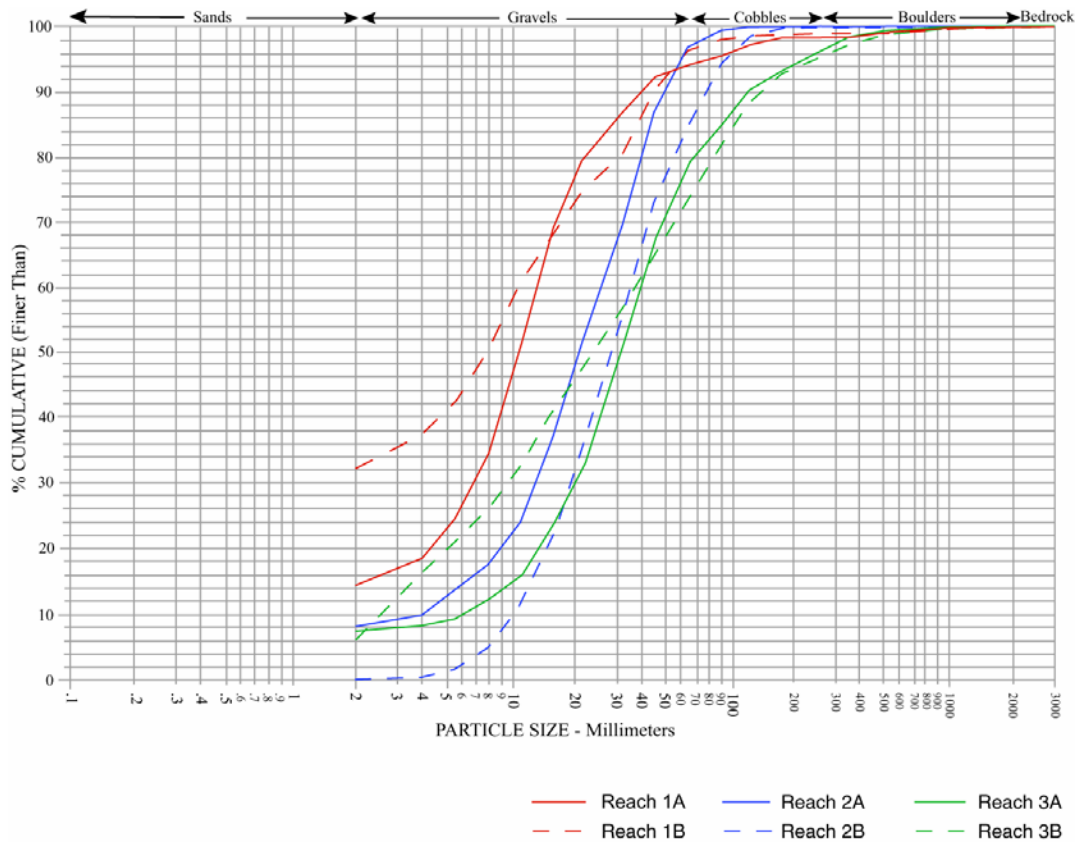
Figure 5. Particle size distribution curves showing the surface grain size distribution for sample reaches 1A through 3B.

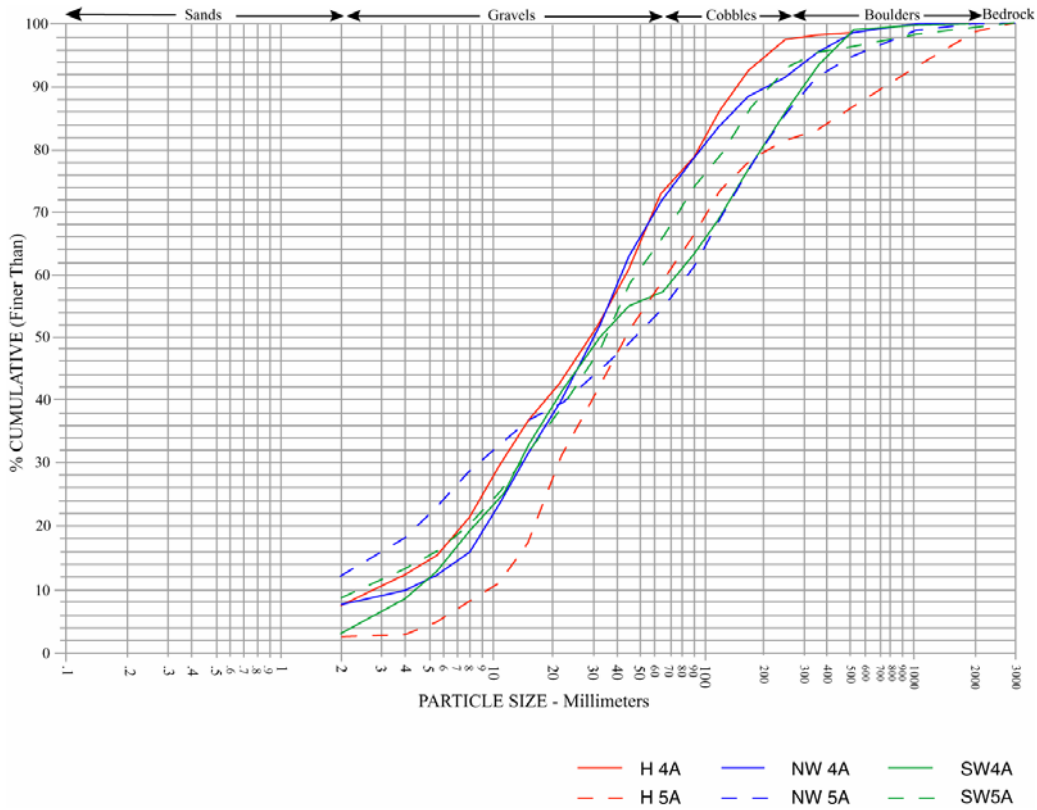
Figure 6. Particle size distribution curves showing the surface grain size distribution for sample reaches Heath (H) 4A and 5A, Northwest Branch (NW) 4A and 5A, and Southwest Branch (SW) 4A and 5A.

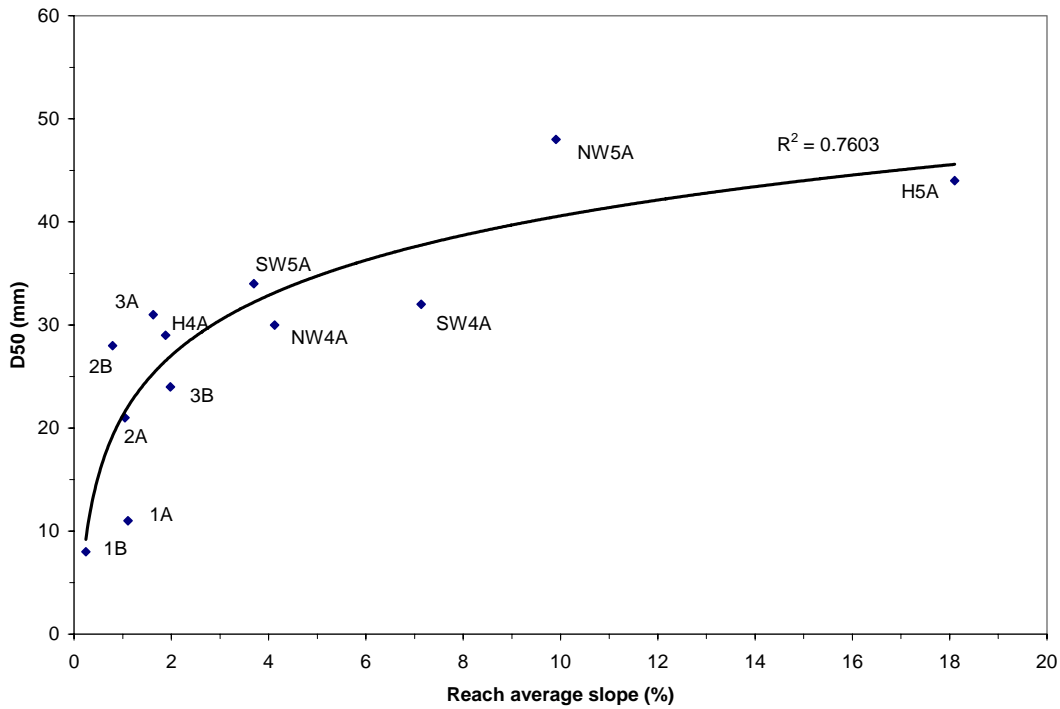
Figure 7. Reach average slope versus mean grain size (D50) for each sample reach.

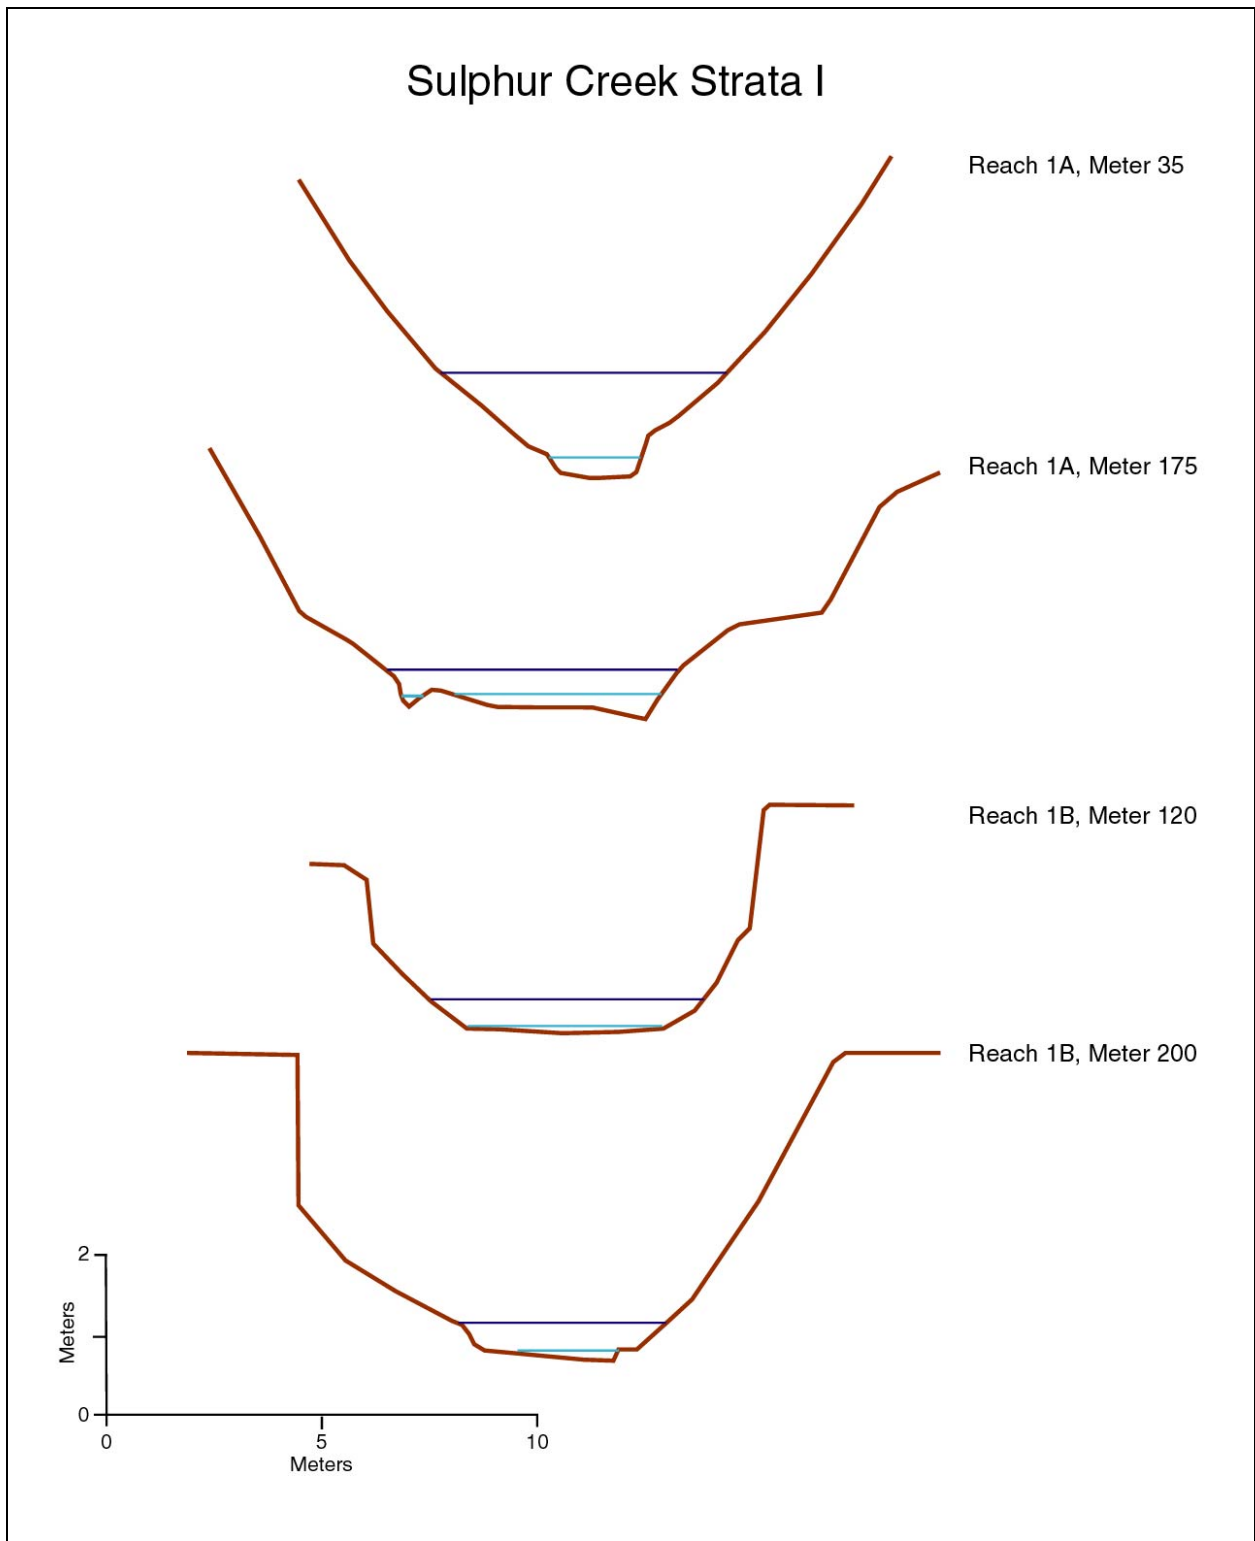
Figure 8. Sulphur Creek cross-sections for sample Strata I. The thick line represents the ground surface, the lower line represents the water depth on the date the cross-section was surveyed, and the upper line represents the field interpretation of bankfull. Cross-sections are oriented looking downstream, with the left bank on the left-hand side.

Scale drawings of cross-sections generated from field measurements demonstrate the variability of morphologies present in Sulphur Creek (Figures 8 through 12). The cross-sections illustrate the channel's width, depth, entrenchment, bank slope, and floodplains. Where water was present on the date of survey, it is shown on the cross-section. The field interpretation of "bankfull" flow is also shown; this is considered to be the water depth of the 1.5 to 2 year recurrence interval flood, as opposed to the water depth that would fill the channel to the top of its banks. Cross-sections from Stratum I reflect the influence and modification to the channel by the residents and the town of St. Helena, including bank revetments and flood control measures. Reach 1A, Meter 175 is the only cross-section in Stratum I that represents a channel morphology with a low amount of modification. Stratum II cross-sections have been scaled down by 50% to fit the entire section on the page. These reaches are the alluvial fan component of Sulphur Creek, illustrated by the wide and shallow cross-sections. Bankfull widths are much larger in these reaches, averaging 11 m in width.

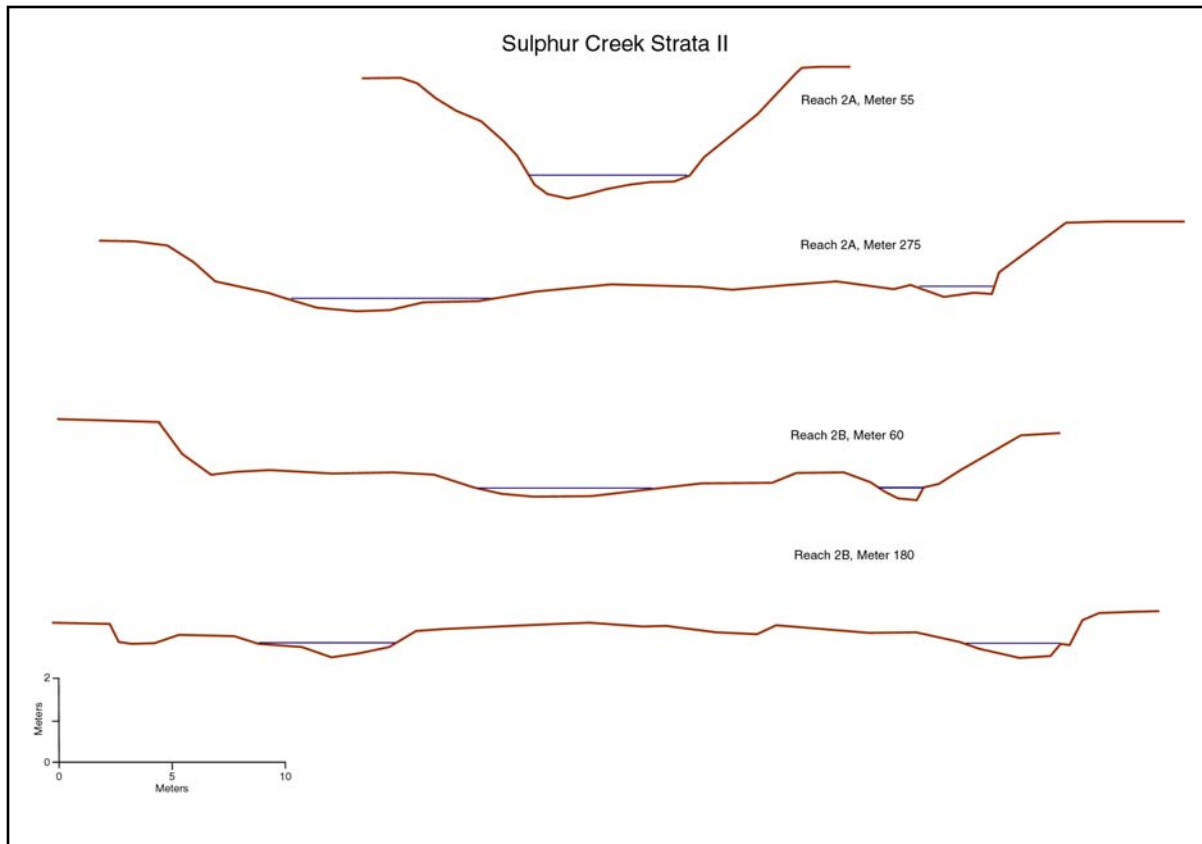
Figure 9. Sulphur Creek cross-sections for sample Strata II. The thick line represents the ground surface, and the thin the line represents the field interpretation of bankfull. Cross-sections are oriented looking downstream, with the left bank on the left-hand side. Cross-sections have been scaled down by 50% compared to other Strata.

The morphology of the channel in Stratum II is controlled by the flow dispersal, high sediment supply, and storage occurring in this braided reach. Reach 2A, Meter 55 is narrower than other cross-sections immediately upstream because this portion of the channel has been confined and revetted in association with a historic relocation of the channel (Historical Ecology). The valley width in Stratum III is generally larger than further upstream, allowing the deposition of bars and terraces in these reaches. In this

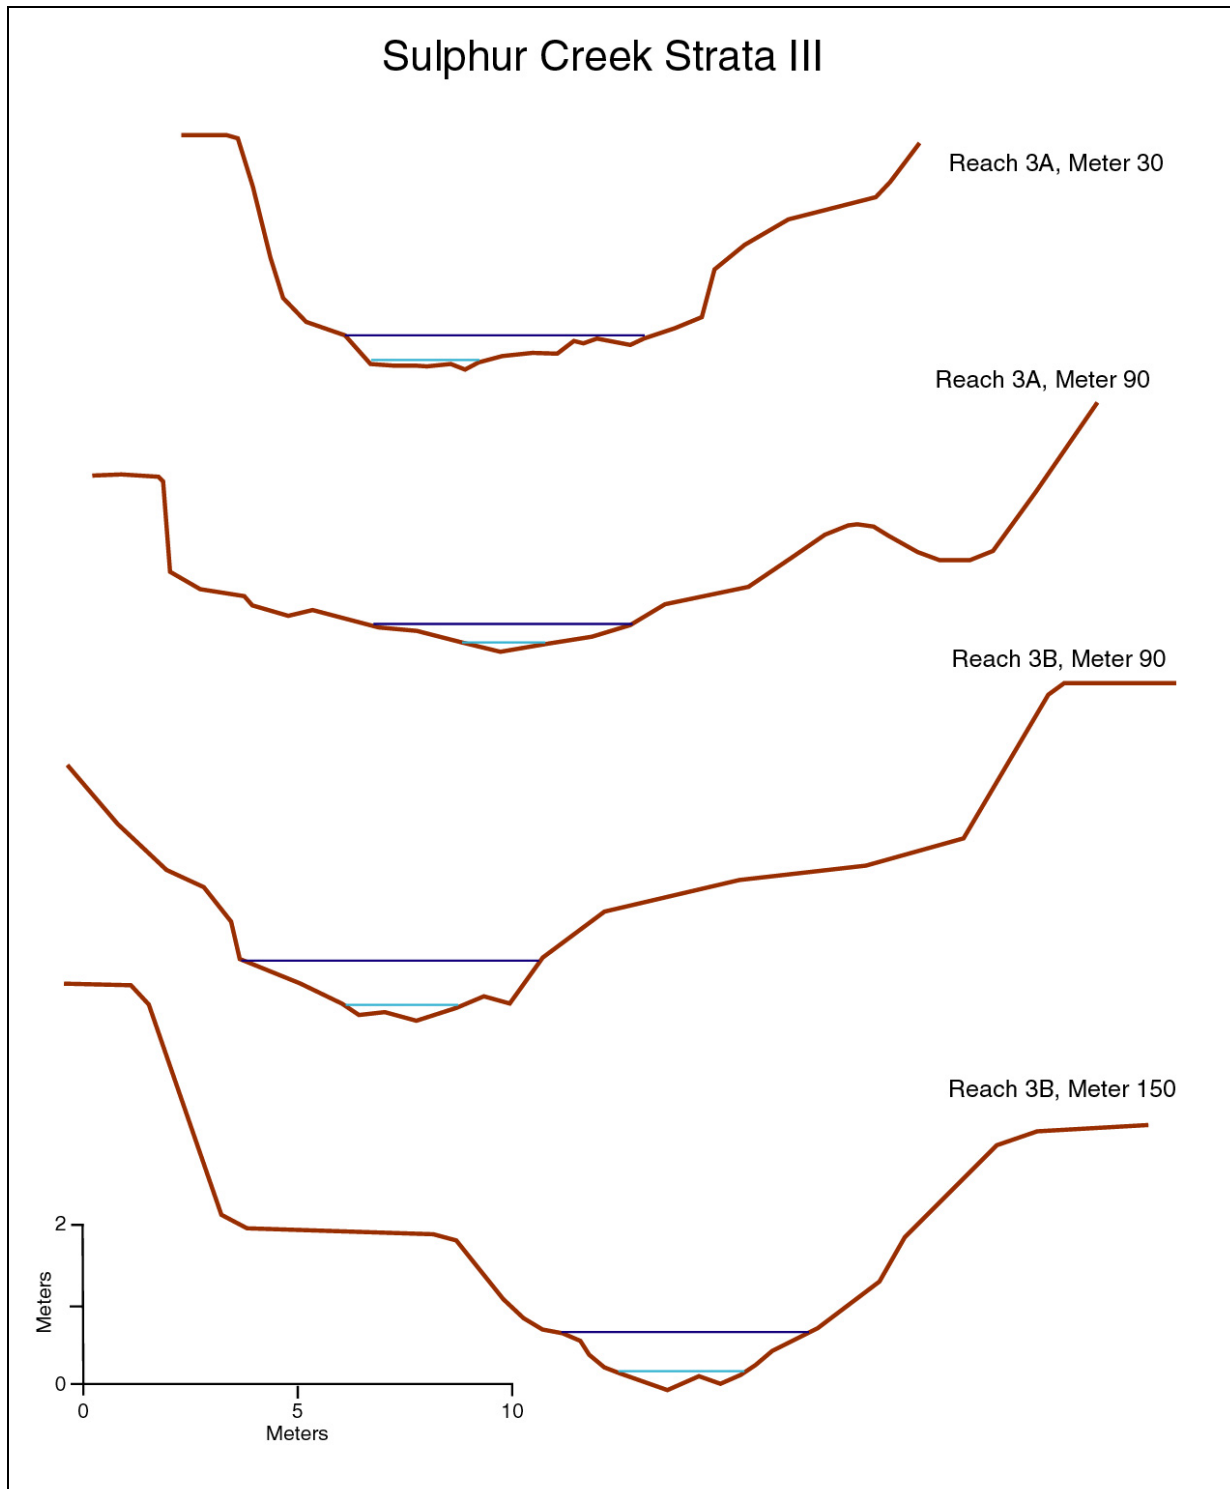
Figure 10. Sulphur Creek cross-sections for sample Strata III. The thick line represents the ground surface, the lower line represents the water depth on the date the cross-section was surveyed, and the upper line represents the field interpretation of bankfull. Cross-sections are oriented looking downstream, with the left bank on the left-hand side.

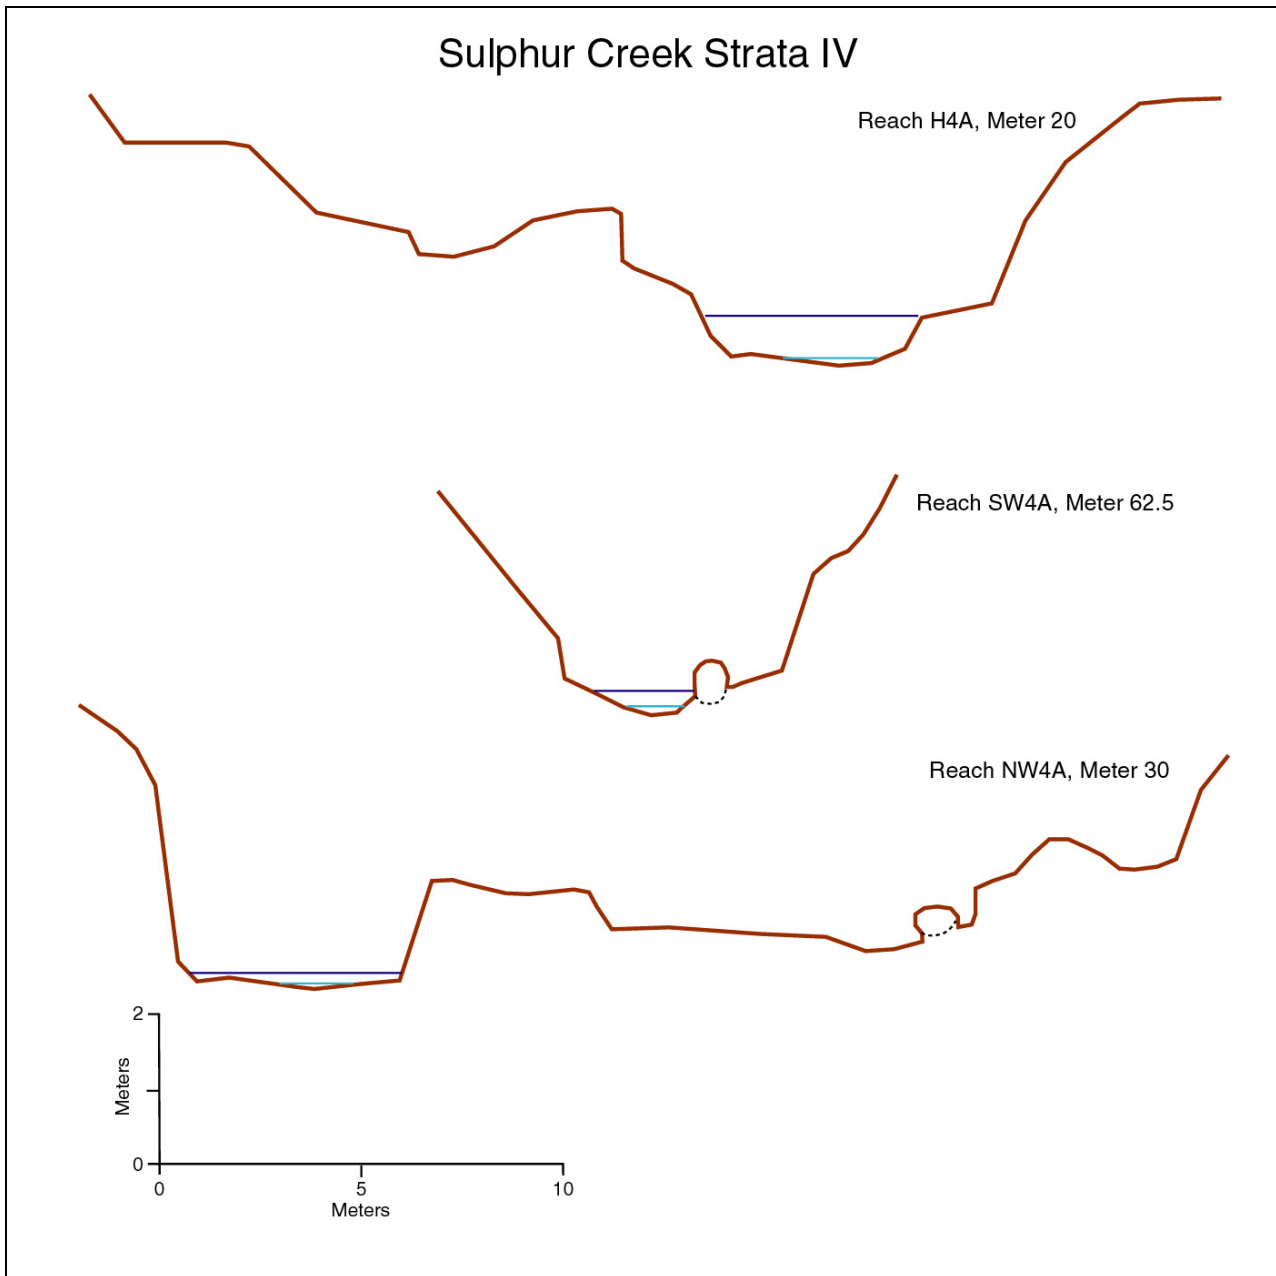
Figure 11. Sulphur Creek cross-sections for sample Strata IV. The thick line represents the ground surface, the lower line represents the water depth on the date the cross-section was surveyed, and the upper line represents the field interpretation of bankfull. Dashed lines represents the inferred extent of logs and boulders in the cross-section. Cross-sections are oriented looking downstream, with the left bank on the left-hand side.

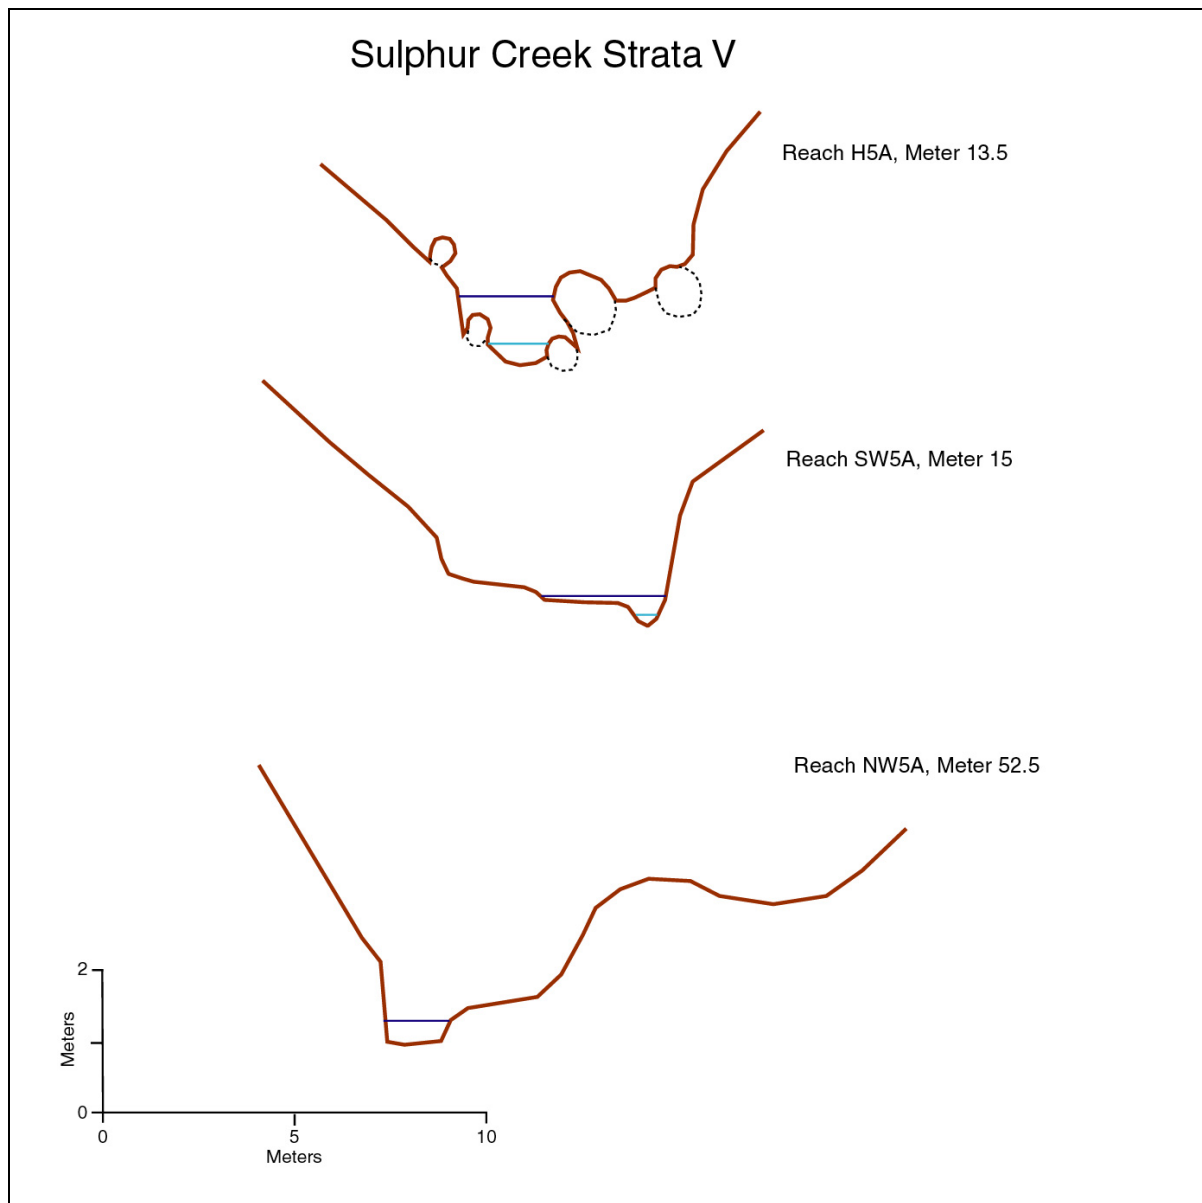
Figure 12. Sulphur Creek cross-sections for sample Strata V. The thick line represents the ground surface, the lower line represents the water depth on the date the cross-section was surveyed, and the upper line represents the field interpretation of bankfull. Dashed lines represent the inferred extent of logs and boulders in the cross-section. In Cross-section NW5A, the thin line represents the field interpretation of bankfull. Cross-sections are oriented looking downstream, with the left bank on the left-hand side.

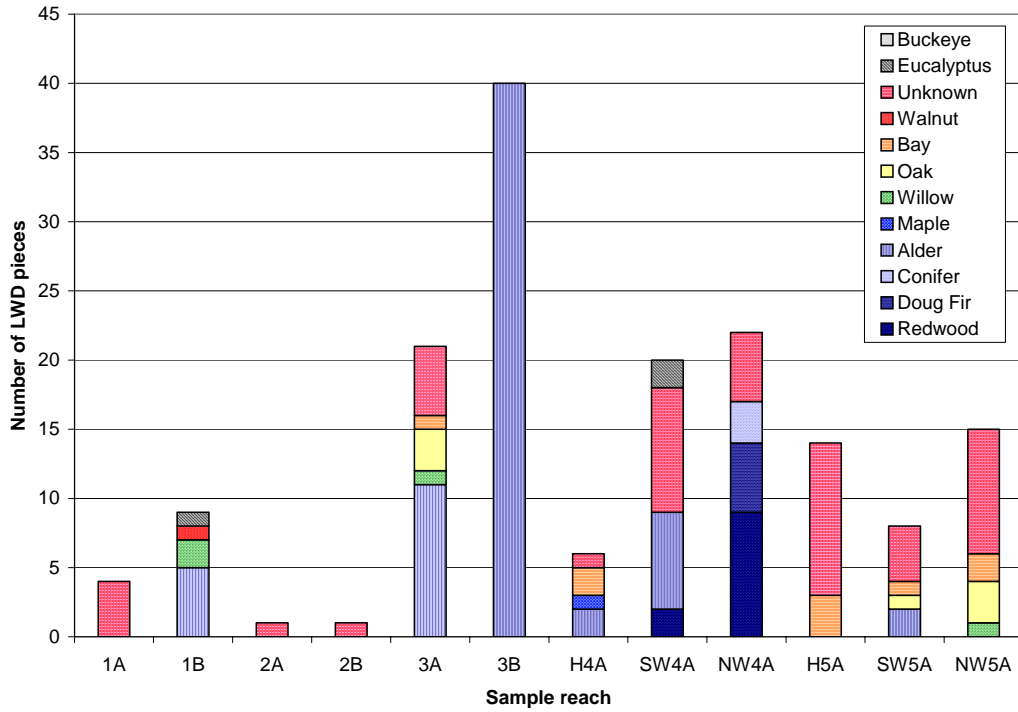
Figure 13. Number and species of woody material (LWD and live trees) per sample reach.

A wide variety of species of live upright trees and LWD pieces were measured along the length of Sulphur Creek (Figure 13). The number of LWD pieces is larger in the upper watershed, reflecting the more continuous riparian corridor. The lower reaches have fewer pieces of LWD, especially in reaches 2A and 2B, the alluvial fan portion of the watershed. Overall LWD abundance is low, especially considering that this watershed has coniferous trees, which are important because of their size and time of residence in-channel. A majority of sample reaches have less than 20 pieces of LWD, and half have less than 10 pieces. Alder and conifers dominate the middle reaches, while bay laurel (bay) and oak dominate the upper reaches. A large number of pieces, especially logs, have decayed beyond identification, most probably being hardwoods. Reach 3A is unique because it only contains alder, with all but one piece being live upright trees. This continuous stretch of alder trees help shape and stabilize the banks in this reach. Reach NW4A contains the largest percentage of conifers, Douglas firs, and Redwood trees, which are likely emplaced in the channel during landslide events. A majority of LWD pieces in the middle watershed are live upright trees, while logs dominate the LWD count in both the upper and lower watershed reaches (Figure 14). If live upright trees are excluded, all of the sample reaches downstream of SW4A would have fewer than 10 pieces of LWD.

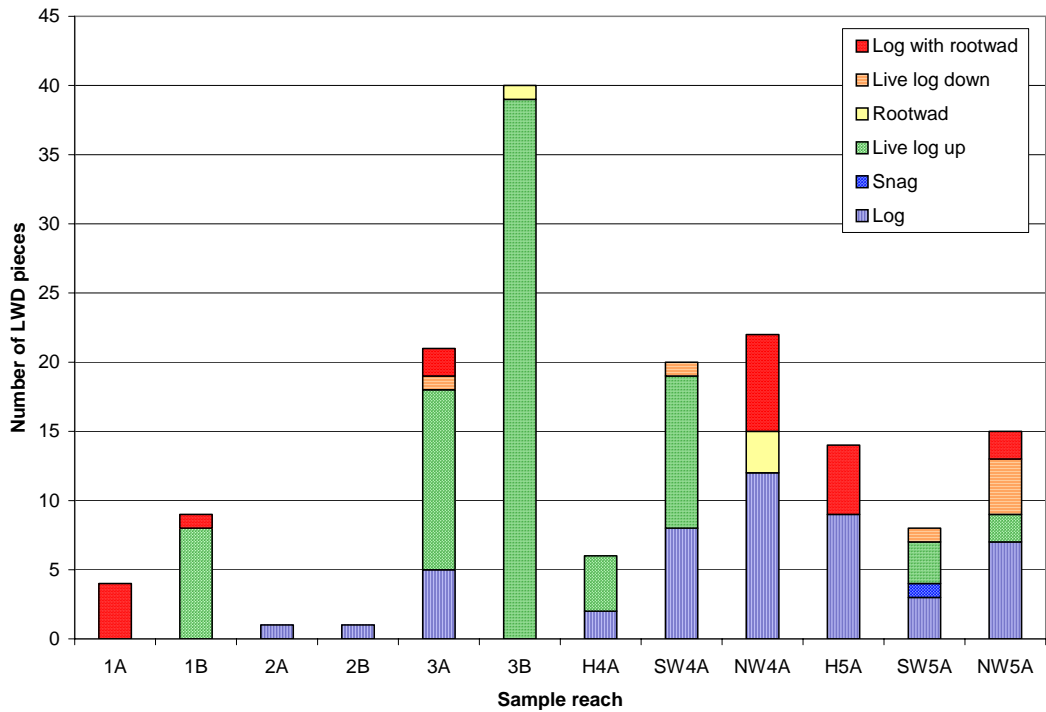
Figure 14. Number, position, and form of large woody debris (LWD) per reach.

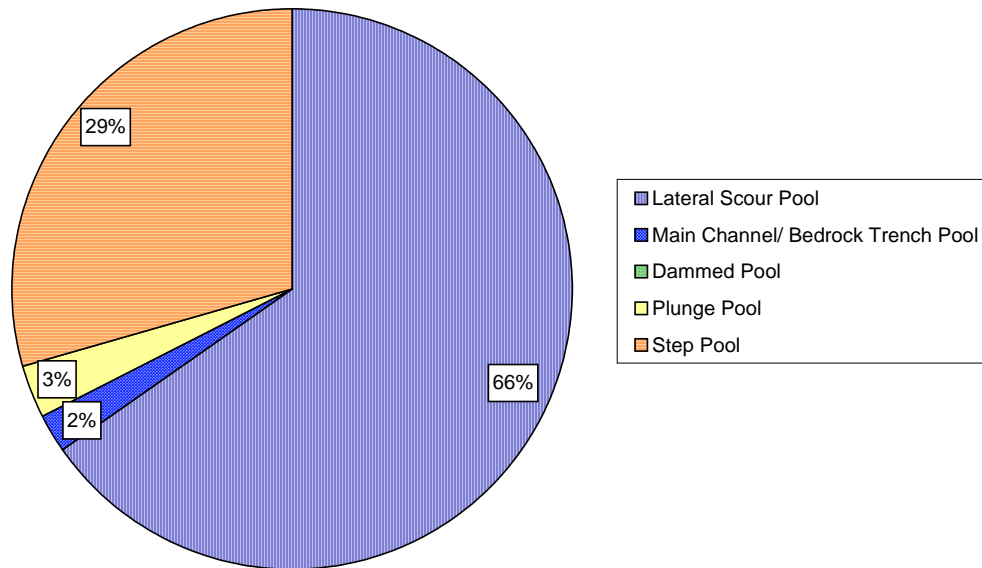
Figure 15. Percentage of each pool class measured in the 12 sample reaches combined.

A total of 92 pools were measured in the 12 sample reaches of Sulphur Creek. The causes of pool formation were categorized into five classes (after the California Department of Fish and Game Salmonid Stream Habitat Restoration manual, Flosi et al., 1998): step-pools, plunge pools, dammed pools, main channel/ bedrock trench pools, and lateral scour pools. Lateral scour pools and step-pools comprise 95% of all pools measured (Figure 15).

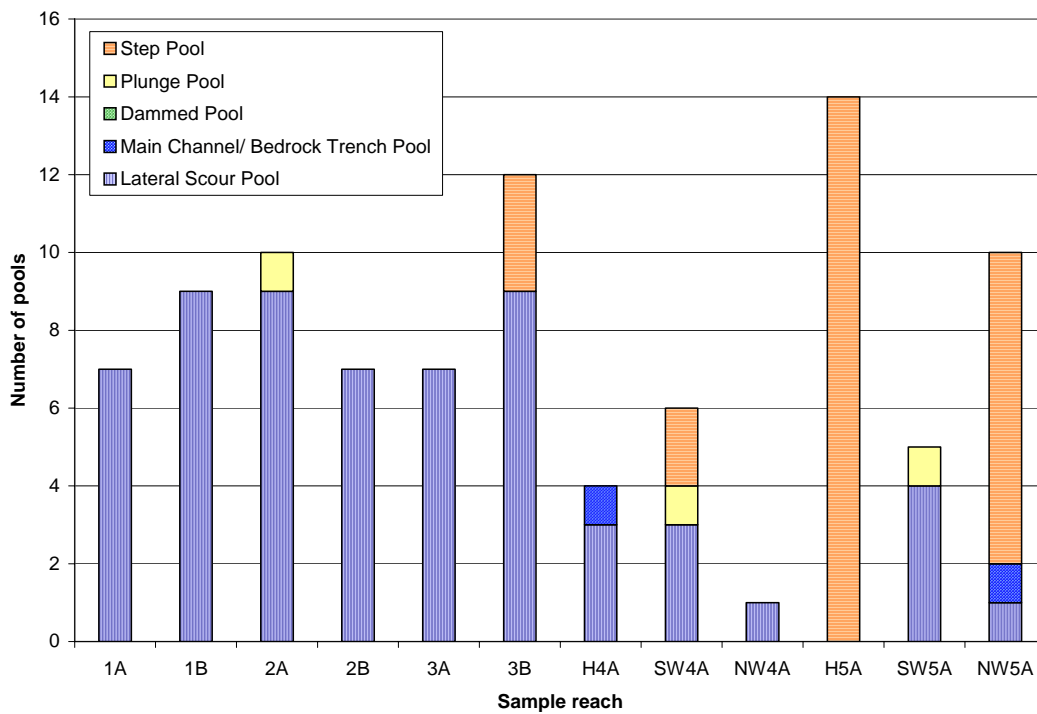
Figure 16. Number and class of pools in each sample reach.

The types of pool formed appear to follow a spatial pattern along Sulphur Creek related to channel geometry (Figure 16). For example, step-pools, plunge pools and main channel/bedrock trench pools only form in the upper watershed. Reach 2A does have a plunge pool, but it is associated with poured concrete on the bed of the channel, and plans have been developed to remove this concrete as a part of an upcoming restoration project (Fish Habitat Assessment). Also, all reaches except NW4A have four or more pools; NW4A is a reach that is highly impacted by large landslides upstream, causing it to be a transport-limited reach, with simply too much sediment for pools to form and persist. Reach H5A has the highest number of pools (14), all being step-pools, reflecting the many large boulders in this reach, and their influence on channel geometry and pool formation. With the exception of reach NW4A, average pool spacing was less than every seven bankfull widths, with eight of 12 reaches having pools spaced less than every four bankfull widths (Table 9).

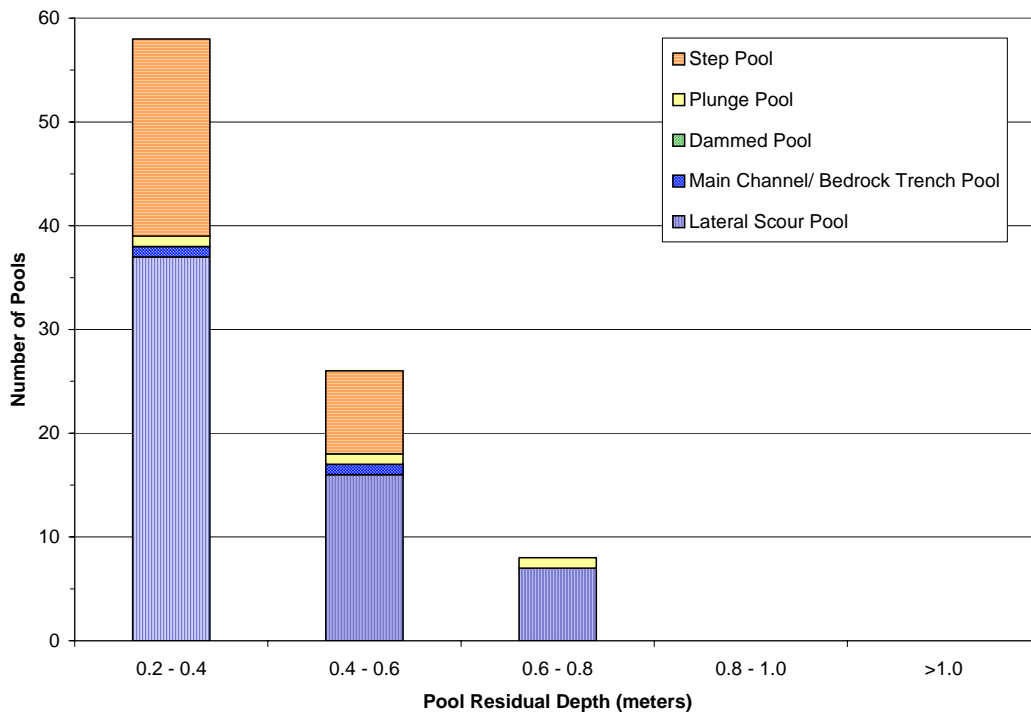
Figure 17. Number of pools per residual depth class and their associated cause for all sampled reaches.

The pools measured in Sulphur Creek are segregated into residual depth size classes, ranging from 0.2 – 0.4 m up to >1 m in depth (Figure 17). Although Sulphur Creek contains a fairly large number of pools, none of the pools measured have a residual depth deeper than 0.8m. Whereas lateral scour pools are present in all three size classes, step-pools and main channel/ bedrock trench pools are only present in the smallest two

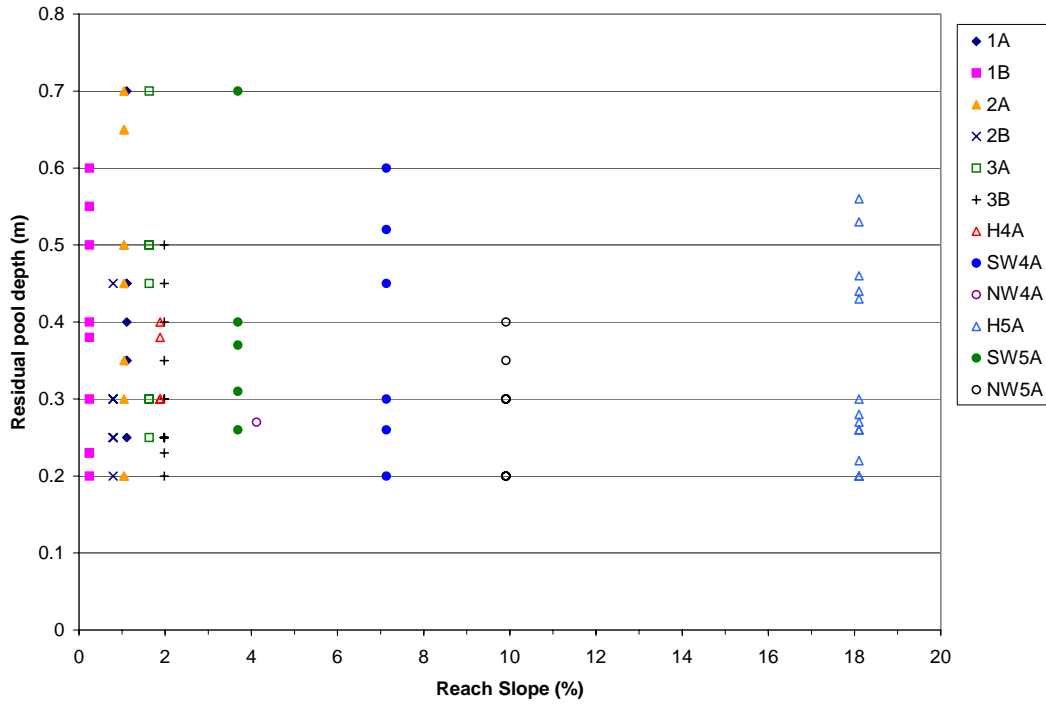
Figure 18. Residual pool depth versus reach average slope.

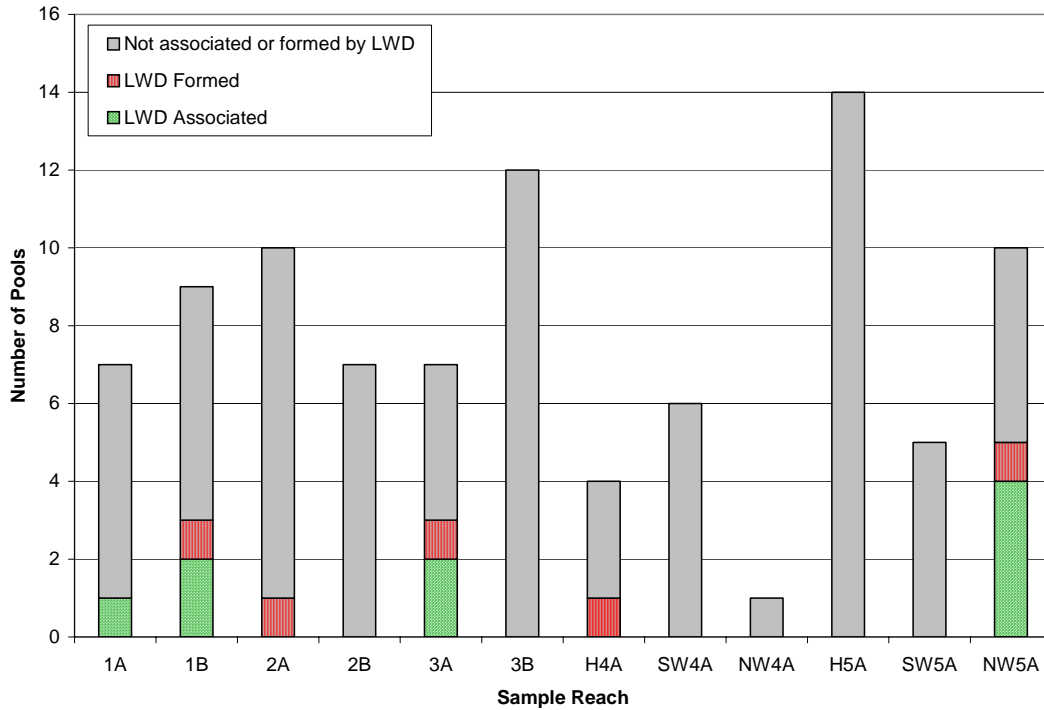
Figure 19. Number of pools formed by or associated with LWD in each sample reach.

LWD pieces do not play a large role in pool formation in Sulphur Creek (Figure 19). Only 5% of all pools measured are directly formed by LWD, and an additional 10% are associated with LWD, that is, the piece is present, but is not a primary contributor to the formation of the pool. Although Sulphur Creek has a large number of pools, not many have the benefit of cover and complexity given by LWD. The number and habitat value of pools could potentially increase with an increase of well-placed LWD in-channel.

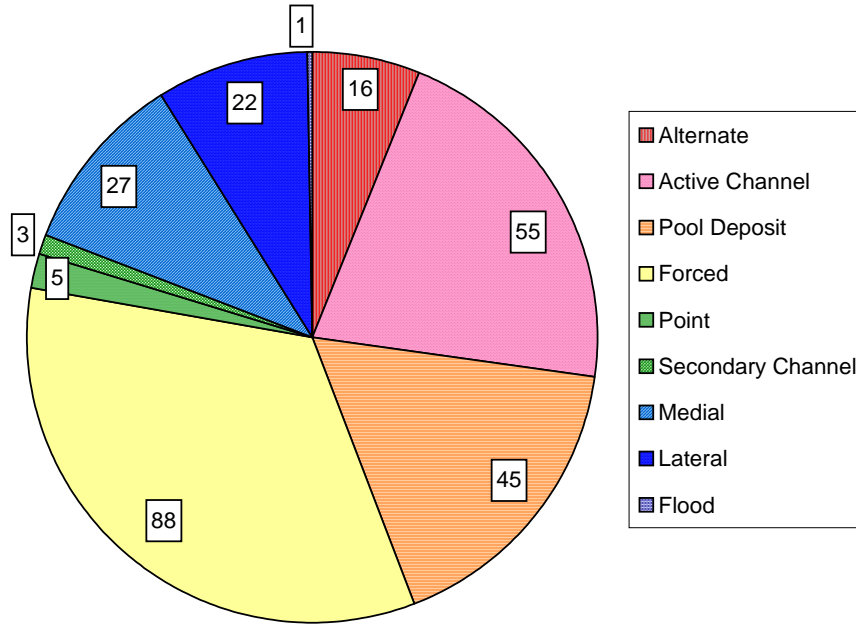
Figure 20. Number and type of bars measured in all 12 sample reaches.

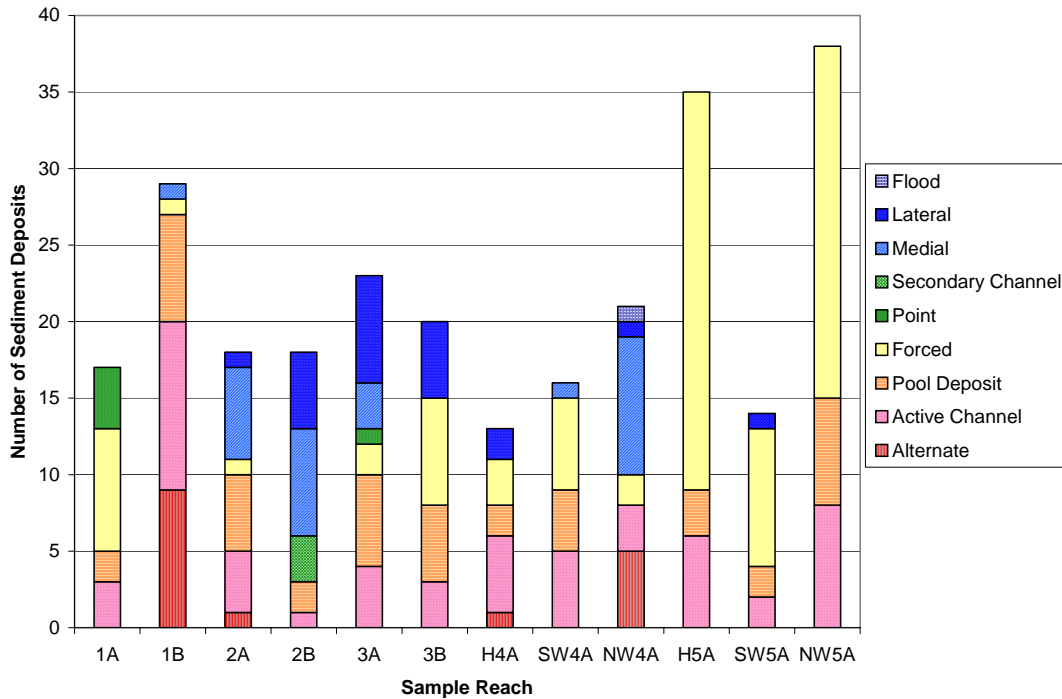
Figure 21. Number and type of bars in each sample reach.
